## Memorandum

From: Tim Hawke (Maven Waikato Limited)

Subject: Ashbourne - Infrastructure Technical Memorandum for Referral

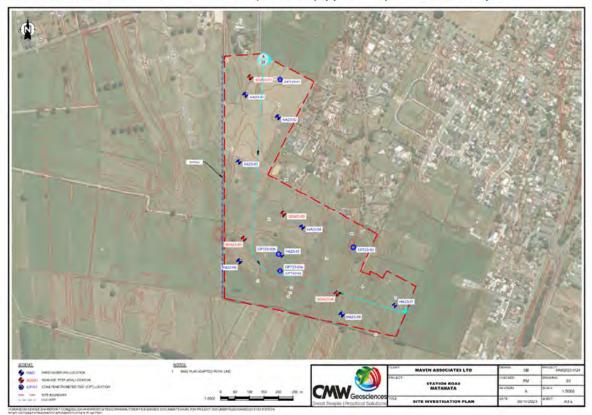
CMW Site Investigation Plan 1

CMW were engaged by Maven in December 2023 to prepare a geotechnical investigation report for the central residential and southern residential blocks, refer to (Appendix B) for the CMW report.

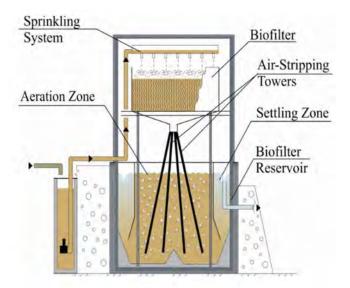
Wastewater Treatment Plant Treatment Process

The treated greywater would discharge to the ground prior to entering an artificial wetland. The treated sludge would then be carted offsite using a honey sucker truck and then sent to a nearby approved landfill or worm farm for offsite disposal.

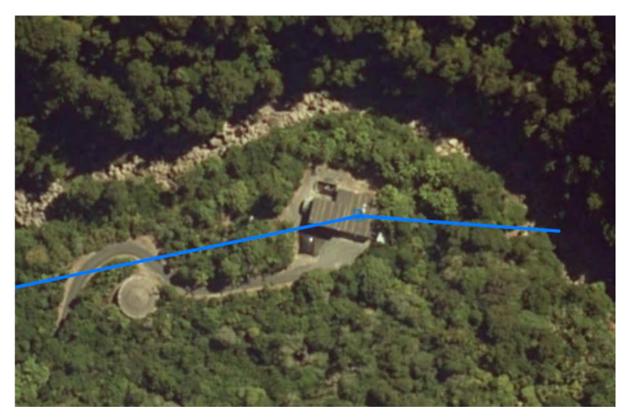
Matamata Water Treatment Plant

Matamata township has one existing centralised water treatment plant, located at the end of Tills Road in Okauia. The raw water is sourced from the stream flows off the Kaimai ranges. An average of 4.7 million litres of water is collected on average per day. The only known public upgrades for the water supply network are upgrading the water supply measurement instruments and no network upgrades.

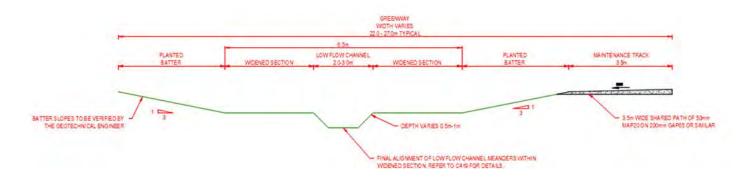
**Greenway Corridor**

The proposed greenway is sized to accommodate the 100-year ARI stormwater event flows less the 10-year ARI event flows from the residential Catchment B and the Retirement Village Catchment B. The greenway will provide the stormwater treatment prior to discharging into the Waitoa River.

To provide for future maintenance of the greenway a 3.5m wide maintenance track will be constructed along the northern side of the greenway. The maintenance track will also provide a shared access track for pedestrians and cyclists. The greenway will have widened sections to provide some additional flood storage and to enhance the aesthetics of the greenway. The typical greenway sections are shown below.

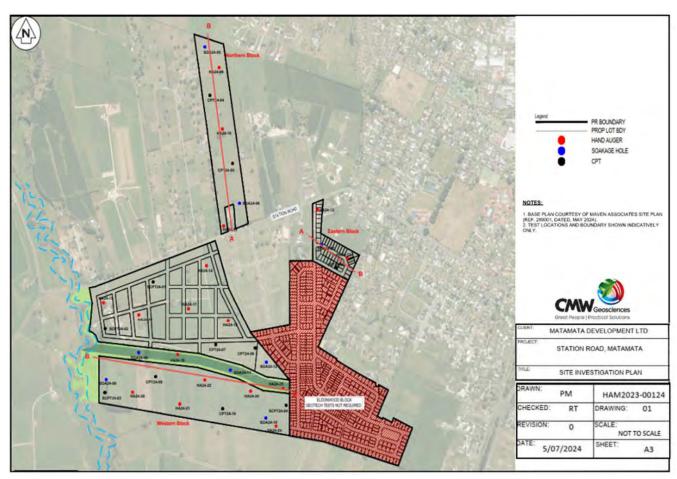
CMW Site Investigation Plan 2

CMW were engaged by Maven in July 2024 to prepare a preliminary geotechnical investigation report for the Ashbourne solar farm sites, the retirement village site and 127 Station Road Residential northern block site. Refer to (Appendix D) for the CMW report.

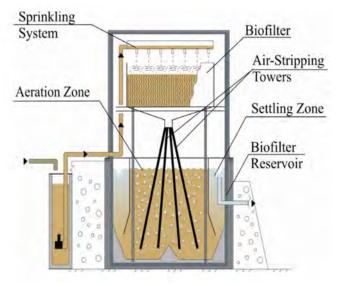
**Wastewater Treatment Plant Treatment Process**

The treated greywater would discharge to the ground prior to entering an artificial wetland. The treated sludge would then be carted offsite using a honey sucker truck and then sent to a nearby approved landfill or worm farm for offsite disposal.

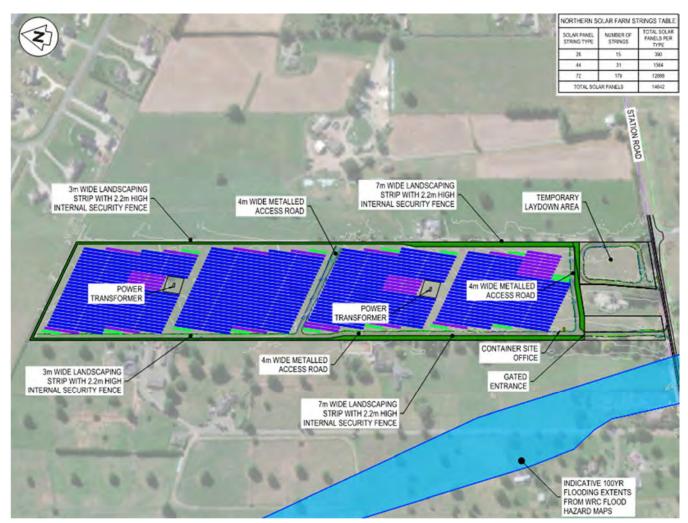
Northern Solar Farm Site

The northern Solar farm site is located at 172 Station Road. This solar farm site will include 14,642 solar panels, power transformers, 4m wide access tracks. The site will have a 2.2m high internal perimeter security fence and a 3m wide landscape perimeter strip between the boundary and the security fence and it will be extended to 7m wide strip where the boundary adjoins with the rural properties, where there are houses and main accessways. The Solar Farm will generate 9.04MW of power per day.

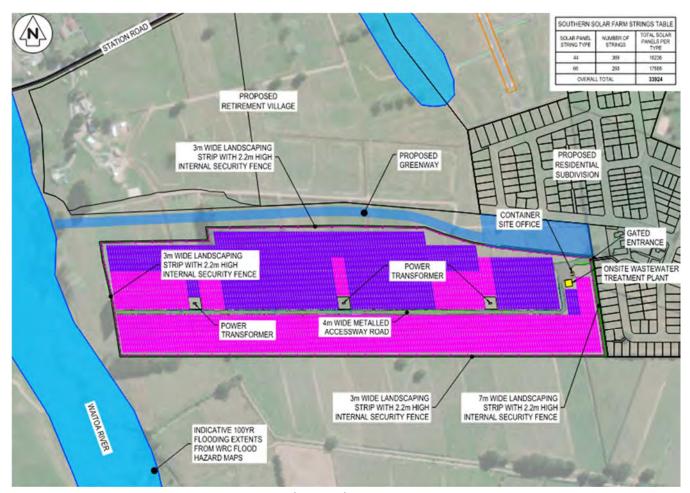
Southern Solar Farm Site

The Southern Solar Farm site is south of the proposed greenway and to the west of the proposed Ashbourne residential subdivision. This solar farm site will include 33,924 solar panels, power transformers, a 4m wide central access track, an onsite wastewater treatment plant. The onsite wastewater treatment plant will service Ashbourne residential development. The site will have a 2.2m high internal perimeter security fence and a 3m wide landscape perimeter strip between the boundary and the security fence and it will be extended to 7m wide strip where the boundary adjoins with the residential properties. The Solar Farm will generate 21.03MW of power per day.

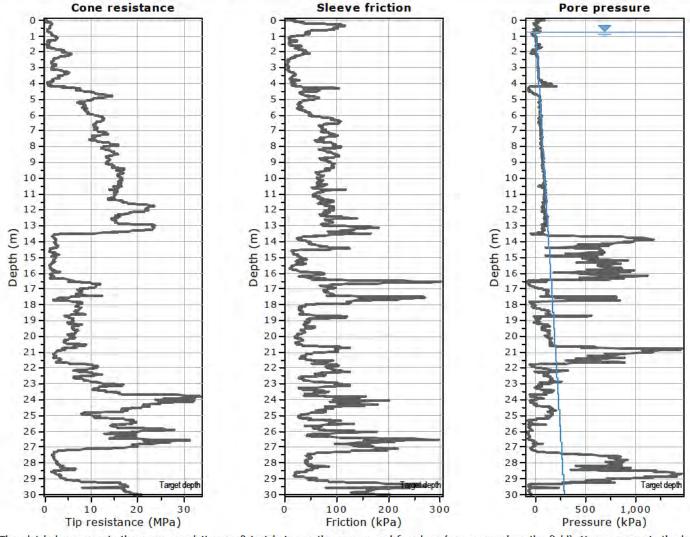
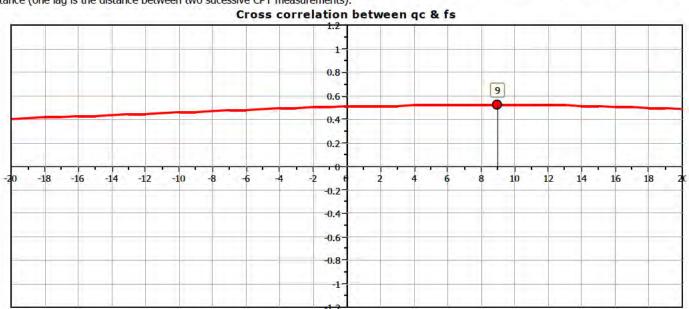
CPT: 23-01

Project: CMW Geosciences | HAM2023-0124 | GDS NZ Ltd Location: Peakdale Dr - Matamata | Holes dipped onsite using Dipmeter Total depth: 30.01 m, Date: 24/11/2023 Coords: lat -37.820381° lon 175.759032°

The plot below presents the cross correlation coeficient between the raw qc and fs values (as measured on the field). X axes presents the lag distance (one lag is the distance between two sucessive CPT measurements).

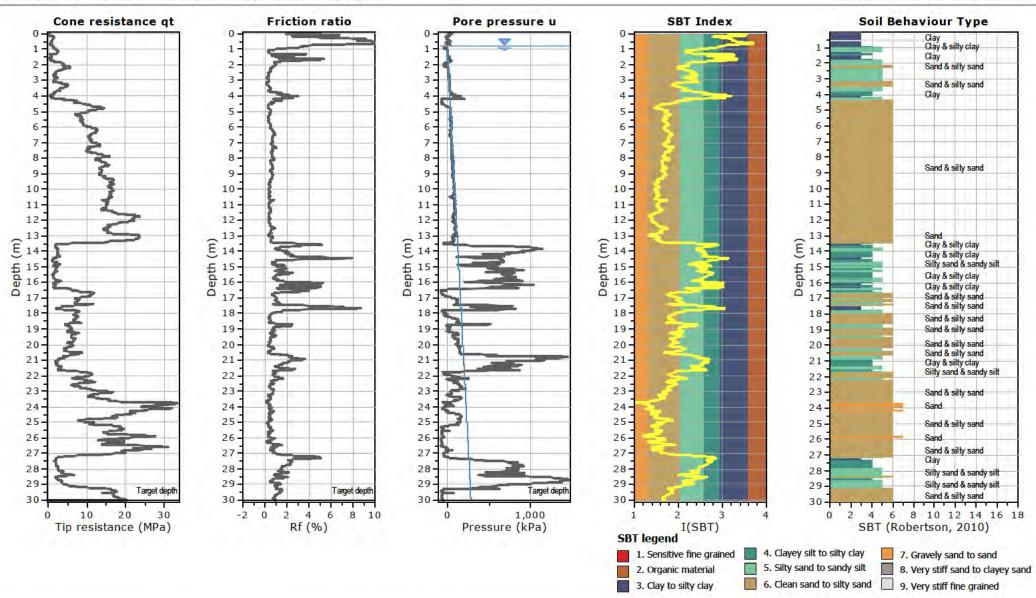
CPT: 23-01
Total depth: 30.01 m, Date: 24/11/2023
Coords: lat -37.820381° lon 175.759032°

Location: Peakdale Dr - Matamata | Holes dipped onsite using Dipmeter

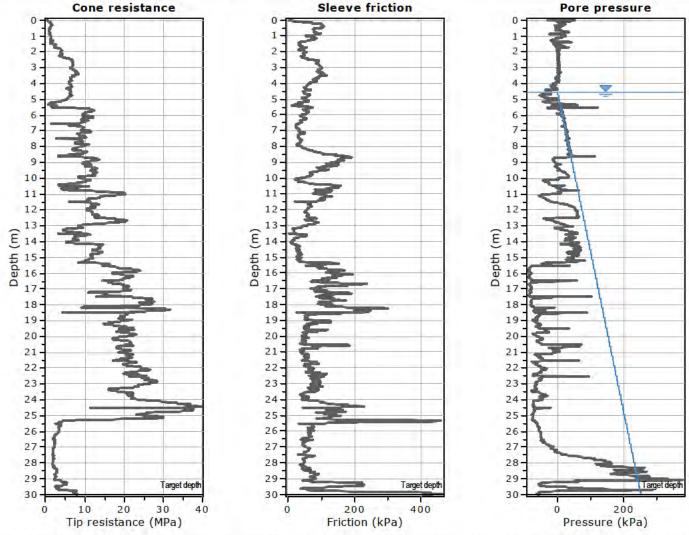
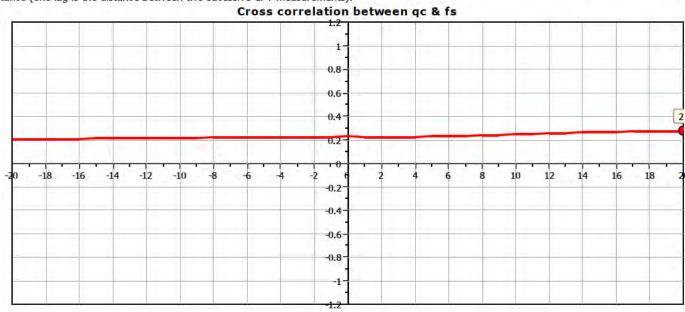
Total depth: 30.02 m, Date: 24/11/2023 Coords: lat -37.825563° lon 175.762228°

The plot below presents the cross correlation coeficient between the raw qc and fs values (as measured on the field). X axes presents the lag distance (one lag is the distance between two sucessive CPT measurements).

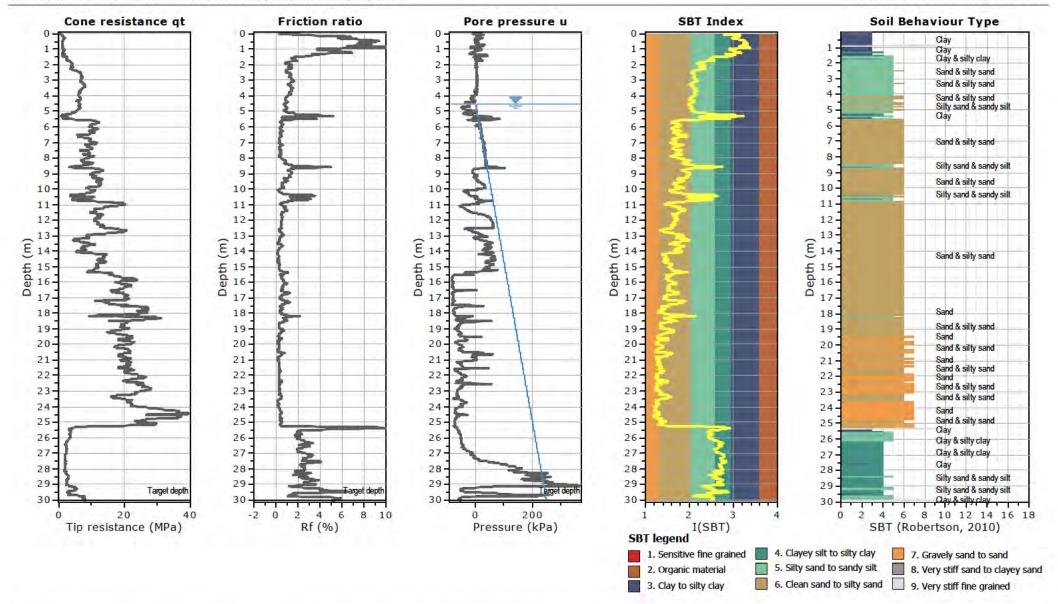
**CPT: 23-02**Total depth: 30.02 m, Date: 24/11/2023
Coords: lat -37.825563° lon 175.762228°

Location: Peakdale Dr - Matamata | Holes dipped onsite using Dipmeter

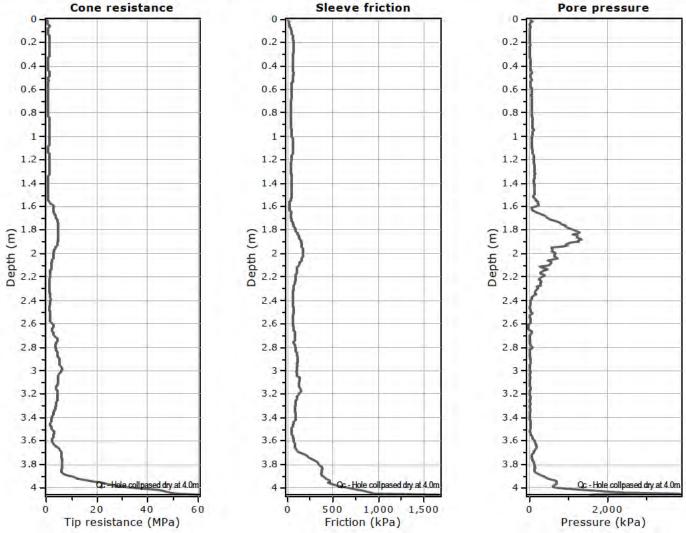
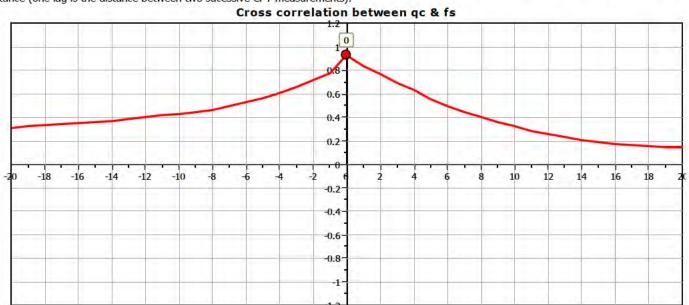
Total depth: 4.06 m, Date: 24/11/2023 Coords: lat -37.826393° lon 175.75937°

The plot below presents the cross correlation coeficient between the raw qc and fs values (as measured on the field). X axes presents the lag distance (one lag is the distance between two sucessive CPT measurements).

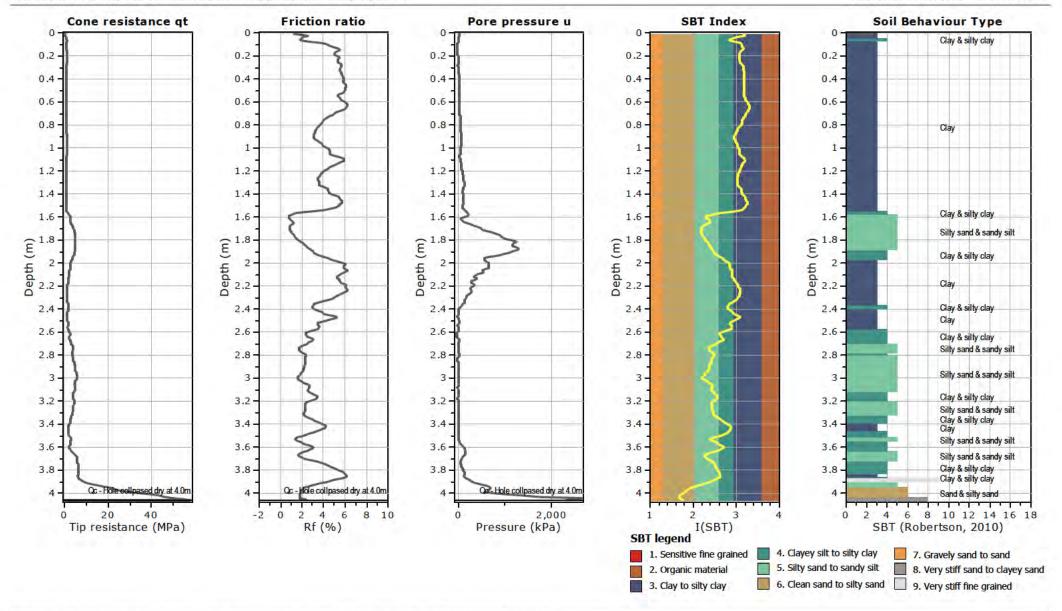
**CPT: 23-03**Total depth: 4.06 m, Date: 24/11/2023
Coords: lat -37.826393° lon 175.75937°

Location: Peakdale Dr - Matamata | Holes dipped onsite using Dipmeter

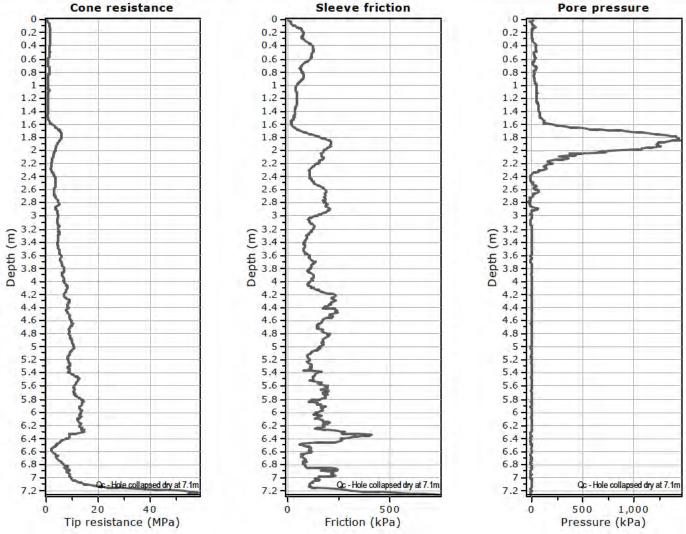
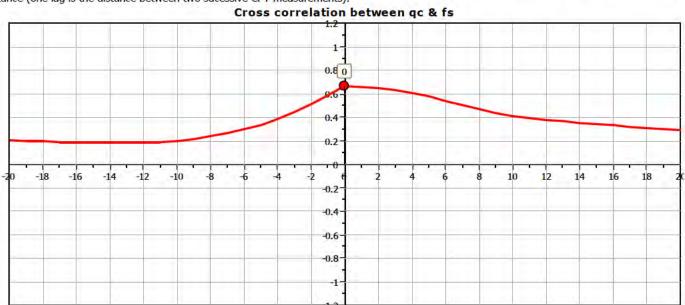
Total depth: 7.26 m, Date: 24/11/2023 Coords: lat -37.826395° lon 175.759397°

The plot below presents the cross correlation coeficient between the raw qc and fs values (as measured on the field). X axes presents the lag distance (one lag is the distance between two sucessive CPT measurements).

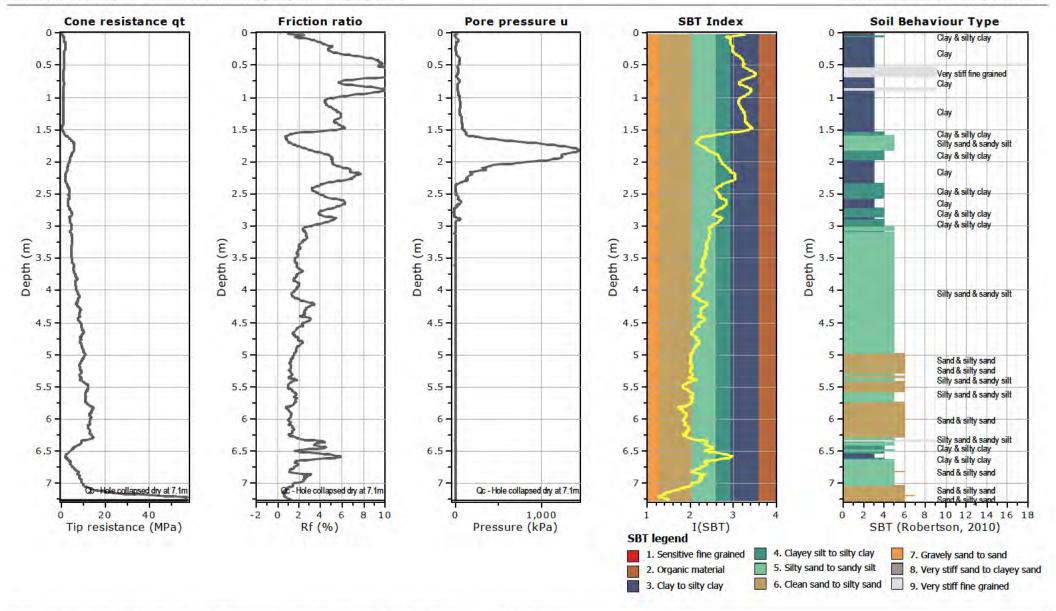
**CPT: 23-03a**Total depth: 7.26 m, Date: 24/11/2023
Coords: lat -37.826395° lon 175.759397°

Location: Peakdale Dr - Matamata | Holes dipped onsite using Dipmeter

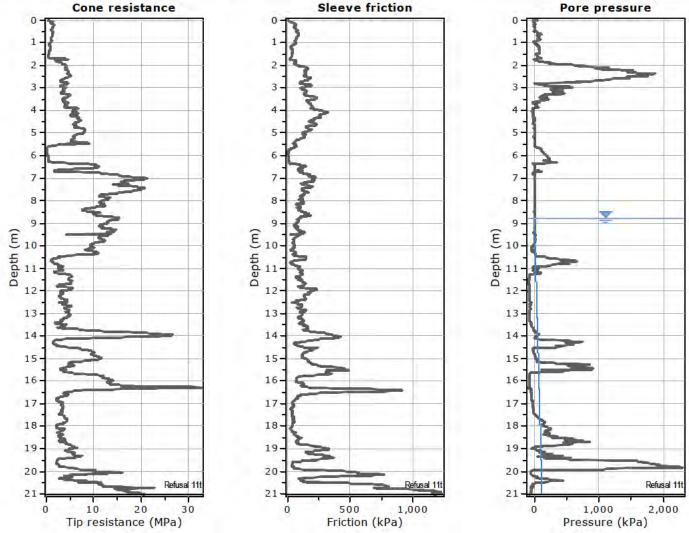
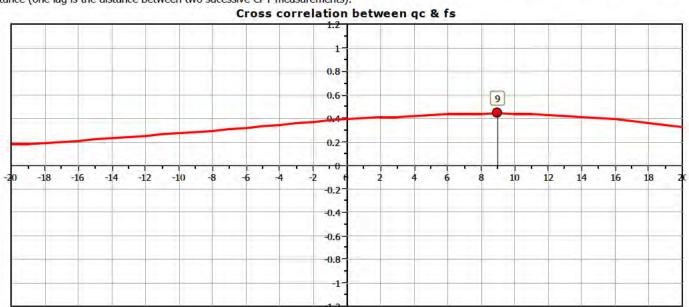
CPT: 23-03b

Project: CMW Geosciences | HAM2023-0124 | GDS NZ Ltd Location: Peakdale Dr - Matamata | Holes dipped onsite using Dipmeter Total depth: 21.04 m, Date: 24/11/2023 Coords: lat -37.825805° lon 175.759309°

The plot below presents the cross correlation coeficient between the raw qc and fs values (as measured on the field). X axes presents the lag distance (one lag is the distance between two sucessive CPT measurements).

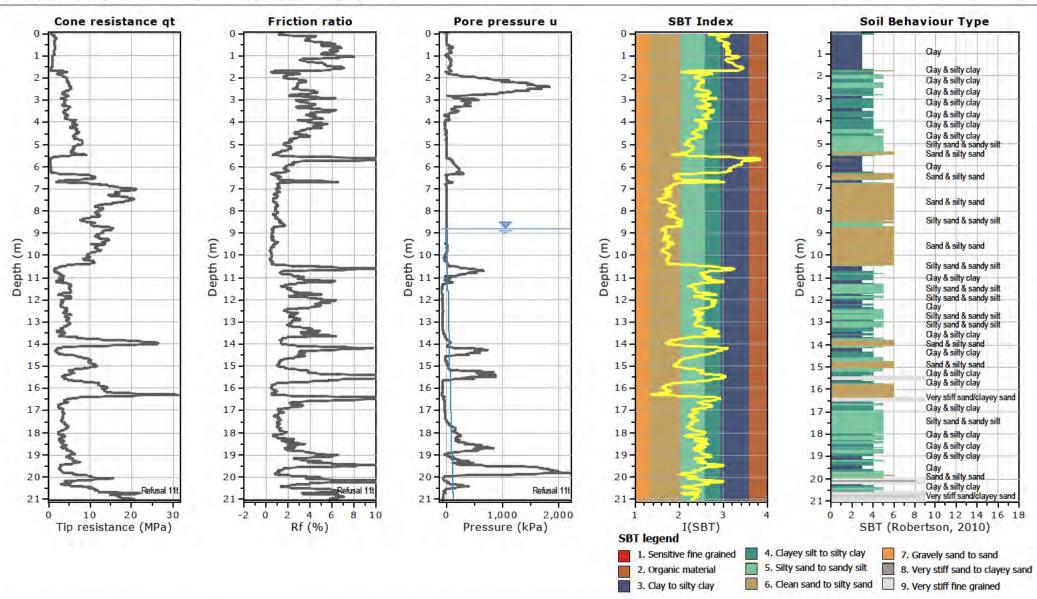
**CPT: 23-03b** Total depth: 21.04 m, Date: 24/11/2023

Coords: lat -37.825805° lon 175.759309°

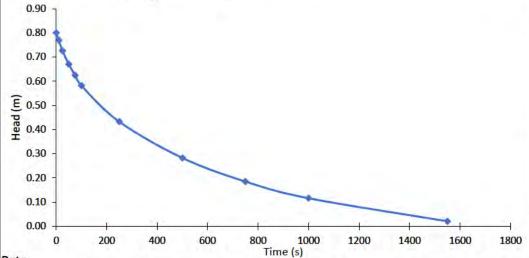
Time (s)	Tape Avg (m)	Head (m)	Perm. Length	Hvorslev 'k'	CIRIA 113 'k'
0	0.000	0.800	(m)	Case G (ms <sup>-1</sup> )	(ms <sup>-1</sup> )
10	0.030	0.770	0.785	1.41E-05	7.04E-05
25	0.074	0.726	0.748	1.49E-05	7.23E-05
50	0.129	0.671	0.698	1.26E-05	5.83E-05
75	0.175	0.625	0.648	1.19E-05	5.20E-05
100	0.218	0.582	0.603	1.24E-05	5.18E-05
250	0.368	0.433	0.507	9.59E-06	3.59E-05
500	0.518	0.283	0.358	1.01E-05	3.03E-05
750	0.616	0.184	0.234	1.24E-05	2.86E-05
1000	0.684	0.116	0.150	1.62E-05	2.88E-05
1550	0.780	0.020	0.068	3.31E-05	4.55E-05

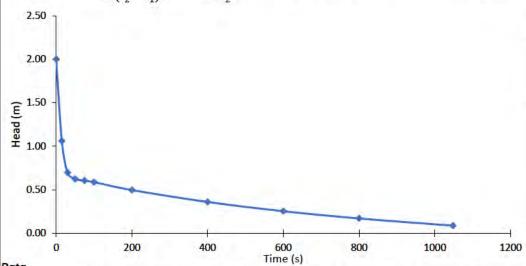
Time (s)	Tape Avg (m)	Head (m)	Perm. Length	Hvorslev 'k'	CIRIA 113 'k'
0	0.000	2.000	(m)	Case G (ms <sup>-1</sup> )	(ms <sup>-1</sup> )
15	0.941	1.060	1.530	9.89E-05	8.57E-04
30	1.305	0.695	0.878	9.63E-05	5.36E-04
50	1.376	0.624	0.660	2.25E-05	1.00E-04
75	1.396	0.604	0.614	5.52E-06	2.33E-05
100	1.414	0.586	0.595	5.24E-06	2.16E-05
200	1.504	0.496	0.541	7.82E-06	3.04E-05
400	1.641	0.359	0.427	8.67E-06	2.90E-05
600	1.747	0.253	0.306	1.13E-05	3.04E-05
800	1.831	0.169	0.211	1.53E-05	3.30E-05
1048	1.914	0.086	0.128	2.47E-05	4.10E-05

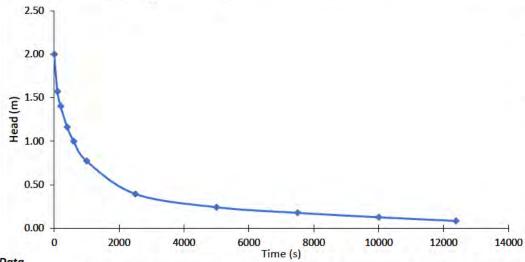
Time (s)	Tape Avg (m)	Head (m)	Perm. Length	Hvorslev 'k'	CIRIA 113 'k'
0	0.000	2.000	(m)	Case G (ms <sup>-1</sup> )	(ms <sup>-1</sup> )
100	0.429	1.571	1.785	5.04E-06	4.65E-05
200	0.599	1.401	1.486	2.72E-06	2.17E-05
400	0.837	1.163	1.282	2.47E-06	1.77E-05
600	1.001	0.999	1.081	2.26E-06	1.43E-05
1000	1.229	0.771	0.885	2.21E-06	1.22E-05
2500	1.607	0.393	0.582	2.00E-06	8.70E-06
5000	1.759	0.241	0.317	1.24E-06	3.48E-06
7500	1.824	0.176	0.208	9.65E-07	2.05E-06
10000	1.875	0.125	0.150	1.17E-06	2.06E-06
12380	1.917	0.083	0.104	1.67E-06	2.41E-06

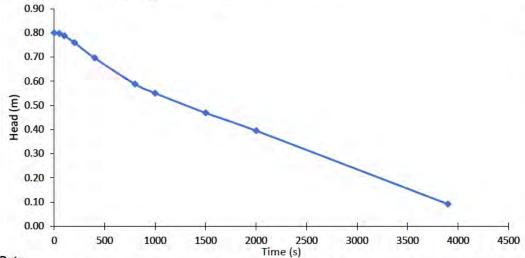
1.35E-06 ms<sup>-1</sup>

0.12 m/day

Time (s)	Tape Avg (m)	Head (m)	Perm. Length	Hvorslev 'k'	CIRIA 113 'k'
0	0.000	0.800	(m)	Case G (ms <sup>-1</sup> )	(ms <sup>-1</sup> )
50	0.002	0.798	0.799	1.83E-07	9.26E-07
100	0.012	0.788	0.793	9.06E-07	4.57E-06
200	0.040	0.760	0.774	1.35E-06	6.68E-06
400	0.104	0.697	0.728	1.70E-06	8.06E-06
800	0.212	0.588	0.642	1.77E-06	7.75E-06
1000	0.250	0.550	0.569	1.50E-06	6.00E-06
1500	0.331	0.469	0.510	1.56E-06	5.80E-06
2000	0.405	0.395	0.432	1.82E-06	6.08E-06
3000					
3900	0.709	0.091

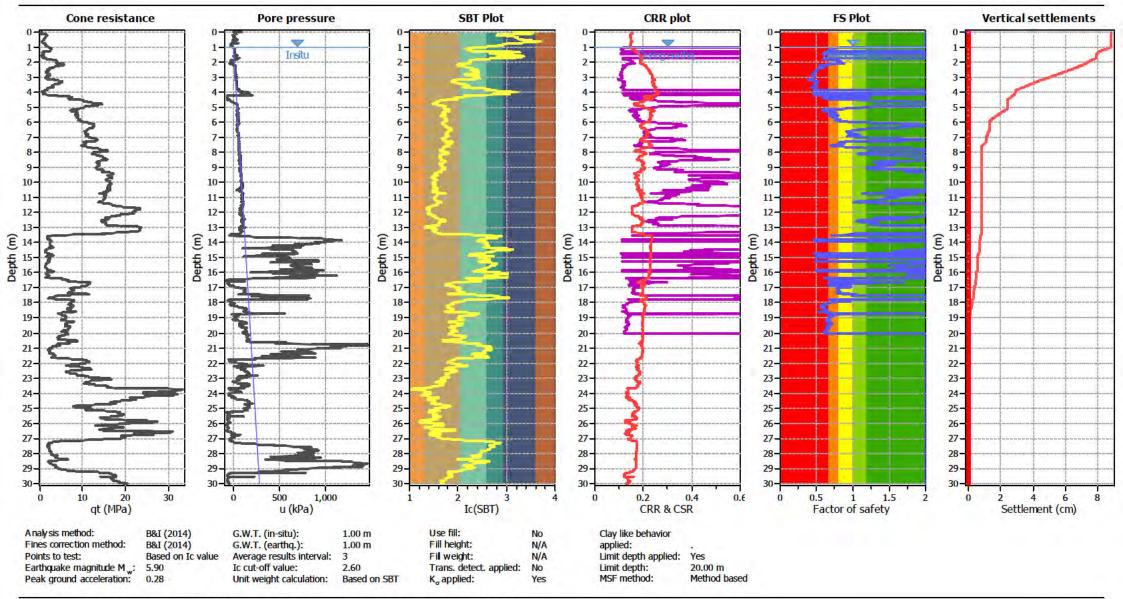
Project: Location: **CPT: CPT23-01**

Total depth: 30.01 m

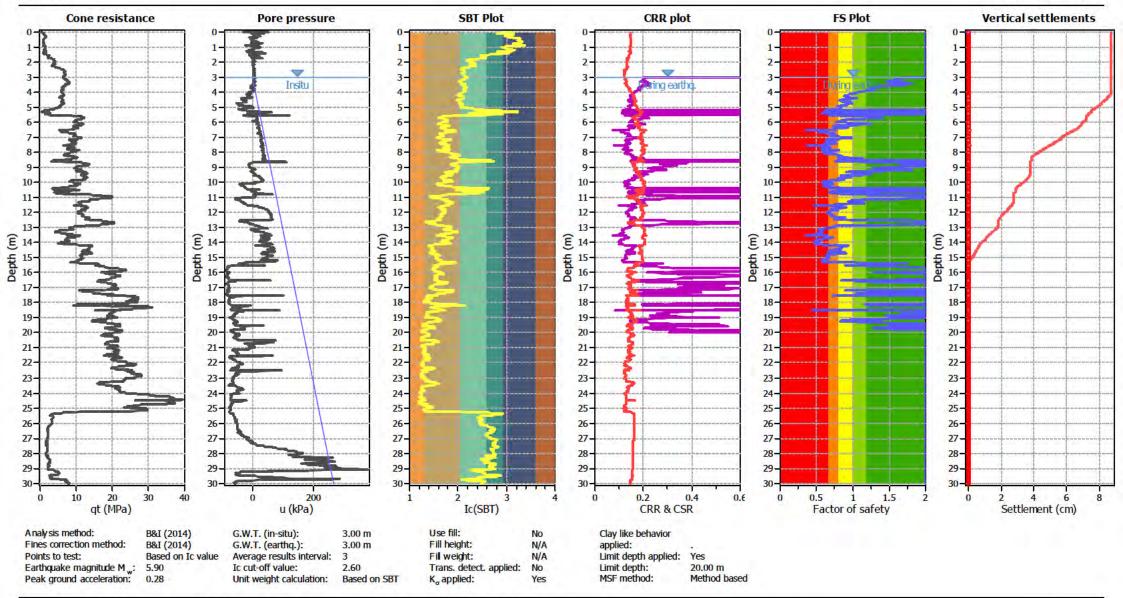
Project: Location: CPT: CPT23-02

Total depth: 30.02 m

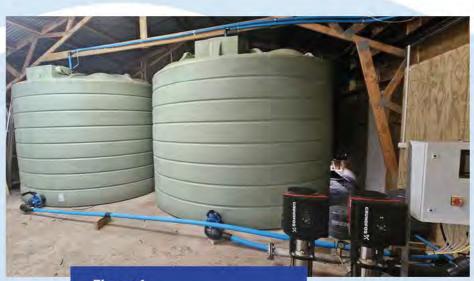
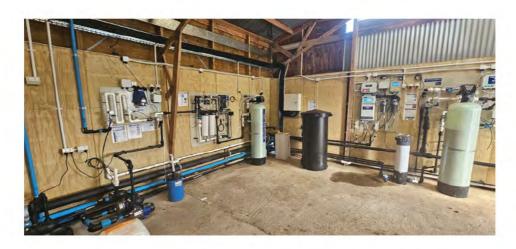
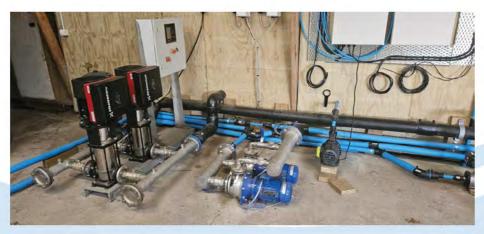
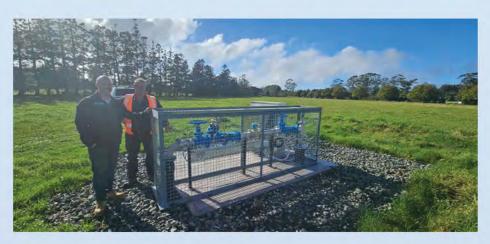
Figure 1 Installations at Waipapa

We designed headworks and reticulation for 26 L/s headworks coupled to a 1 to 16 l/s irrigation pump set and reticulation system. We designed a 12.5 L/s 110 kPa fire reticulation system including water storage. We also designed an 8 L/s Purification with Temple Water and the reticulation system for the complete sports facility.

Figure 1 Below are some photos of the construction. The pumps are in operation and irrigation of the sports fields have been in operation for the last week without any hick ups. We will do official commissioning and hand over early in April.

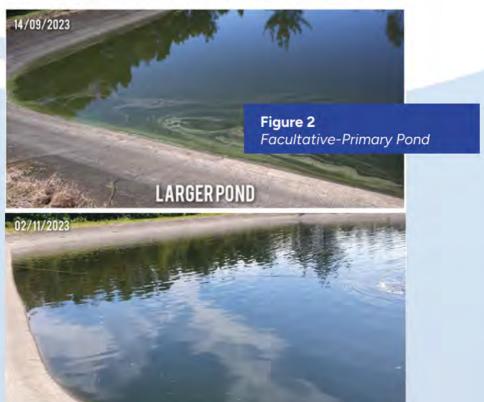
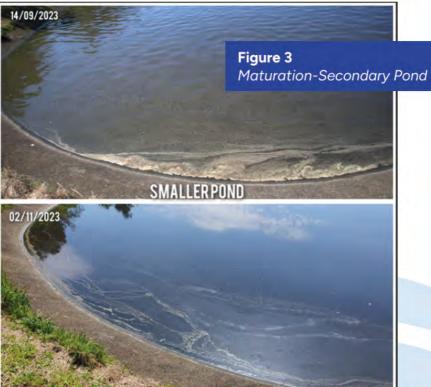
Figure 2 indicates the visible change in the condition of the facultative pond in the first two months of application.

Figure 3 indicates the visible change in the condition of the maturation pond in the first two months of application.

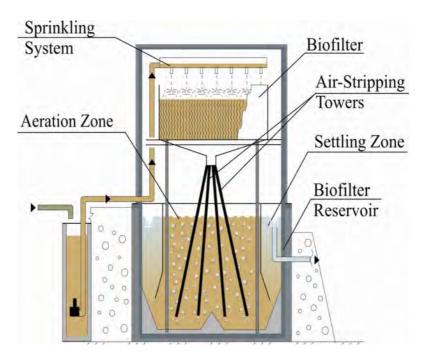
- Waste water is mixed with activated sludge in mixing the chamber
- Sludge mixture is pumped to the biofilter sprinkling system by the circulation pump
- Falling drops are broken upon the disks and sprinkled across the biofilter feed
- Liquid exiting the biofilter feed is collected in collection tray
- Sludge mixture is conveyed by air-stripping towers to the aeration zone of the aeration tank

- Natural aeration with shock treatment and bubble flow in aeration zone
- Sludge from settling zone is pumped back to the mixing chamber completing the cycle
- Pure water is collected in the collection trays in the settling zones and gravitates to anoxic zone for denitrification

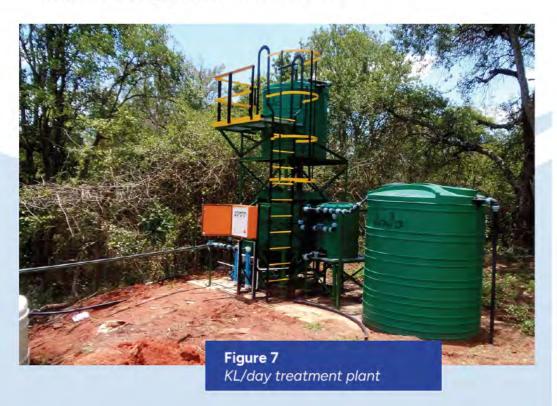
Figure 7 is a photo of a 12.5 KL/day plant we constructed. The process remains the same for plants from 12 500 L/day up to 120 000 L/day. The blocks expand and increase parabolically as treatment capacity increases.

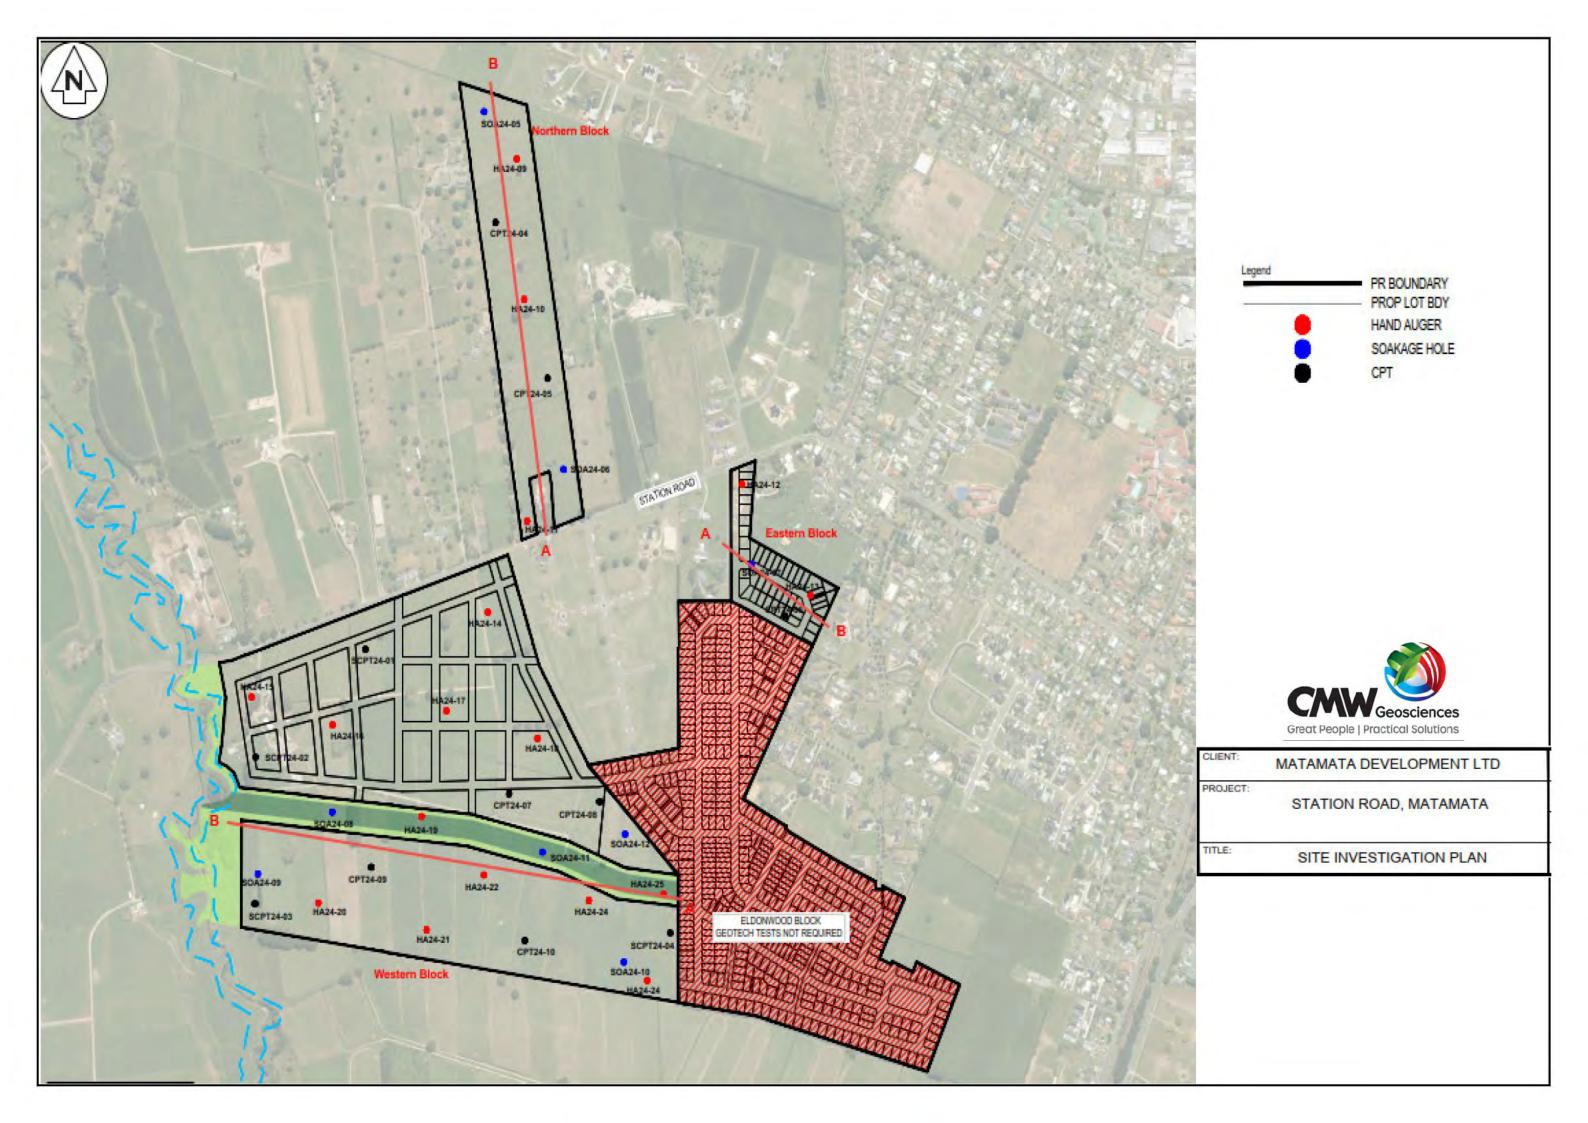
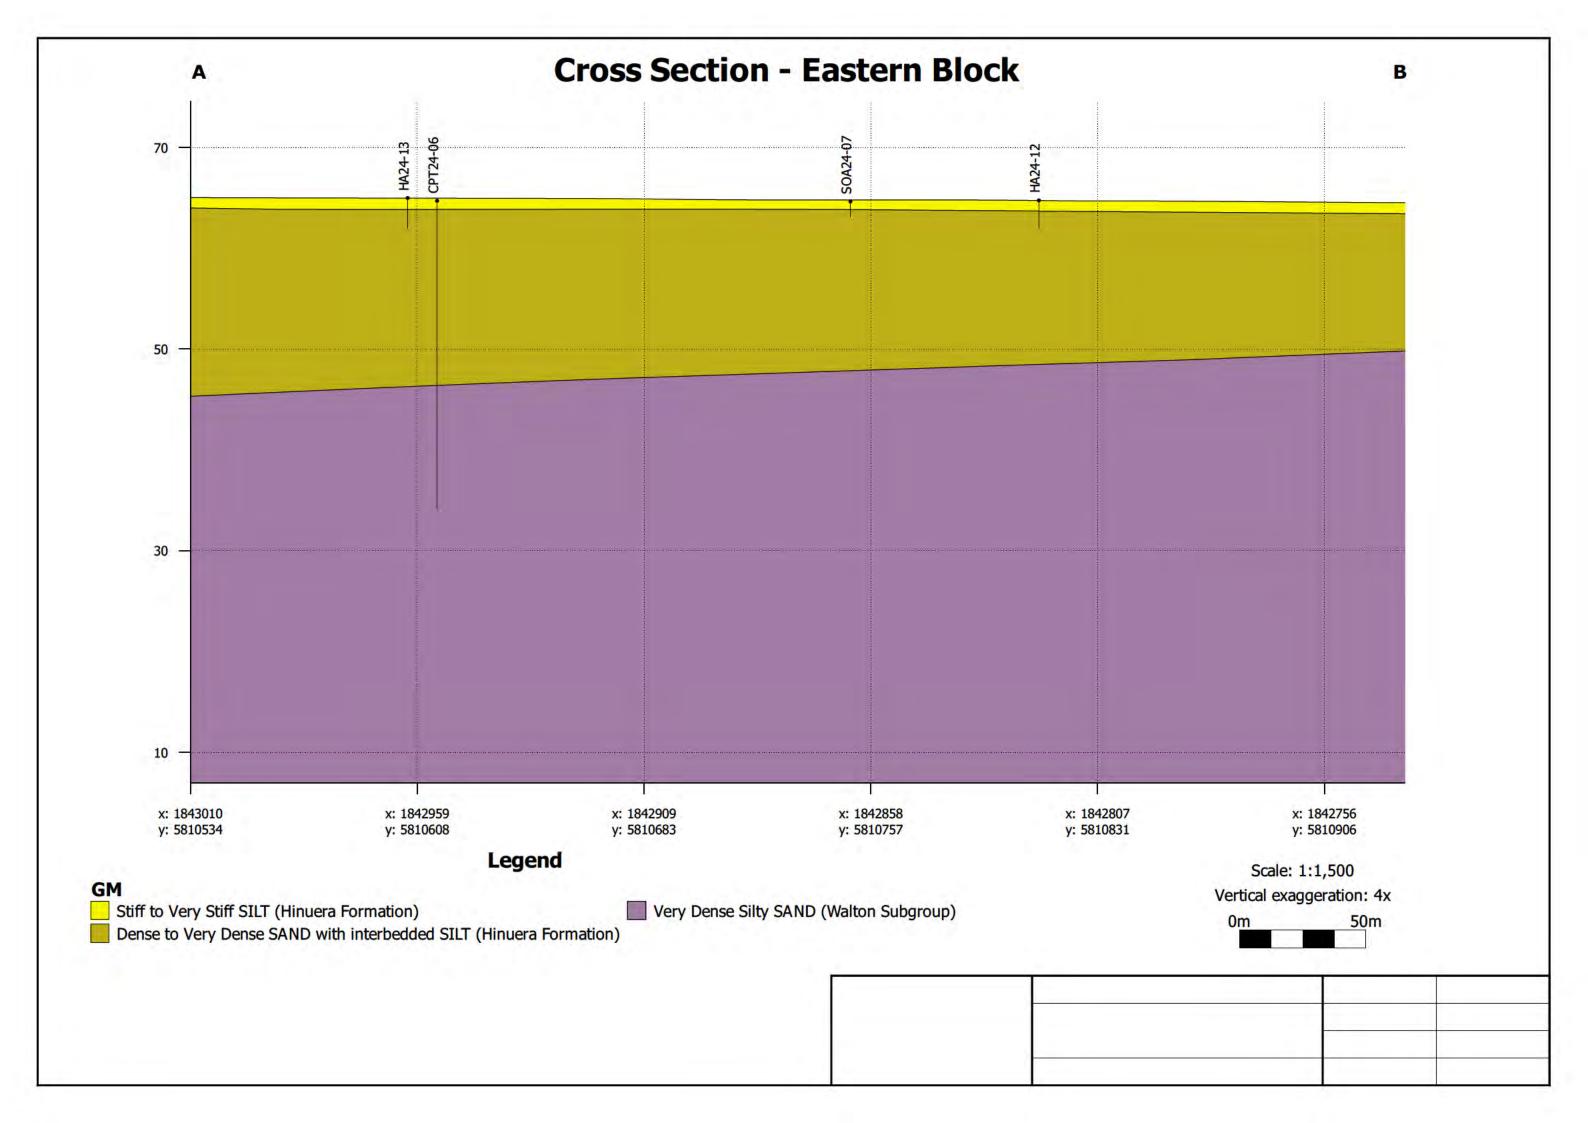
Title	Reference No.	Date	Revision
Site Investigation Plan	1	05/07/2024	0
Cross Section A – Eastern Block	2	05/07/2024	0
Cross Section B – Northern Block	3	05/07/2024	0
Cross Section C – Western Block	4	05/07/2024	0

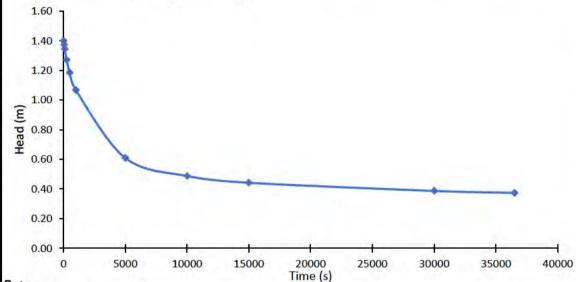
6.54E-07 ms<sup>-1</sup>

0.06 m/day

Time (s)	Tape Avg (m)	Head (m)	Perm. Length	Hvorslev 'k'	CIRIA 113 'k'
0	0.000	1.400	(m)	Case G (ms <sup>-1</sup> )	(ms <sup>-1</sup> )
50	0.027	1.373	0.900	1.32E-06	7.40E-06
100	0.056	1.344	0.900	1.42E-06	7.97E-06
250	0.129	1.271	0.900	1.26E-06	7.04E-06
500	0.216	1.184	0.900	9.56E-07	5.35E-06
1000	0.333	1.067	0.900	7.05E-07	3.93E-06
5000	0.791	0.609	0.838	4.95E-07	2.72E-06
10000	0.913	0.487	0.548	2.07E-07	8.13E-07
15000	0.958	0.442	0.465	9.99E-08	3.49E-07
30000	1.013	0.387	0.414	4.83E-08	1.57E-07
36510	1.026	0.374	0.380	3.07E-08	9.39E-08

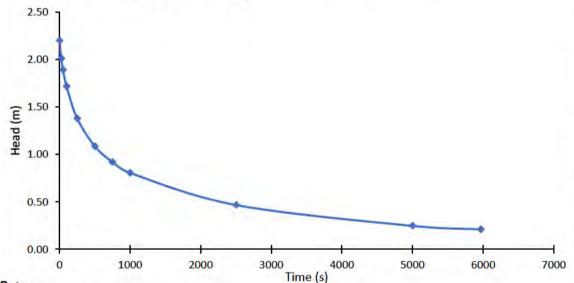
2.80E-06 ms<sup>-1</sup>

0.24 m/day

Time (s)	Tape Avg (m)	Head (m)	Perm. Length	Hvorslev 'k'	CIRIA 113 'k'
0	0.000	2.200	(m)	Case G (ms <sup>-1</sup> )	(ms <sup>-1</sup> )
25	0.186	2.014	2.207	6.32E-06	6.78E-05
50	0.308	1.892	2.053	4.71E-06	4.77E-05
100	0.483	1.718	1.905	3.85E-06	3.69E-05
250	0.820	1.380	1.649	3.23E-06	2.80E-05
500	1.114	1.086	1.333	2.46E-06	1.82E-05
750	1.280	0.920	1.103	1.96E-06	1.25E-05
1000	1.395	0.805	0.963	1.71E-06	9.90E-06
2500	1.734	0.466	0.736	1.40E-06	6.95E-06
5000	1.954	0.246	0.456	1.32E-06	4.68E-06
5970	1.990	0.210	0.328	1.03E-06	2.72E-06

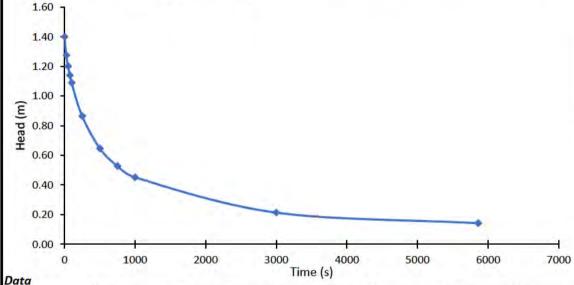
4.94E-06 ms<sup>-1</sup>

0.43 m/day

Time (s)	Tape Avg (m)	Head (m)	Perm. Length	Hvorslev 'k'	CIRIA 113 'k'
0	0.000	1.400	(m)	Case G (ms <sup>-1</sup> )	(ms <sup>-1</sup> )
25	0.125	1.275	1.000	1.17E-05	7.07E-05
50	0.199	1.201	1.000	7.58E-06	4.55E-05
75	0.260	1.140	1.000	6.49E-06	3.89E-0
100	0.311	1.089	1.000	5.79E-06	3.46E-0
250	0.535	0.865	1.000	4.83E-06	2.90E-0
500	0.753	0.647	0.856	4.04E-06	2.17E-0
750	0.873	0.527	0.687	3.29E-06	1.49E-0
1000	0.949	0.451	0.589	2.76E-06	1.12E-0
3000	1.187	0.213	0.432	1.99E-06	6.94E-0
5860	1.258	0.142	0.278	9.56E-07	2.26E-0

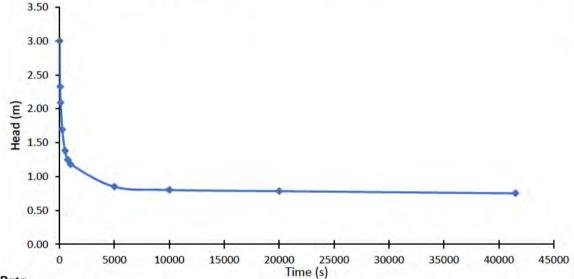
1.84E-06 ms<sup>-1</sup>

0.16 m/day

EOH@3m

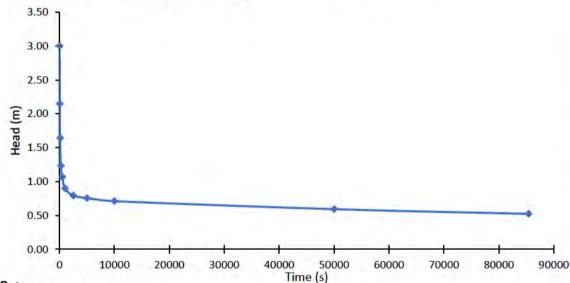
2.92E-06 ms<sup>-1</sup>

0.25 m/day

Silt
	Sand
	Silt
ЕОН	@ 3m

Time (s)	Tape Avg (m)	Head (m)	Perm. Length	Hvorslev 'k'	CIRIA 113 'k'
0	0.000	3.000	(m)	Case G (ms <sup>-1</sup> )	(ms <sup>-1</sup> )
50	0.853	2.147	2.573	1.07E-05	1.31E-04
100	1.357	1.644	1.895	1.07E-05	1.03E-04
250	1.767	1.233	1.438	4.68E-06	3.68E-05
500	1.934	1.066	1.149	1.66E-06	1.10E-05
1000	2.102	0.898	0.982	1.09E-06	6.43E-06
2500	2.207	0.793	0.846	2.91E-07	1.54E-06
5000	2.245	0.756	0.774	7.29E-08	3.62E-07
10000	2.290	0.710	0.733	4.80E-08	2.29E-07
50000	2.408	0.592	0.651	1.89E-08	8.35E-08
85440	2.477	0.523	0.557	1.61E-08	6.38E-08

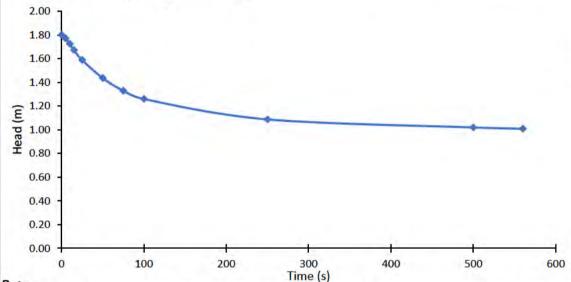
7.00E-06 ms<sup>-1</sup>

0.60 m/day

Time (s)	Tape Avg (m)	Head (m)	Perm. Length	Hvorslev 'k'	CIRIA 113 'k'
0	0.000	1.800	(m)	Case G (ms <sup>-1</sup> )	(ms <sup>-1</sup> )
5	0.031	1.769	1.785	7.19E-06	6.56E-05
10	0.077	1.723	1.746	1.12E-05	1.00E-04
15	0.127	1.673	1.698	1.30E-05	1.14E-04
25	0.213	1.587	1.630	1.17E-05	9.97E-05
50	0.364	1.436	1.511	9.45E-06	7.63E-05
75	0.472	1.328	1.382	7.81E-06	5.89E-05
100	0.541	1.259	1.293	5.67E-06	4.07E-05
250	0.713	1.087	1.173	2.75E-06	1.85E-05
500	0.781	1.019	1.053	7.83E-07	4.84E-06
560	0.792	1.008	1.013	5.74E-07	3.45E-06

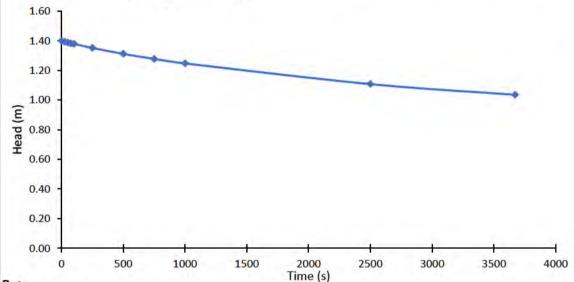
2.80E-07 ms<sup>-1</sup>

0.02 m/day

Time (s)	Tape Avg (m)	Head (m)	Perm. Length	Hvorslev 'k'	CIRIA 113 'k'	
0	0.000	1.400	(m)	Case G (ms <sup>-1</sup> )	(ms <sup>-1</sup> )	
25	0.007	1.393	1.597	4.41E-07	3.69E-06	
50	0.013	1.387	1.590	3.99E-07	3.32E-06	
75	0.018	1.383	1.585	3.02E-07	2.52E-06	
100	0.021	1.379	1.581	2.44E-07	2.03E-06	
250	0.048	1.352	1.565	3.03E-07	2.49E-06	
500	0.088	1.312	1.532	2.82E-07	2.28E-06	
750	0.122	1.278	1.495	2.49E-07	1.98E-06	
1000	0.153	1.247	1.462	2.32E-07	1.82E-06	
2500	0.292	1.108	1.377	1.99E-07	1.49E-06	
3670	0.364	1.036	1.272	1.53E-07	1.08E-06

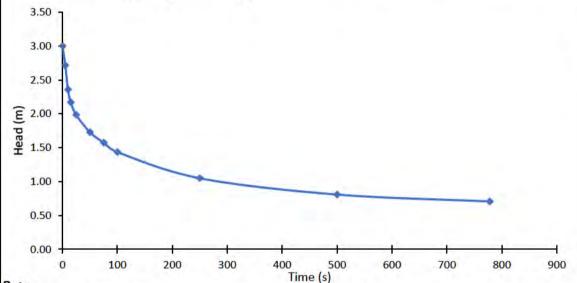
1.60E-05 ms<sup>-1</sup>

1.38 m/day

Silt	
Sand	
[ [44	
1

Time (s)	Tape Avg (m)	Head (m)	Perm. Length	Hvorslev 'k'	CIRIA 113 'k'	
0	0.000	3.000	(m)	Case G (ms <sup>-1</sup> )	(ms <sup>-1</sup> )	
5	0.287	2.713	2.857	2.96E-05	3.87E-04	
10	0.643	2.357	2.535	4.53E-05	5.42E-04	
15	0.832	2.168	2.262	2.93E-05	3.21E-04	
25	1.016	1.984	2.076	1.65E-05	1.70E-04	
50	1.273	1.727	1.855	1.13E-05	1.06E-04	
75	1.427	1.574	1.650	8.22E-06	7.08E-05	
100	1.566	1.434	1.504	8.78E-06	7.06E-05	
250	1.951	1.049	1.241	5.65E-06	4.00E-05	
500	2.193	0.807	0.928	3.45E-06	1.97E-05	
778	2.295	0.705	0.756	1.84E-06	9.01E-06

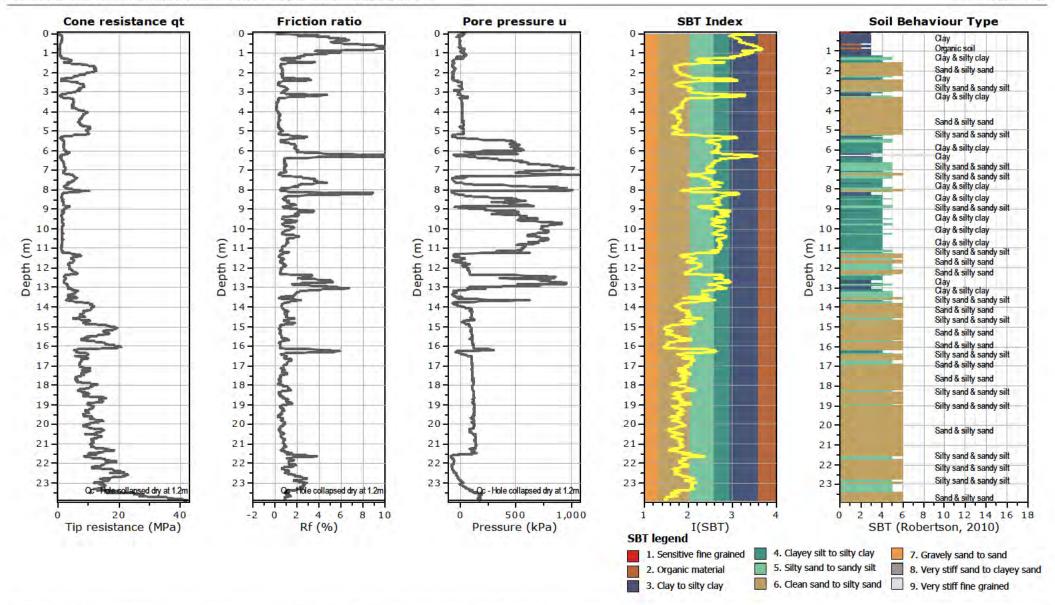
Total depth: 23.89 m, Date: 4/06/2024 Coords: lat -37.82614° lon 175.752408°

Cone Type: DC10

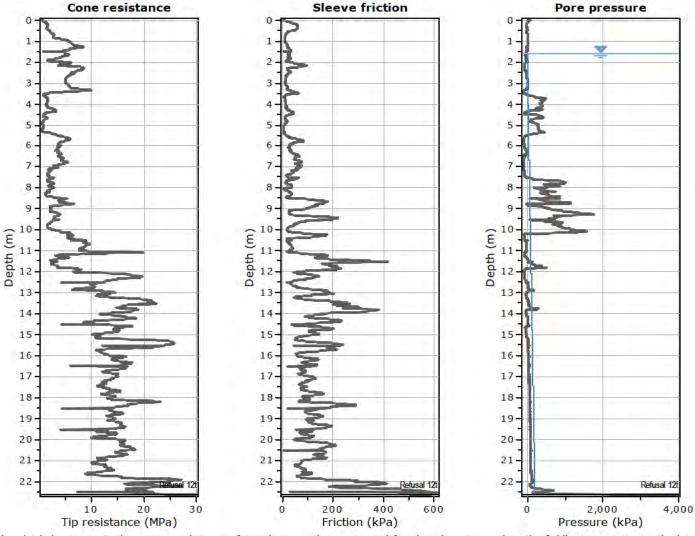
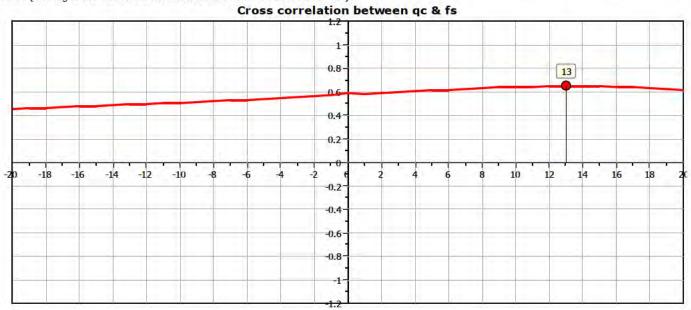
The plot below presents the cross correlation coeficient between the raw qc and fs values (as measured on the field). X axes presents the lag distance (one lag is the distance between two sucessive CPT measurements).

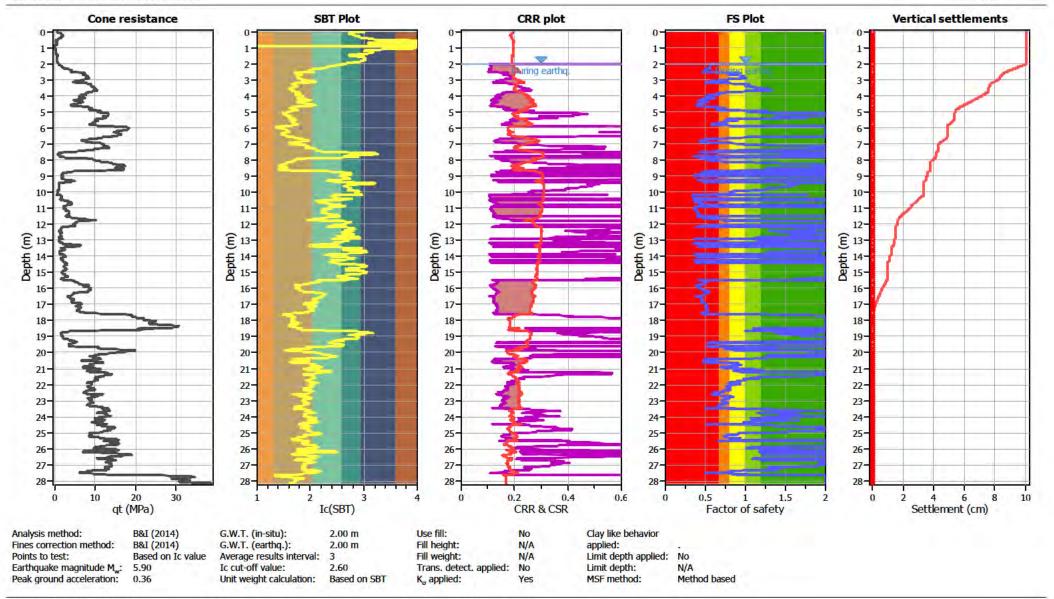
**CPT: CPT24-05**

Total depth: 28.14 m

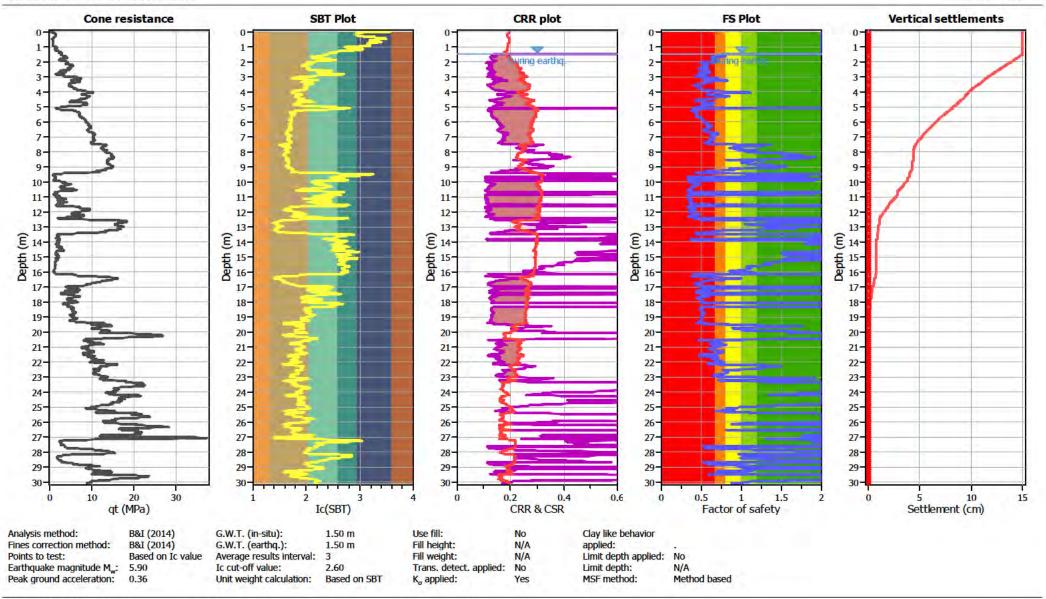
CPT: CPT24-07

Total depth: 30.07 m
