## Memorandum

From: Tim Hawke (Maven Waikato Limited)

Subject: Ashbourne - Infrastructure Technical Memorandum for Referral

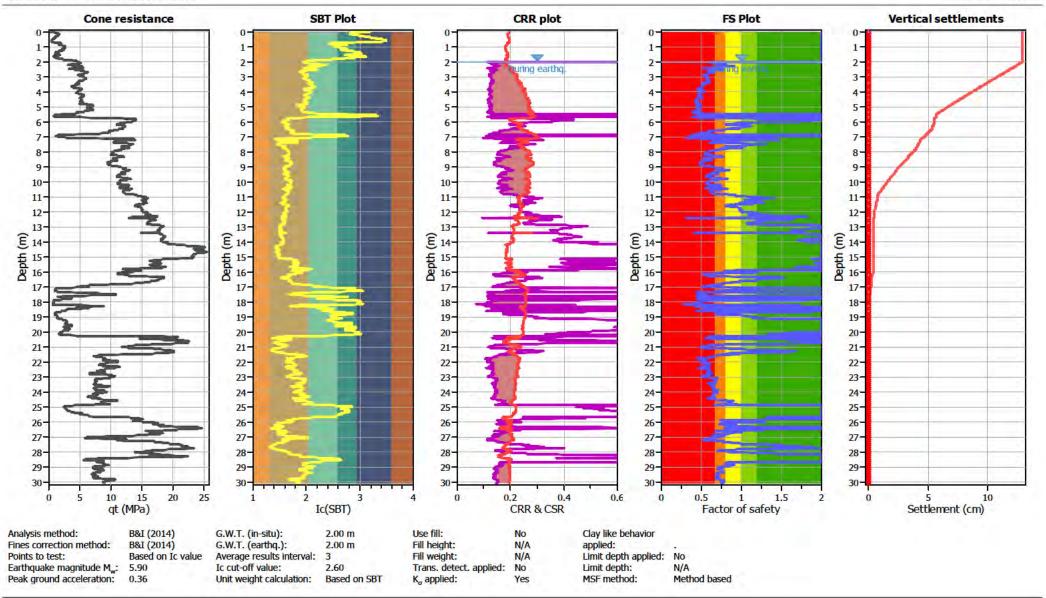
CPT: CPT24-08

Total depth: 30.08 m

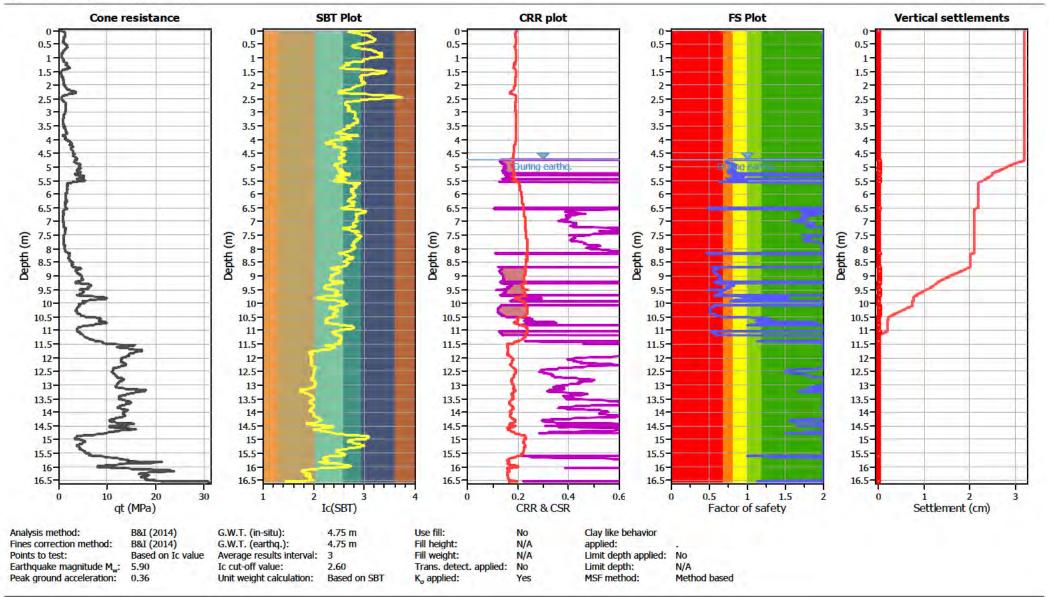
CPT: CPT24-09

Total depth: 16.56 m

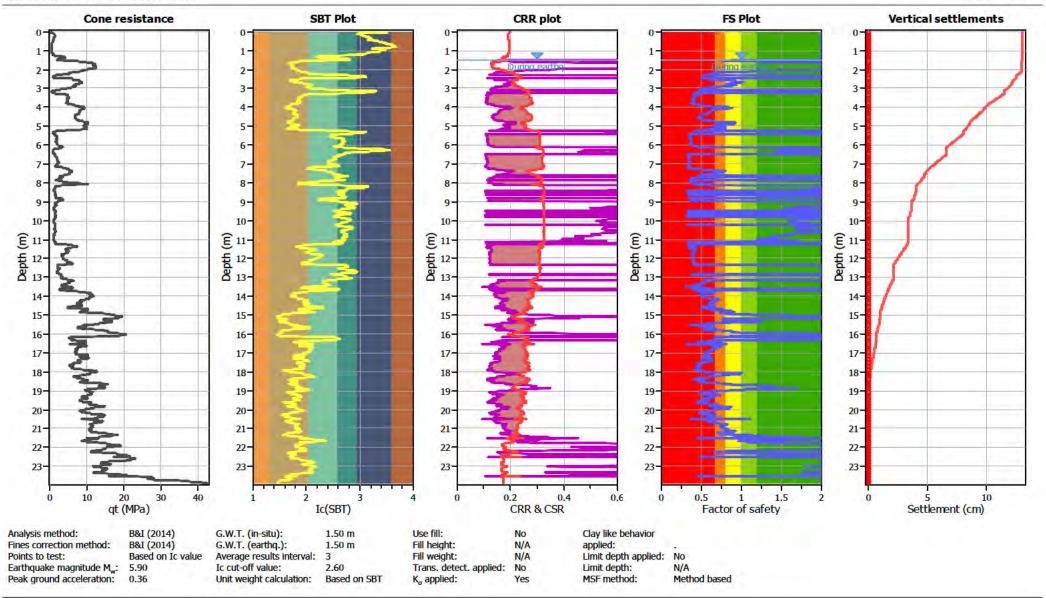
CPT: CPT24-10

Total depth: 23.89 m

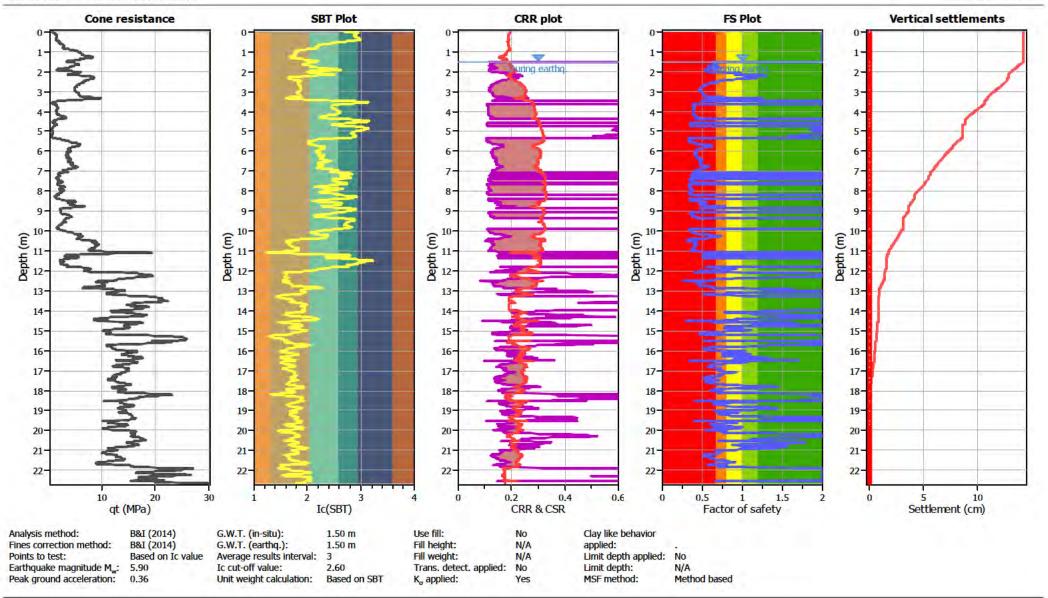
CPT: SCPT24-01

Total depth: 22.64 m

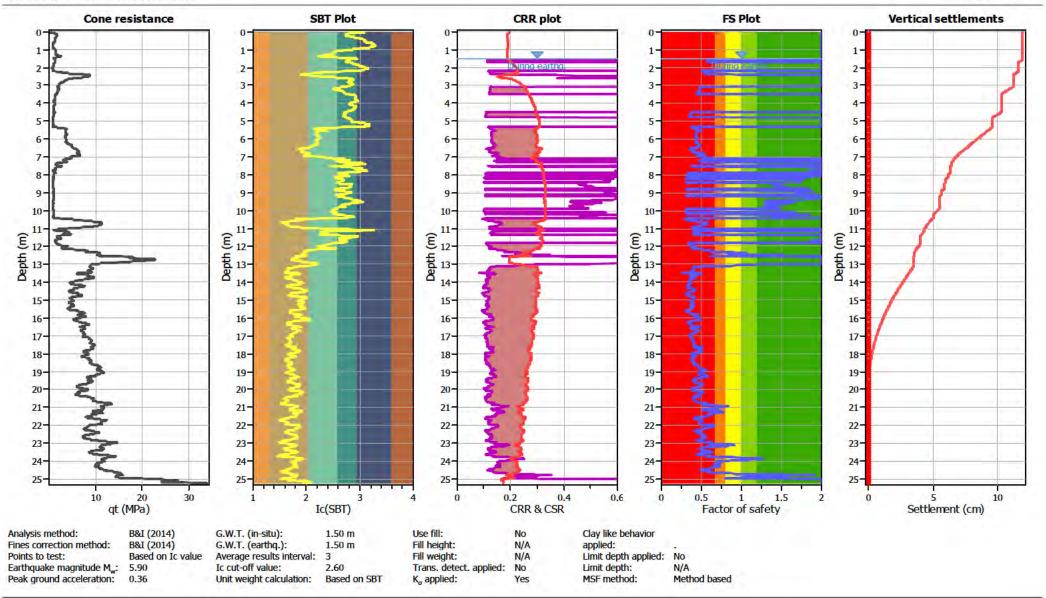
CPT: SCPT24-02

Total depth: 25.23 m

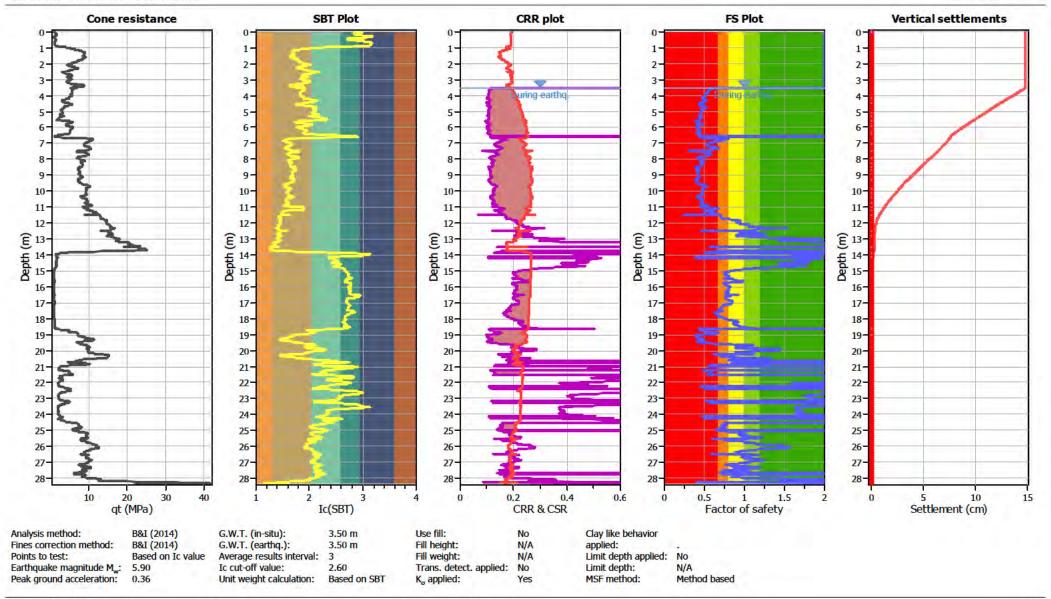
CPT: SCPT24-04

Total depth: 28.31 m
