# Delmore Fast Track Application

## Appendix 8: A21 (Auckland Transport - Stormwater) to Response to Comments letter

Re: Auckland Transport Stormwater Memorandum

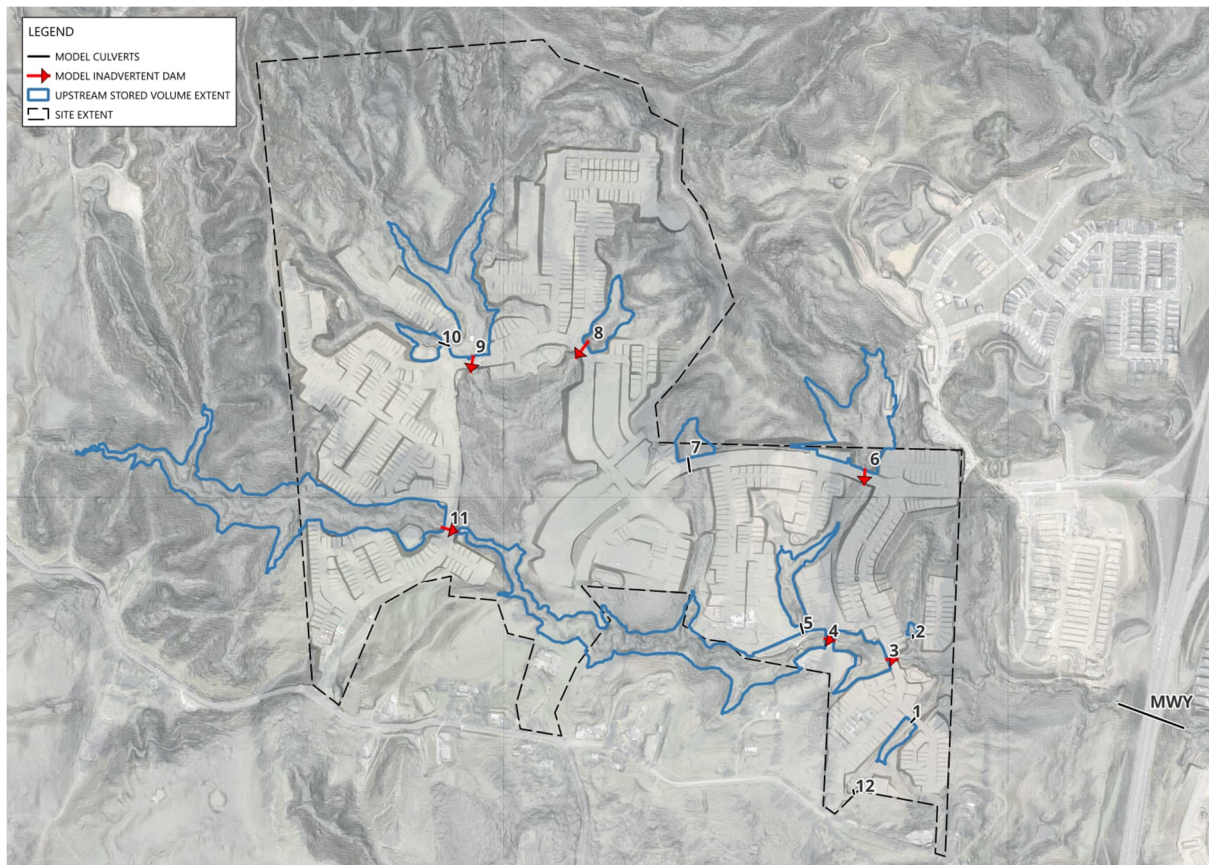
Of the twelve culverts assessed, Culverts 3, 4, 6, 8, 9, and 11 are identified as *inadvertent dam*. The remaining six culverts (Culverts 1, 2, 5, 7, 10, and 12) do not meet both criteria and are not identified as *inadvertent dam* (refer to Table 1 for results). Figure 1 shows the location of all the culvert embankments included in the classification assessment.

Figure 1: Location of culverts and inadvertent dams

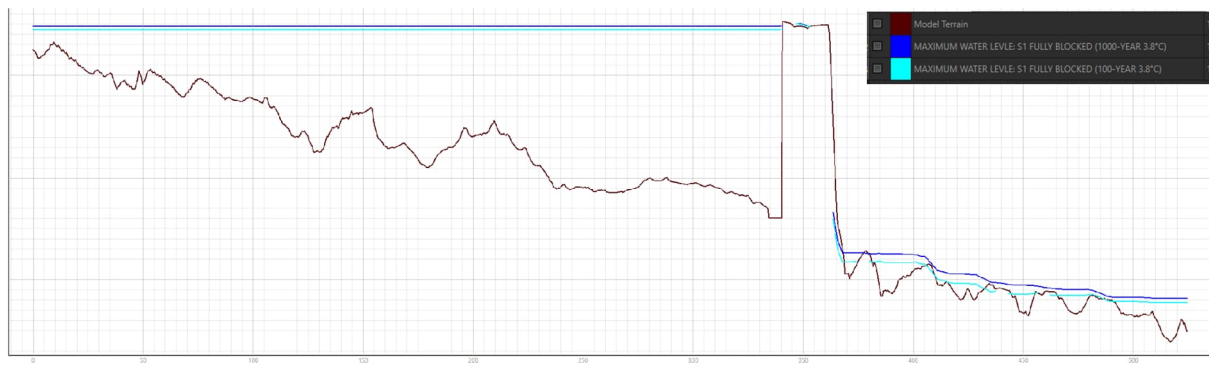
Figure: Embankment 9 cross-section

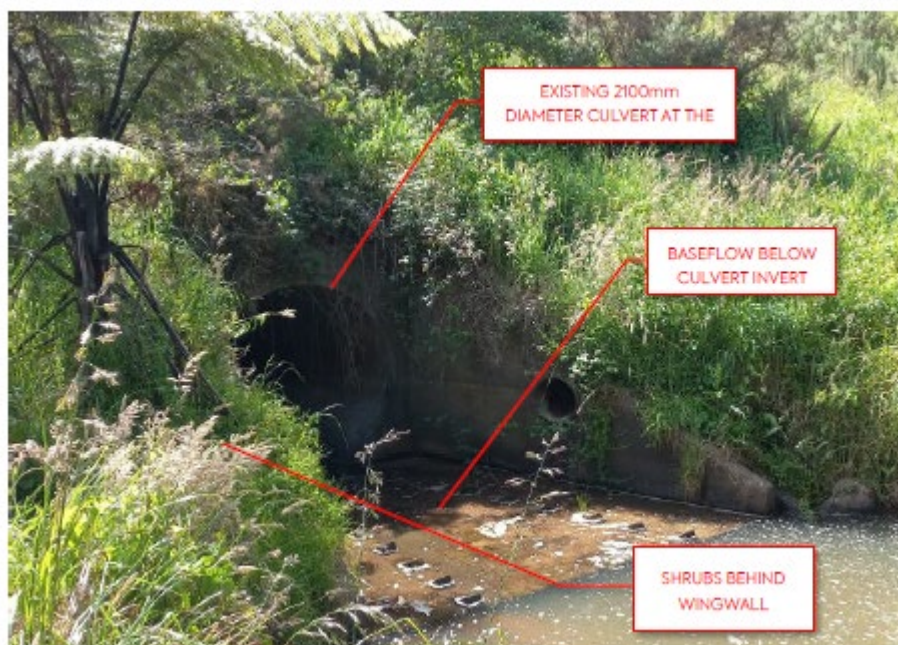
The SH1 embankment crosses the dam breach floodplain (Figure 2). Flows are passed under the embankment through a culvert. The inlet to the culvert is of large diameter (several meters). The hydraulic modelling considers 50% blockage of the culvert inlet, which is considered to be quite a conservative blockage scenario.

Figure 2: State Highway 1 Culvert (Reproduced from MCKENZIE & CO. Flood Assessment Report)

Regardless of the blockage assumed at the SH1 culvert inlet, flows downstream of the SH1 embankment are heavily attenuated. In all modelled scenarios, the flood extent remains very similar to the flood extent in the baseline (no dam breach) flood scenario. We have therefore limited the assessment of effects to areas upstream of the SH1 embankment. We note that there are a number of cultural sites and bridges downstream of the SH1 embankment.

Even if dams 06 and 11 were to breach while storing water to their crest, it seems unlikely that the SH1 embankment would overtop.

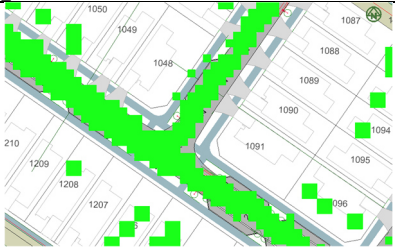
| Location | | Depth Map | Hazard Map | Comments |
|---|---|---|---|---|
| 1 | Road 21 / Road 18 | | | Flood Depth within this area ranges within 0mm to 150mm.<br><br>DxV are less than 0.4m <sup>2</sup> /s |

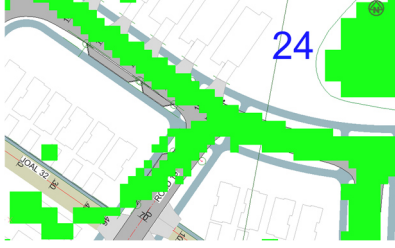
| Location | | Depth Map | Hazard Map | Comments |
|---|---|---|---|---|
| 4 | Road 19 / Road 18 | | | Flood Depth within this area ranges within 0mm to 200mm.<br><br>DxV are less than 0.4m <sup>2</sup> /s |

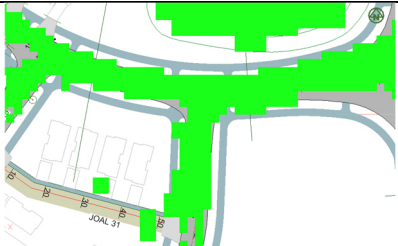
| 5 | Road 18 / Road 20 | | | <p>Flood Depth within this area ranges within 0mm to 200mm.</p> <p>DxV are less than 0.4m<sup>2</sup>/s</p> |

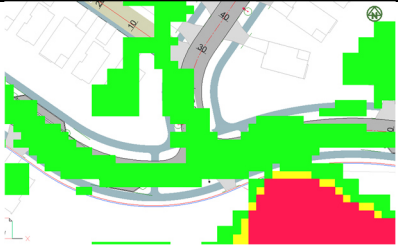
| 8 | Road 22 / Road 26 | | | <p>Flood Depth within this area ranges within 0mm to 400mm.</p> <p>DxV are less than 0.4m<sup>2</sup>/s</p> |

The predicted flood hazard at the identified discharge points 6, 8, 9, 11, 18, 19, 28, 30, 34 and 35 are characterised by depths between 300 mm and 400 mm, with D\*V values remaining below 0.4. While the resulting depths exceed Auckland Transport's preferred general thresholds for nuisance flooding, the associated hazard rating indicates that the flow conditions are low risk in terms of pedestrian and vehicle stability.

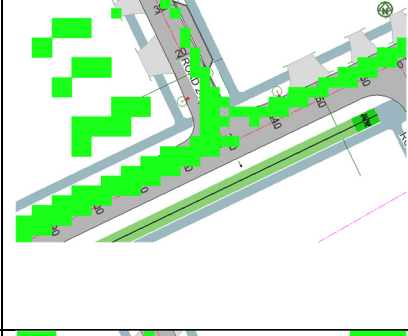
| 12 | Road 24 / 17 | | | <p>Flood Depth within this area ranges within 0mm to 150mm.</p> <p>DxV are less than 0.4m<sup>2</sup>/s</p> |

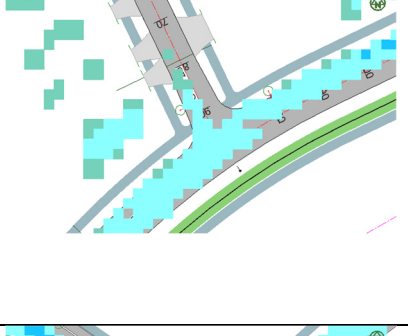
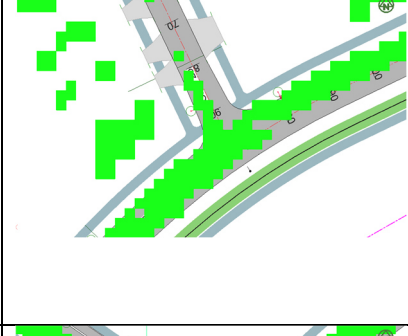
| 13 | Road 25 / Road 17 | | | <p>Flood Depth within this area ranges within 0mm to 100mm.</p> <p>DxV are less than 0.4m<sup>2</sup>/s</p> |

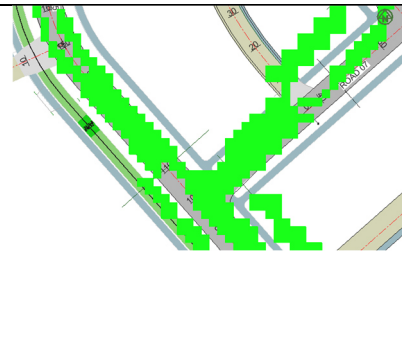
| 20 | Road 05 / Road 07 | | | <p>Flood Depth within this area ranges within 0mm to 200mm.</p> <p>DxV are less than 0.4m<sup>2</sup>/s</p> |

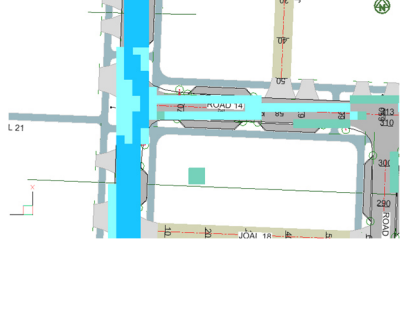
| 24 | Road 14 / Road 14 | | | <p>Flood Depth within this area ranges within 0mm to 150mm.</p> <p>DxV are less than 0.4m<sup>2</sup>/s</p> |

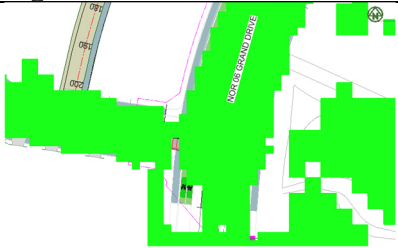
| 28 | Road 12 / Nor 06 Grand Drive | | | <p>Flood Depth within this area ranges within 0mm to 300mm.</p> <p>DxV are less than 0.4m<sup>2</sup>/s</p> |

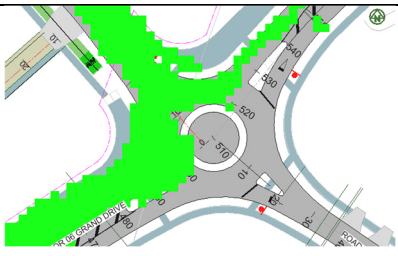
| 30 | Road 06 / Nor 06 Grand Drive / Road 05 | | | <p>Flood Depth within this area ranges within 0mm to 300mm.</p> <p>DxV are less than 0.4m<sup>2</sup>/s</p> |

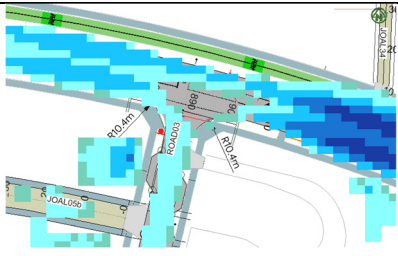
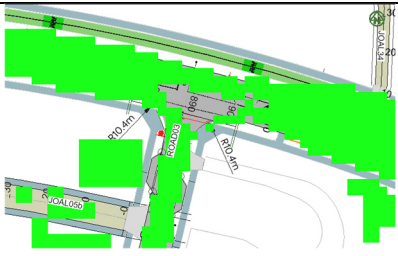
| 31 | Road 03 / Nor 6 Grand Drive | | | <p>Flood Depth within this area ranges within 0mm to 250mm.</p> <p>DxV are less than 0.4m<sup>2</sup>/s</p> |

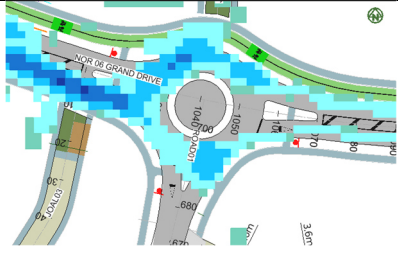
| 32 | Road 01 / Nor 6 Grand Drive | | | <p>Flood Depth within this area ranges within 0mm to 250mm.</p> <p>DxV are less than 0.4m<sup>2</sup>/s</p> |

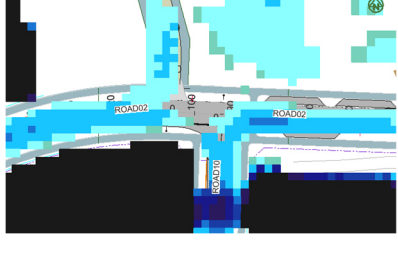
| 34 | Road 02 / Road 10 | | | <p>Flood Depth within this area ranges within 0mm to 350mm.</p> <p>DxV are less than 0.4m<sup>2</sup>/s</p> |

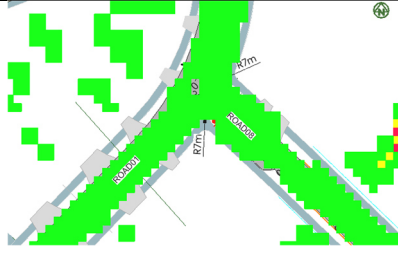
| 37 | Road 01 / Road 08 | | | Flood Depth within this area ranges within 0mm to 250mm.<br><br>DxV are less than 0.4m <sup>2</sup> /s |

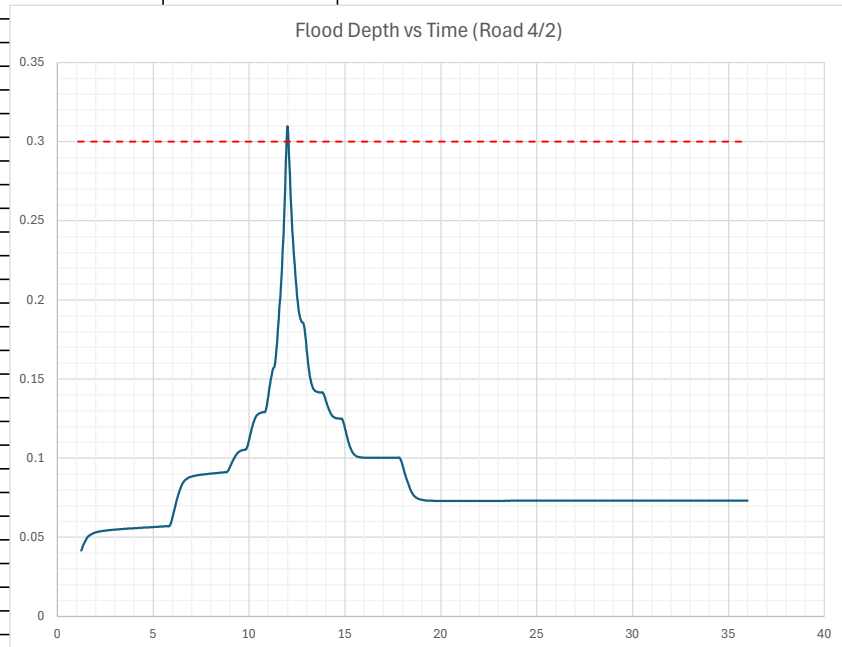
| Duration above 0.3m (hr): | 0.0797 |
| Duration in Minutes | 4.8 |
