**OCEANA GOLD (NEW ZEALAND) LIMITED  
MACRAES OPERATION  
MACRAES PHASE 4  
MTI AND SP11A TECHNICAL REPORT**

| <b>Title</b> | Oceana Gold (New Zealand) Ltd, Macraes Operation, Macraes Phase 4, MTI and SP11A Technical Report |

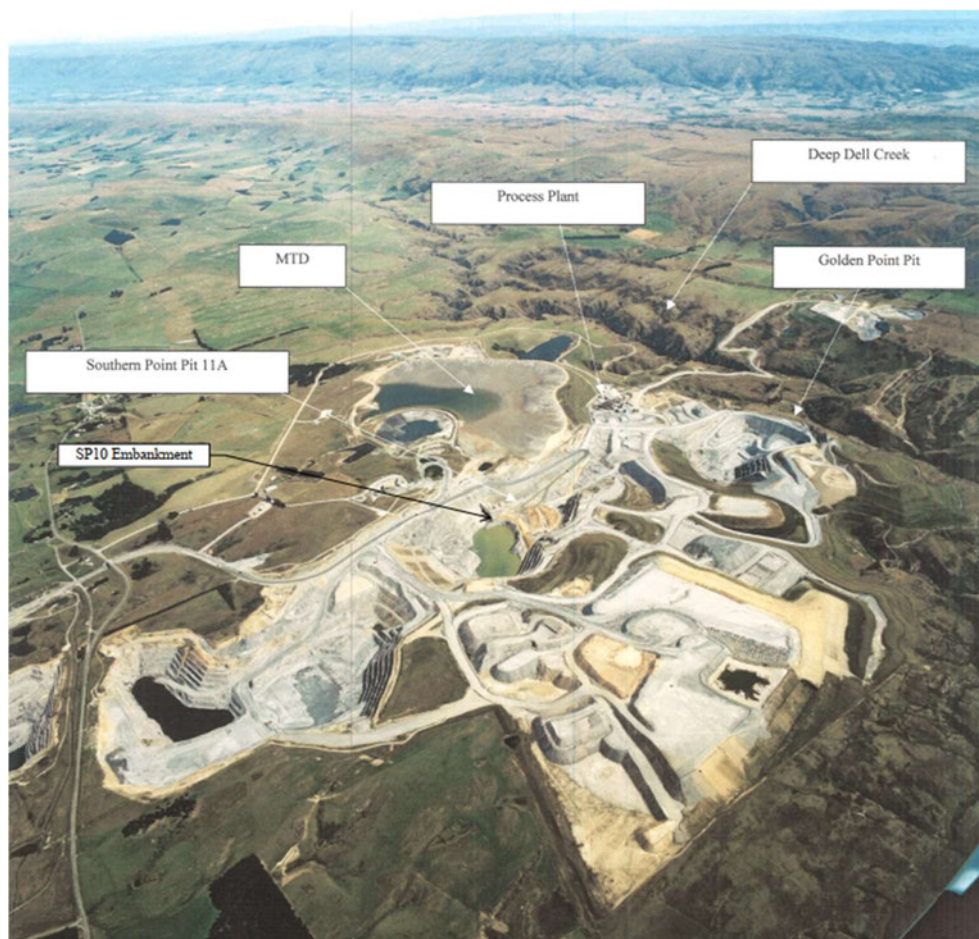
**Figure 4: Mine site aerial in 2002**

Figures 4 and 5 show the MTI, SP10 and IMBE in 2002.

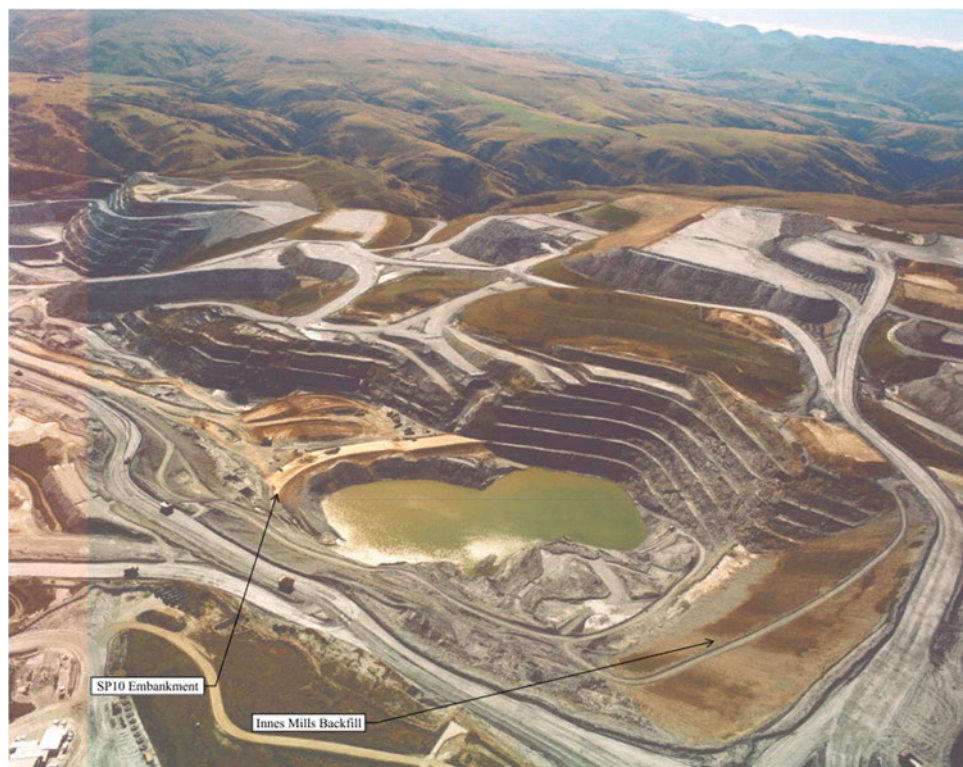
**Figure 5: Aerial photo showing SP10 Zone A being placed at the upstream toe of the SP10 embankment in 2002**

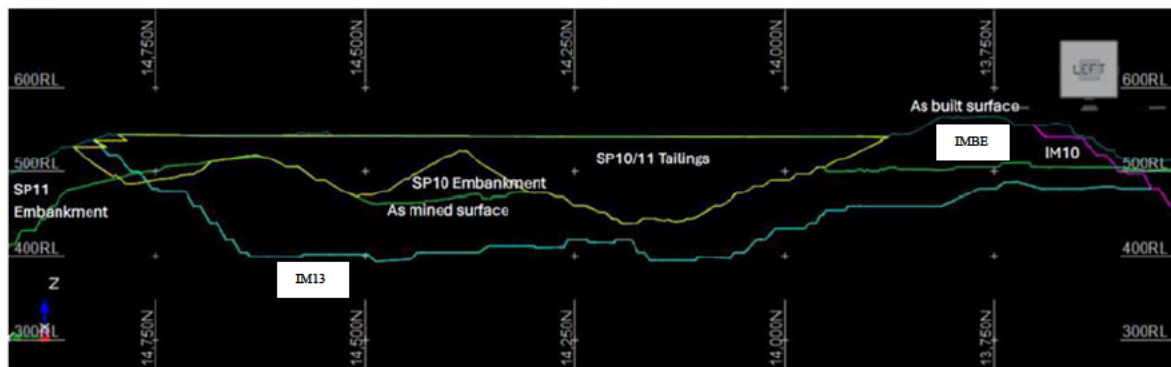
**Figure 9: Section through 69,900 mE at SP11A, SP10 and IMBE**

generally coincides with the lowering of tailings. Figure 9 shows the general arrangement of SP11A, SP10 and IMBE embankments.
