## Memo

**Subject:** **Tekapo B Power Station tailrace weir and chute – implementation of draft consent conditions**

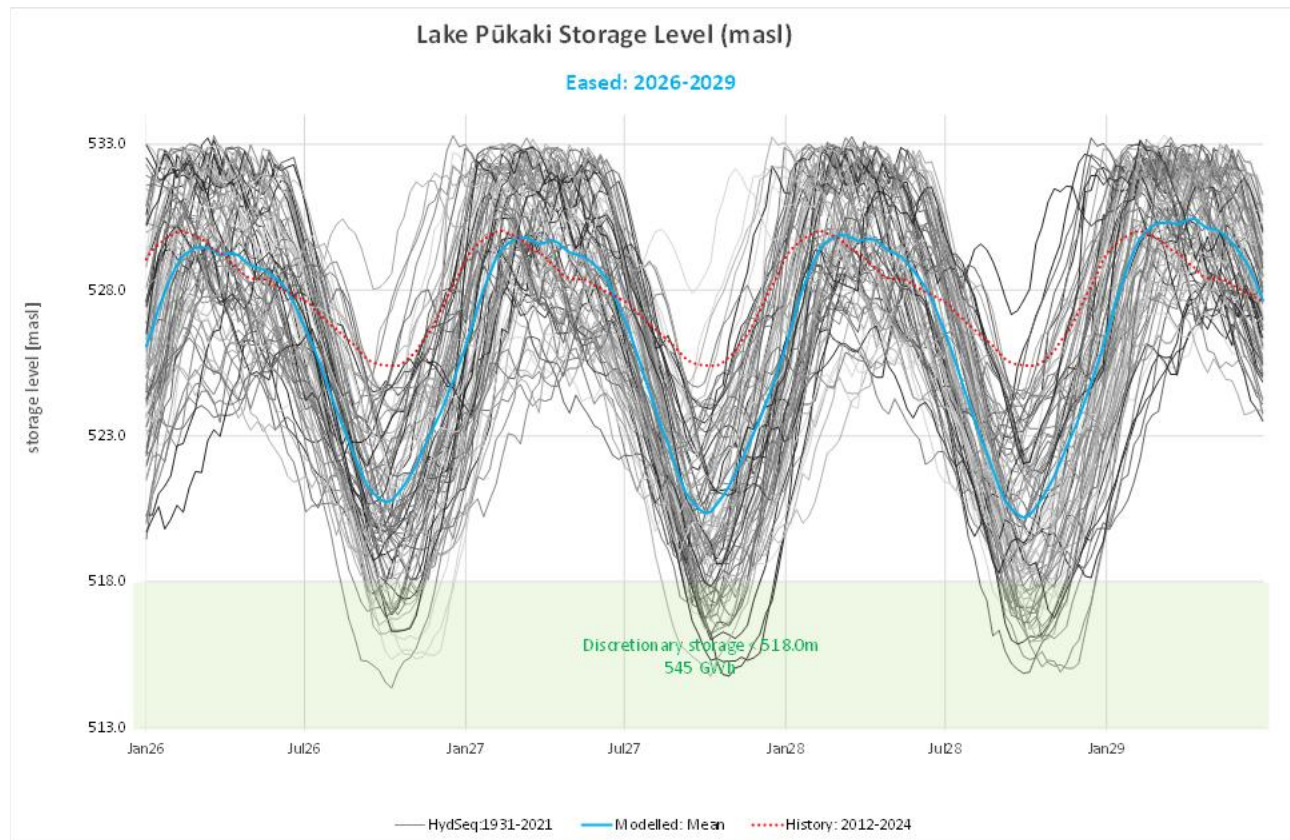
Figure 1 shows predicted Lake Pūkaki storage levels for the period 2026-2028 under the draft consent based on historic lake inflows and estimates of projected future power demand and likely future generation availability. Preceding dry conditions with low inflows would need to occur for the level of Lake Pūkaki to fall below RL 518 m. As seen in Figure 1, this would typically occur within the August to December period.

**Figure 1: Predicted Lake Pūkaki storage levels for the period 2026-2028 under conditions of eased operation with draft consent**
