**GEOTECHNICAL INVESTIGATION REPORT  
FOR NOTICE OF REQUIREMENT APPLICATION**

**Waitākere District Courthouse**

**14 Edmonton Road  
Henderson, Auckland**

Project Number: 1496-01-24

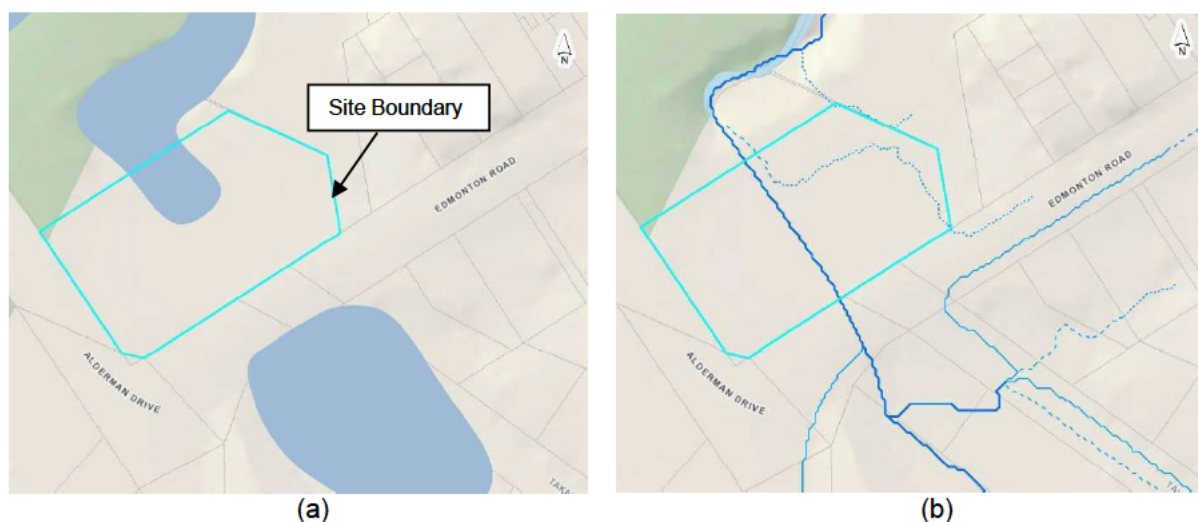
Figure 4-1 – Flood Plain (a); Overland flow paths (b)

The small portion of the northern part of the site is shown to be located within an Auckland Council-identified 'flood plain' area (AC Geomaps, 2025) – indicating that it is predicted to be covered by water as a result of a 1 in 100-year flood as shown in Figure 4-1. An overland flow path identified as draining an area of between 3 ha and 100 ha is also shown to run through the central portion of the site in a southerly direction. WP understands that site-specific flood modelling of the site is being undertaken by others and the AC flood information is shown for information only.
