Lake Pūkaki Reservoir Hydro Storage and Dam Resilience Works

Lake Processes and Geomorphology

Meridian Energy Limited

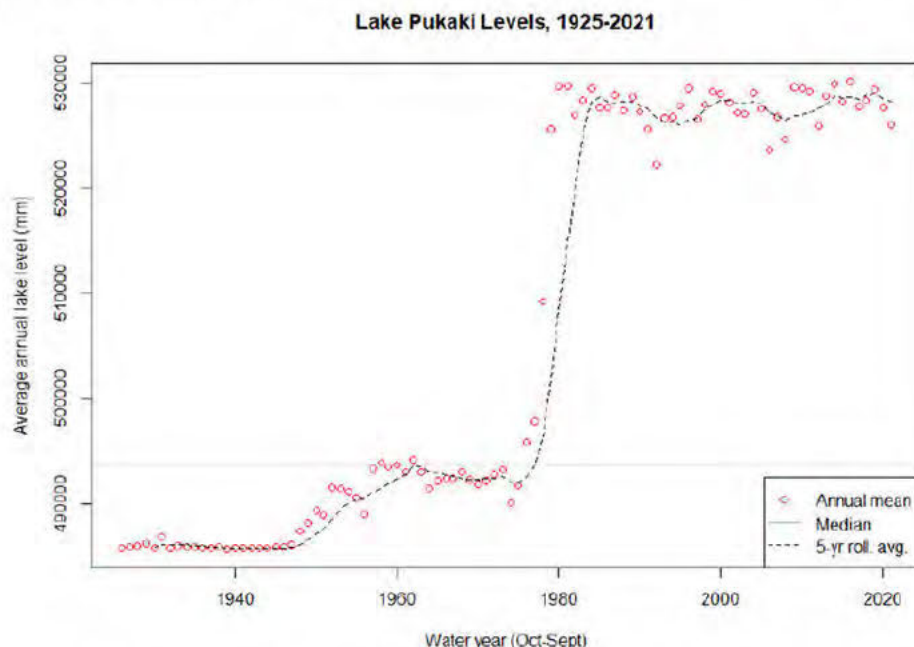
Figure 3 Mean annual lake levels in Lake Pūkaki, 1925 – 2021. The notable change reflects the change in operations when the operational level was raised by 37 m (source: Figure 2.4, NIWA, 2024)

Lake levels determine the wave impact zone along the lake shore. As noted in Section 2.1, Lake Pūkaki levels have been raised twice due to dam construction (see Figure 3). Prior to artificial control, lake levels were about 484.0 m RL (Sutherland *et al.*, 2019³). Lake level fluctuation has been dependent on different operational regimes. Since 1999, levels have been higher, on average, than during the 1979 – 1999 period, with lake levels typically over 527.0 m RL. Typically, the full extent of the operating range is not experienced every year, with minimum and maximum levels associated with extreme climatic conditions.

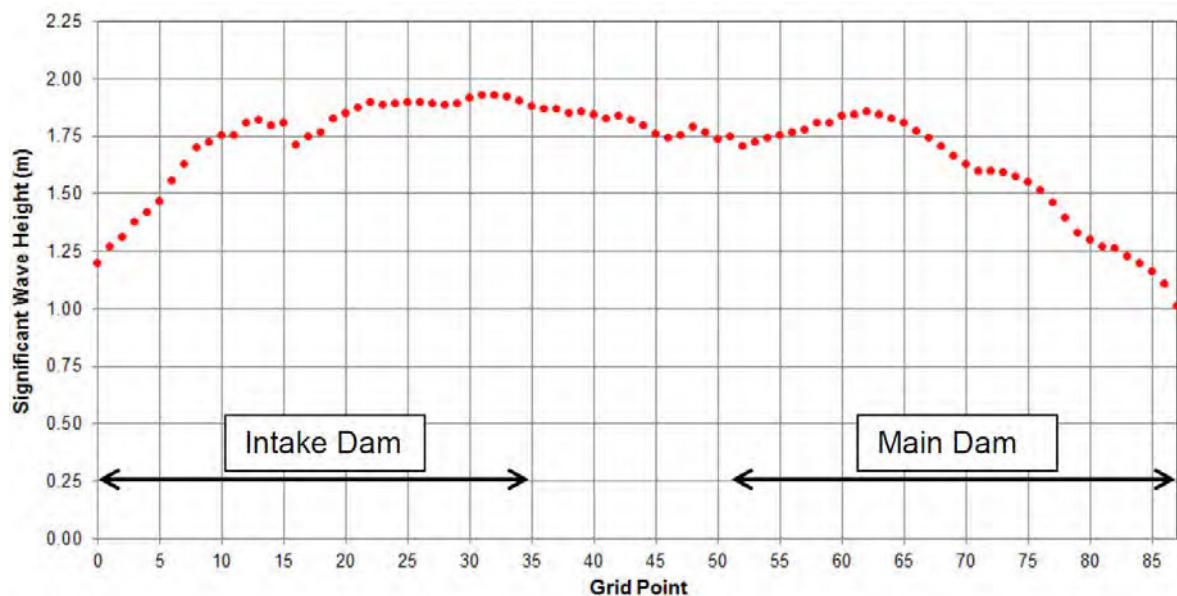
Figure 6 1 in 100 AEP significant wave heights at 513 m RL: Top: modelling output plan view of southern section of Lake Pūkaki; Bottom: Modelled wave heights across cross section shown in top image (source: Damwatch, 2013, Figures 2.1 and 2.2).

These critical wave heights have been re-evaluated in GHD's Pūkaki Dam Protection Works report (GHD, 2025¹¹), conducted for the FTCC application. This assessment revised the significant wave height slightly to 2.27 m RL, with a 90th percentile wave height (i.e., design wave height) of 2.59 m.

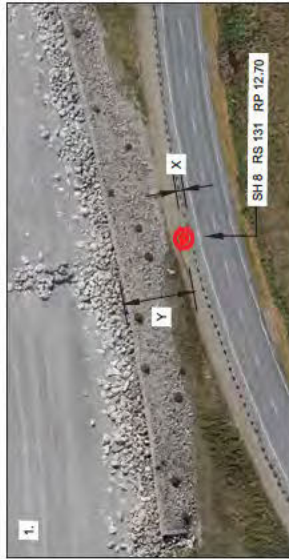
1	Date of measurement	Dimension X	Dimension Y
	11 February 2016	1.6m	14.5m
	15 March 2017		14.5m
	7 Nov 2017		14.5m
	16 April 2018		14.5m
	Loss of bank		0.0m

Key	Point showing the location of the survey pillar
X	Dimension from edge of seal to the survey pillar
Y	Dimension from survey pillar to edge of bank

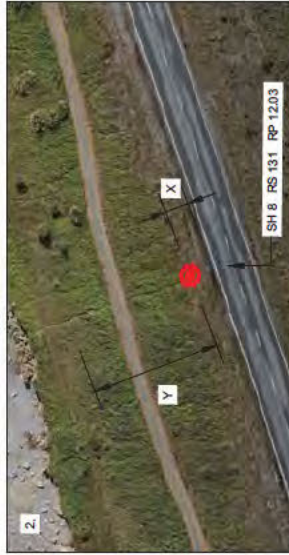
2	Date of measurement	Dimension X	Dimension Y
	11 February 2016	5.3m	35.4m
	15 March 2017		27.1m
	7 Nov 2017		26.1m
	16 April 2018		26.1m
	Loss of bank		9.3m
