Lake Pūkaki Reservoir Hydro Storage and Dam Resilience Works

**Pūkaki Dam Rip-Rap Design and
Construction Methodology**

Meridian Energy Limited

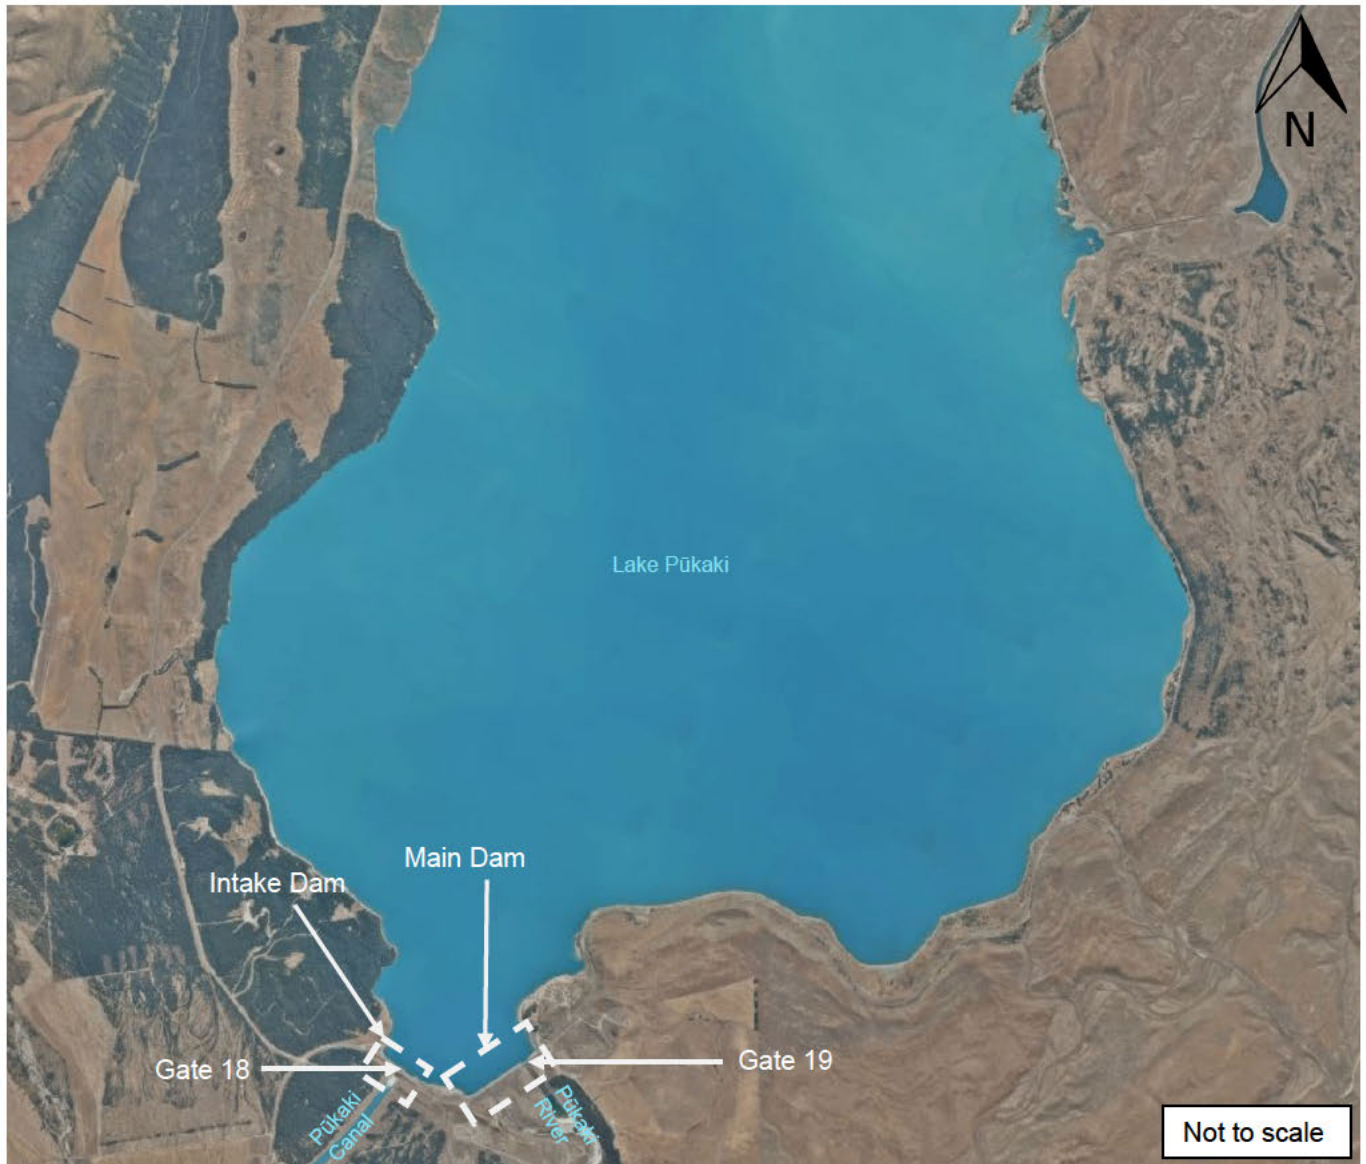
Figure 1 Site overview with indicative locations of the key structures (Aerial photo source: LINZ, 2022)

Figure 1 shows the location of the structures under consideration in this report and Section 6 provides further details on the proposed works.

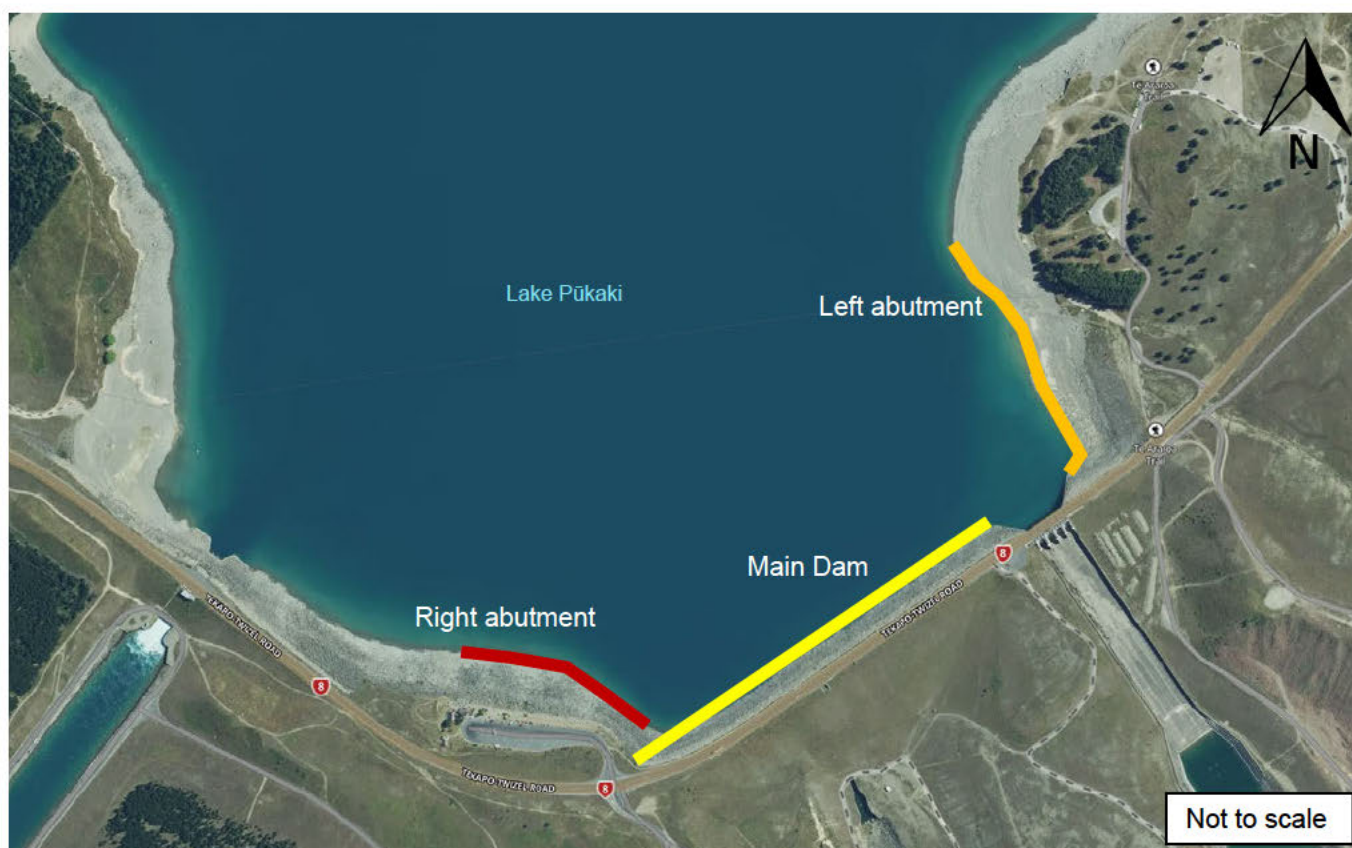
Figure 9 Work zones

As illustrated in Figure 9, the rip-rap placement works are divided into three primary work zones:

- Right abutment
- Left abutment
- Main Dam

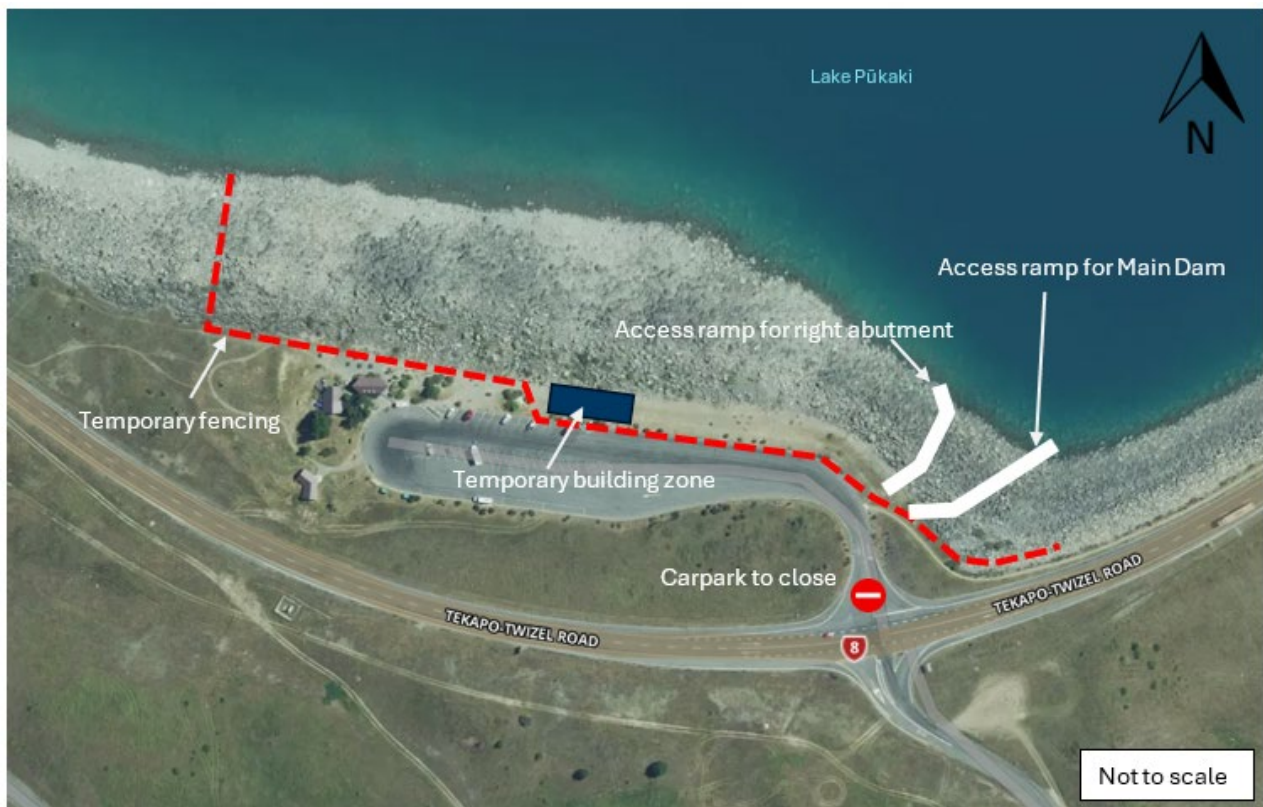
Figure 10 Dam and right abutment - security fencing, closed access, access ramps and temporary buildings

For each construction event, site security will be maintained through the installation of temporary fencing and controlled access measures. Temporary fencing will be erected to prevent public access to the designated work area, with lockable site gates provided to secure the entry points. The proposed fencing layout is shown on Figure 10 and Figure 11.

Access to the right abutment and Main Dam will be established via the main carpark site entrance (see Figure 10). Dedicated access ramps will be established using an excavator to relocate existing Zone 10 materials as required, followed by the placement of granular material to infill voids within Zone 10/6 materials. This process will create a stable running surface suitable for road truck movement.

Temporary offices and work room facilities/ablutions will be established on site for the duration of each construction event. The proposed locations are shown on Figure 10 and Figure 11.

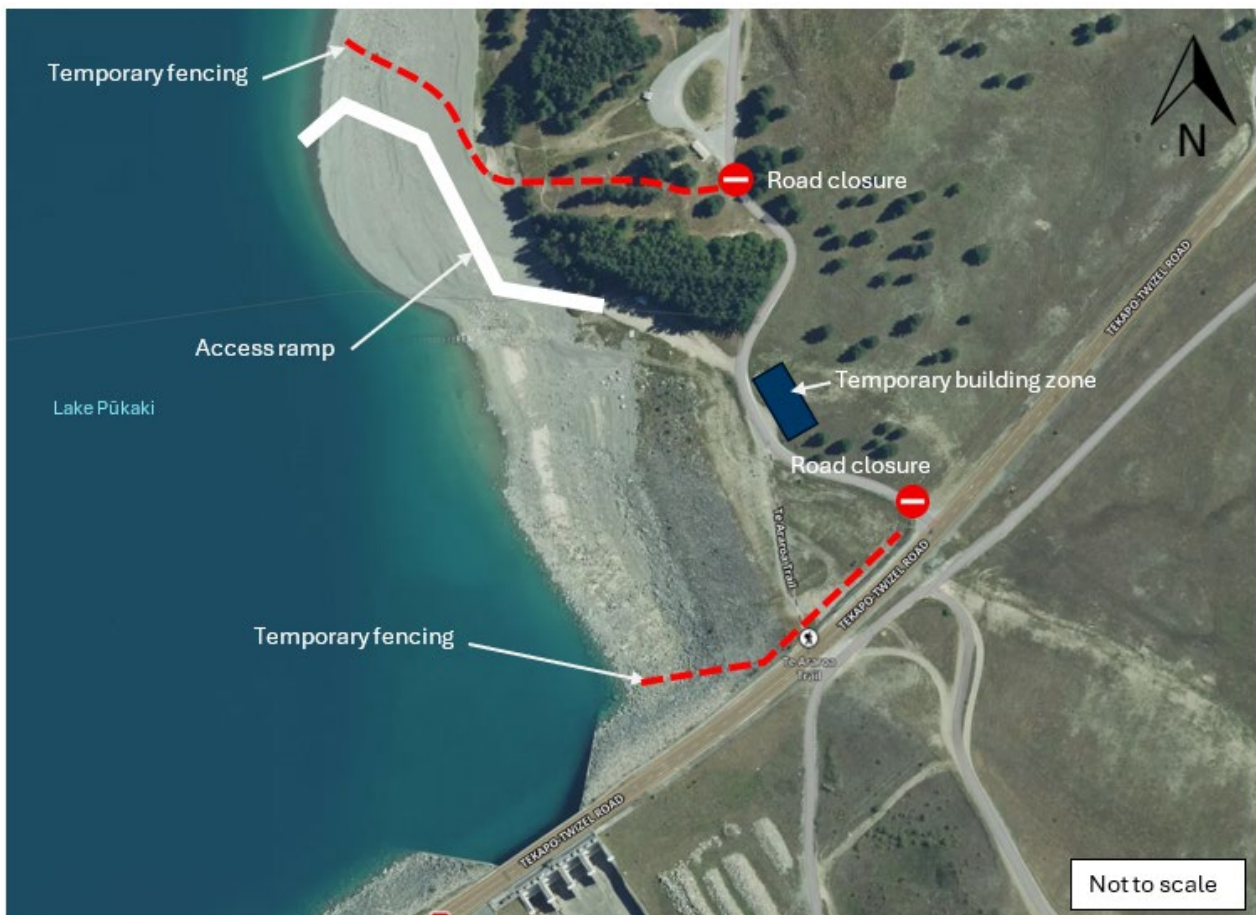
Figure 11 Left abutment - security fencing, closed access and access ramp

Access to the left abutment will be provided via the existing unsealed road (see Figure 11).

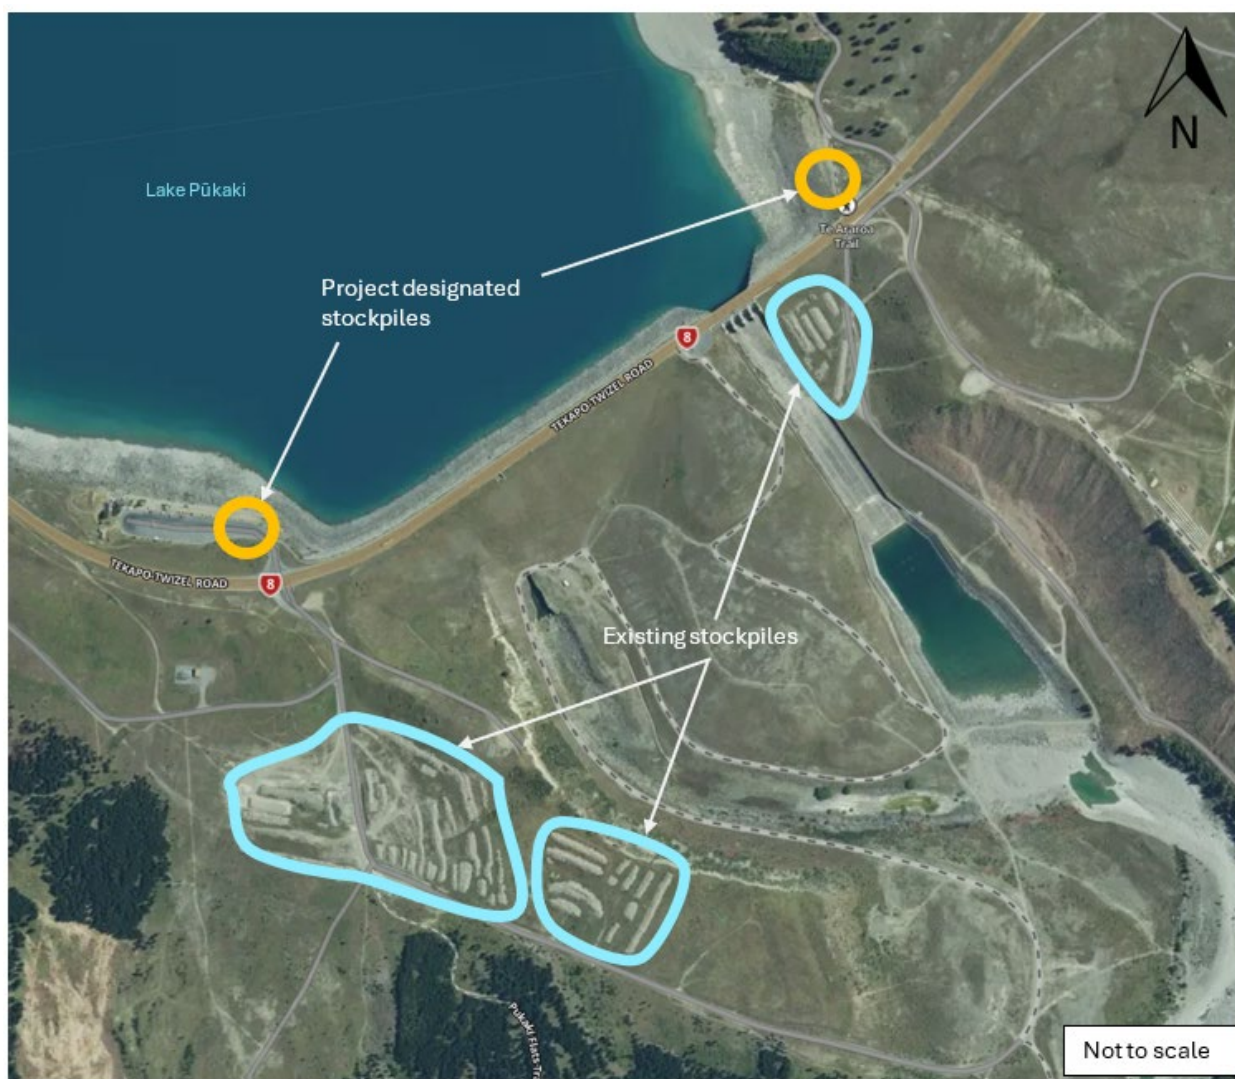
Figure 12 Stockpile locations

Rock material has been previously harvested and stockpiled near the site. The locations of the existing stockpiles are shown on Figure 12. At present, approximately 23,000 tonnes of rock is available, which is sufficient to complete the proposed works across all three work zones down to 514.0 m RL.

Prior to the commencement of active construction, rock will be transported by road trucks to two designated stockpile areas as shown in Figure 12:

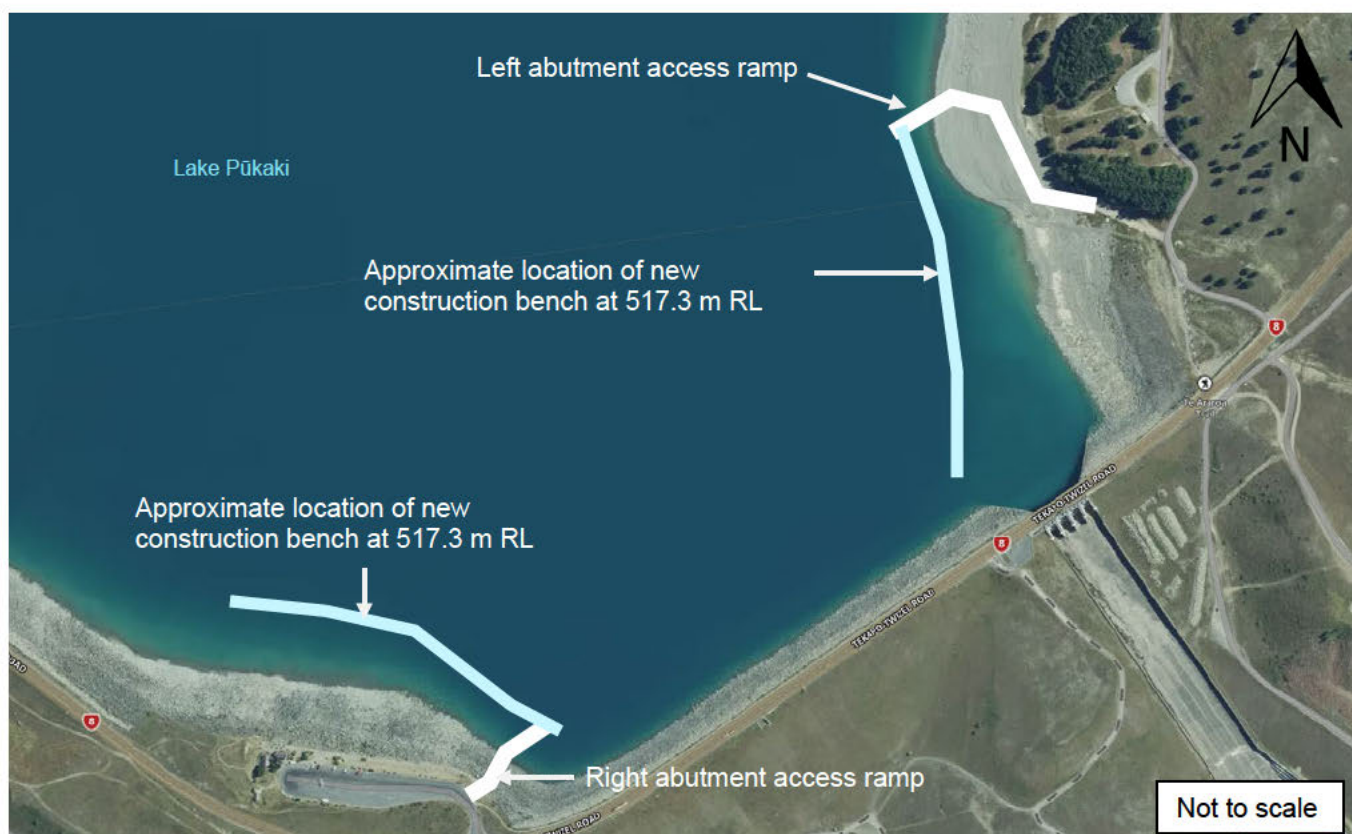
Figure 20 Site plan (abutments) and indicative 517.3 m RL construction bench

- The construction bench will be established along the full length of each abutment (see Figure 20) with excavated rip-rap placed at 15 m intervals to start the formation of the groynes. Imported granular material will be placed on the excavated bench as a running course for construction. This process is expected to take 1 week.

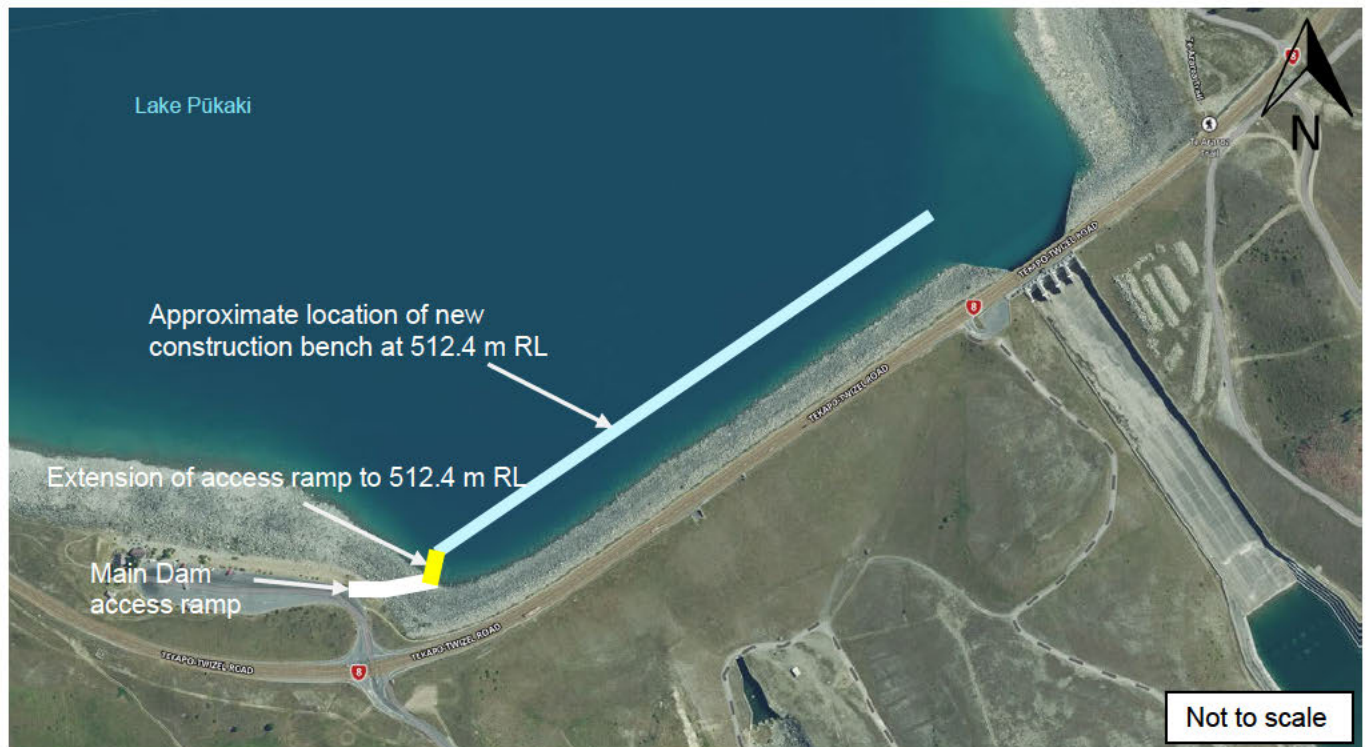
Figure 24 Site plan (Main Dam) and indicative 512.4 m RL construction bench

- Extend the existing ramp to 512.4 m RL (see Figure 24).

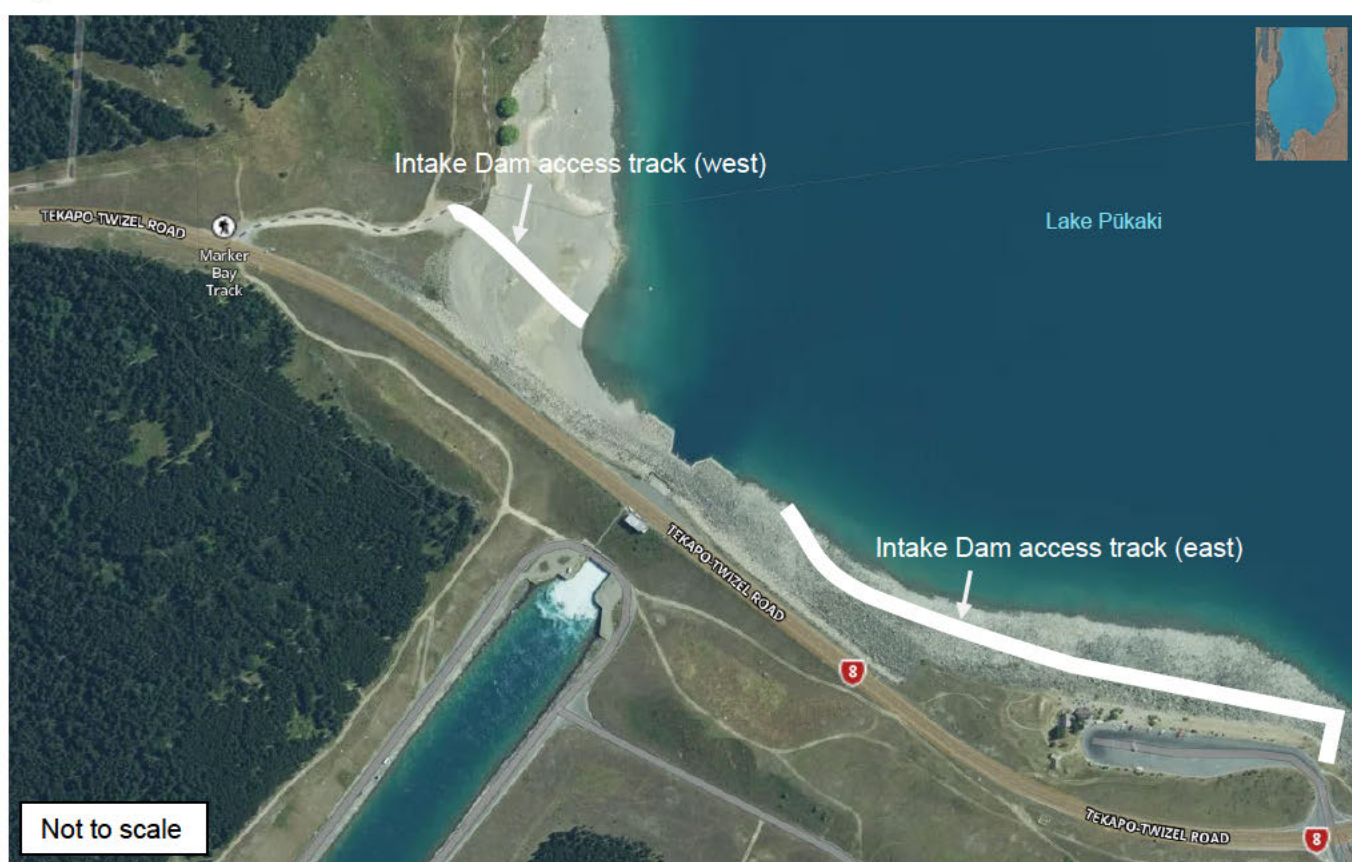
Figure 32 Intake Dam access tracks

In the event works are required, to facilitate access for inspection and potential maintenance, construction of access tracks to both ends of the Intake Dam may be required. These tracks will be developed using methods consistent with those employed for the Main Dam and its abutments. The indicative access tracks are shown in Figure 32.
