Basic Information:

Drill hole ID: BH2B\_1128  
Client: McMillan Drilling (NI) Ltd  
Run Number(s): 03, 04, 06  
Tool Type(s): ABI40-2G Acoustic Televiwer  
OBI40-2G Optical Televiwer  
QL40-CAL Mechanical Calliper

Service Company: RDCL  
Operator: L Peters  
Date Logged: 07/11/2025  
Field: Brynderwyn Hills  
State / Province: Auckland  
Country: New Zealand

Located approximately 1 km west from State Highway 1, adjacent to the logging track in the Bynderwyn Hills.

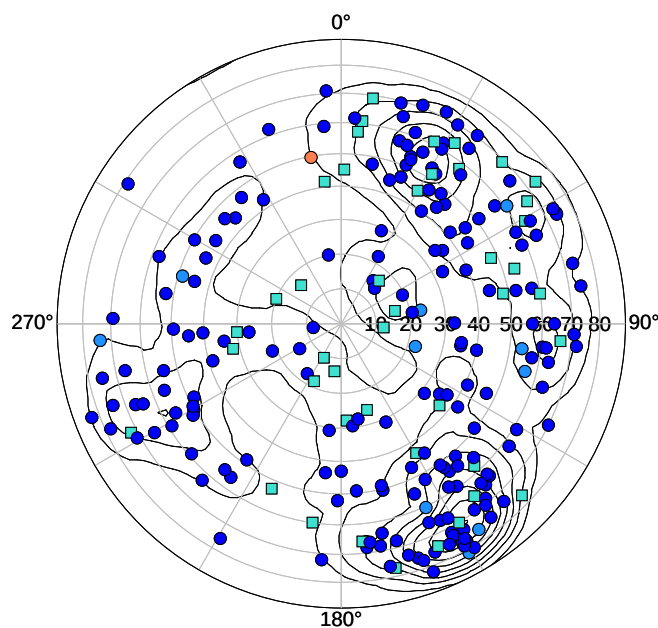
Stereoplot - Polar Projection Dip

Schmidt Plot - Upper (Northern) Hemisphere - Structures - True  
Depth: 2.63 m to 49.67 m

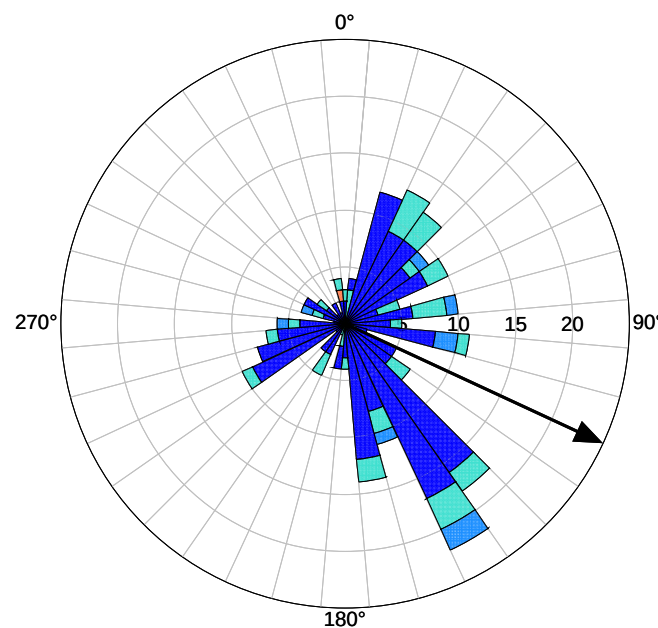
Rose Diagram - Azimuth

Depth: 2.63 m to 49.67 m

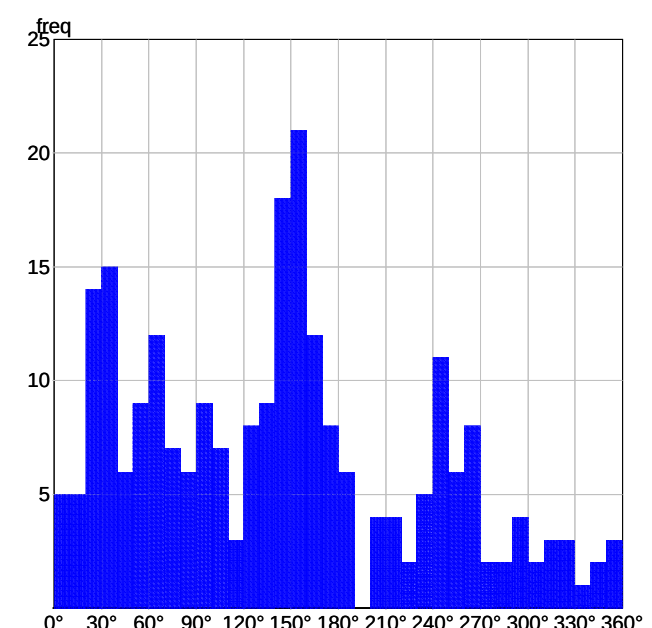
Histogram - Azimuth

Depth: 2.63 m to 49.67 m

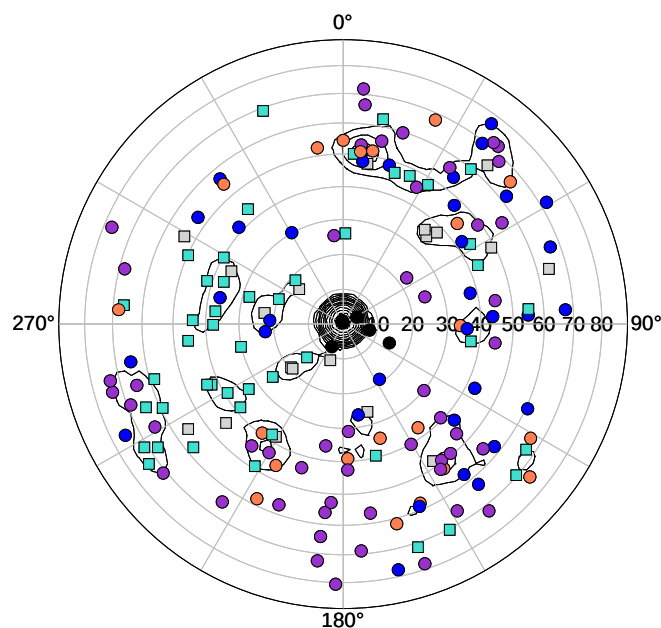
### Stereoplot - Polar Projection Dip

Schmidt Plot - Upper (Northern) Hemisphere - Structures - True  
Depth: 1.16 m to 45.00 m

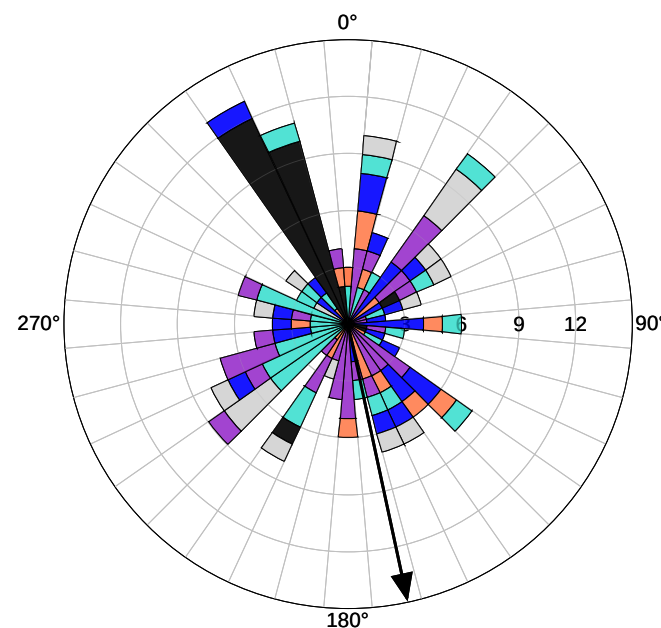
### Rose Diagram - Azimuth

Depth: 1.16 m to 45.00 m

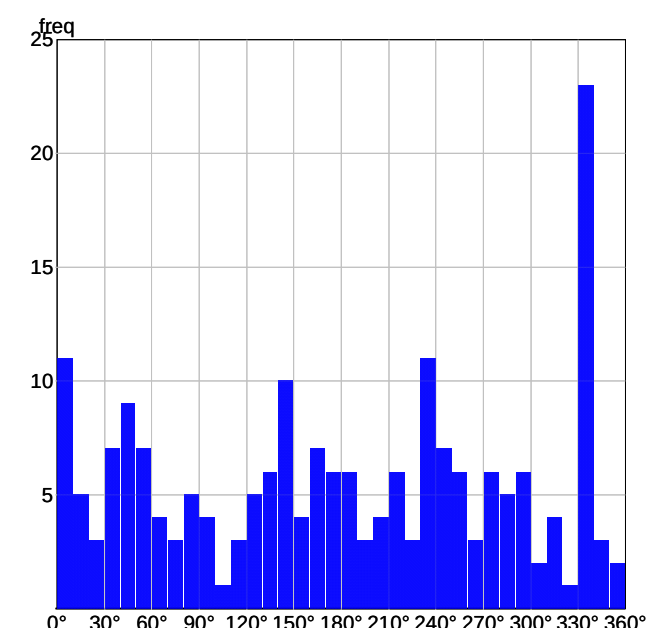
### Histogram - Azimuth

Depth: 1.16 m to 45.00 m

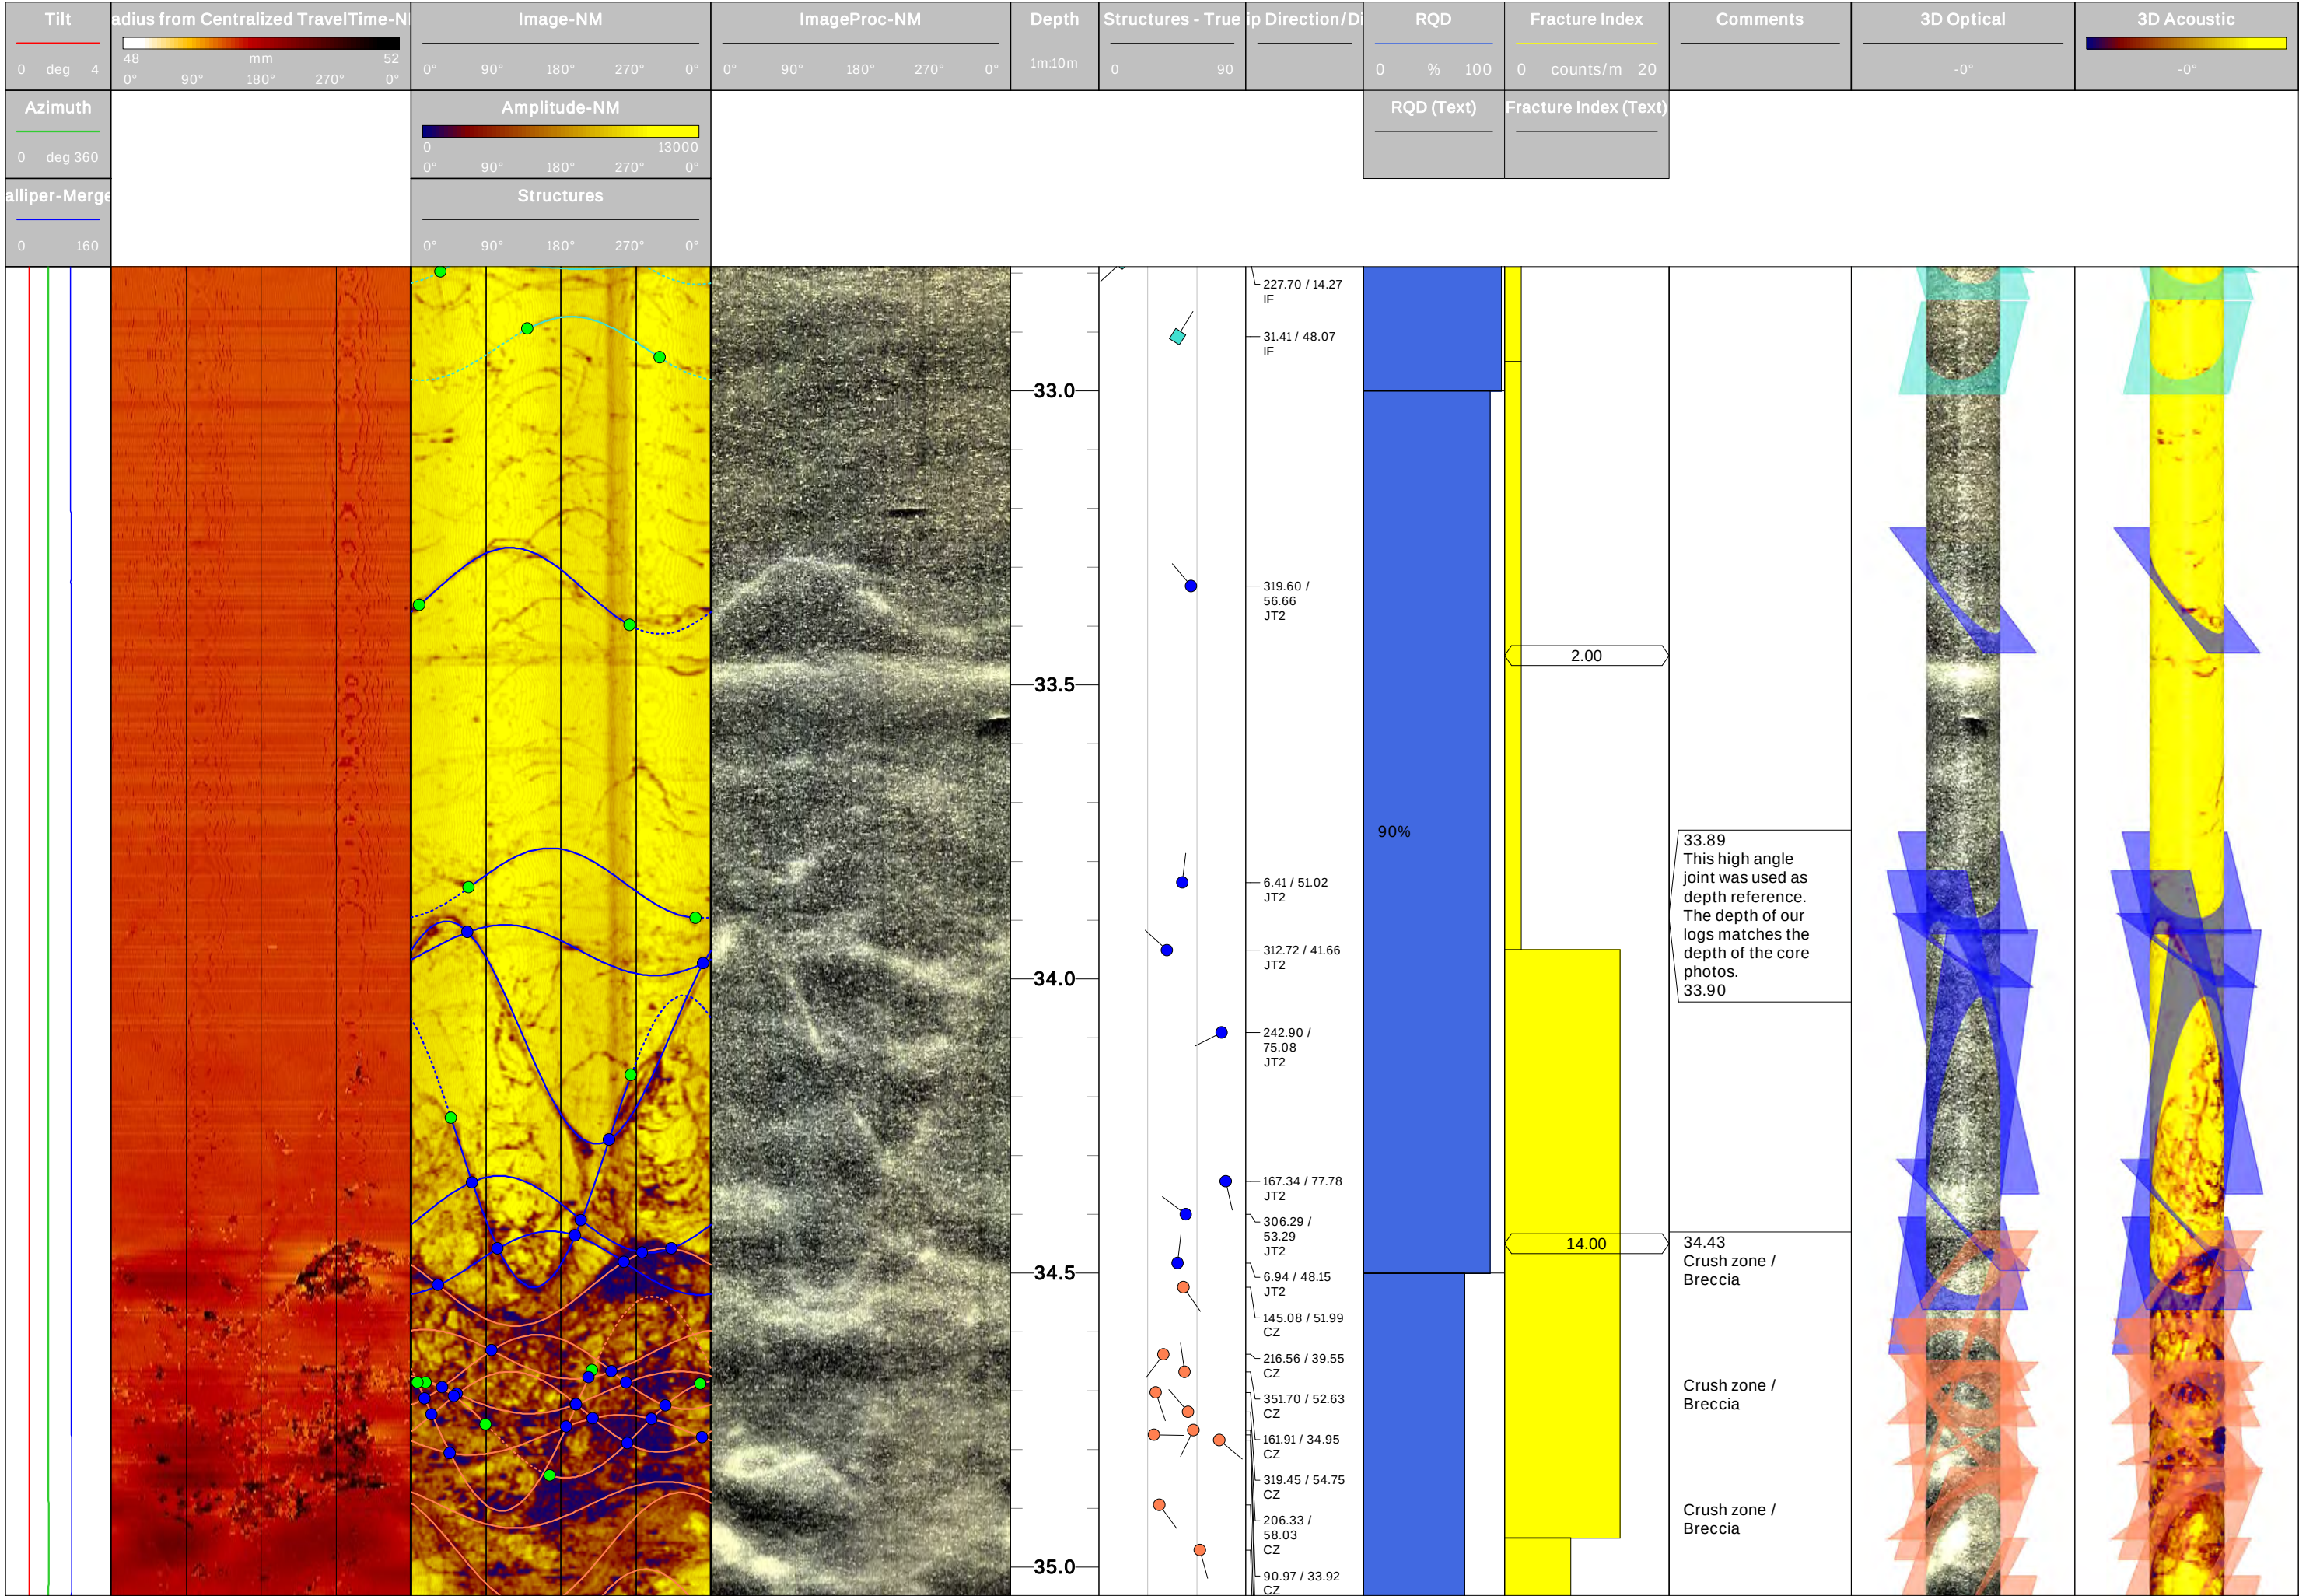
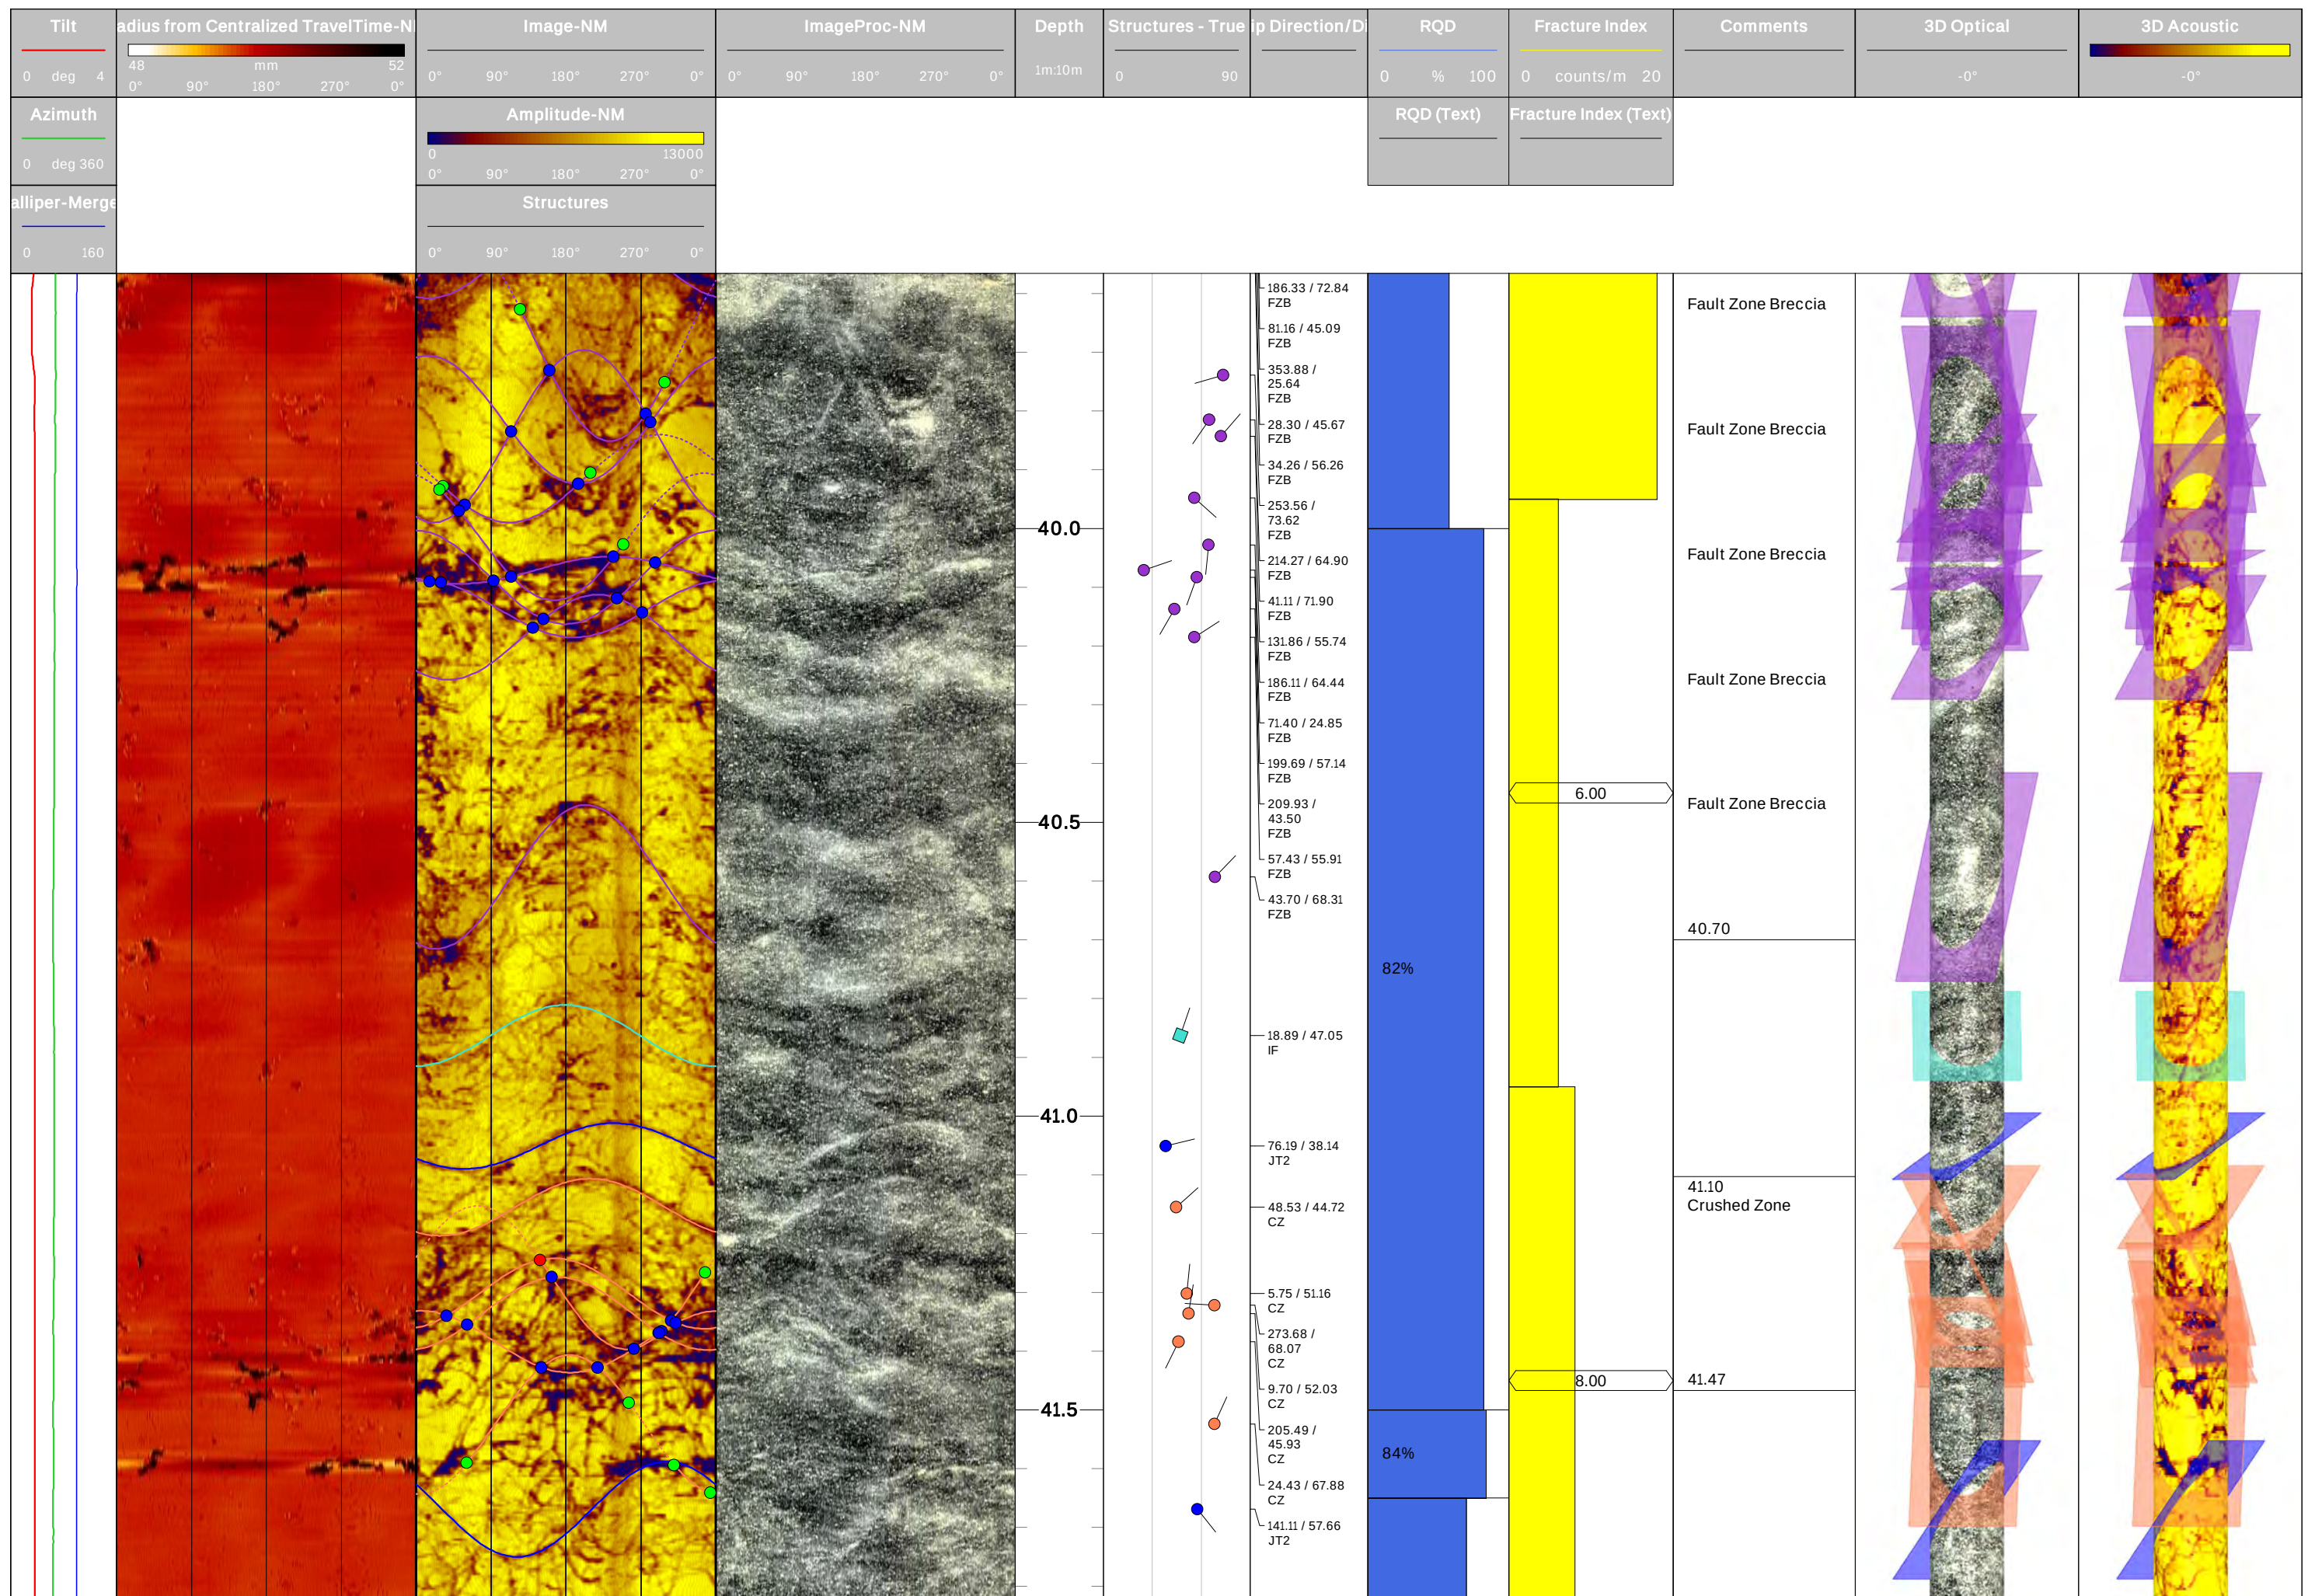
| Tilt | Radius from Centralized TravelTime-NM | Image-NM | ImageProc-NM | Depth | Structures - True | ip Direction/Di | RQD | Fracture Index | Comments | 3D Optical | 3D Acoustic |
| 0 deg 4 | 48 mm 52 | 0° 90° 180° 270° 0° | 0° 90° 180° 270° 0° | 1m:10m | 0 90 | | 0 % 100 | 0 counts/m 20 | | -0° | -0° |
| Azimuth | | Amplitude-NM | | | | | RQD (Text) | Fracture Index (Text) | | | |

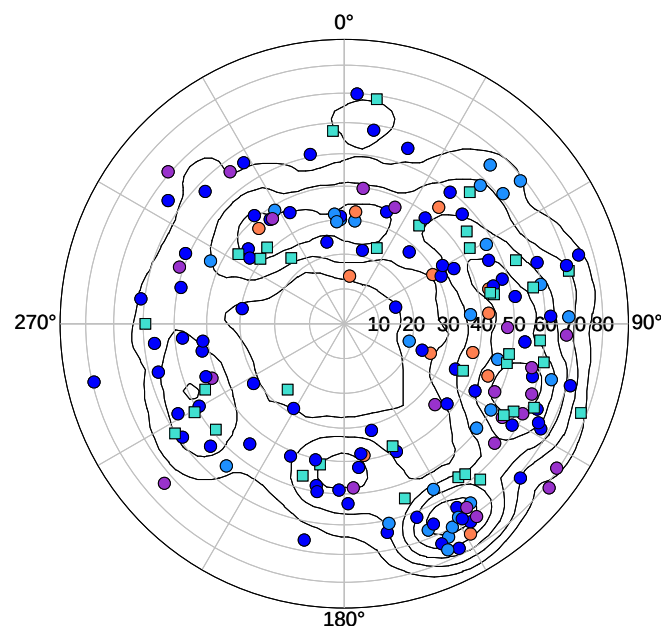
### Stereoplot - Polar Projection Dip

Schmidt Plot - Upper (Northern) Hemisphere - Structures - True  
Depth: 11.95 m to 43.80 m

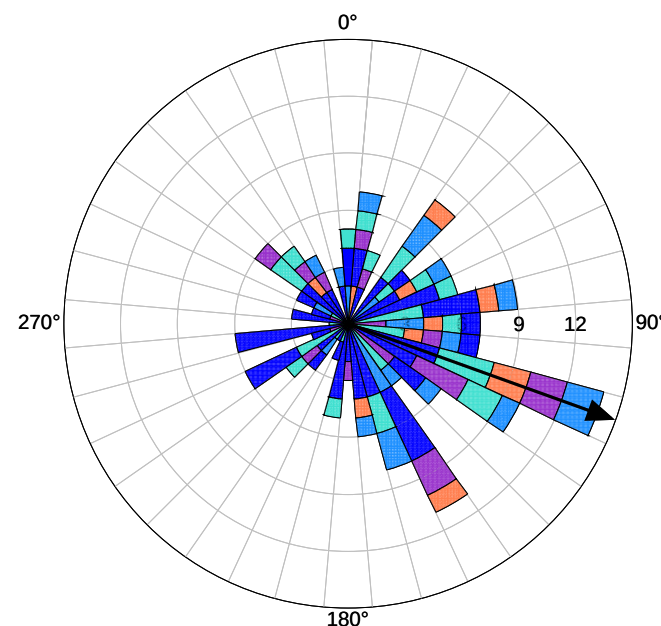
### Rose Diagram - Azimuth

Depth: 11.95 m to 43.80 m

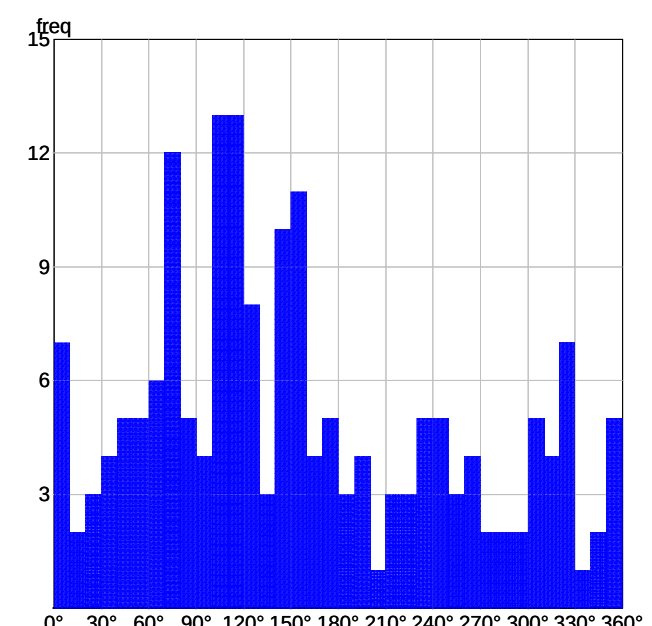
### Histogram - Azimuth

Depth: 11.95 m to 43.80 m
