Memo – NZTA

Subject:– Delmore Stage 1 and 2- Response to Regional NZTA Memo (Annexure 31 to Council family comments)

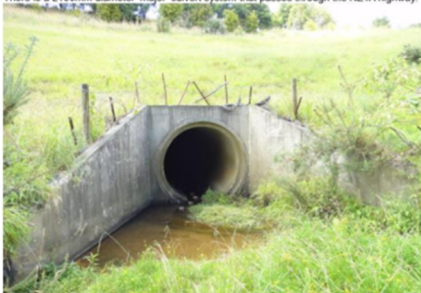
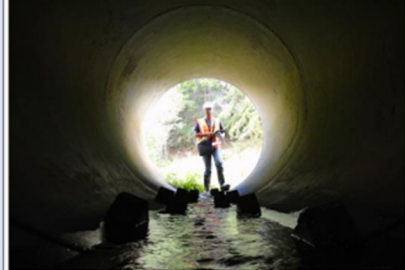
<p>This culvert system was designed and built as part of the Transit ALPURT B1 Project in the mid to late 1990's. The culvert inlet has a simple standard headwall, and there is fish passage through the culvert (simple wooden baffle blocks that were designed and installed prior to the release of any HZ guidance documents on fish passage design). A copy of the relevant engineering layout plan can be seen here: 01328.TIF.</p> <p>At the time the ALPURT B1 was only designed for maximum probable discharges that would arise from the contributing catchment under allowances of the previous Auckland Regional Council (ARC) Air Land Water Plan (ALWP). The Auckland Unitary Plan (AUP) and this current plan proposal will result in measurably increased rates and volumes of runoff, due to the increased impermeable surface area. This presents a flood resilience risk at the state highway network where flood depths and velocities against the motorway embankment present a measurably increased risk of erosion, scour, and increased risk of failure at the already aged and limited performance major culvert system.</p>

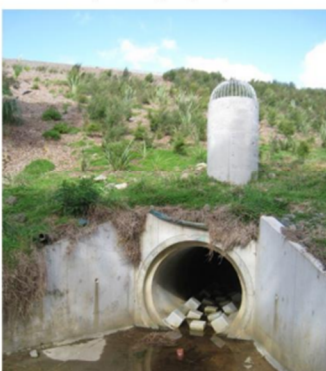
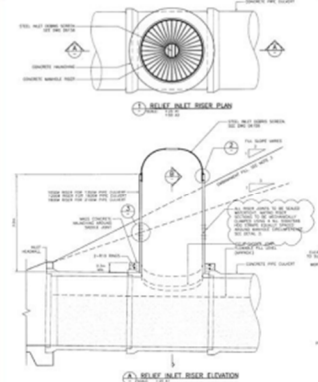
<p>It is anticipated that as a minimum this inlet will need a culvert relief inlet riser as well as erosion and scour protection/resilience measures at the highway embankment at the culvert inlet (to a height above the 1% AEP flood level - including climate change 3.8 percent)</p>

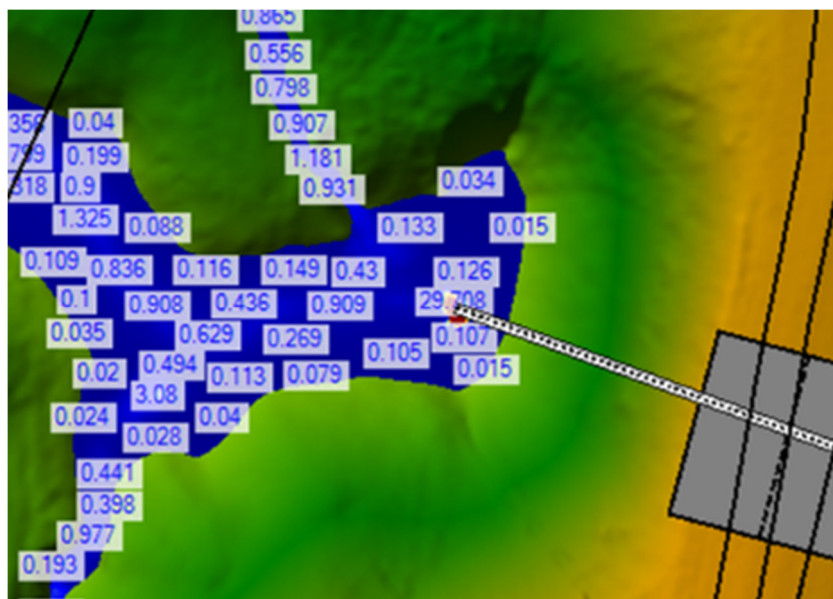
Figure 1- Velocities around culvert inlet in 2 year peak (including Climate Change)

Our hydraulic modelling confirms that, despite the higher water level, flow velocities of less than 0.2m/s immediately upstream of—and around—the inlet remain well below the critical velocities of 1 to 2m/s for erosion and scour, as demonstrated in the paragraph below.

Below is a plot of the 2 year and 10 year events, from the 2D flood model including climate change. This shows the predicted velocities around the culvert inlet. In both scenarios, the flow velocities are very low, and below the velocities that cause erosion in different unlined channel materials, outlined in Auckland Councils Hydraulic Energy Management: Inlet and Outlet Design for Treatment Devices - TR2013/018. This includes the channel material relevant to the culvert NZTA is concerned about, which is highlighted yellow is the snip of Table 1 from TR2013/018 in Figure 3 below, or if the grass cover is considered, then the values in green are of relevance.

Overall, this analysis shows in the Post Development risk of erosion around the inlet is very low, so provision of rip-rap protection (i.e. erosion and scour protection) is not considered to have any benefit.
