# Arboricultural Assessment

Site Address:	88, 130 and 132 Upper Ōrewa Road and 53A, 53B and 55 Russell Road, Orewa
Prepared for:	Vineway Ltd
Purpose of Report:	Arboricultural Assessment of Proposed Vineway Fast Track Act – Residential Housing Proposal

Report Compiled by:		
Date of Report:	11.02.25	
Version:	Final

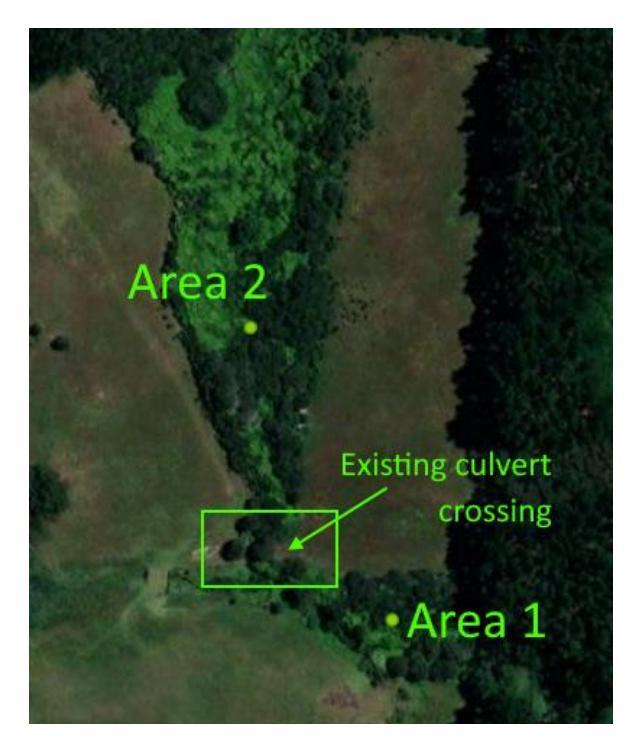
Figure 3 – Aerial image showing Areas 1 & 2

An existing culvert and farm crossing currently travels between Areas 1 & 2 from east to west, with a new road and associated infrastructure proposed to service new residential lots to the northeast. Vegetation removal is proposed to facilitate the 9.41 metre footprint of the new bridge/culvert, as well as the removal of an existing culvert, with new planting proposed to enhance Areas 1 & 2 to mitigate the loss of vegetation within the road access/ earthworks footprint. An estimated 250m2 of vegetation is to be removed for the new road connection.

Further recommendations are provided in Sections 8.0 and within the Draft TMP in terms of addressing any works within the protected root zone of retained vegetation or to address wider arboricultural fringe effects.

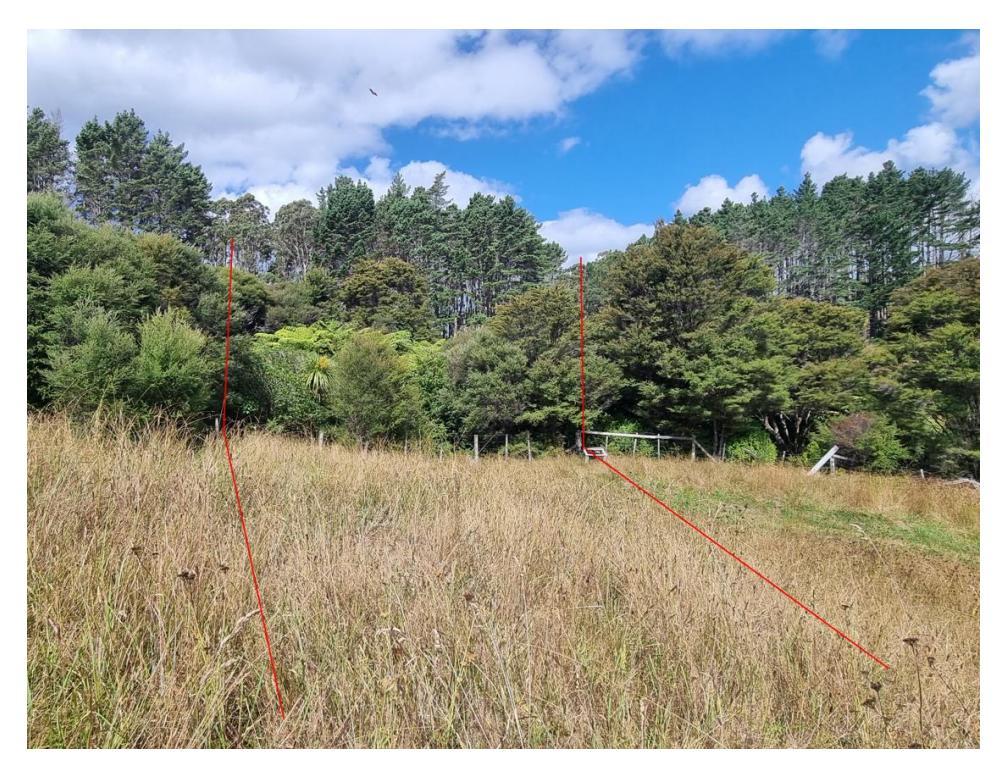
Figure 4 – Snip of proposed bridge/culvert crossing clearance (approximately 250m2)

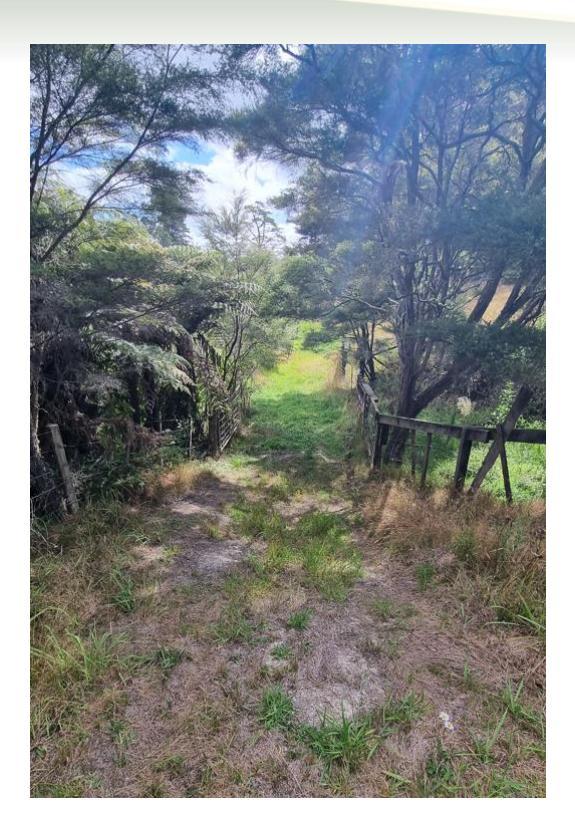
Figure 6 – Existing culvert crossing (Area 2)

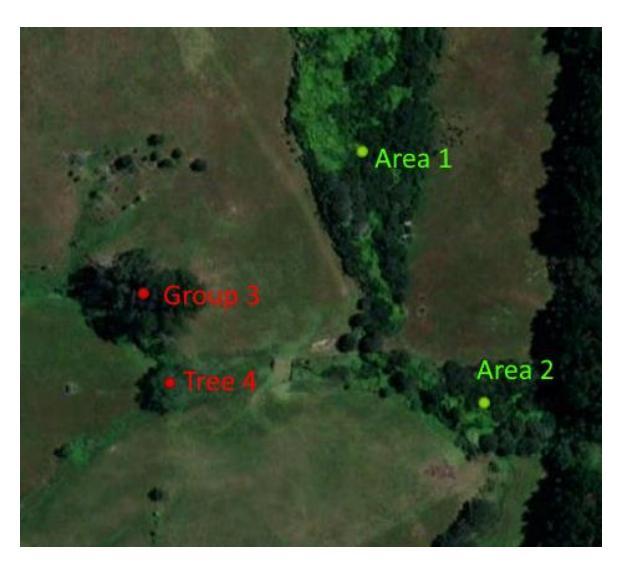
Group 3 is identified as a stand of exotic vegetation, dominated by large Gum trees (*Eucalyptus sp.*), with Tree 4 a Monterey Cypress. It is anticipated that these trees are removed. The trees stand on an embankment to the north of the adjacent stream, with some trees within 20m of the existing stream and some beyond the 10m setback. Those trees within the 20m setback are subject to Rule E15.4.1 (A19).

Figure 7 – Aerial showing Group 3 & Tree 4

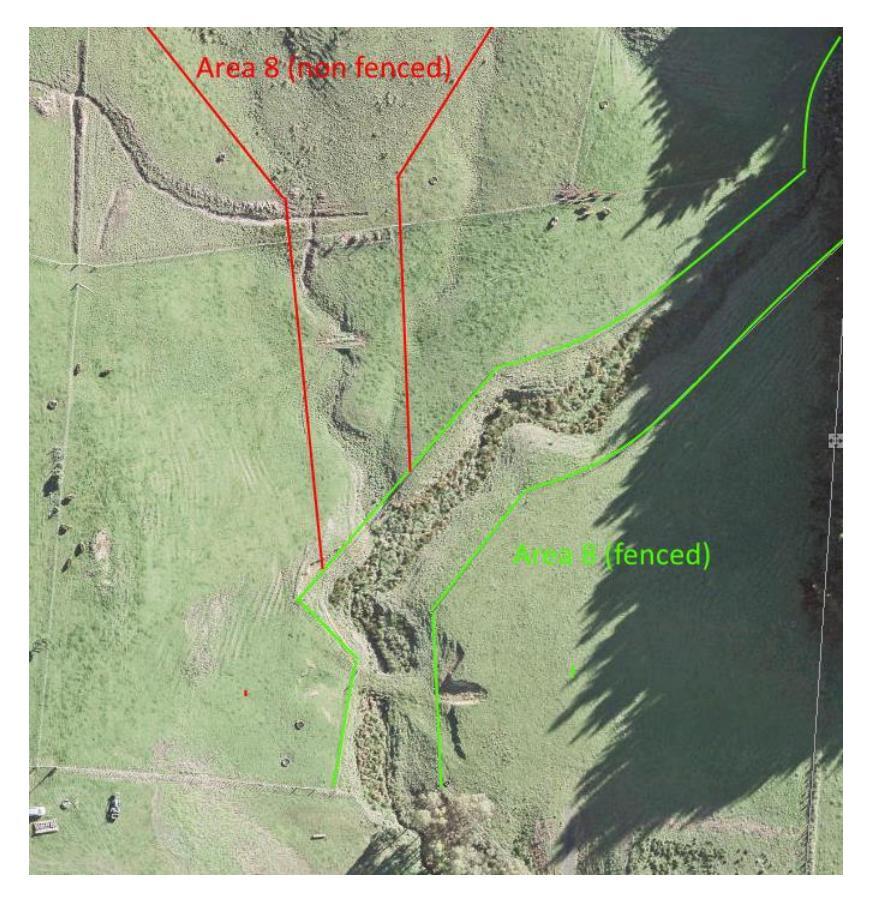
Areas 6 – 8 are identified as vegetation growing adjacent to the stream network running north to south to the northwest of Group 3. The area is currently partially fenced, with minimal enhancement planning undertaken, with the remaining vegetation dominated by Willow and other exotic species. These areas are subject to Chapter E15 of the AUP. and will be enhanced with new plantings. These areas are to be retained and subject to additional planting as part of the Project (see landscape plan prepared by Greenwood Associates). While retained vegetation in this area is minimal, all works within the Protected Root Zone of such vegetation should be undertaken in accordance with the recommended measures outlined in the TMP.

Figure 8 – Image showing fenced and non-fenced portions of Area 8

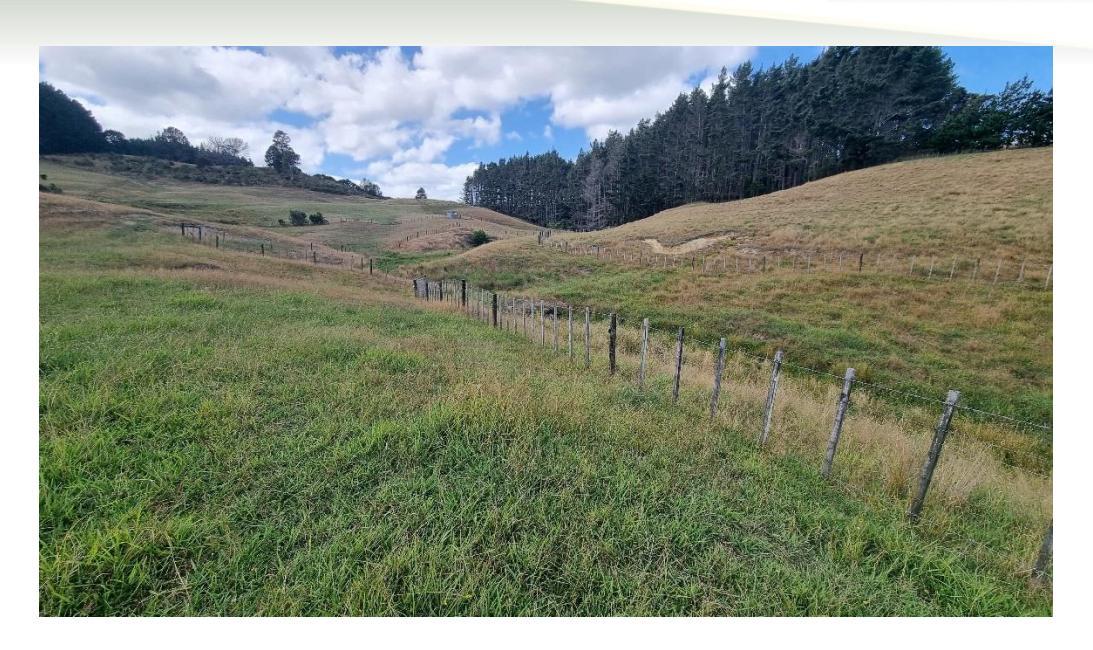
Figure 9 – View of Area 8 (fenced portion). Area 8a can be seen in the distance to the northeast.

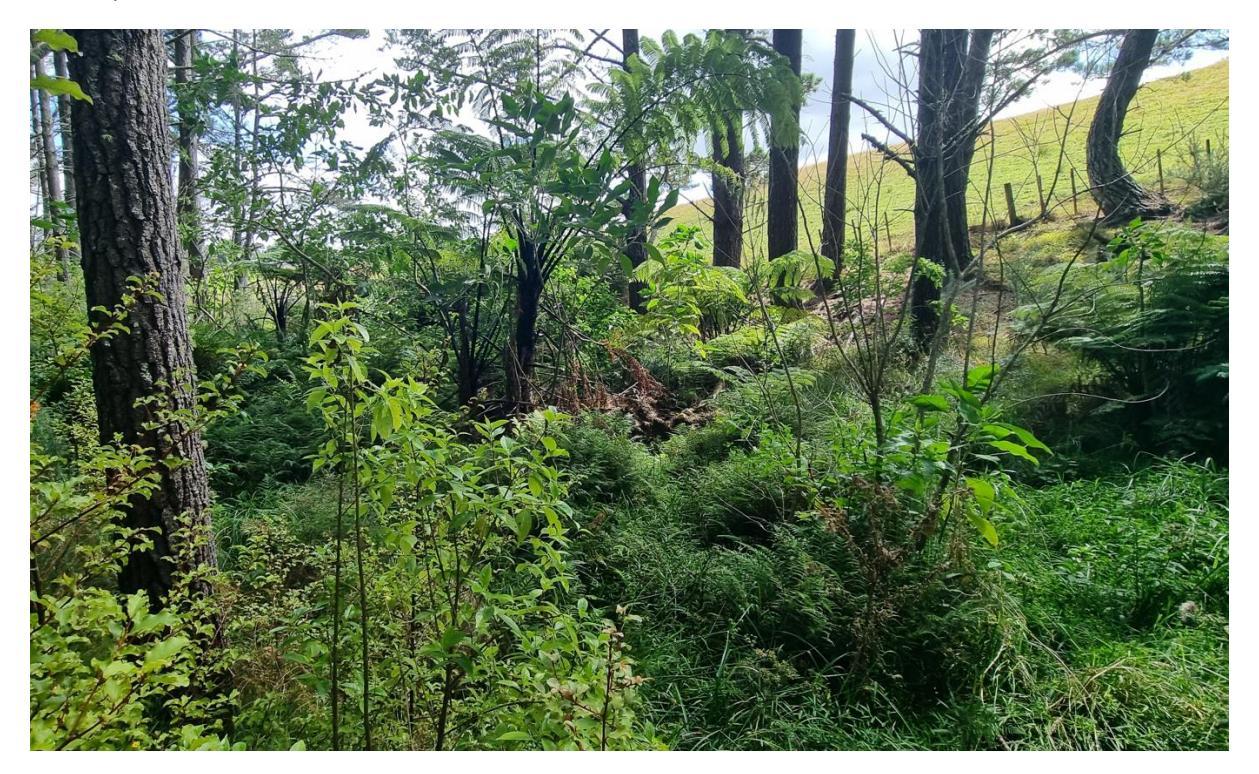
Area 8a is identified a large Monterey Pine block with an understorey of both pest plants and emerging pioneer indigenous species. The Pine block will be removed, with a small stream area feeding into Area 8 to be cleared of exotic vegetation, with indigenous species retained and protected where practical.

Figure 10 – Stream area within Area 8a

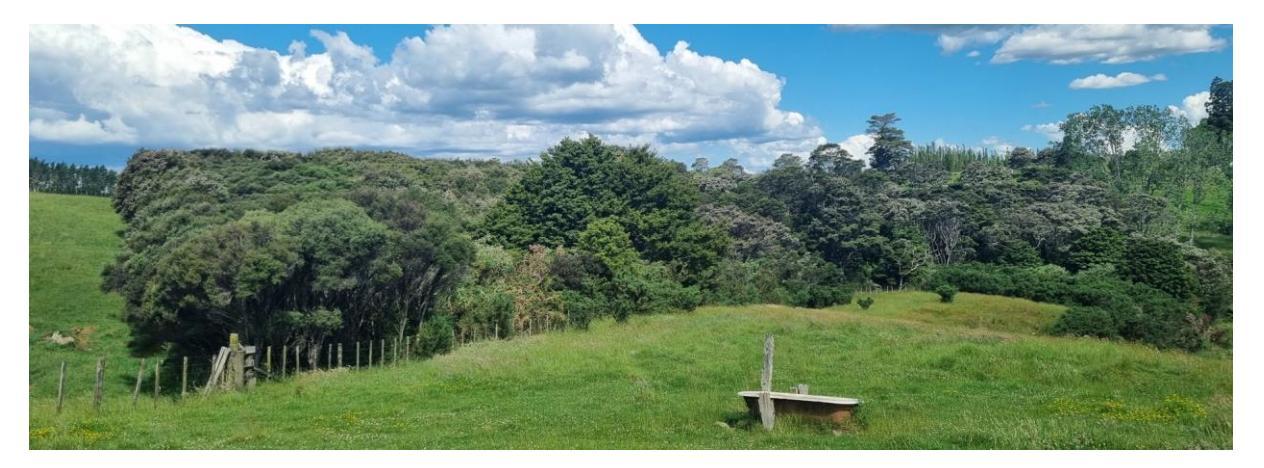
Area 9 is identified as an area of bush subject to consent notice growing on the neighbouring property. This bush area is predominantly indigenous, dominated by Totara and Manuka. This area is retained as part of the project.

Figure 11 – View of Area 9 located on the adjoining property (3 Russell Road)

It is recommended that an earthworks setback (from the edge of the consent notice boundary) is adopted where works are required adjacent to the northern boundary of this neighbouring bush area. This recommendation is due to the extent of cut/fill earthworks, coupled with the proposed road stub proposed as part of the NOR 6 alignment, a setback will enable the installation of erosion and sediment control measures to be suitably distanced from the protected root zone of this vegetation, to minimise negative arboricultural effects relating to ground level changes and overland flow alterations. Further protection measures and specific methodologies can be included as part of the TMP where necessary.

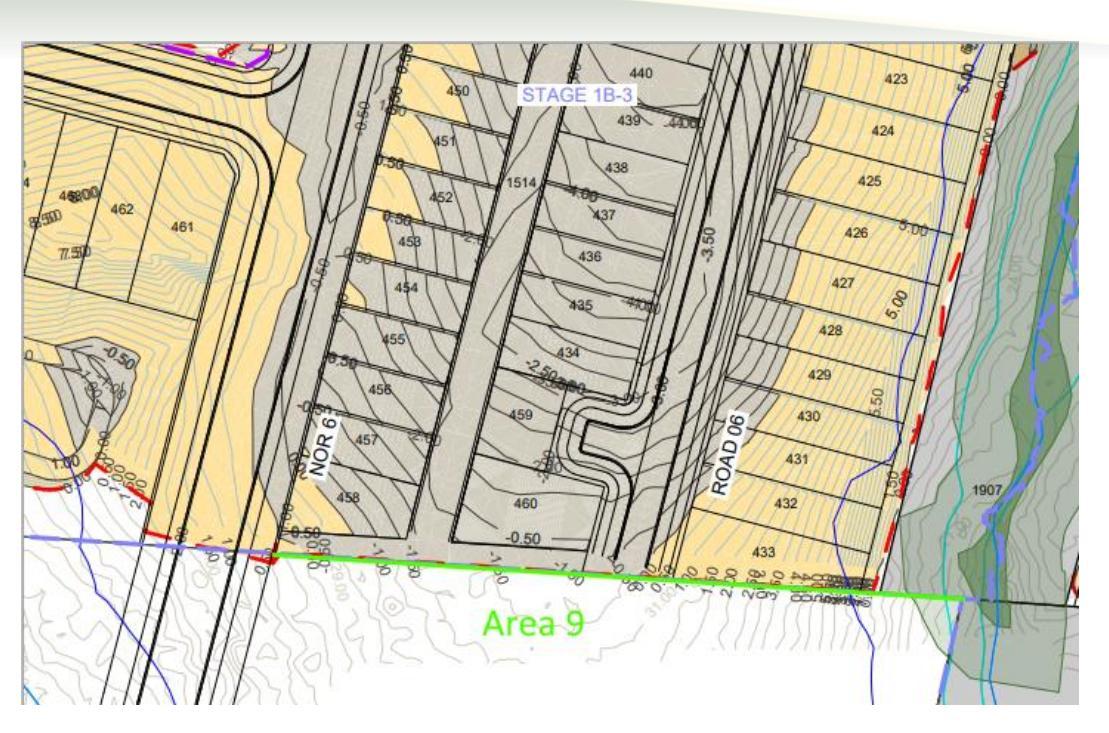
Figure 13 – Earthworks Plan snip showing location of earthworks adjacent to Area 9

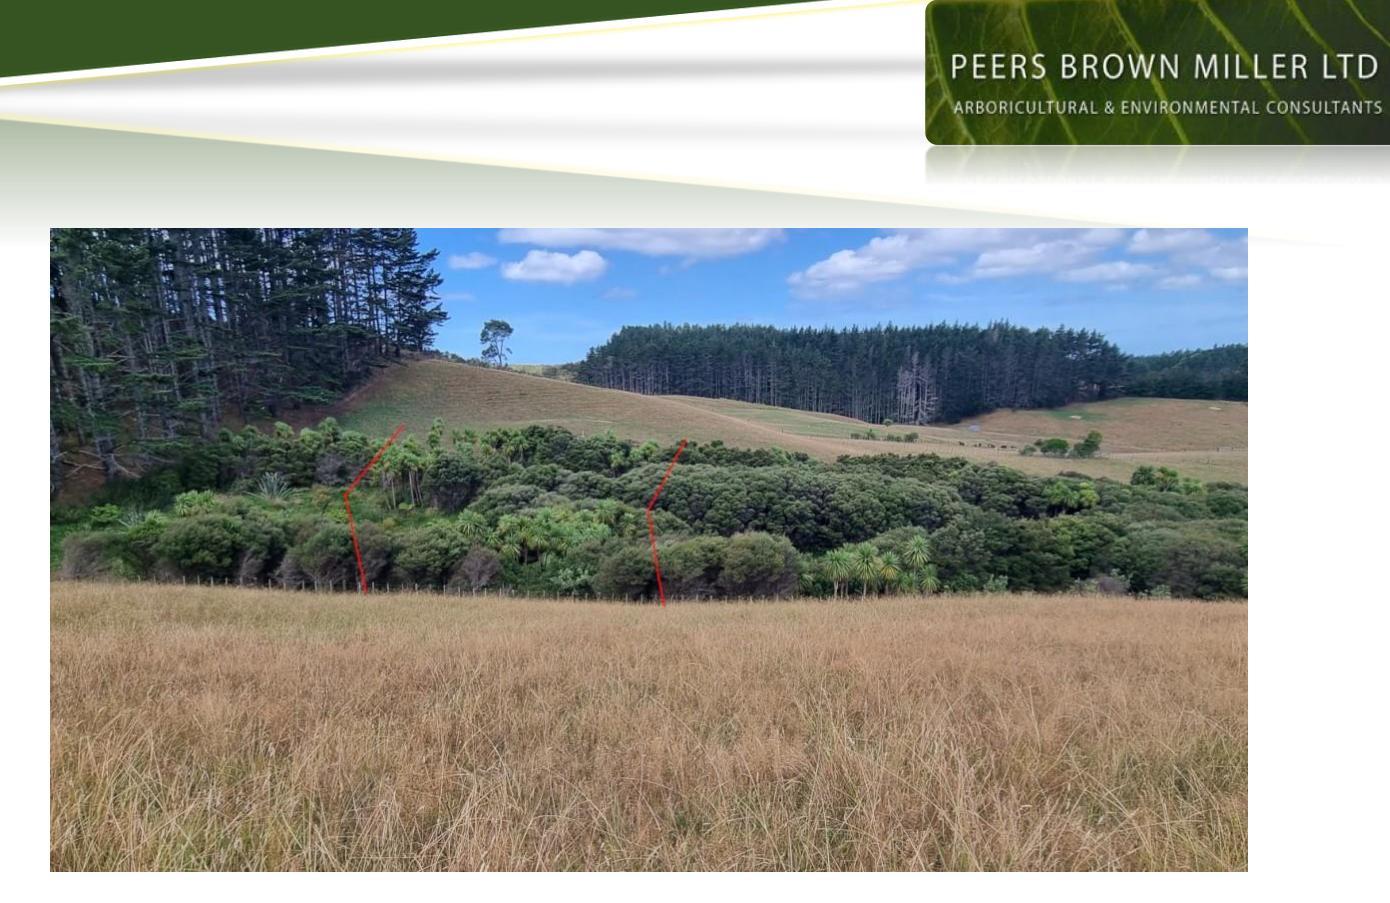
The vegetation within this location is dominated by Manuka, Tī Kōuka and Karamū (*Coprosmas robusta*), having been likely planted within the last 10 years. Approximately 1292m2 of vegetation is proposed for removal as part of the NOR 6 works. The remaining vegetation within these areas is to be retained and protected, with tree protection measures provided as part of the TMP. Further recommendations are also provided in Section 6.0.

Figure 14 – Anticipated clearance extent through Area 11 as part of the NOR 6 works

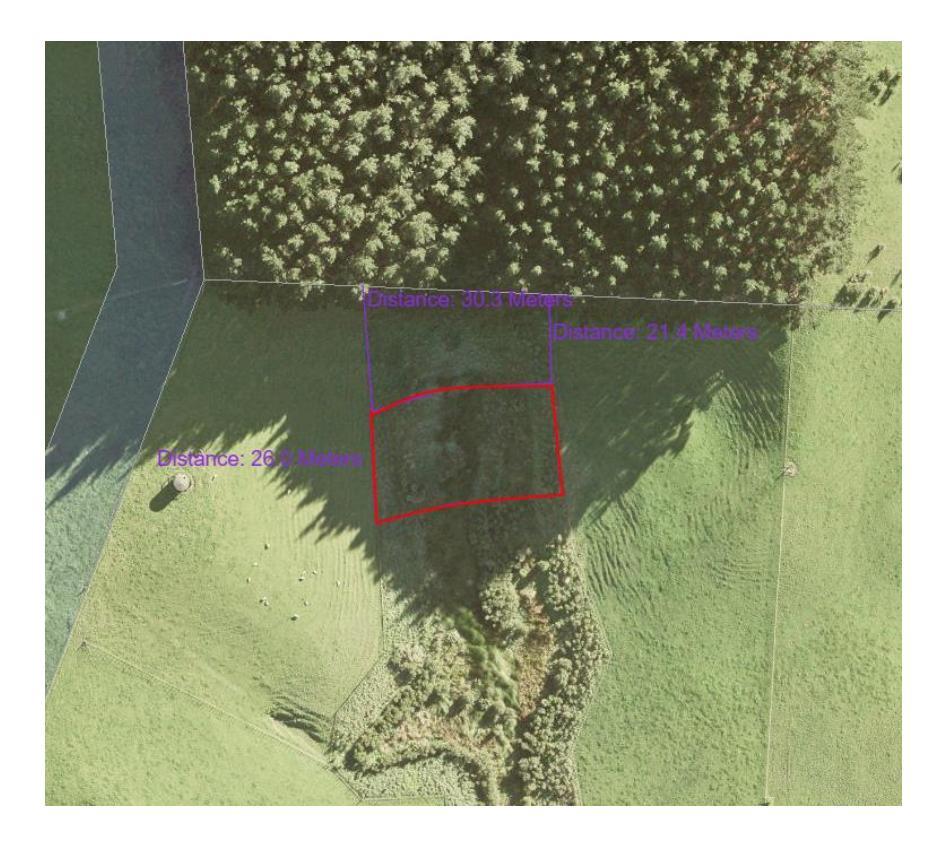
Figure 15 – Aerial view of approximate clearance extent for NOR 6 works (Calculations via Auckland Council GIS Maps

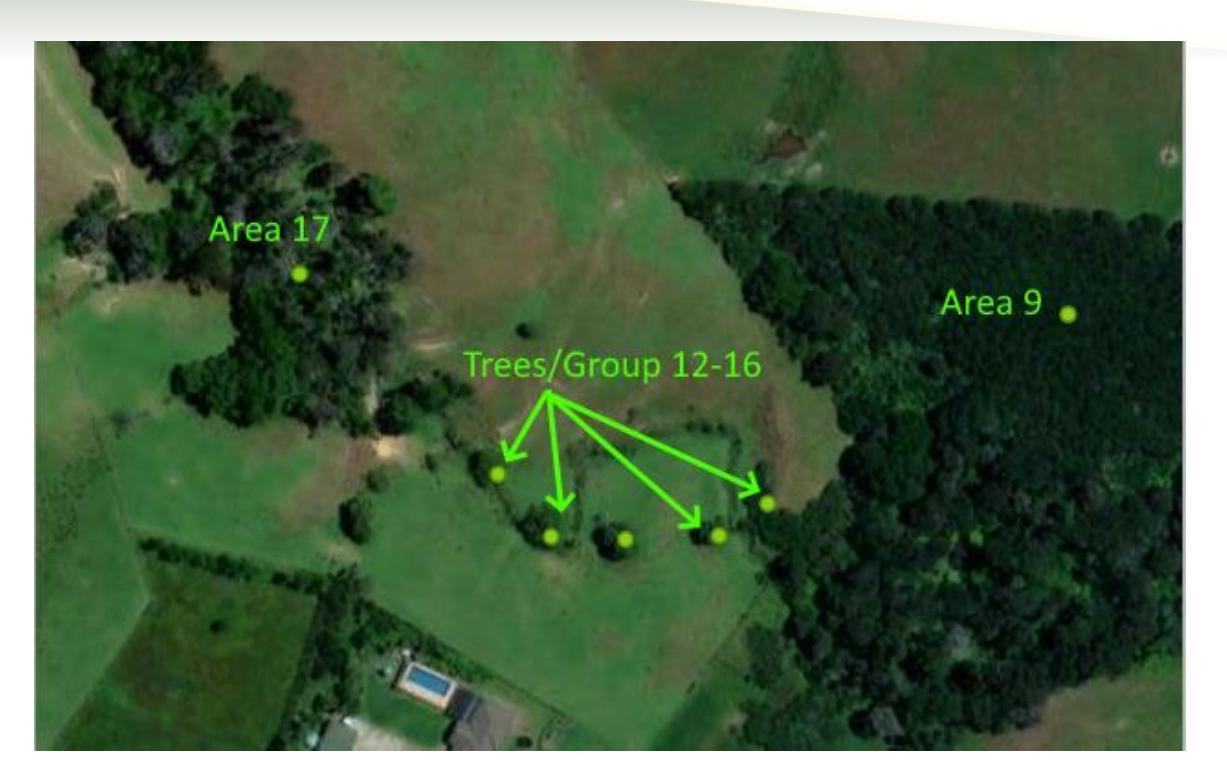
Trees 12 - 16 are located adjacent to the existing stream to the south of the proposed earthworks area. The trees will not be effected as part of the Project layout and as such are proposed for retention.

Figure 17 – Image showing locations of Trees/Groups 12 - 16

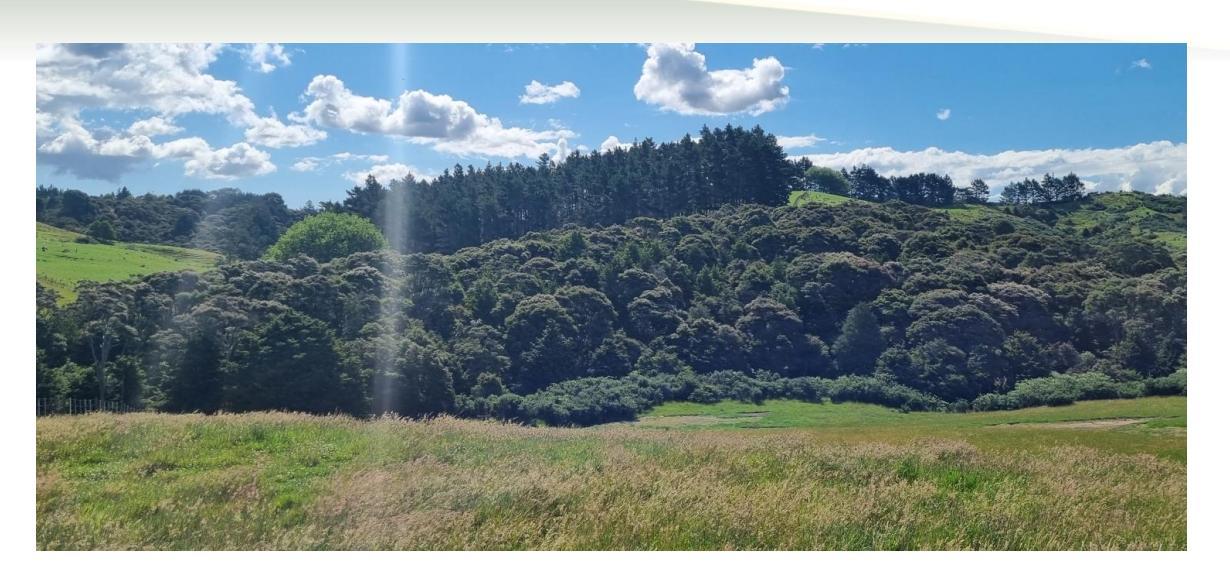
Area 17 is identified as a regenerating indigenous bush area, dominated by Totara, Manuka, Kanuka, Ponga *(Cyathea dealbata)* and Tānekaha (*Phyllocladus trichomanoides*). This area is to be retained, with earthworks required on the western side to form the proposed road network coupled with the removal of an existing culvert and to the north and east as part of the formation of the new residential lots.

Figure 18 – Main portion of Area 17, as viewed from the east

An earthworks setback of is **recommended** to the north and east, with the works to the west largely within the footprint of the existing farm track (bush edge largely defined by a seven-wire fence). This is recommended to ensure works occur beyond the protected root zone (PRZ) of existing vegetation, with the consent notice boundaries not a true reflection of the current environment. Further recommendations of works adjacent to and within the PRZ of this Area is to be included in the TMP.

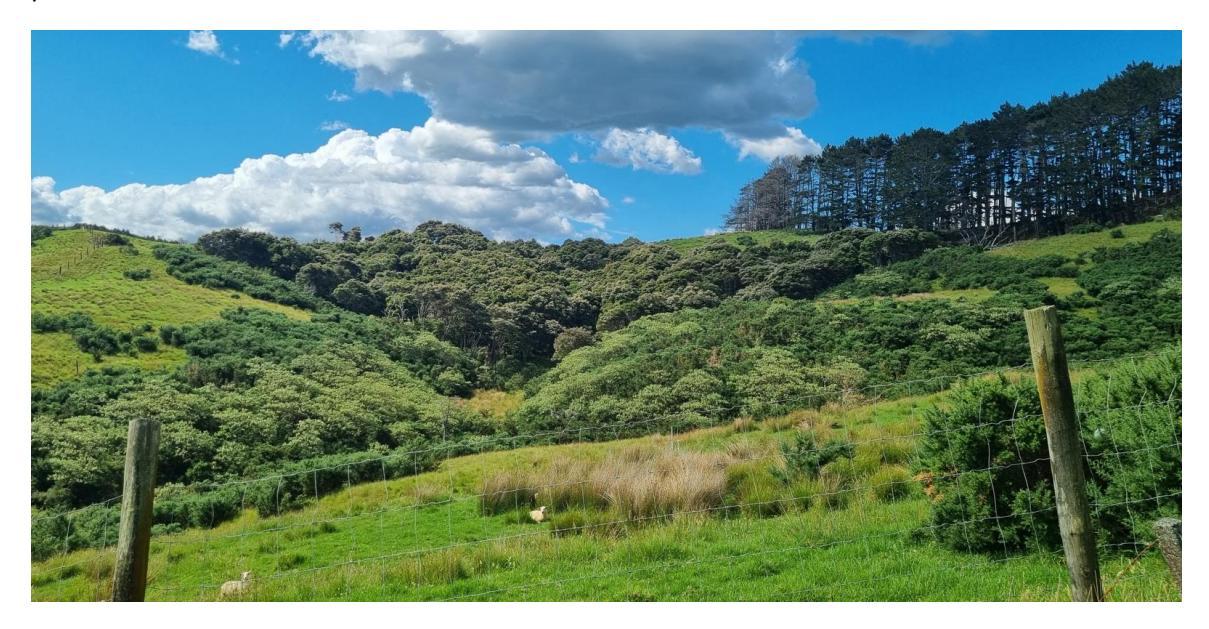
Areas 18 and 21 are directly north of Area 17 and consist almost entirely of pest plants (including Gorse & Woolly Nightshade (*Solanum mauritianum*), with the occasional regenerating Mahoe or Ti Kouka. All pest plants are to be removed within the catchment, with indigenous plant species replacement and enhancement planting proposed. Where indigenous trees/vegetation is to be retained, all adjacent earthworks should be undertaken in accordance with the recommended TMP protection measures.

Figure 18 – Area 18 looking north from adjacent to Area 17 (Area 20 seen at top of image)

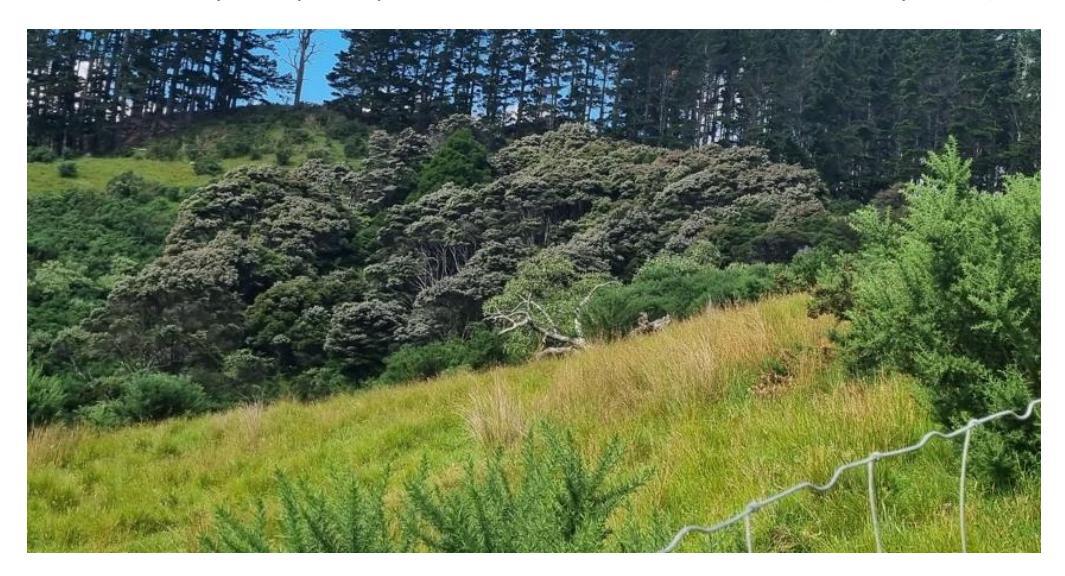
Areas 19 - 22 are identified as remnant indigenous bush areas, dominated by Manuka, Kanuka and Ponga, with a mature Rimu (*Dacrydium cupressinum*) growing within Area 19. These bush areas are to be retained and protected, with a possible walking tracks proposed.

Figure 19 – Area 19 to the northeast. Canopy of Rimu tree can be seen in the centre of the remnant.

It is **recommended** that any works proposed as part of the walking track are to be assessed and included as part of the TMP, to ensure any impacts on Area 19,20 & 22 as part of the construction of the proposed walking track are minimised. It is noted that Area 22 and a portion of 21 is covered by a SEA-Terrestrial overlay. Pest plant species will be removed from all areas (mainly Gorse).

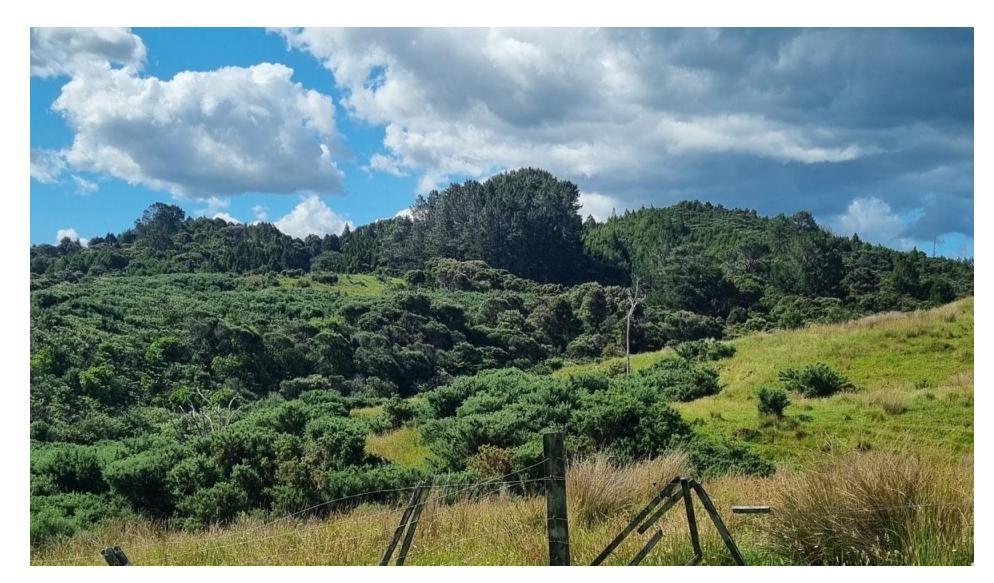
Figure 20 – Area 22 seen from the central portion of the site, pest plant species will be removed adjacent to this grouping (Area 21)

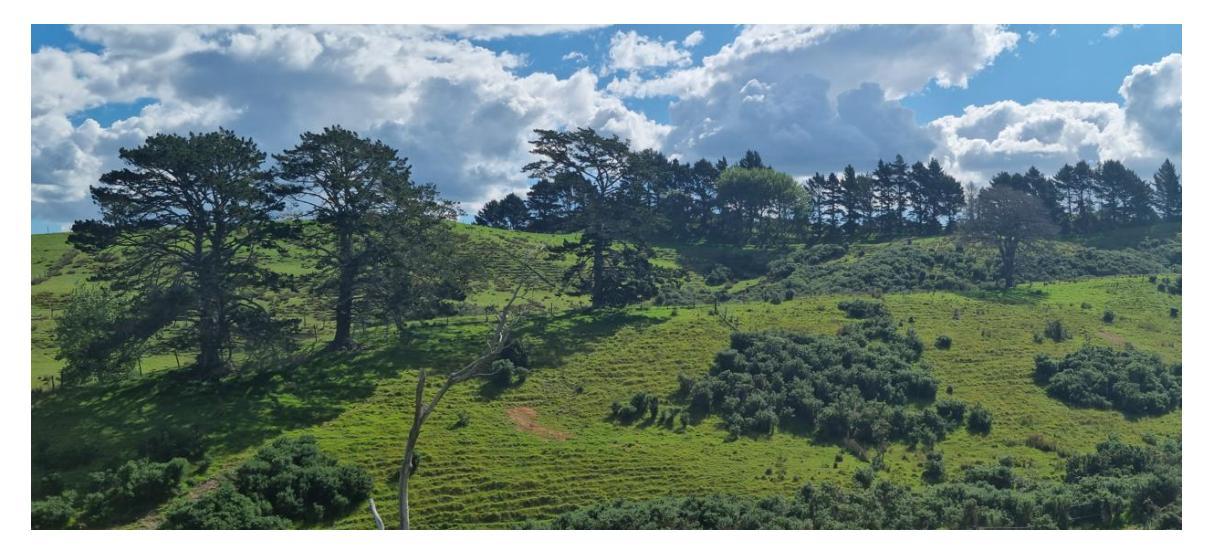
Group 23 is identified as a grouping of three (3) Monterey Pine trees growing along the ridgeline to the northwest of Area 17, a fourth tree, identified as a dead English Oak (*Quercus robur*) is also growing further west. These trees are non-protected specimens and are proposed for removal.

Figure 22 – Group 23 growing on the ridgeline (adjacent to the proposed access road)

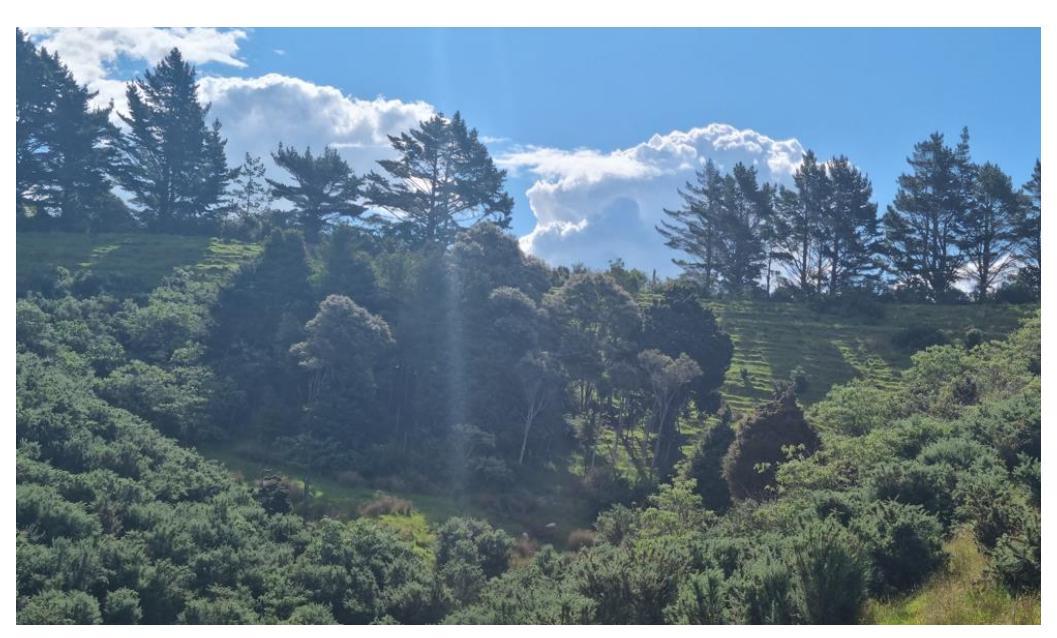
Group 24 is identified as a small cluster of indigenous vegetation growing in a small gully system near the northwest boundary of the project area. The vegetation consists of a mixture of Totara, Manuka, Kanuka and other pioneer indigenous species. This area will be retained and protected as part of the Project. Pest plant species will be cleared around the grouping.

Figure 23 – Group 24 to be retained and protected.

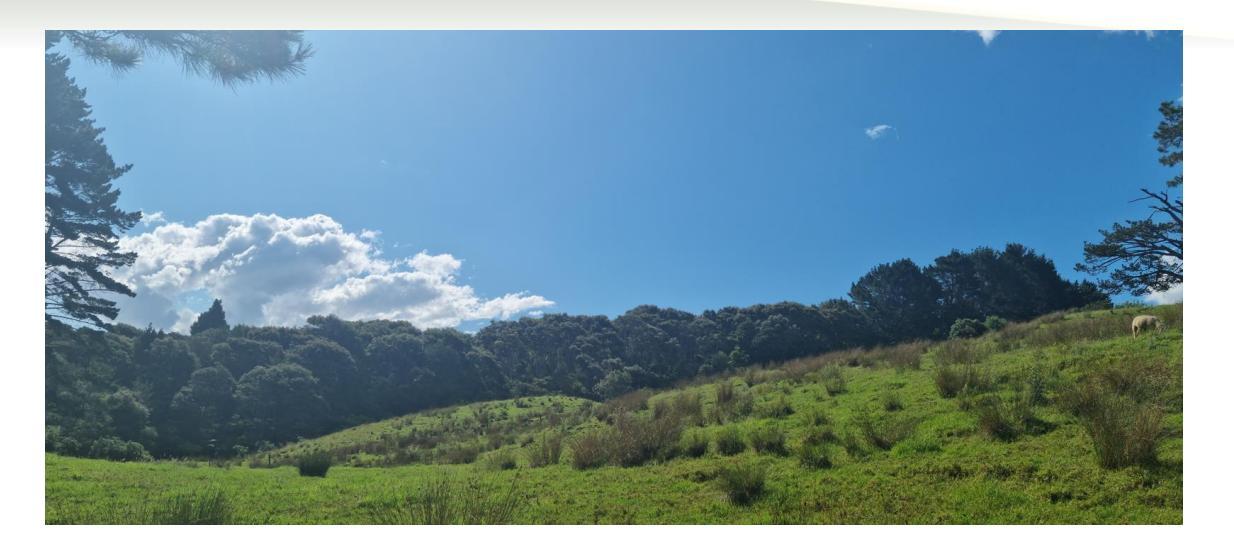
Area 25 is identified as an area of dense indigenous vegetation growing on the neighbouring property to the West (955 Weranui Road) and is subject to protection, covered by an SEA-Terrestrial overlay. It is noted the vegetation making up the wider stand is within the site and is not subject to the SEA overlay. This area as defined as part of Area 26, with a snip of the Area extents provided in Figure 27.

Figure 24– Group 25 located on neighbouring property to the West (955 Weranui Road) (a portion of the vegetation nearest to this area identified as being part of Area 26)

A setback from the boundary of at least 10m for any earthworks is **recommended** to ensure ongoing protection. This is to ensure edge effects on the neighbouring vegetation is minimised, including ensuring erosion and sediment controls do not impact protected root zones.

It is also **recommended** that all works adjacent to this area are to be undertaken in accordance with the proposed TMP to be prepared at the detailed design stage, to incorporate best arboricultural practice.

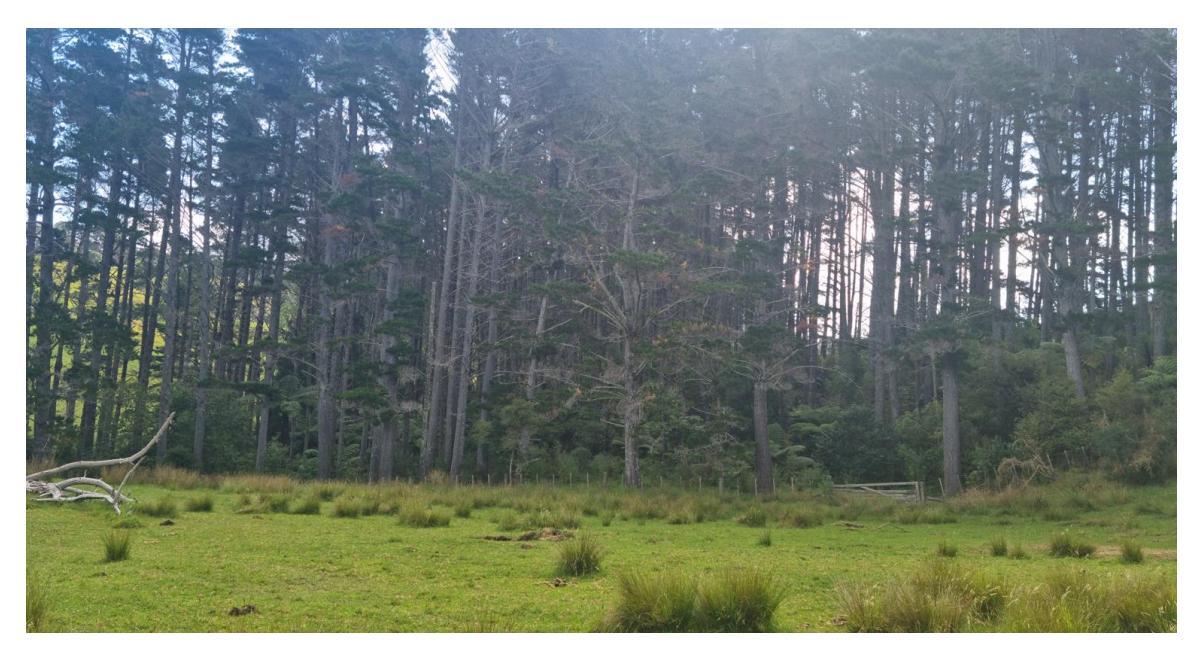
With the exception of the pest plants and Monterey Pine row to the north, forested vegetation within Area 26 is to be retained, with works adjacent to Part B as part of the residential lot creation. A new, widened culvert and access roadway is proposed between the southeast portion of Area 26 and the southwest corner of Area 17.

Figure 26 – View of the Monterey Pine forest section of Area 26 (see Figure 18 for an image of the indigenous vegetation adjacent to the western boundary)

It is **recommended** that all construction works adjacent to these areas is to be defined and assessed as part of the TMP.

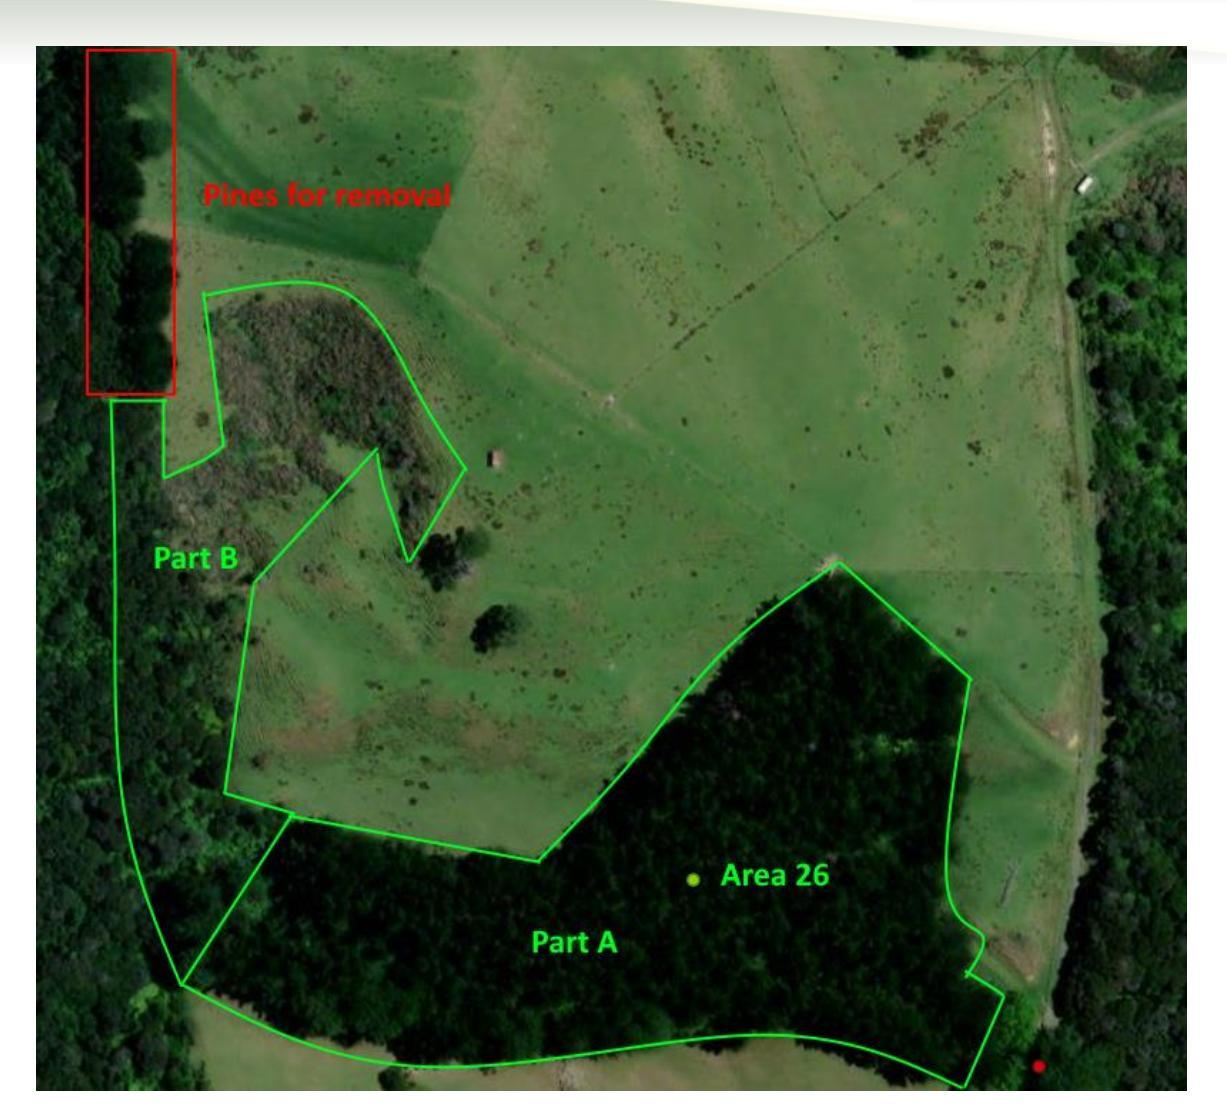
Figure 27 – Illustration of Part A & B areas of Area 26. Monterey Pine trees to be removed also shown.

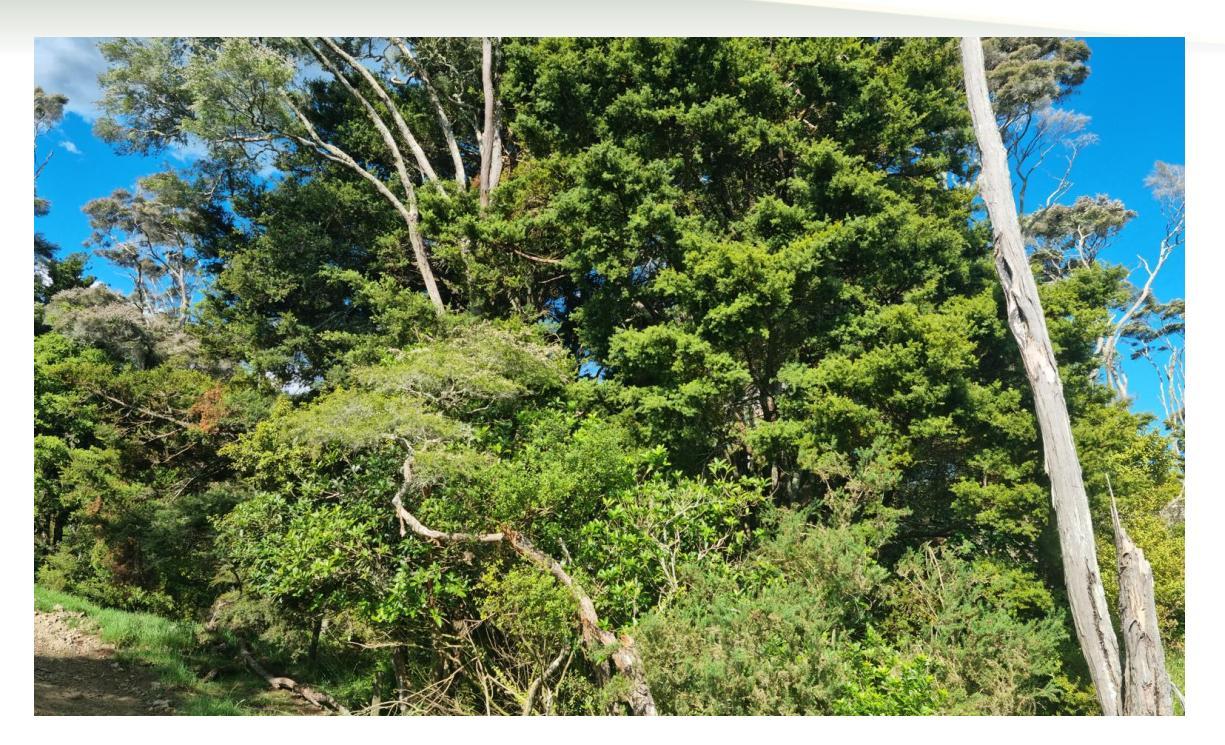
Area 27 is identified as a mixture of exotic vegetation (Willow) and indigenous vegetation (predominately Totara and Manuka) to be removed to enable the construction of the new road access, removal of the existing culvert, and the removal of an existing pipe bridge between Areas 26 and 17.

Figure 28 – View of Area 27 to the east of the existing farm track. Portion to be removed for new roadway and associated infrastructure.

Care must be undertaken to minimise the extent of tree removal, with care taken to ensure vegetation overhanging the proposed works footprint and directly adjacent to the protected root zone is adequately protected. It is recommended that all works are undertaken in accordance with proposed TMP conditions.

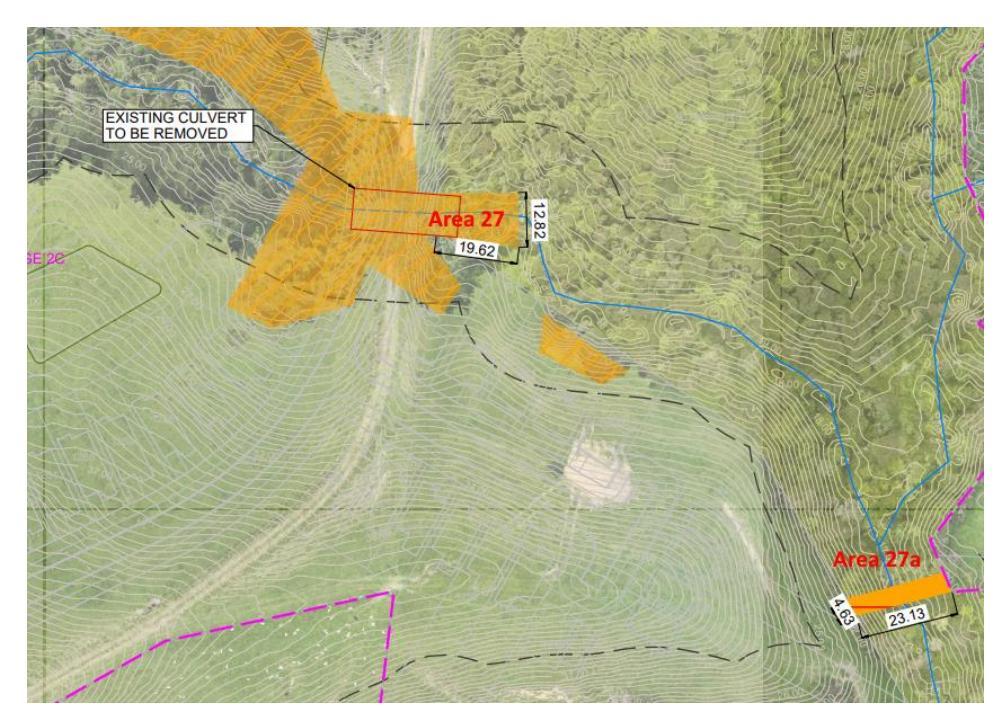
Figure 29 – Anticipated extent of vegetation clearance proposed to enable the removal of the existing culvert, pipe bridge works (27A) and road infrastructure.

Care must be undertaken to minimise the extent of tree removal, with care taken to ensure vegetation overhanging the proposed works footprint and directly adjacent to the protected root zone is adequately protected. It is recommended that all works are undertaken in accordance with proposed TMP conditions.

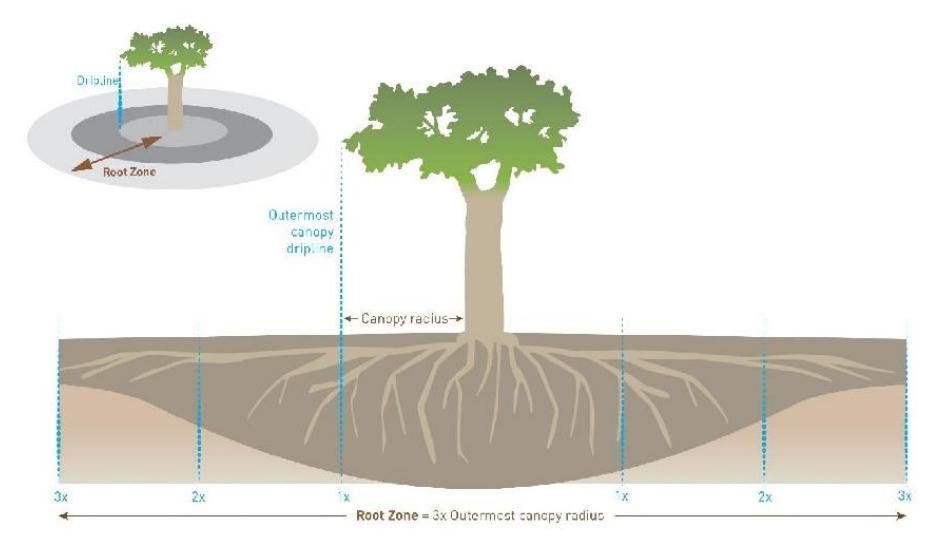
#### Figure 1: Root zone of kauri (3 times the radius of the outermost canopy dripline).
