Geotechnical Report for Resource Consent

Ayrburn Screen Hub 1 Ayr Avenue, Arrowtown **Report prepared for:** Waterfall Park Developments Ltd

Report prepared by: GeoSolve Limited

January 2025 GeoSolve Ref: 150098.11

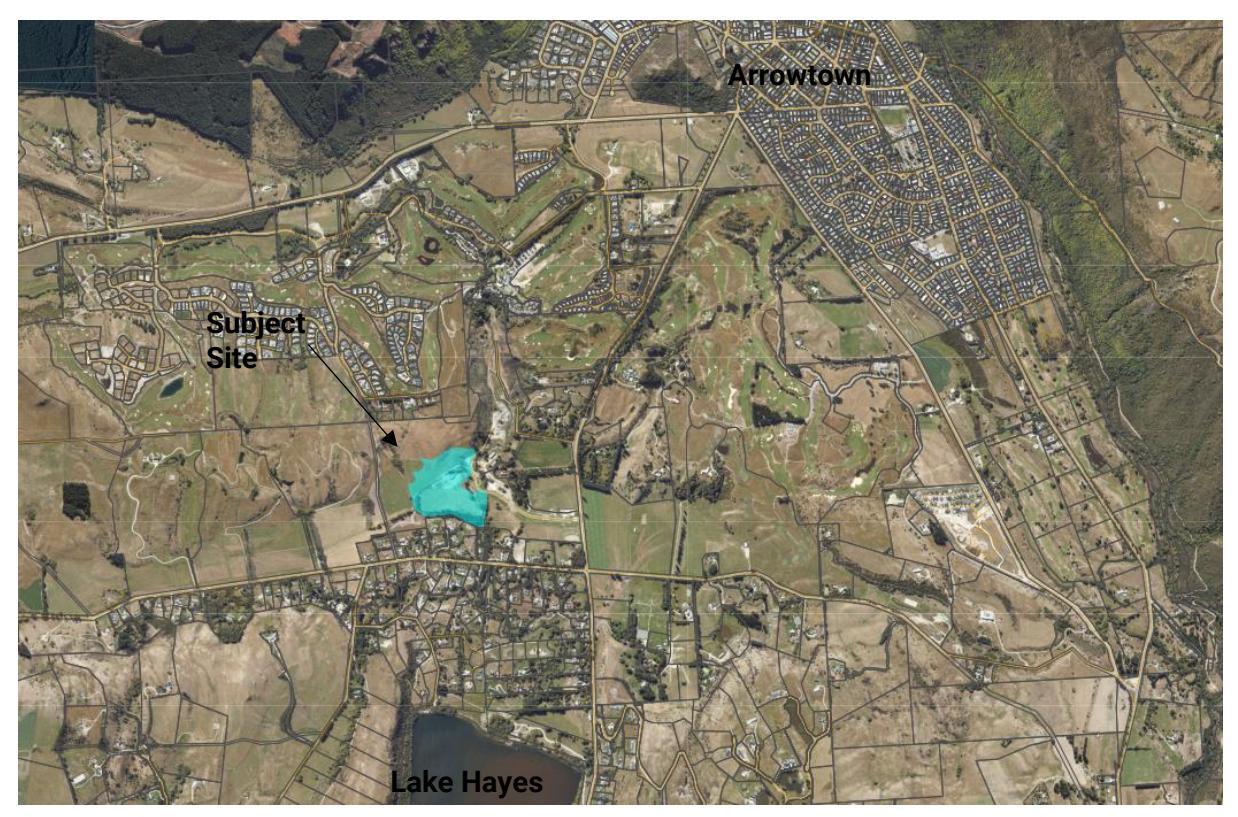
Figure 3.1 – Site Location Plan – ref: QLDC GIS

The subject site is located approximately 1 km north of Lake Hayes and 350 m to the west of the Arrowtown - Lake Hayes Road from which the site is accessed, as shown on Figure 3.1 below.

The subject site is bound to the south by existing residential developments along Speargrass Flat Road, and to the east by the Ayrburn/Northbrook development site. Undeveloped farmland adjoins the western boundary of the site with Millbrook and associated residential development to the north. An aerial view of the approximate site area is provided on Figure 1b, Appendix A.

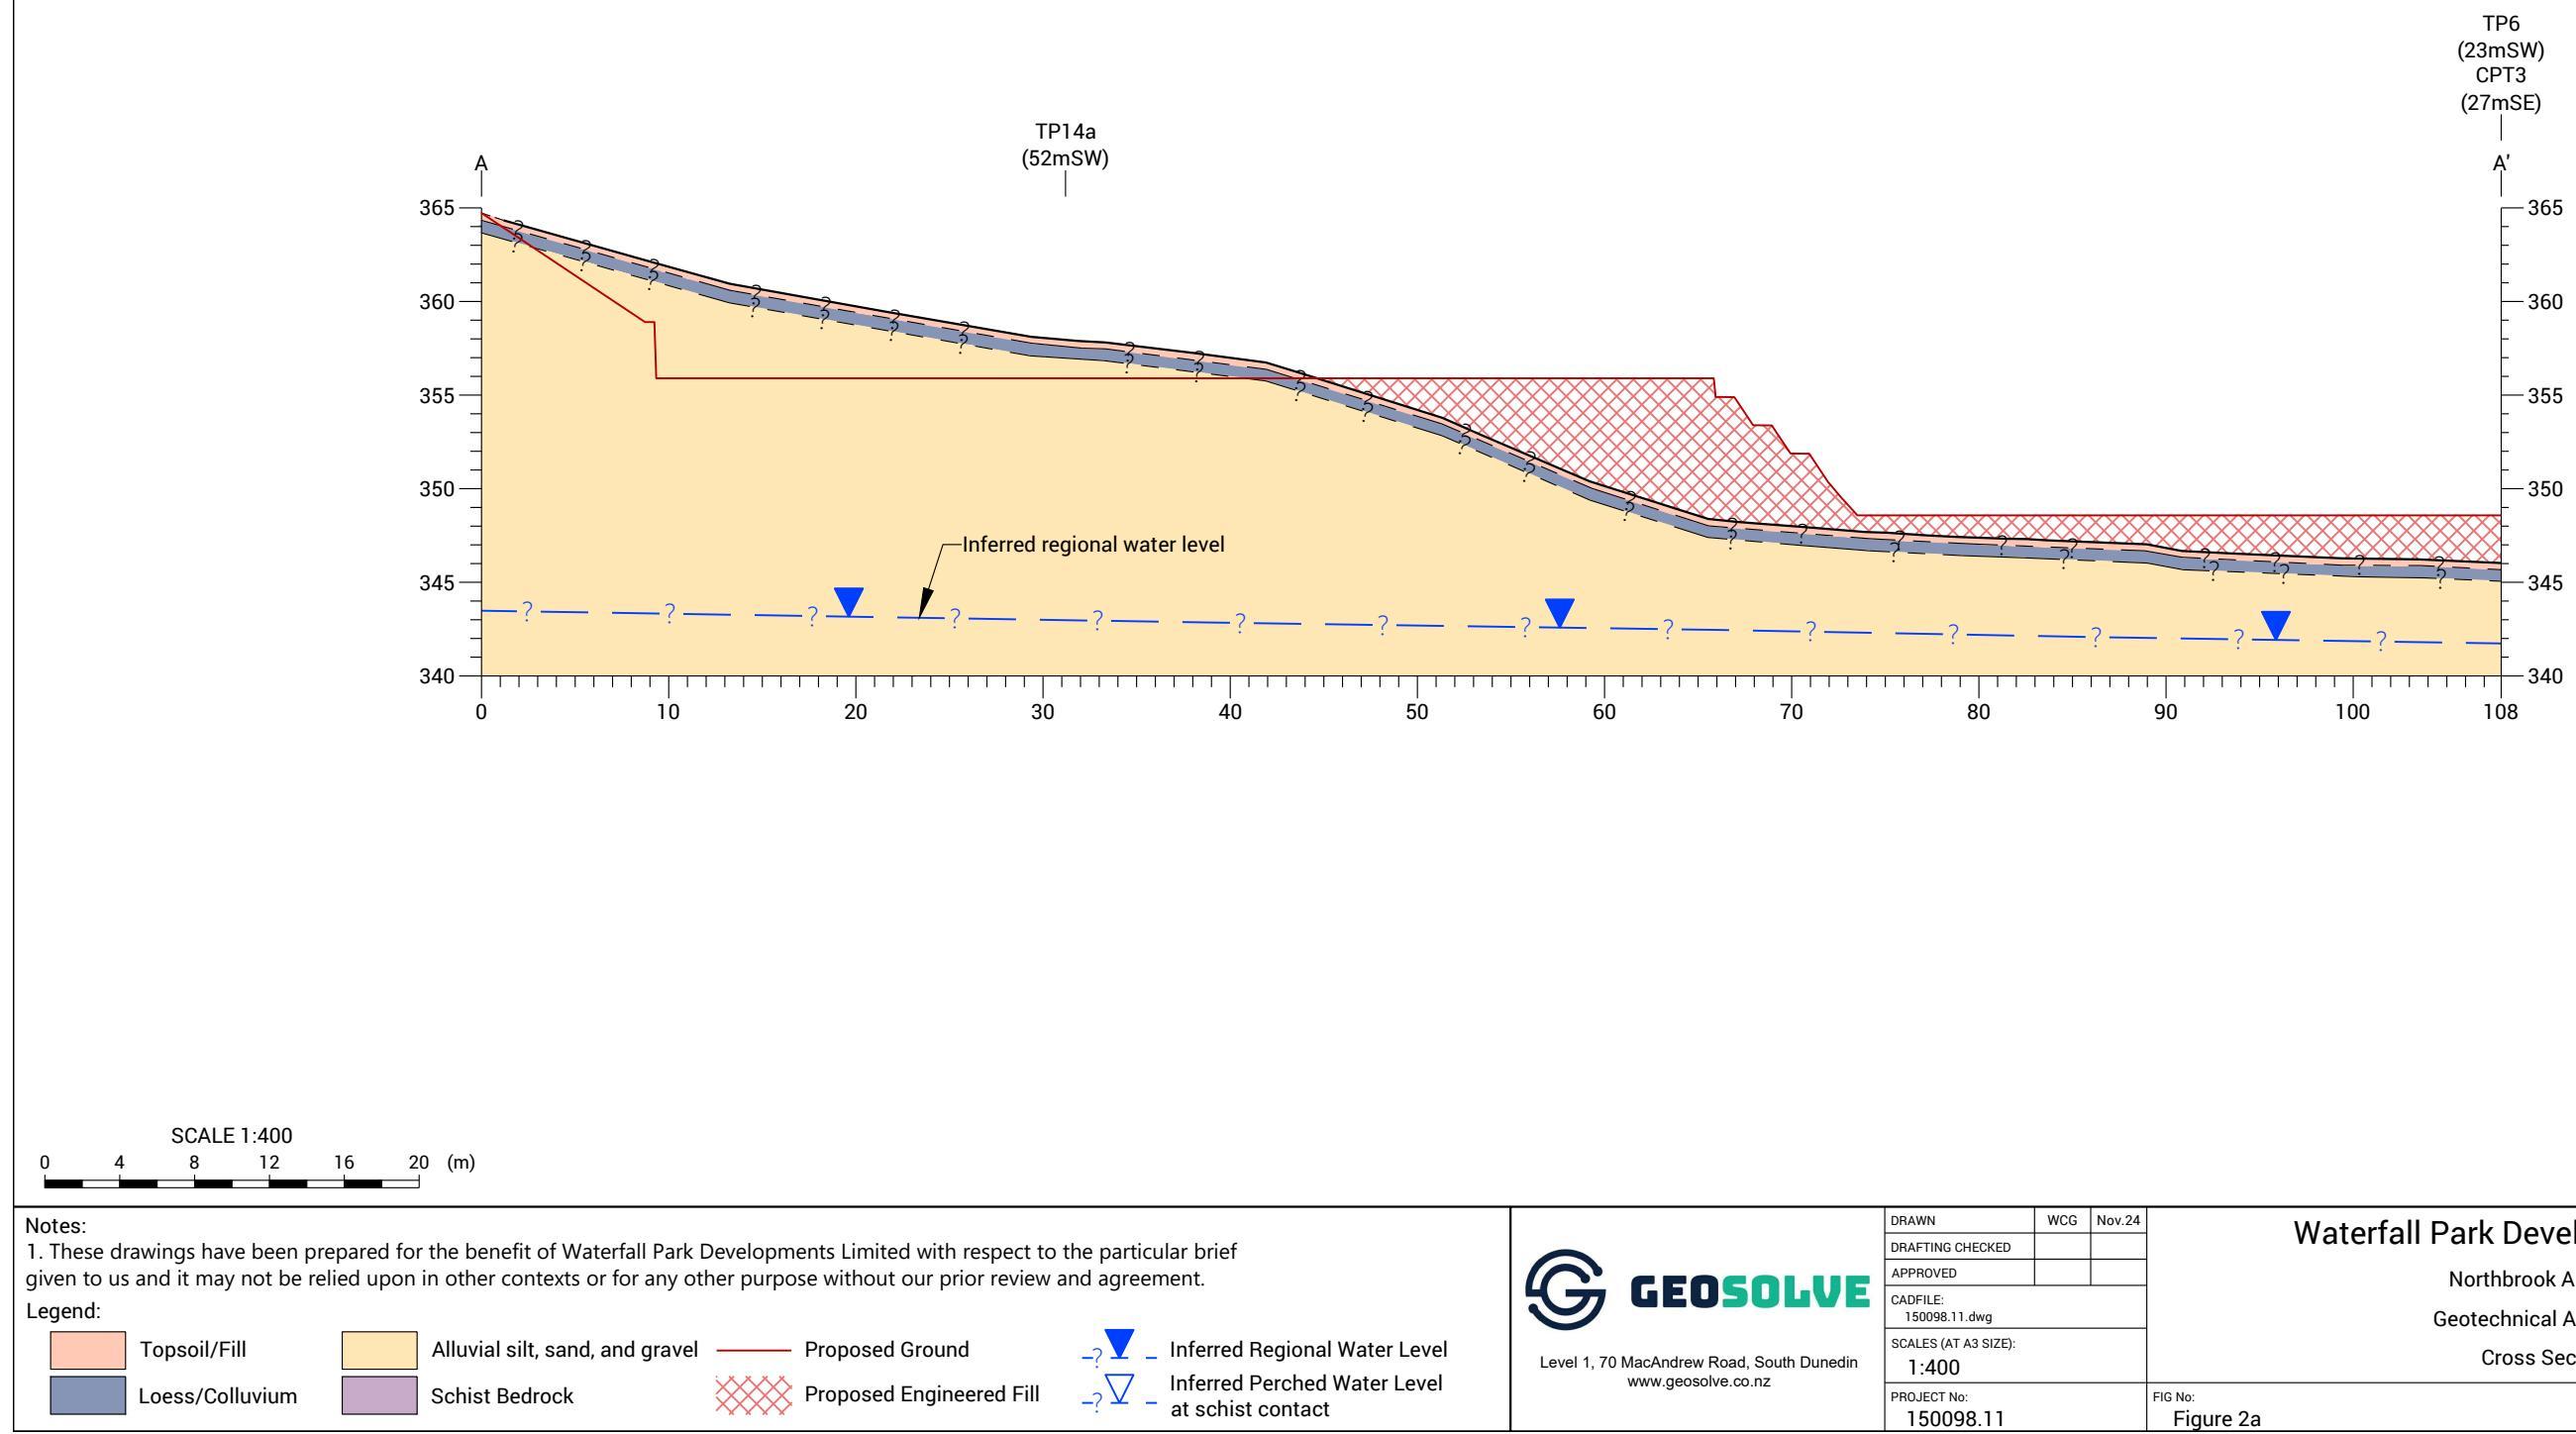
Cross Section A

Full details of the observed subsurface stratigraphy can be found within the test pit and borehole logs contained in Appendix B, and the ground model is shown on the cross-sections provided as Figures 2a to 2f, Appendix A.

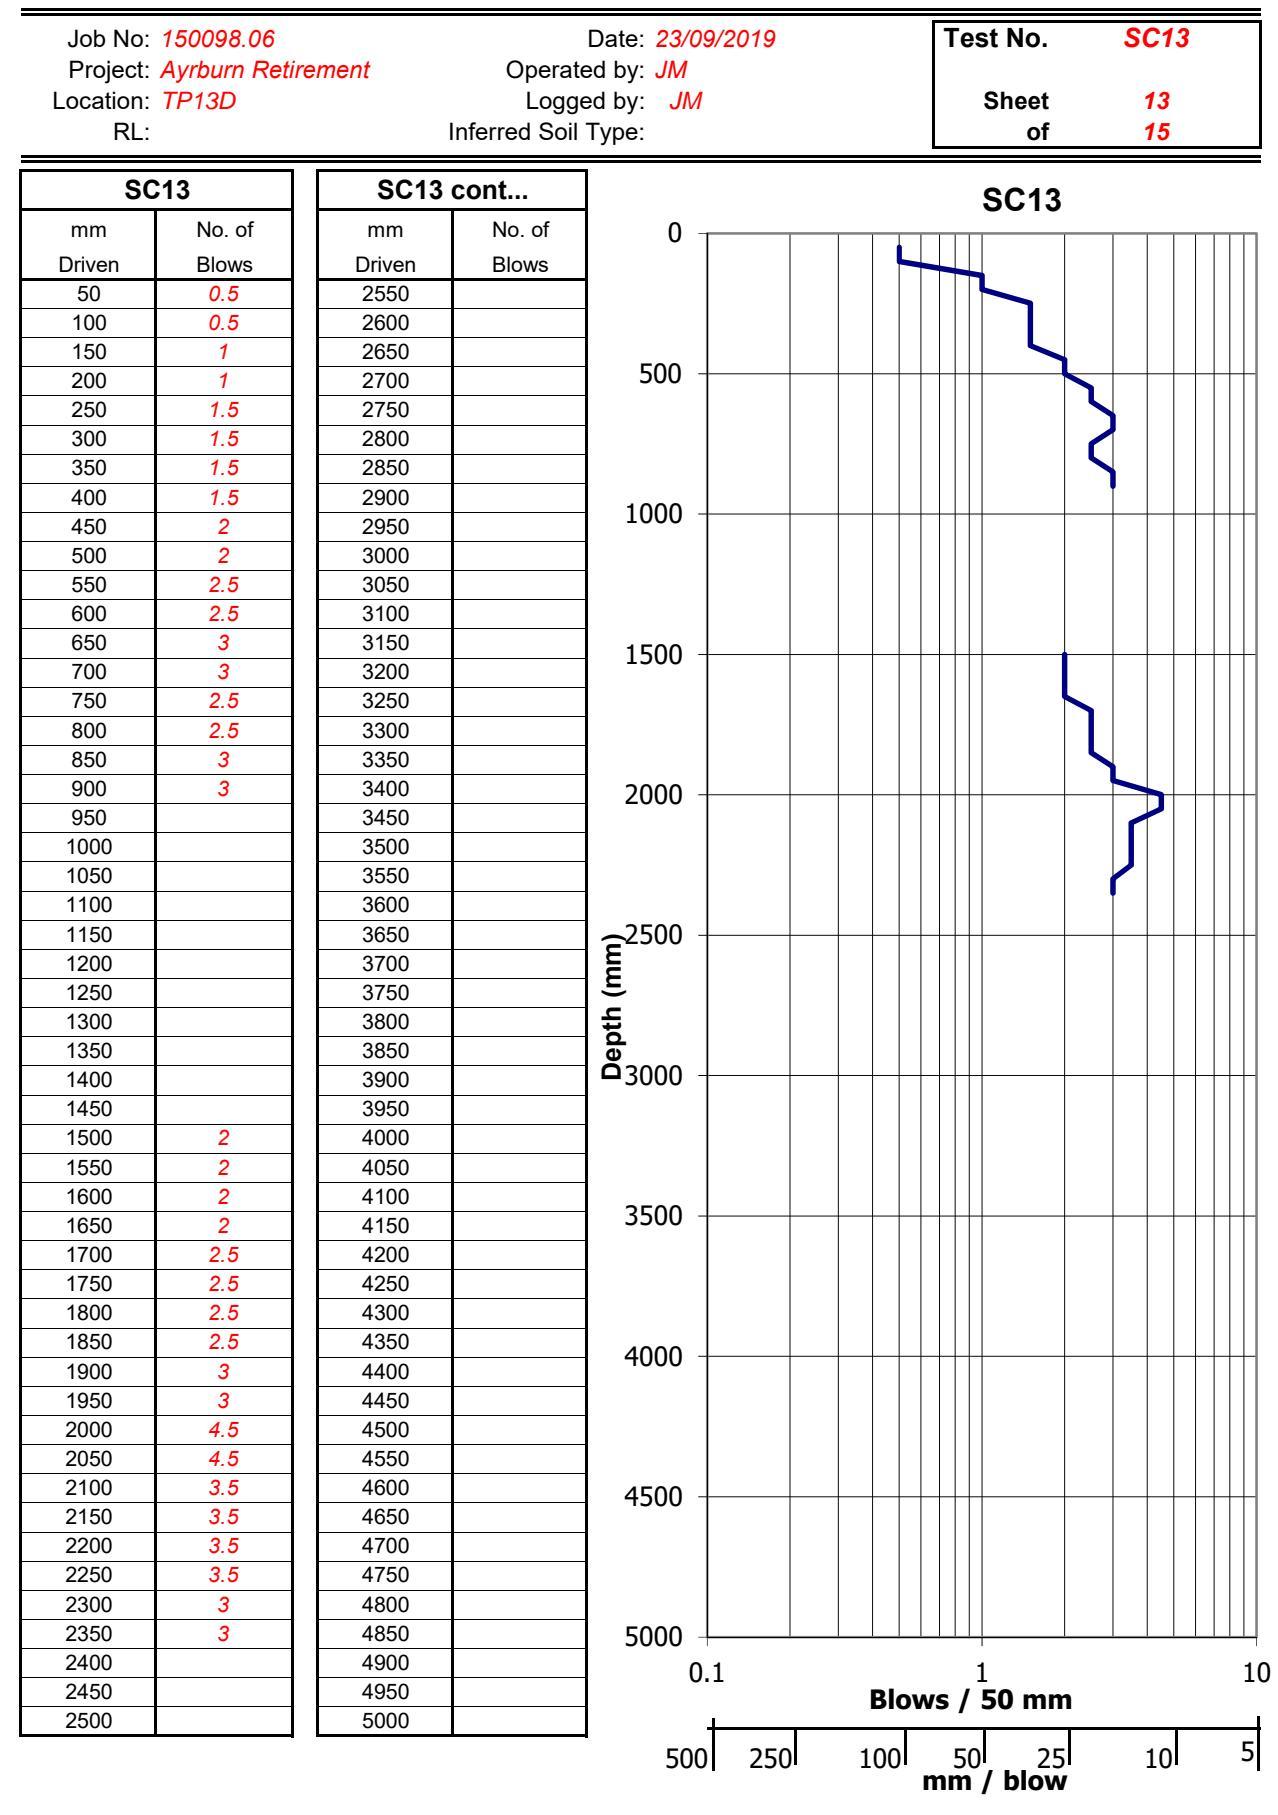
SCALA PENETROMETER LOG

Test Method Used: NZS 4402:1988 Test 6.5.2 Dynamic Cone Penetrometer

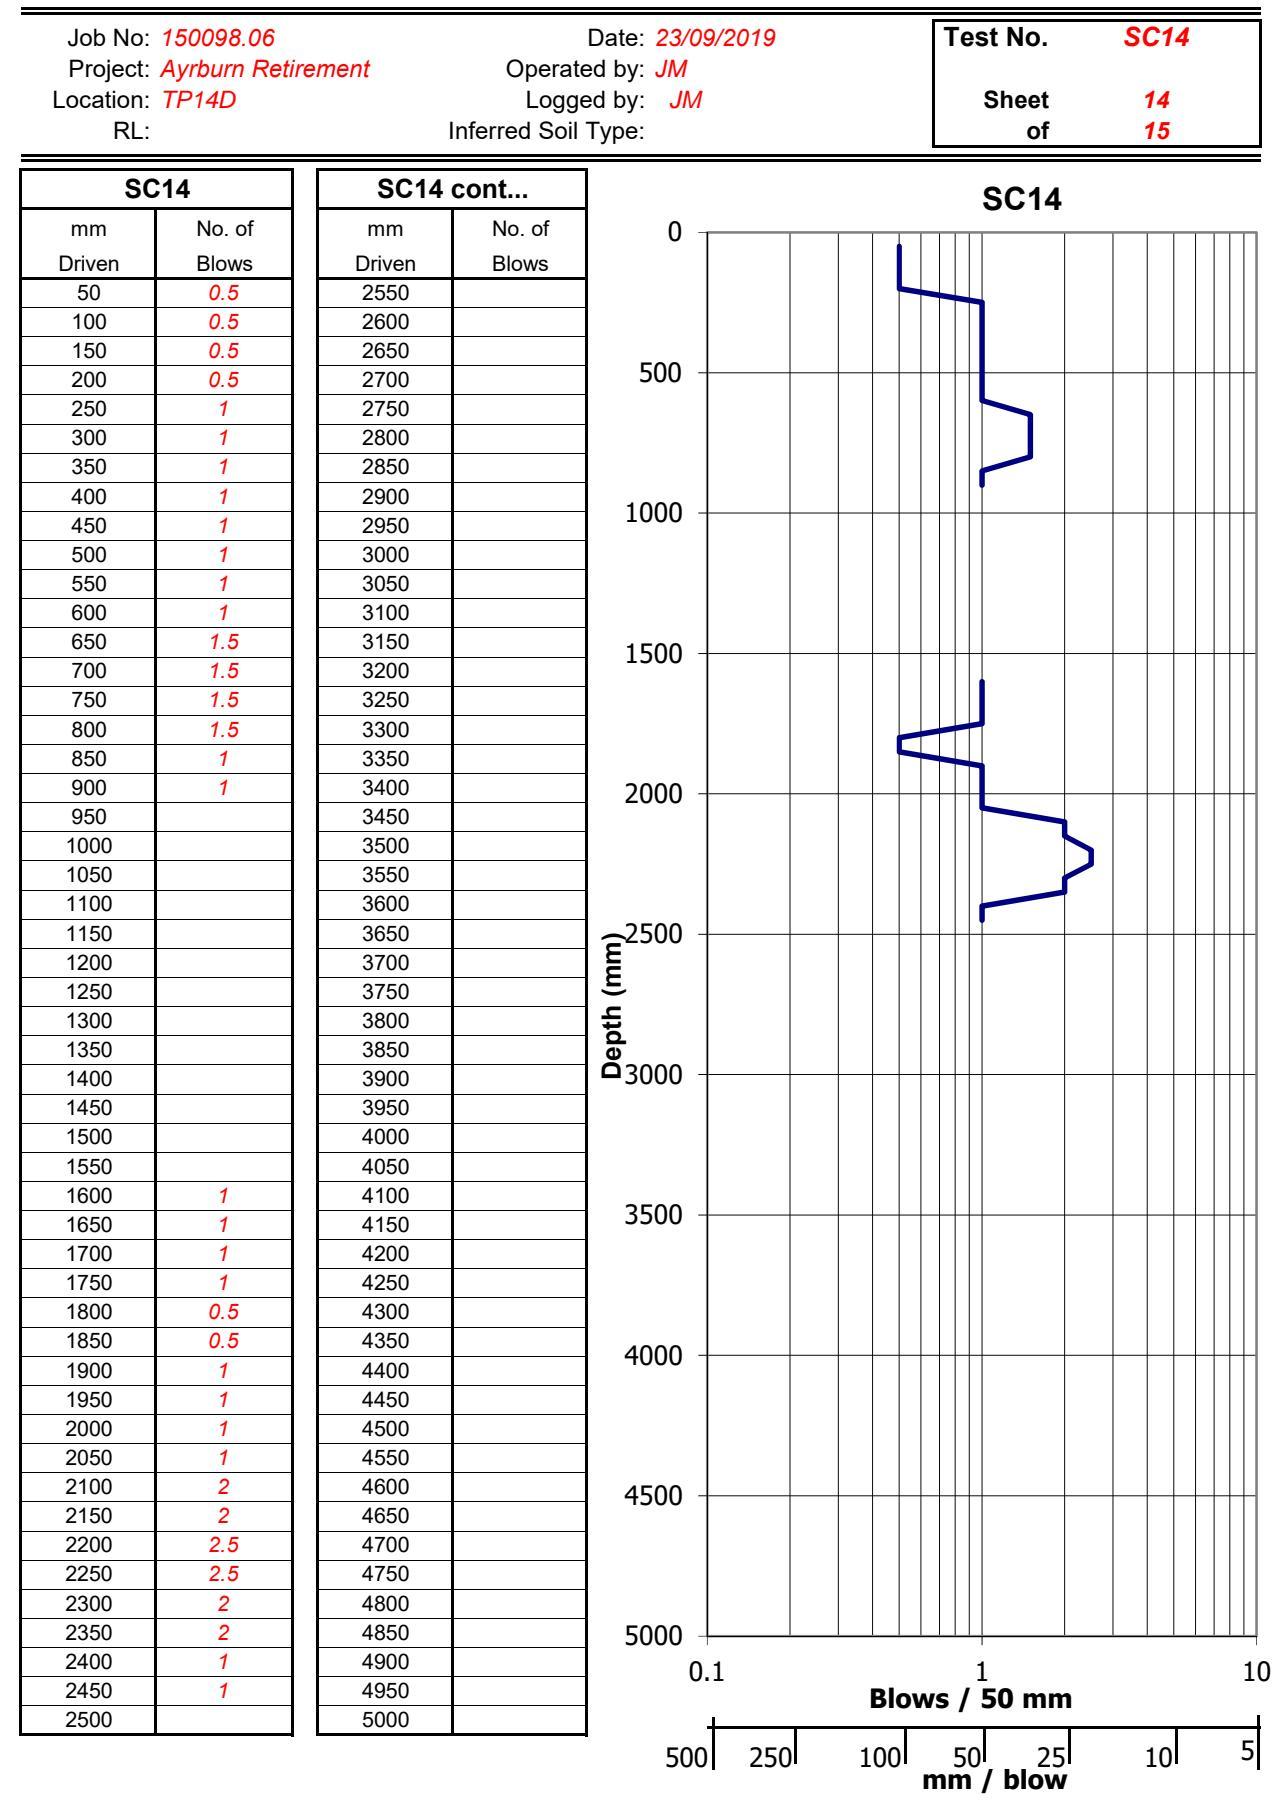
SCALA PENETROMETER LOG

Test Method Used: NZS 4402:1988 Test 6.5.2 Dynamic Cone Penetrometer

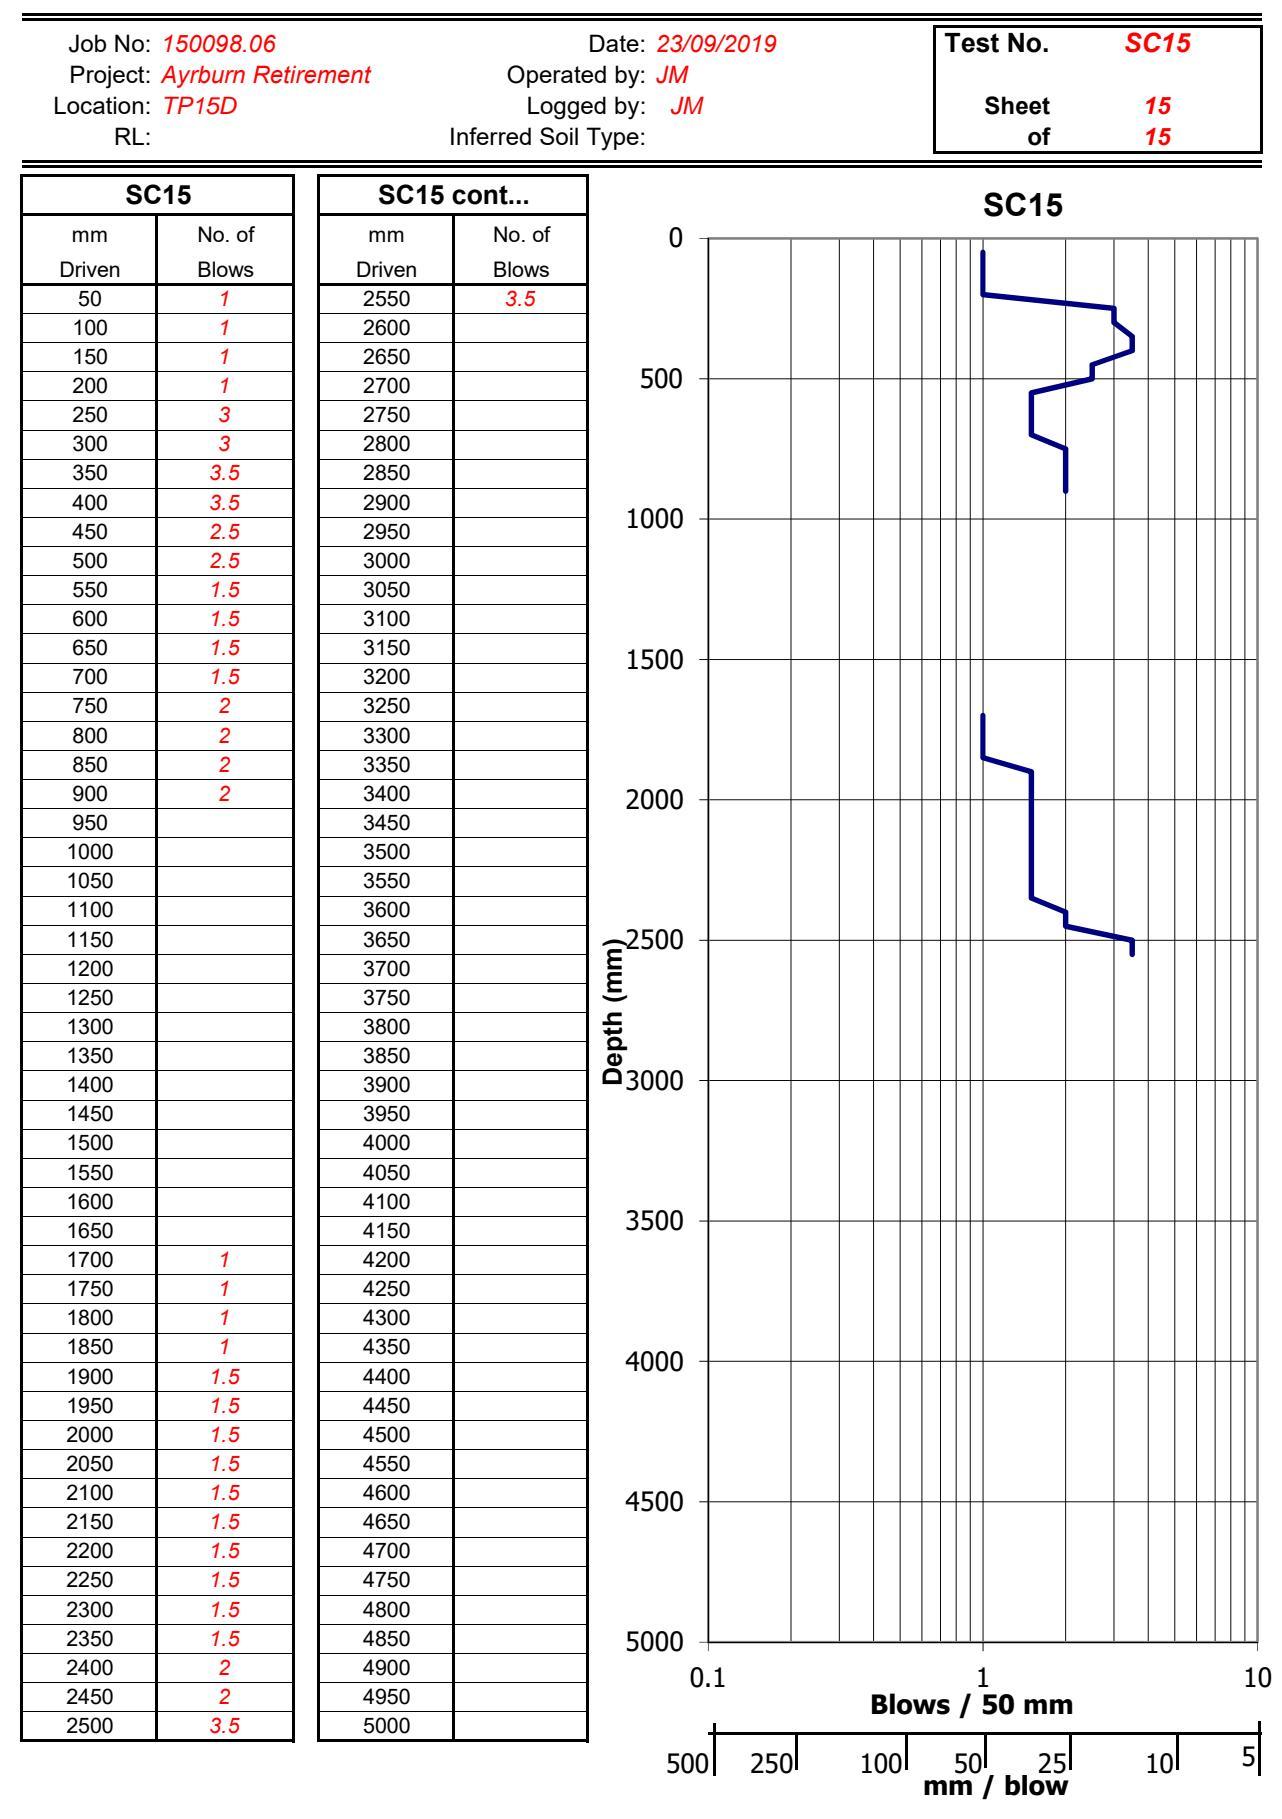
SCALA PENETROMETER LOG

Test Method Used: NZS 4402:1988 Test 6.5.2 Dynamic Cone Penetrometer

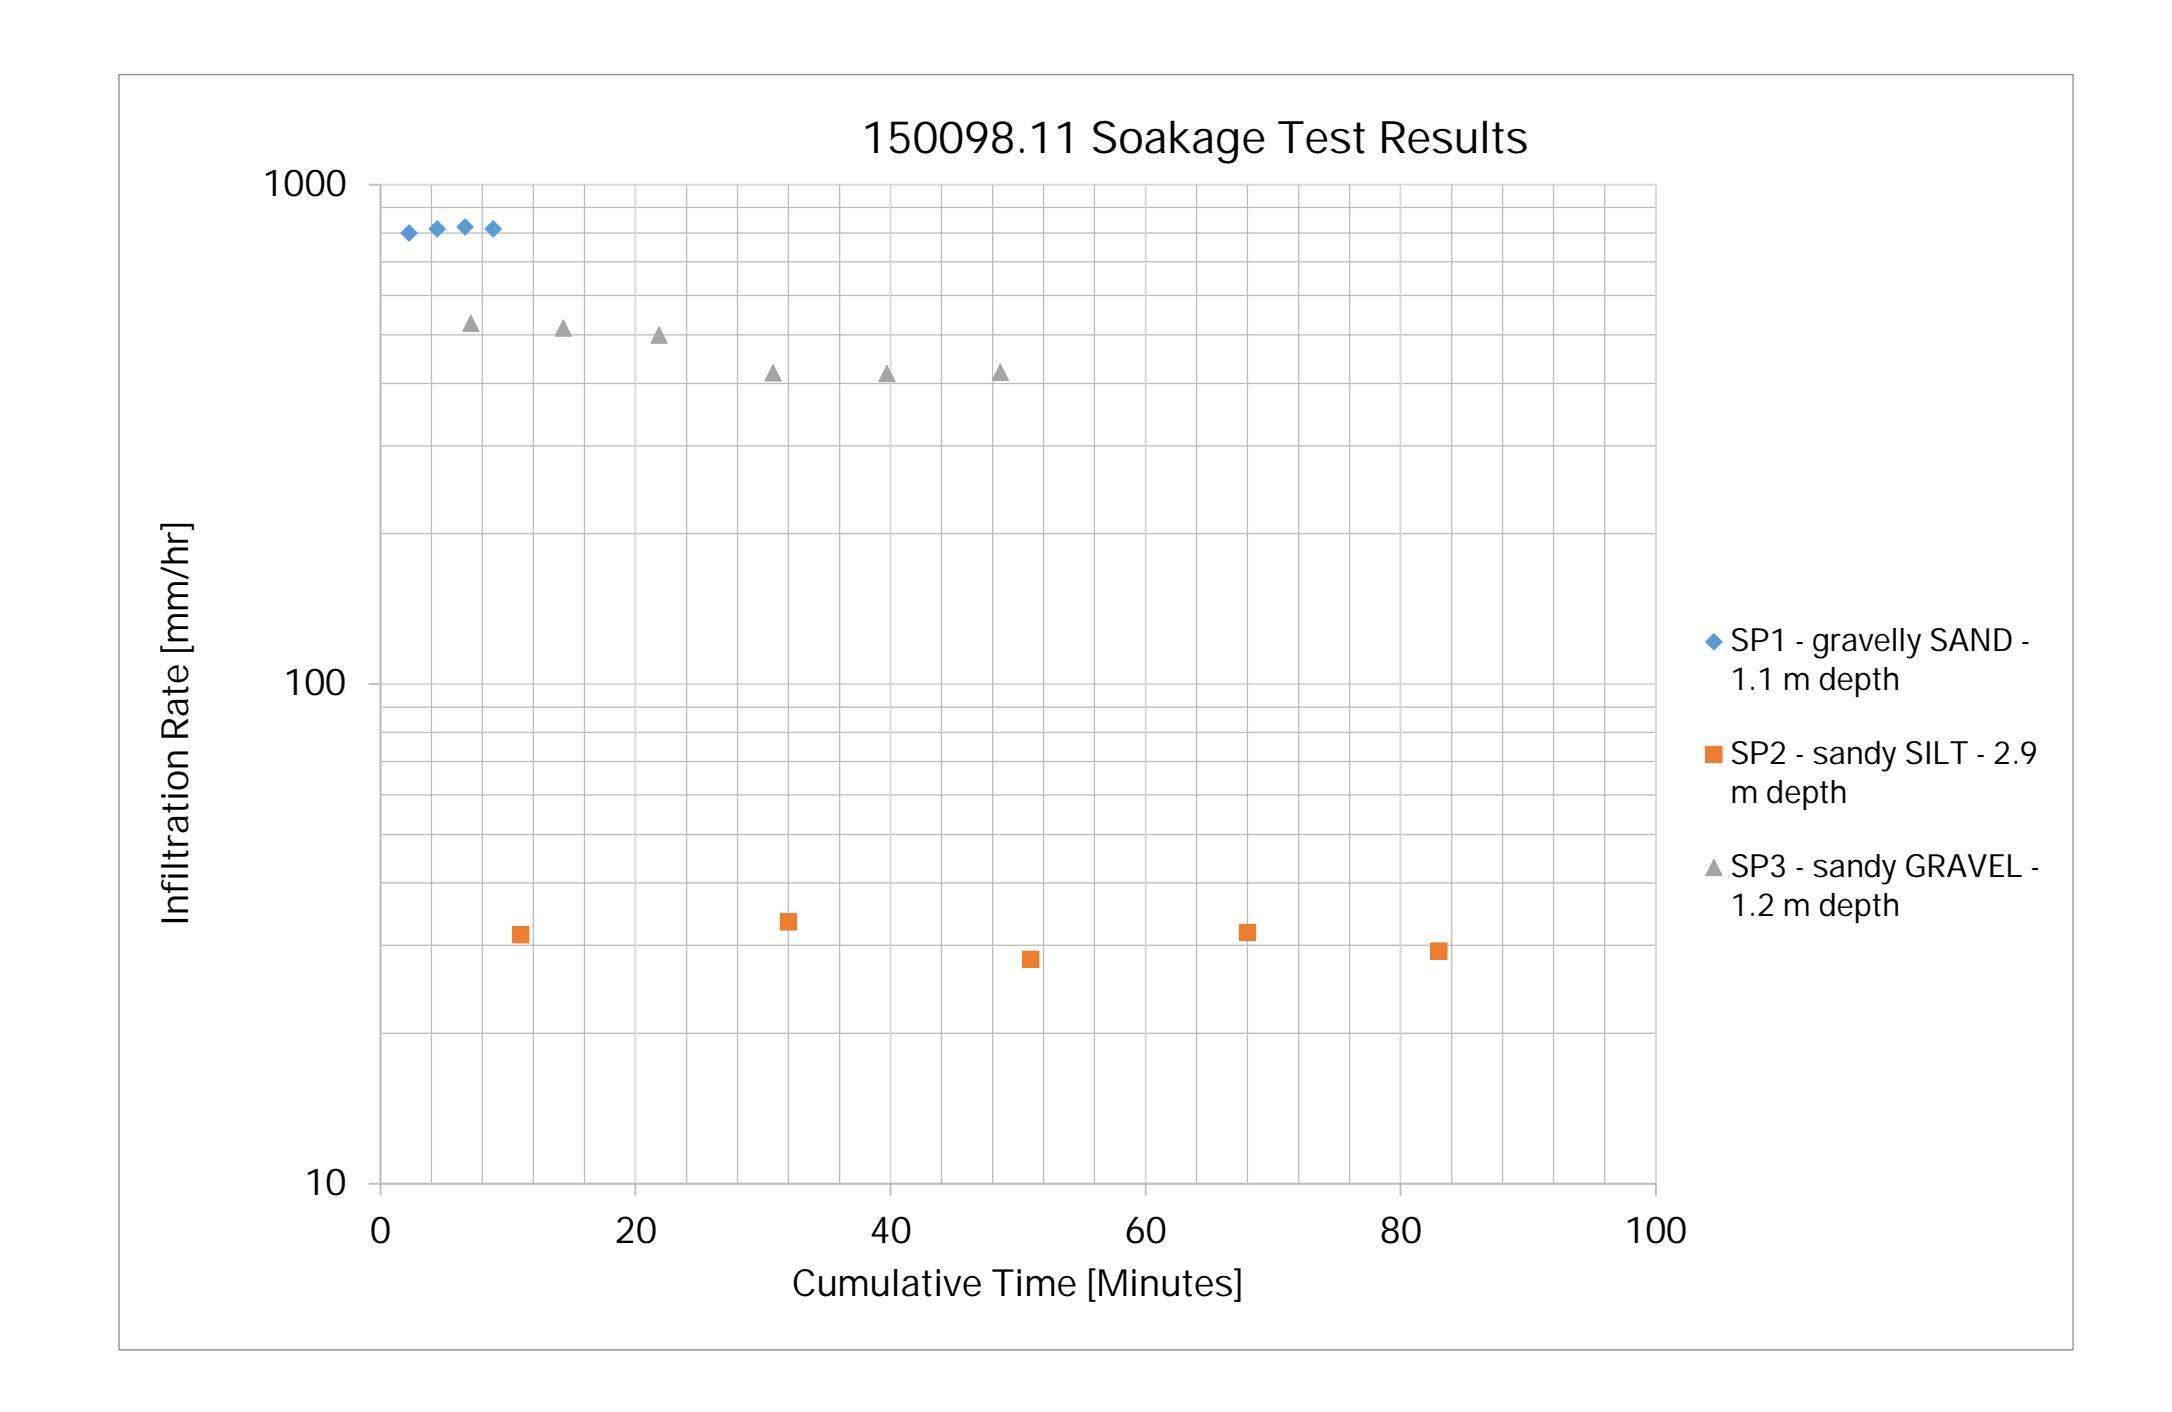
Appendix D: Soakage Testing Results

Soakage testing was performed by introducing water until the water level of the pit reached the designated testing level. Inflow was then ceased, and the time taken for the water level to drop was recorded, i.e., a falling head test. Testing was then completed to ensure saturated conditions were achieved and until three consistent readings had been achieved for each test.

Results from the field soakage testing have been analysed to determine indicative infiltration rates which are provided below in Table 8.1.
