Maitahi Village, Kākā Valley Ecological Impact Assessment

For CCKV Maitai Dev Co LP

February 2025

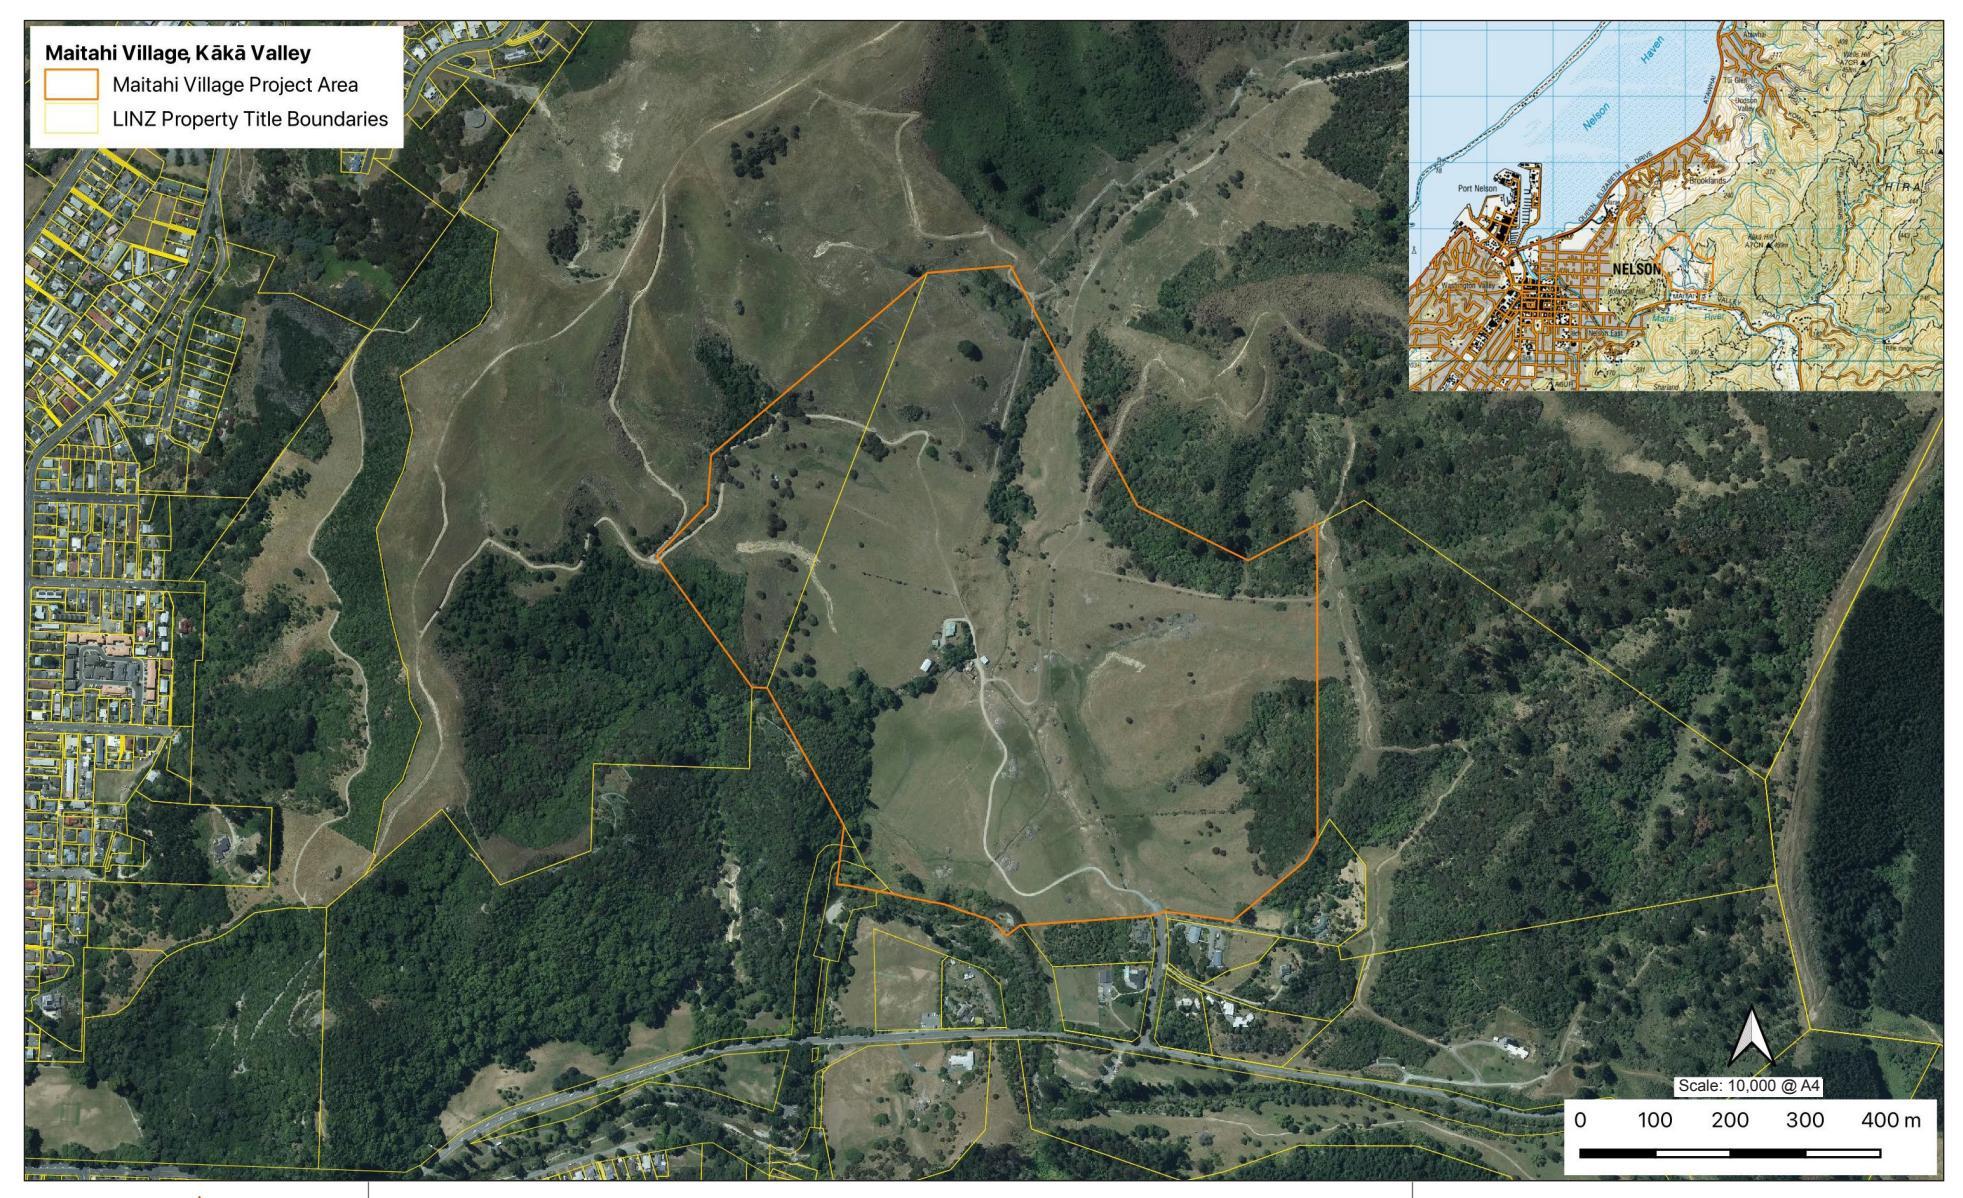
Figure 1.1 The Maitahi Village Project Area considered in this report, including relevant property boundaries, based on the concept landscape masterplan provided to Robertson Enviro by RMM. PROJECT: MAITAHI VILLAGE, KĀKĀ VALLEY

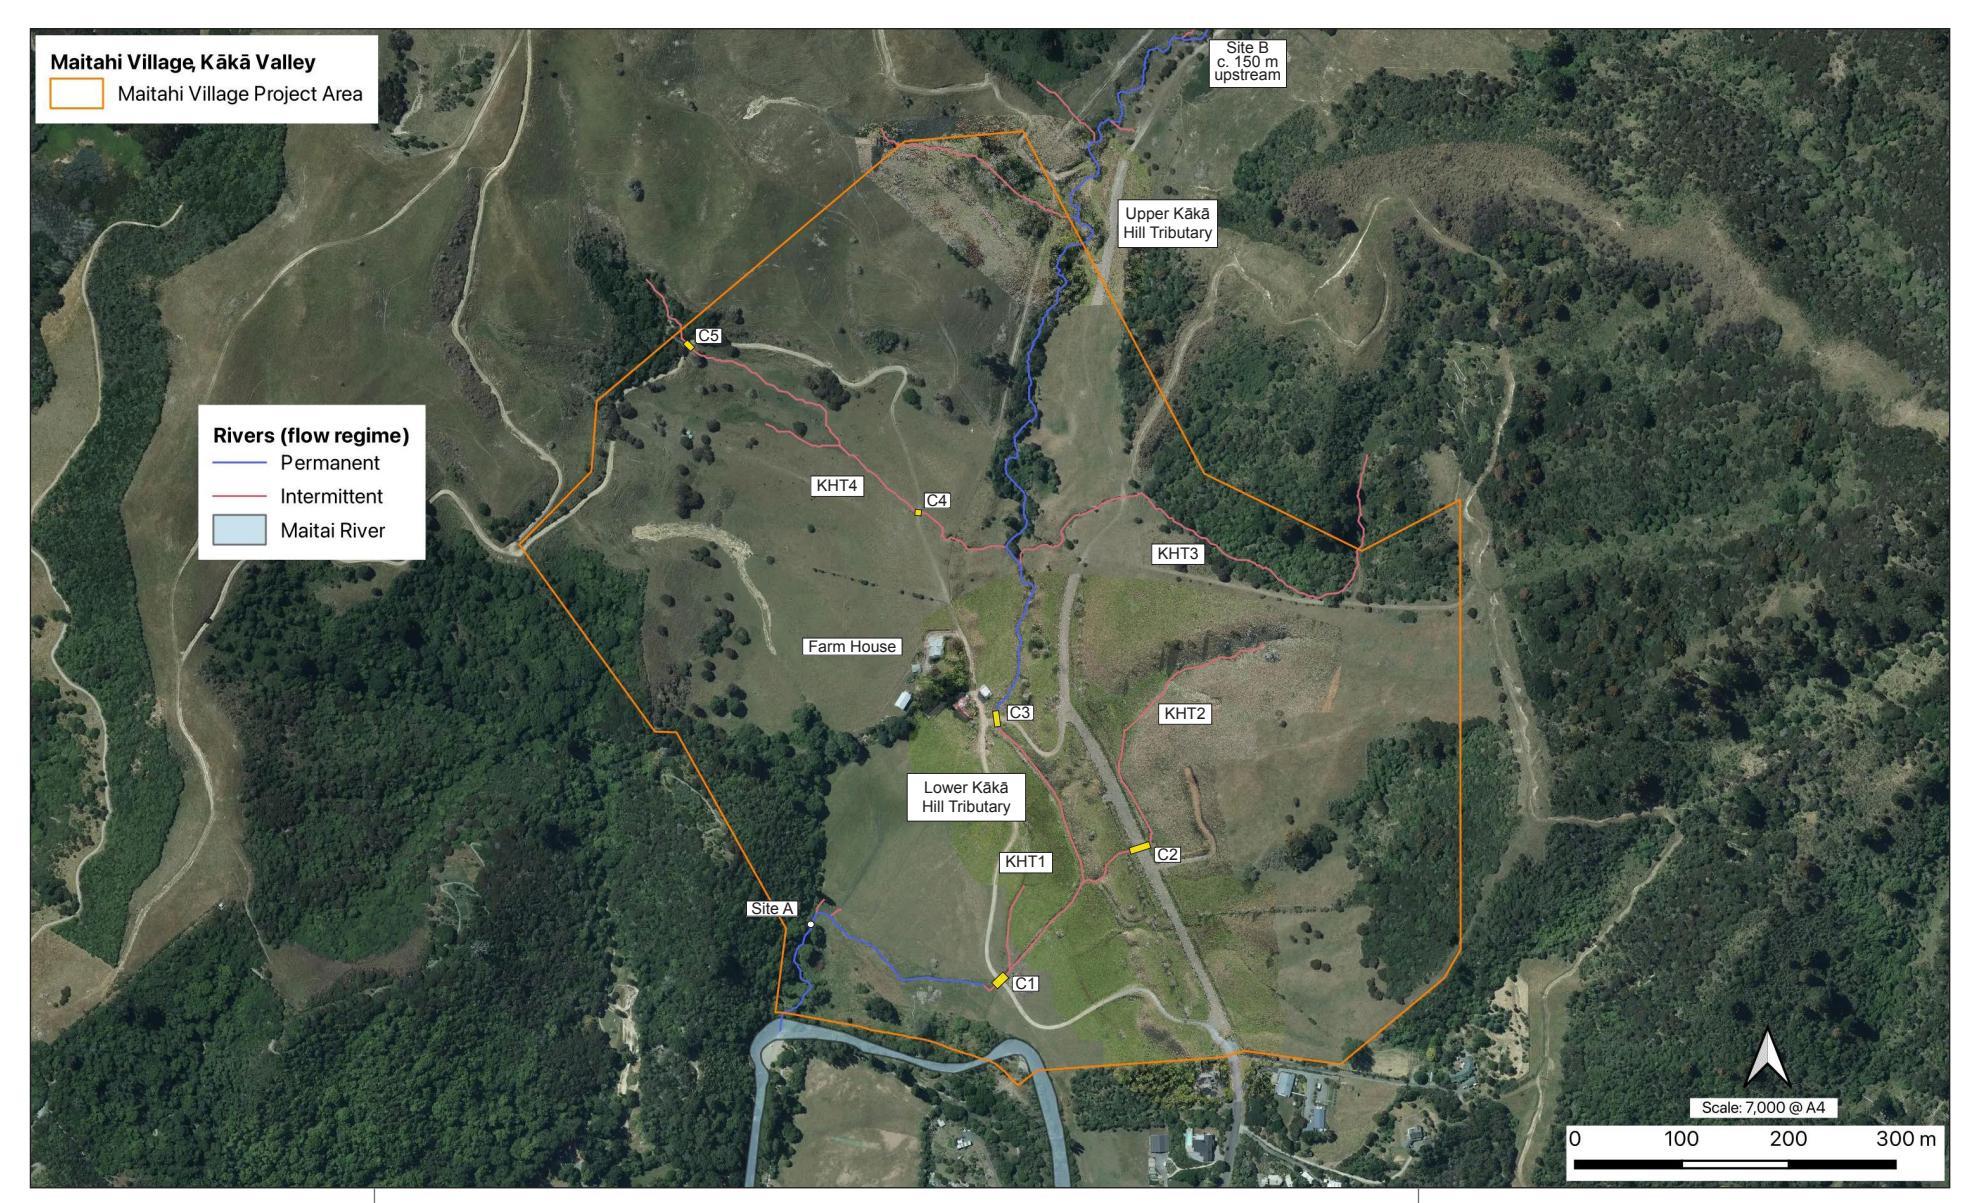
Figure 2.1. Existing watercourse survey locations, showing individual stream reaches and existing culverts C1-5 (—) associated with Kākā Hill Tributary. General direction of in-stream water flow is from north to south across the property. Note mapped permanent and intermittent stream reaches meet the RMA (Part 1, Section 2) and NPS-FM/NES-F definition of a 'river'.

Field surveys were completed during February, March and October 2023 for watercourses associated with the Project Area (see Figure 2.1 for watercourses and survey locations). Relevant information collected as part of PPC28 has been incorporated where appropriate. Table 2.1 outlines the specific methodology employed to determine baseline conditions and ecological value. Representative sites were chosen based on accessibility and location within the Project Area. An overview of the freshwater field assessments and methodologies employed is as follows:

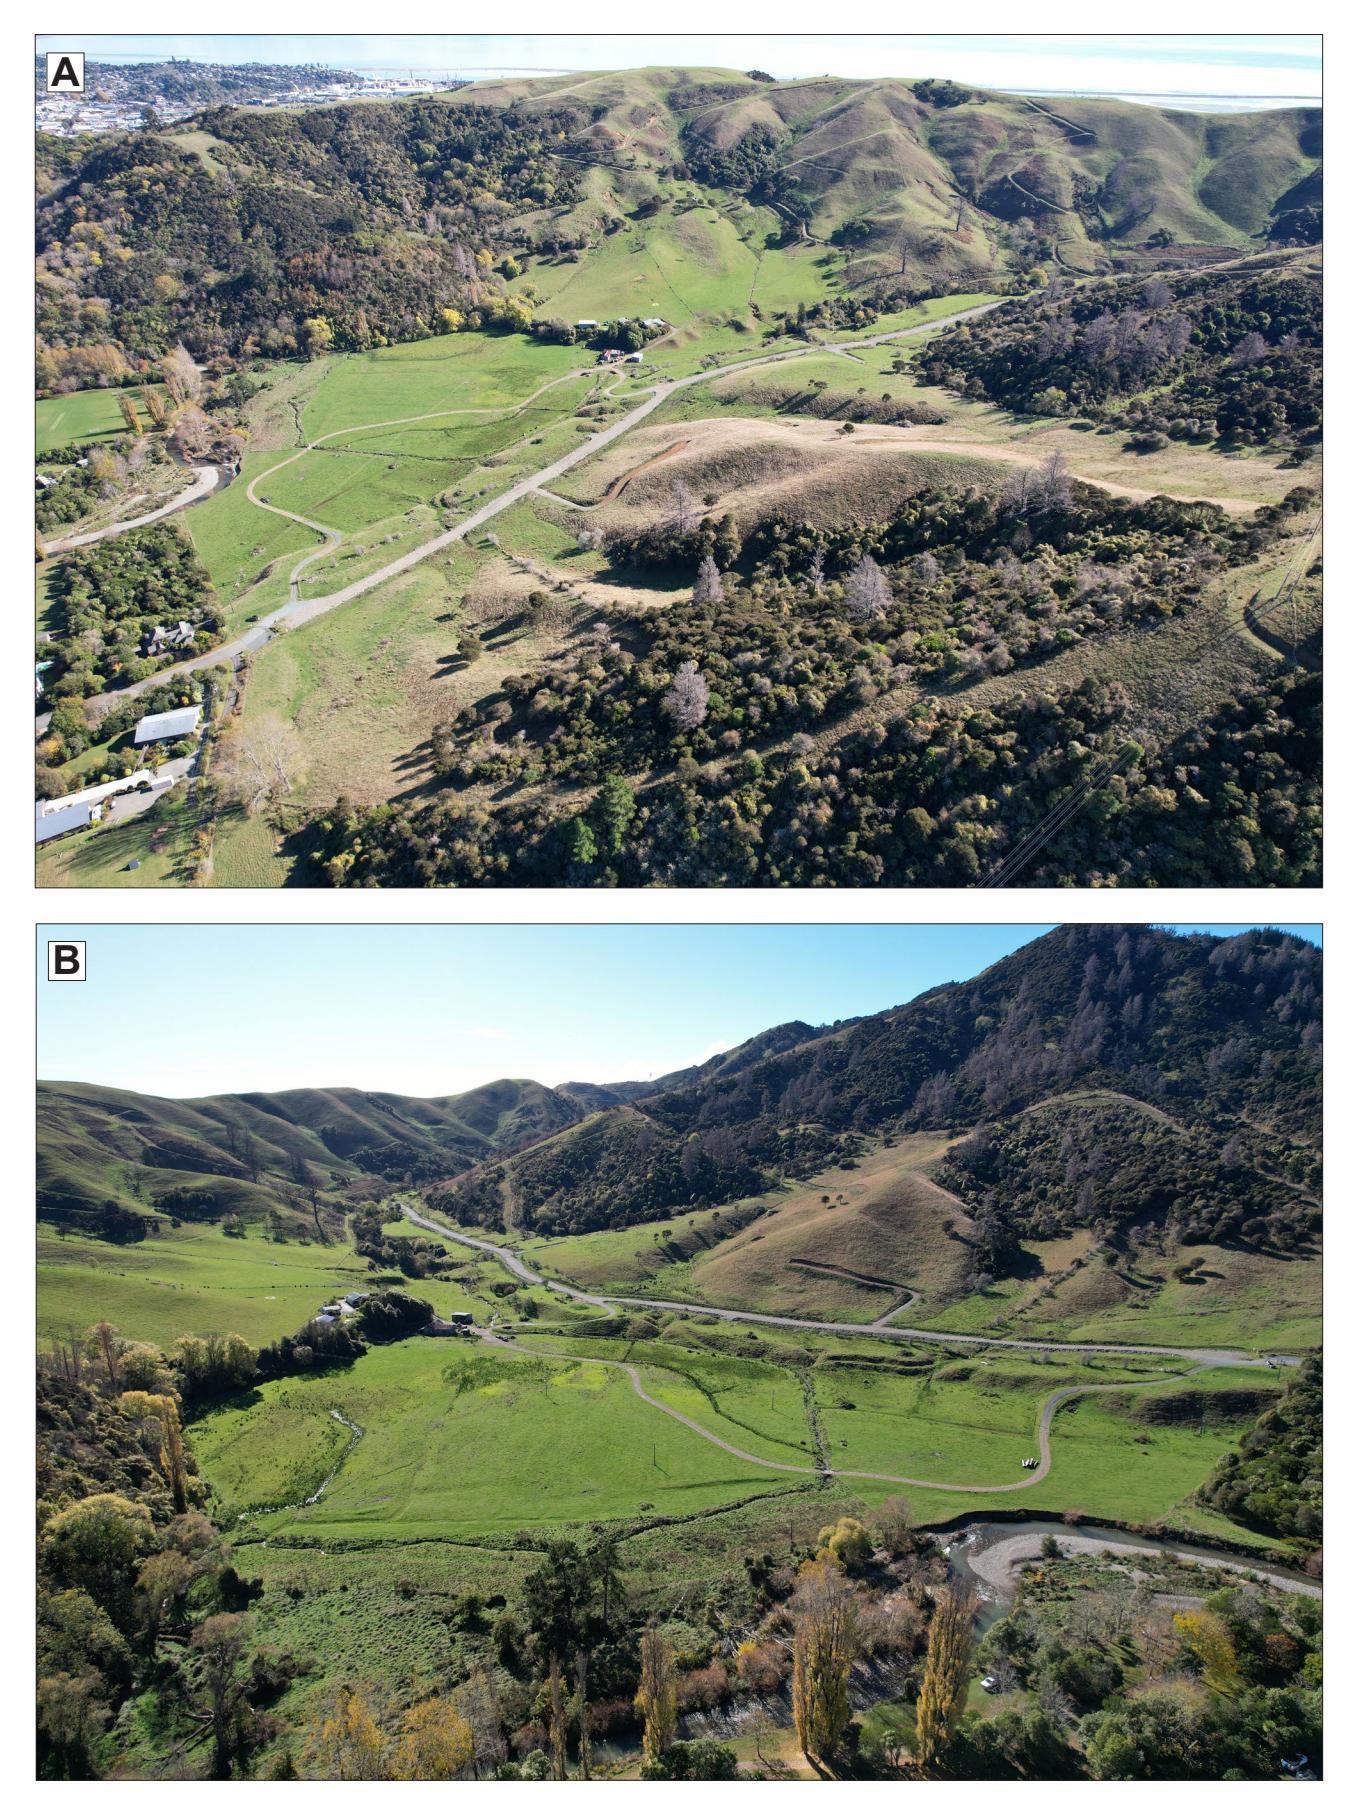
Figure 3.1. (A) Looking northwest toward the low-relief ridgeline at the western boundary near Bayview, across predominantly exotic grassland, access way, and cleared land contiguous with modified reaches of Kākā Hill Tributary. (B) Looking northeast across the Maitai River and similar land cover toward the steeper eastern hillslopes of Kākā Hill, characterised by pasture grassland grading into regenerating native and exotic vegetation, within the Project Area, Kākā Valley, October 2023.

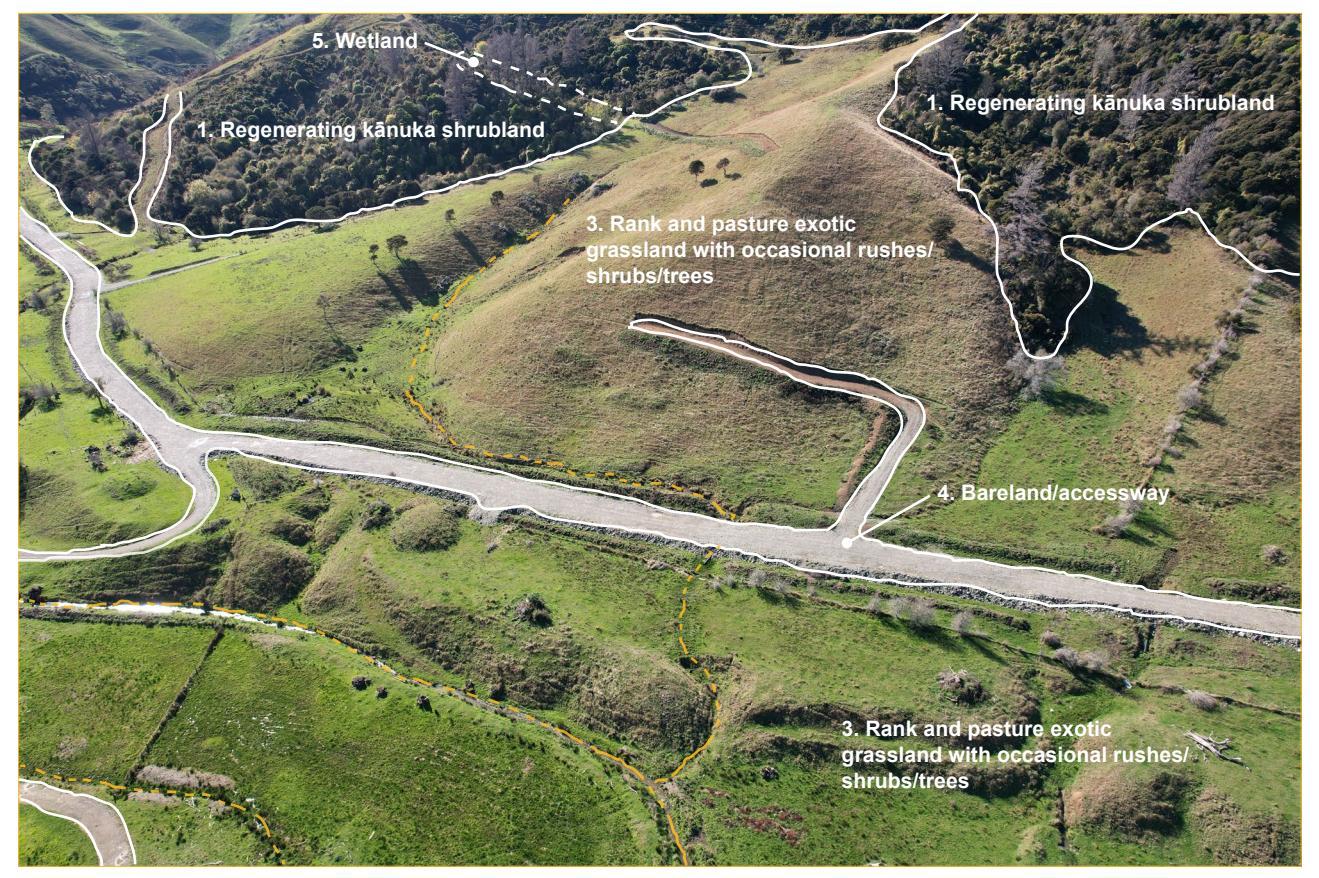
Figure 3.2. Example of the different habitats in the Project Area and mapped during the field investigation. Dashed yellow lines show watercourses. Habitat boundaries are indicative only and do not accurately reflect those presented in Figure 3.3.

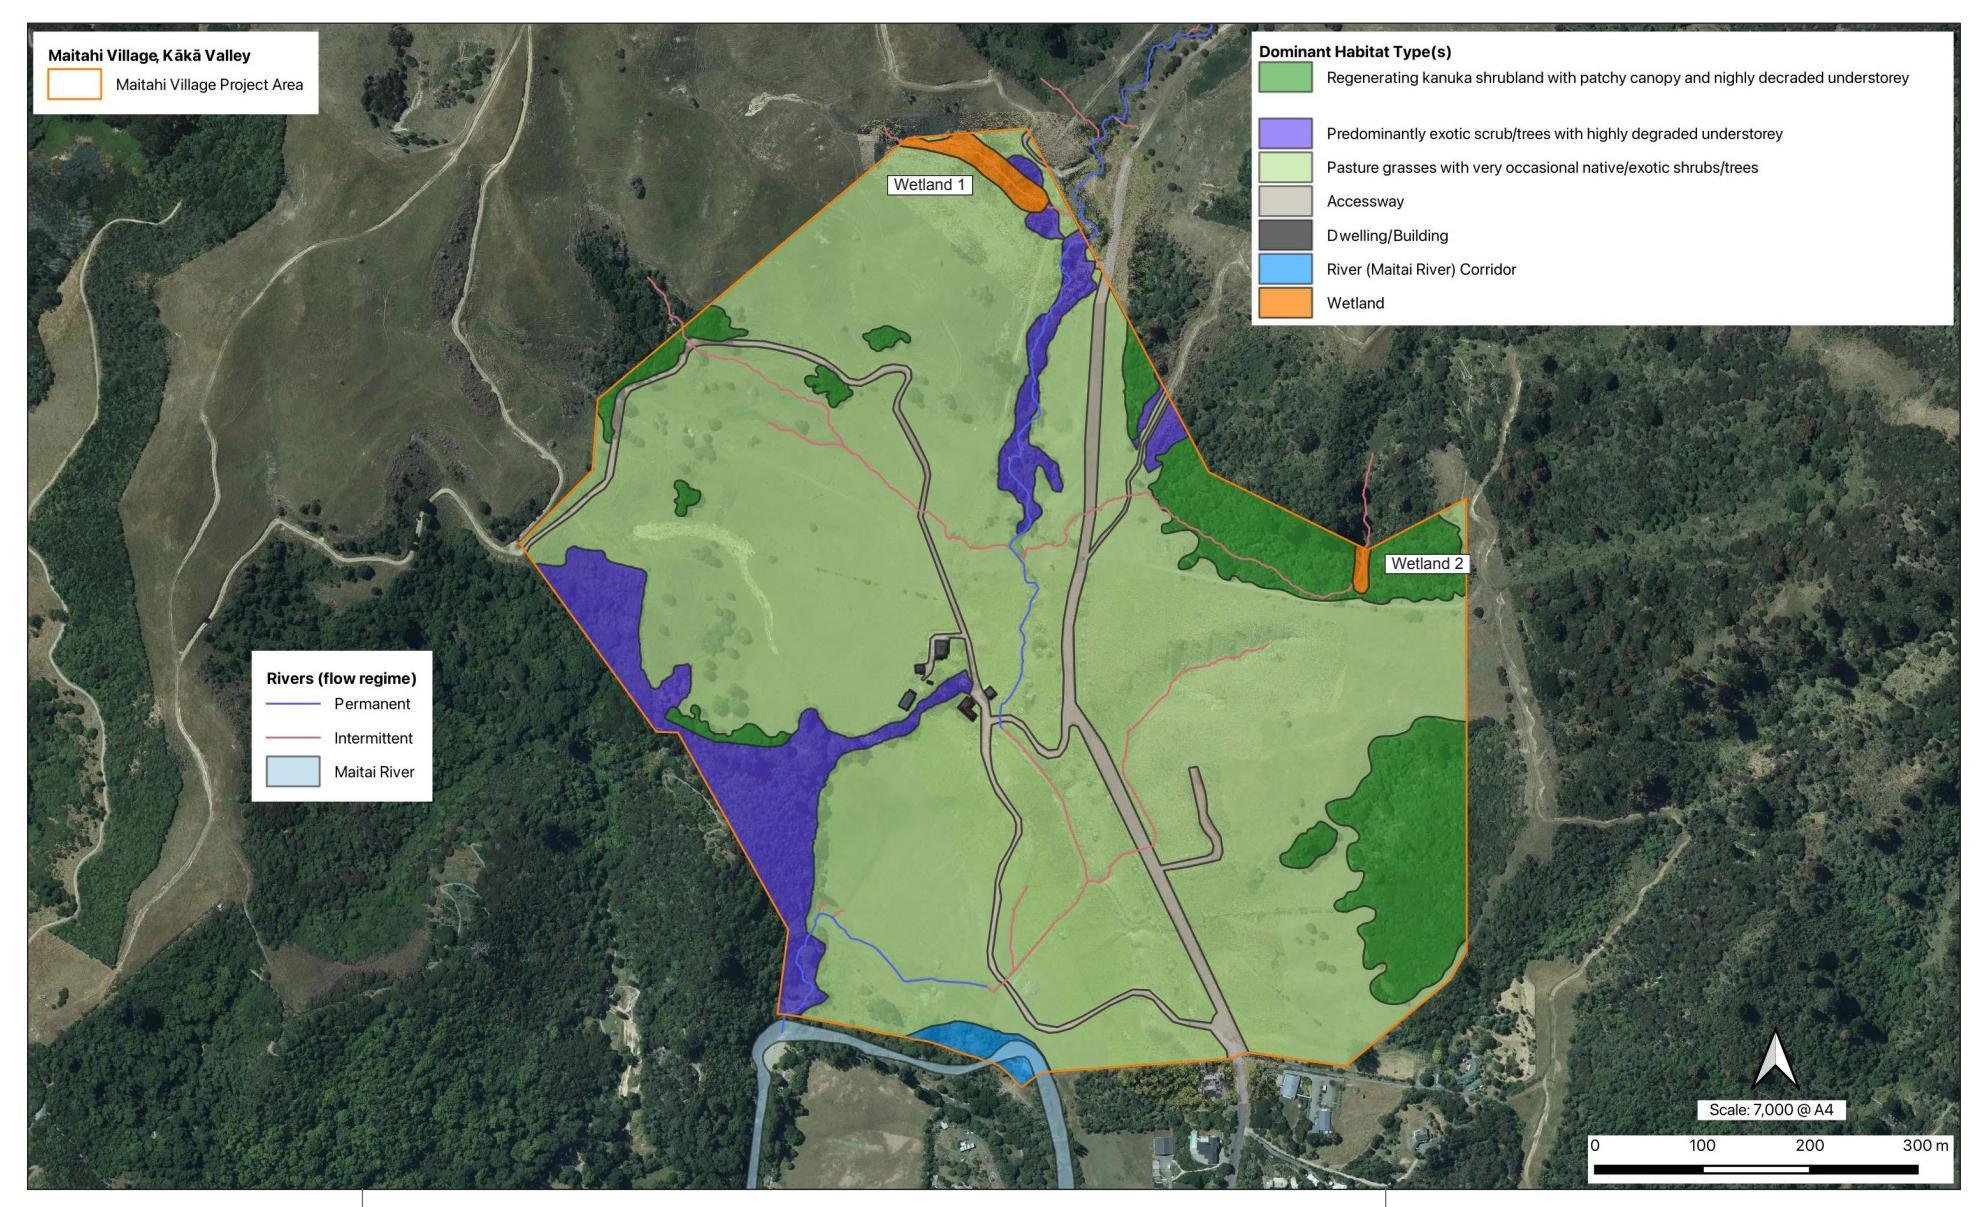
Figure 3.3. Broad scale (indicative) map of existing habitats within the Project Area based on the mapping of freshwater and vegetation features visible in aerial imagery, supported by ground-truthing to validate the visible features. General direction of in-stream water flow is from north to south across the property.

^a Reflects the total extent of the Project Area footprint as shown in Figure 3.3.

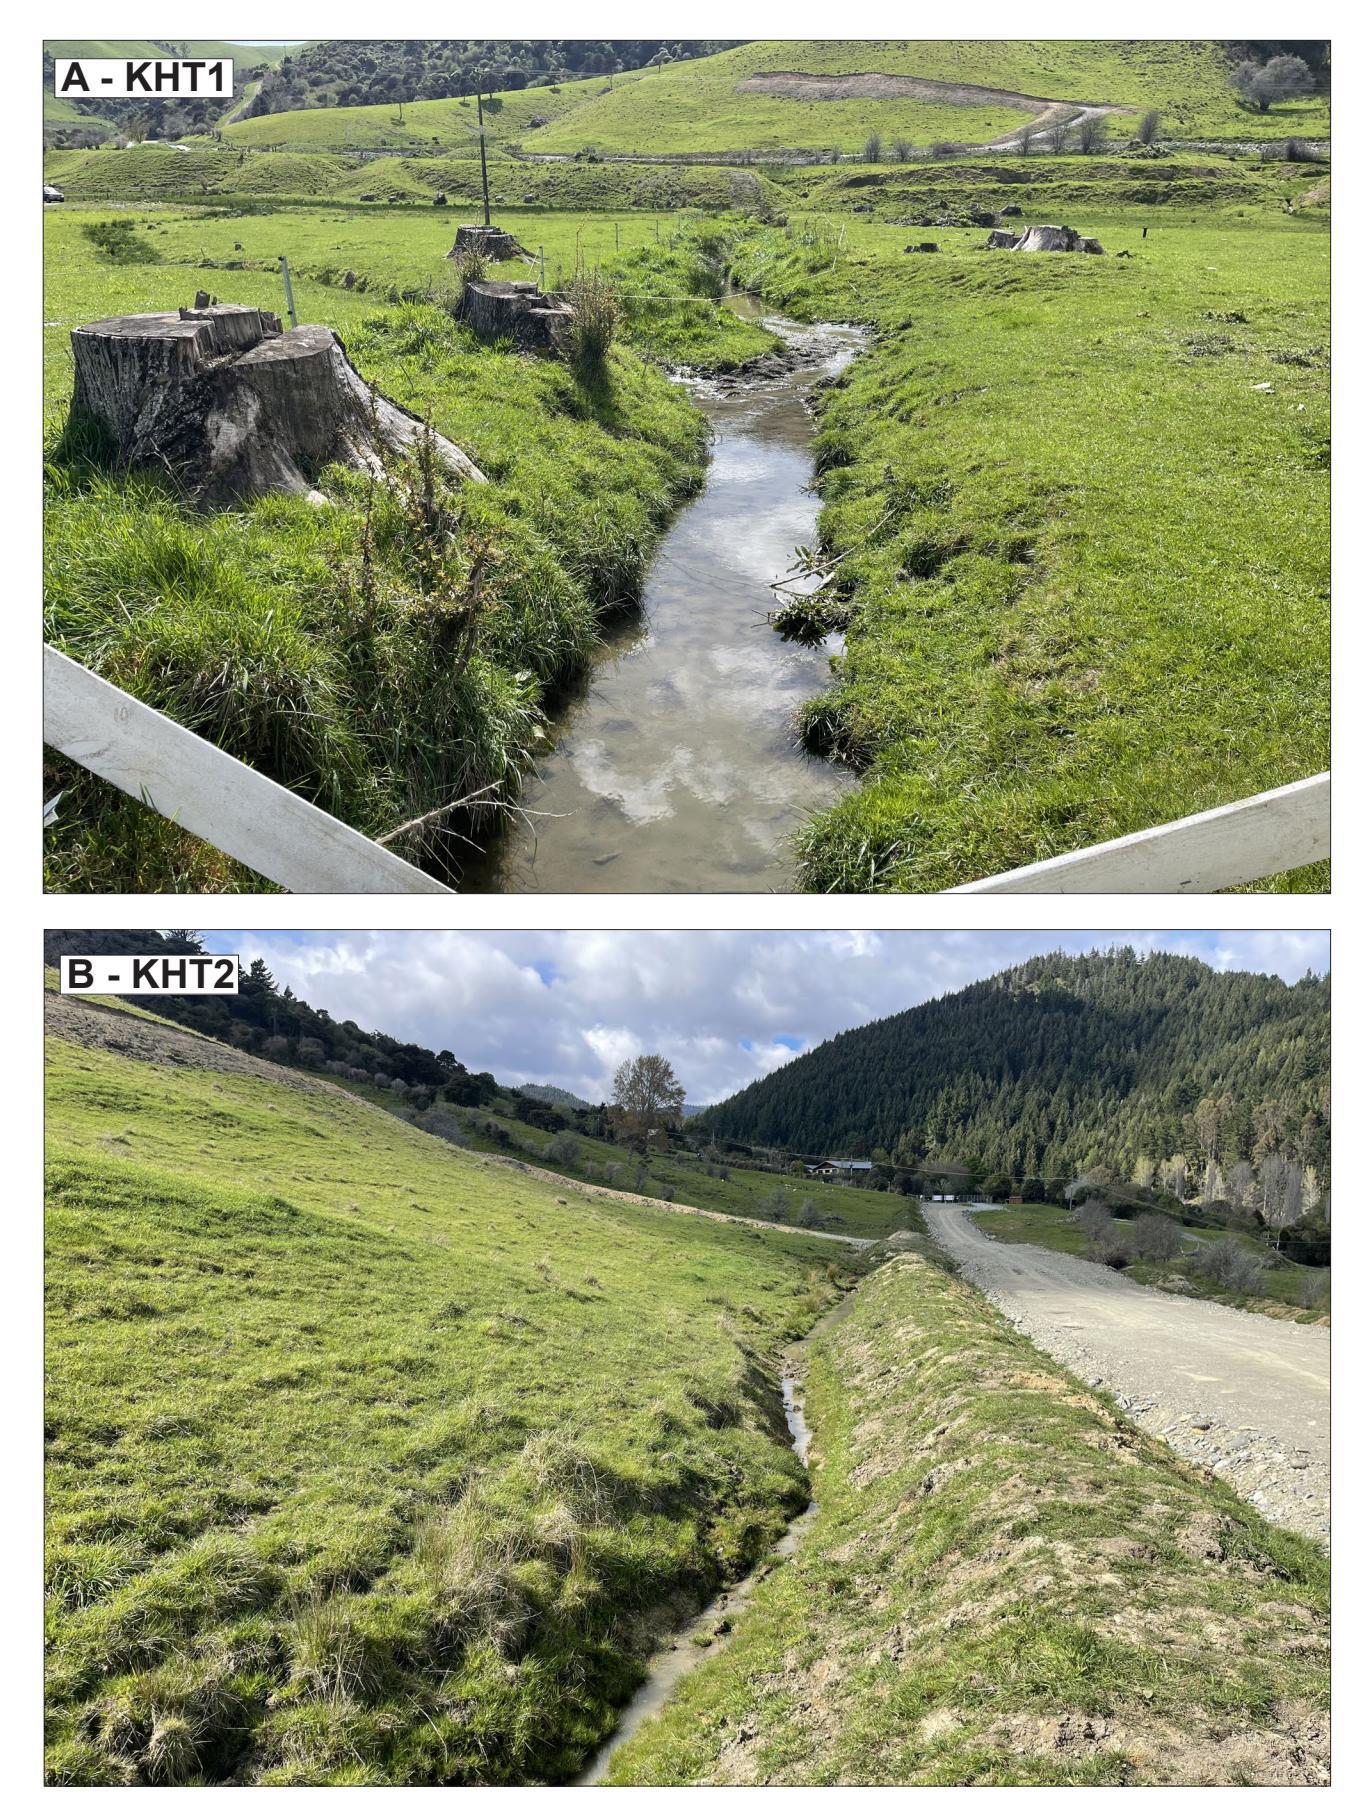
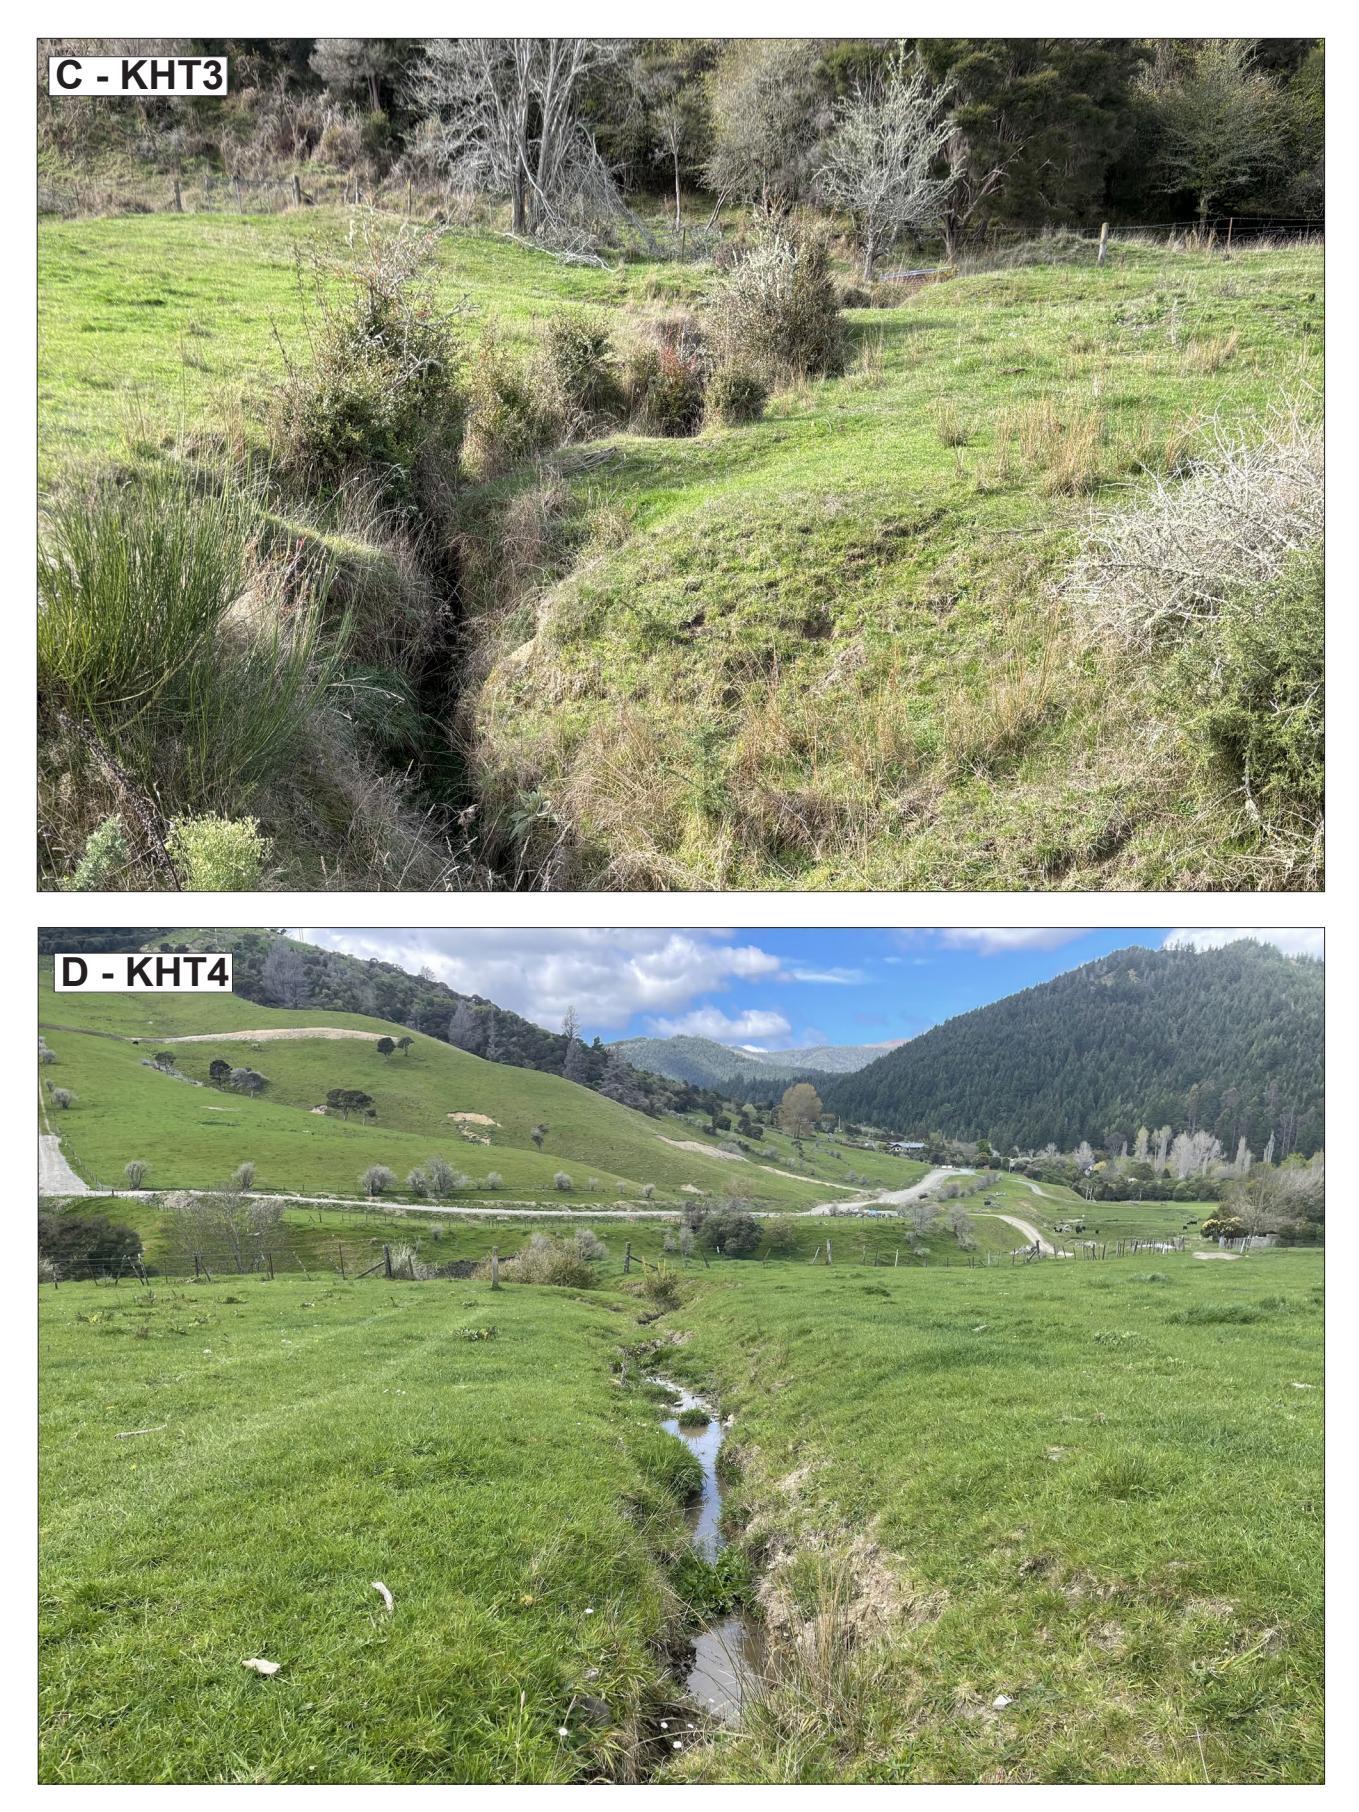
Figure 3.4. Highly modified tributaries of Kākā Hill Tributary contiguous with grazed pasture cover down to the wetted stream edge on floodplain and low relief and low slopes within the Project Area, October 2023. Identifier text in top left indicates stream reach as shown in Figure 2.1.

Figure 3.4 (Cont.). Highly modified tributaries of Kākā Hill Tributary contiguous with grazed pasture cover down to the wetted stream edge on floodplain and low relief and low slopes within the Project Area, October 2023. Identifier text in top left indicates stream reach as shown in Figure 2.1. **Table 3.2** Description of hydrogeomorphic features for each of the stream reach locations assessed during site visit.

In general, riparian margins (at top of incised channel banks) consisted of grazed pasture and rank grass. The open pasture area provided no protection from stock access to the stream and extensive pugging and animal tracks were observed. The majority of the stream banks have been contoured recently and lack vegetation cover, while the remaining banks are generally steep, incised, and contain some areas of bare ground. Bank slumping has been observed, indicating a high potential for erosion on both sides, particularly during higher flow events.

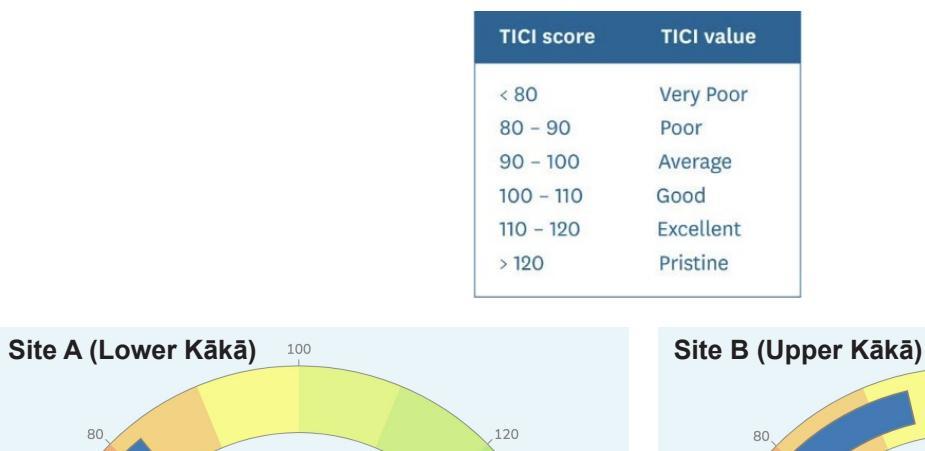
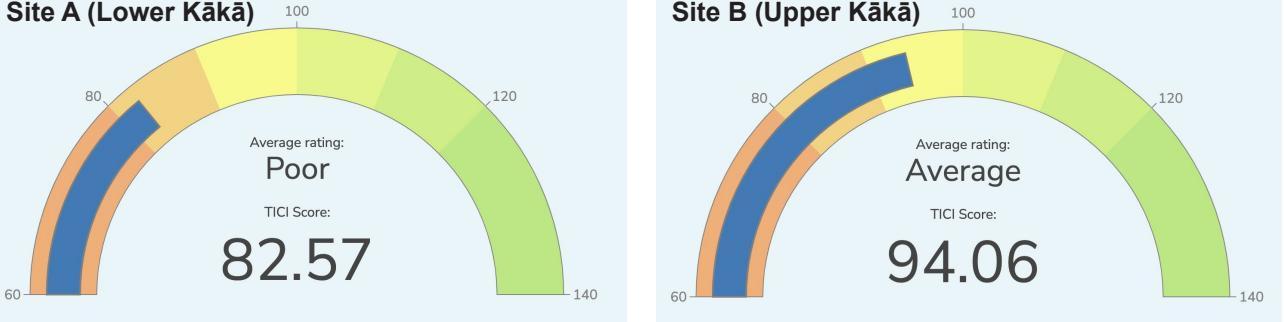
Figure 3.5. TICI results output of single-replicate samples collected from the surveyed reaches, 7 March 2023. Note the inset qualitative score ranking is on the same scale as the NZ MCI-sb.

Figure 3.5 presents the Taxon-Independent Community Index (TICI)²⁶ scores used to interpret stream ecological condition. The TICI results indicate 'poor' stream ecosystem health in the Lower Kākā Hill Tributary (Site A) and 'average' health further upstream at Site B. No TAR macroinvertebrate species were recorded in eDNA data.

The poor ecological health of the Lower Kākā Hill Tributary site is likely exacerbated by exposure to agricultural pollutants coupled with the site's intermittent flow. Many of the detected freshwater macroinvertebrates at Site A, including species such as *Physella acuta*, *Potamopyrgus antipo-darum*, and *Gyraulus corinna*, are known for their adaptability and tolerance to varying environmental conditions, including stagnant and intermittently flowing waters. Their prevalence suggests that the habitat does not sustain more sensitive species that require consistently oxygenated, flowing waters, such as those found in healthier stream systems. The presence of these tolerant species alongside the absence of EPT taxa indicates ecological degradation. This situation is likely compounded by the intermittent flow regime of the tributary, which does not support a stable, diverse aquatic community, leading to reduced biodiversity and compromised ecological health.

The macroinvertebrates detected at Site B in the Upper Kākā Hill Tributary, including sensitive species like the caddisflies *Aoteapsyche colonica* and *Psilochorema bidens*, and the mayfly *Deleatidium* sp., suggest a diverse and healthy aquatic environment. This diversity, marked by the presence of sensitive taxa such as mayflies and caddisflies, indicates a more ecologically balanced and less disturbed habitat compared to the Lower Kākā Hill Tributary, which is dominated by pollution-tolerant species. This contrast supports better ecological health and higher water quality upstream at Site B, with reduced human impact.

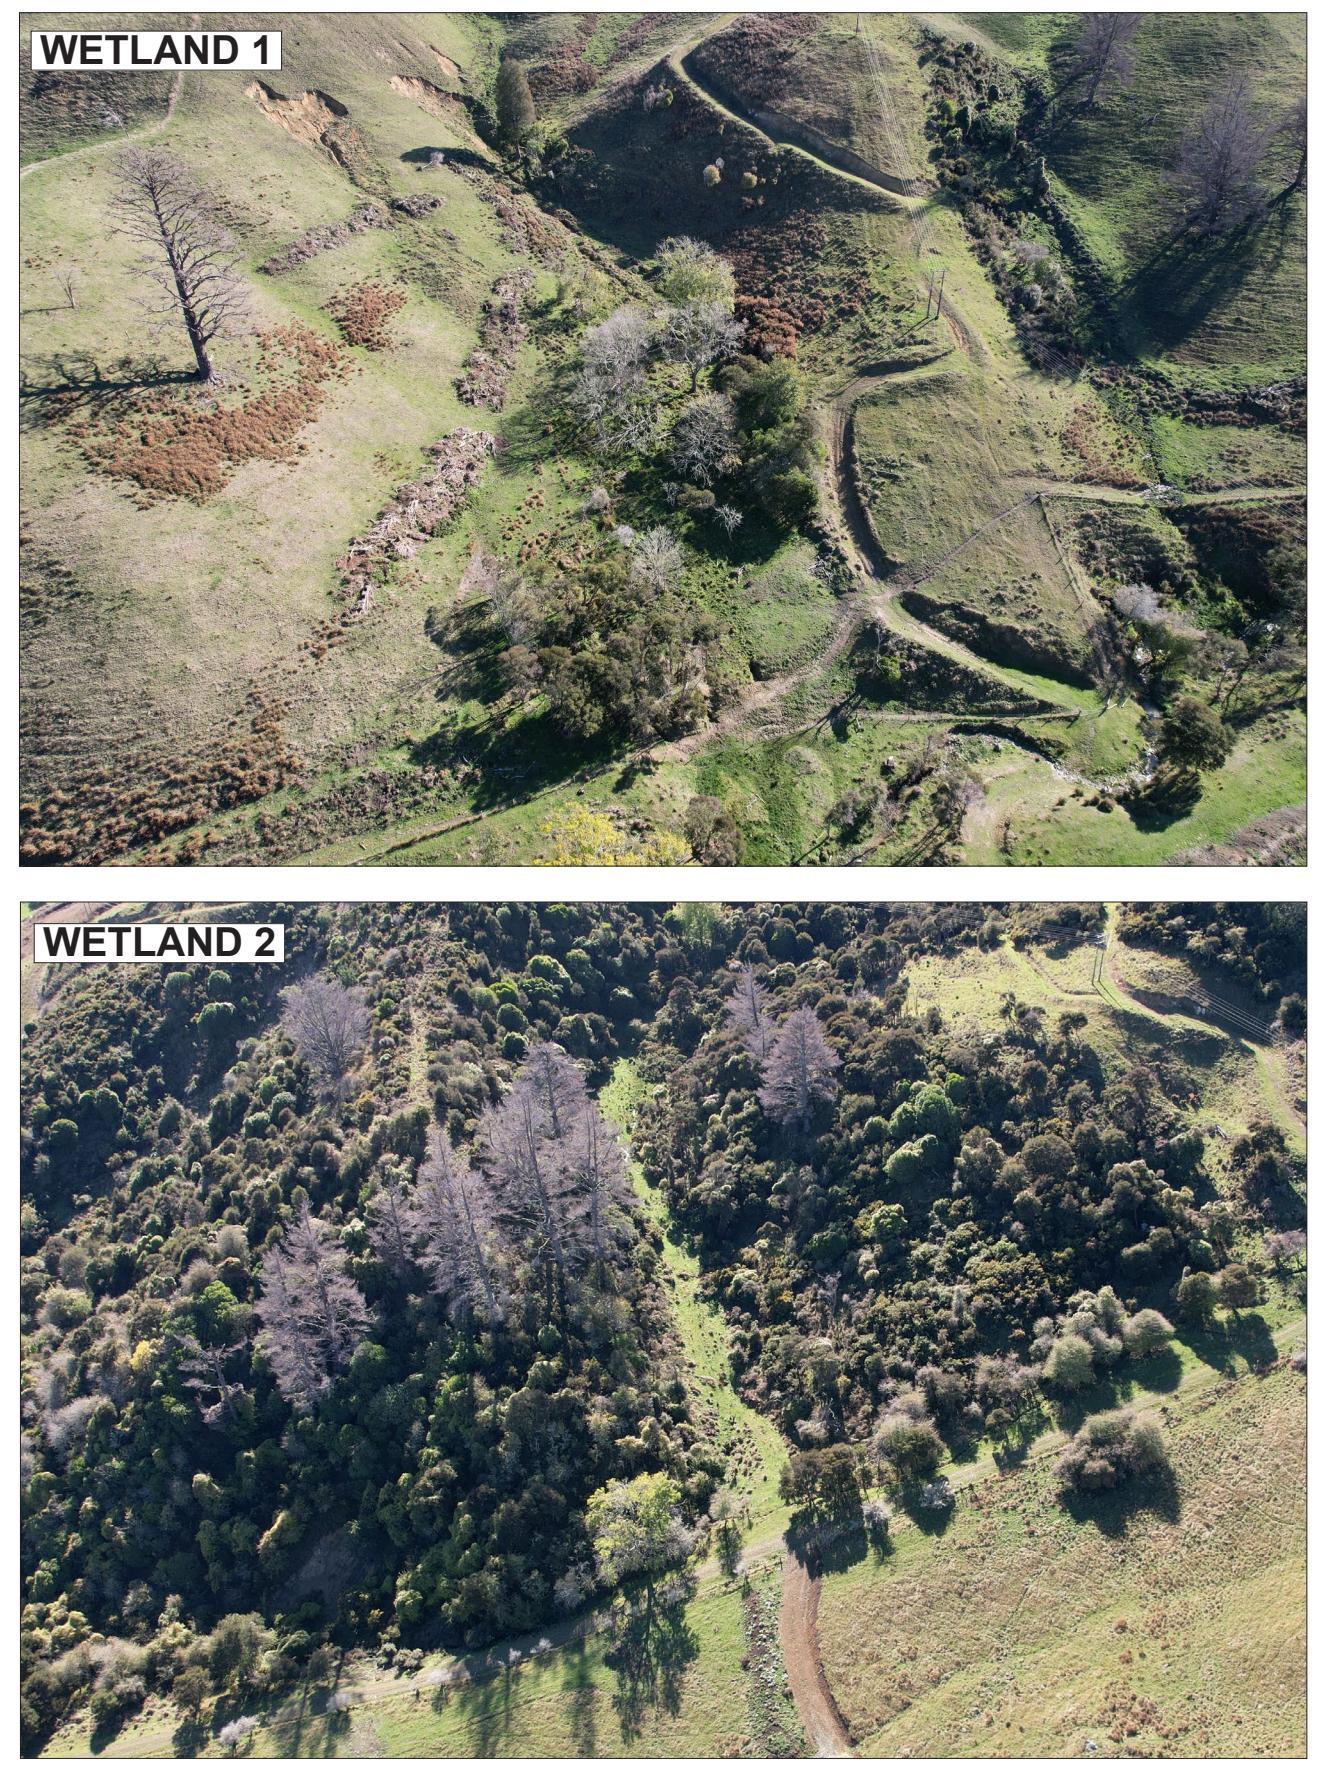
Figure 3.6 Wetland features identified within the Project Area. Wetland 1 is located near the northern extent of the Project Area on the western side of Kākā Valley, while Wetland 2 is situated on the southeastern slopes of the lower valley, as shown in Figure 3.3.

The wetland habitats within the Project Area are predominantly dominated by exotic plant species and have been significantly degraded due to factors such as vegetation removal, livestock grazing, and pugging. Wetland 1, in particular, was heavily impacted by smothering effects from a nearby landslip caused by the August 2022 storm event. However, recent observations indicate that Wetland 1 is undergoing a natural restoration process, with native vegetation such as rautahi and pureī showing signs of regrowth. The condition of the two wetland areas that were mapped were assessed in addition to the wetland delineation process. The assessment involved giving a value based on four "Matters": representativeness (low), rarity/distinctiveness (moderate), diversity and pattern (low), and ecological context (moderate). Although the exotic wetlands are highly modified and relatively small in size, their ecological value is considered to be **Moderate**. This is due to the overall reduction in freshwater wetland habitat across the Bryant Ecological District, which has seen a loss of c. 99% in area (Tasman District Council 2020). Additionally, the retained hydrogeomorphic features of these systems provide ecological functionality for stormwater attenuation and excess contaminant (e.g. sediment, nutrients) removal.

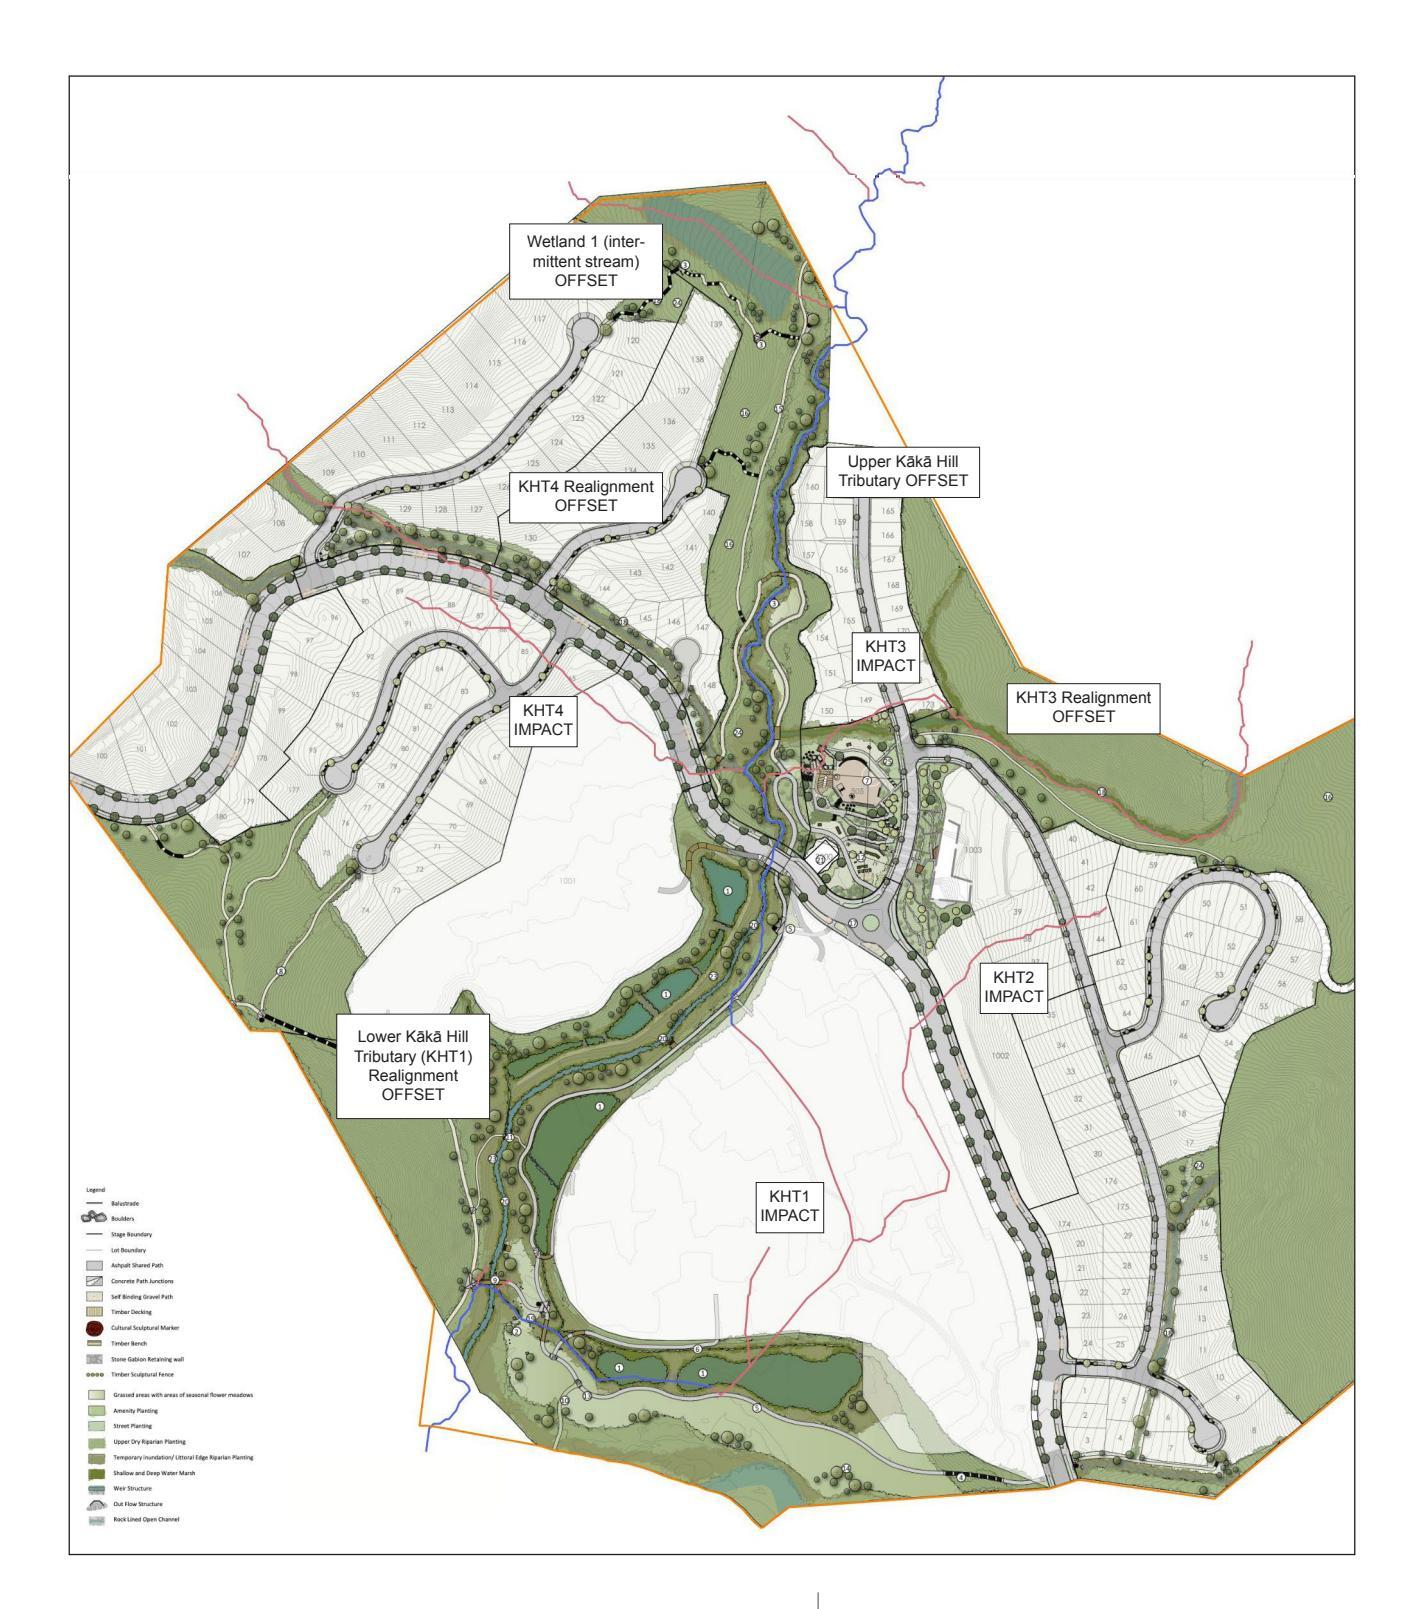
Figure 6.1. Proposed offset stream locations overlaid with the RMM concept landscape plan.
