AUCKLAND SURF PARK COMMUNITY –  
STAGE 2 FAST TRACK CONSENT

GEOTECHNICAL ASSESSMENT REPORT

INITIA REF P-001537-2 REV B

DECEMBER 2025

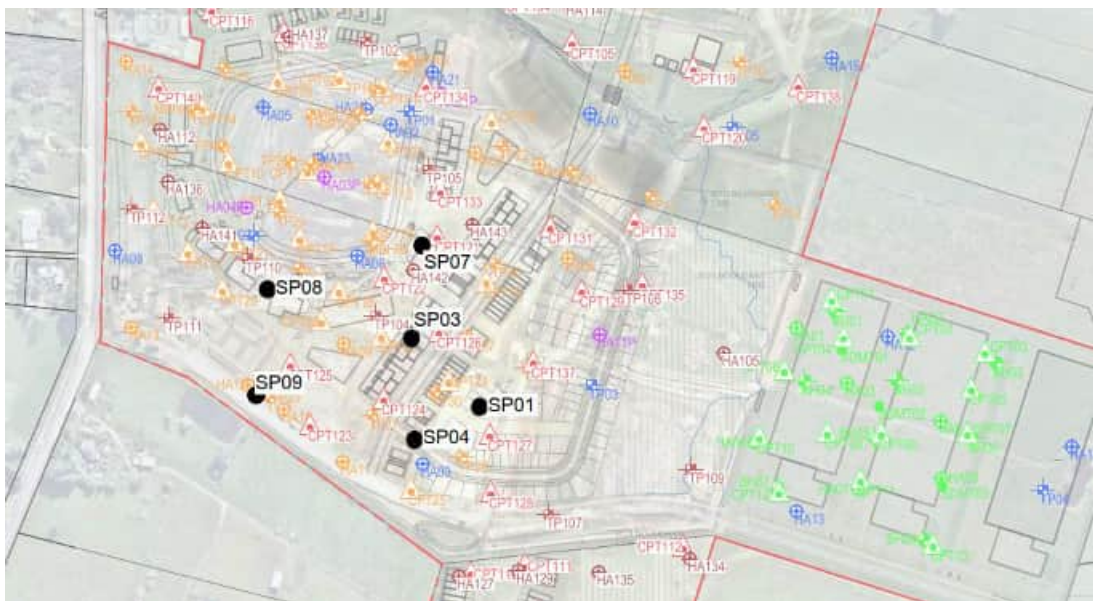
**Figure 7-2: Existing settlement plate monitoring locations**

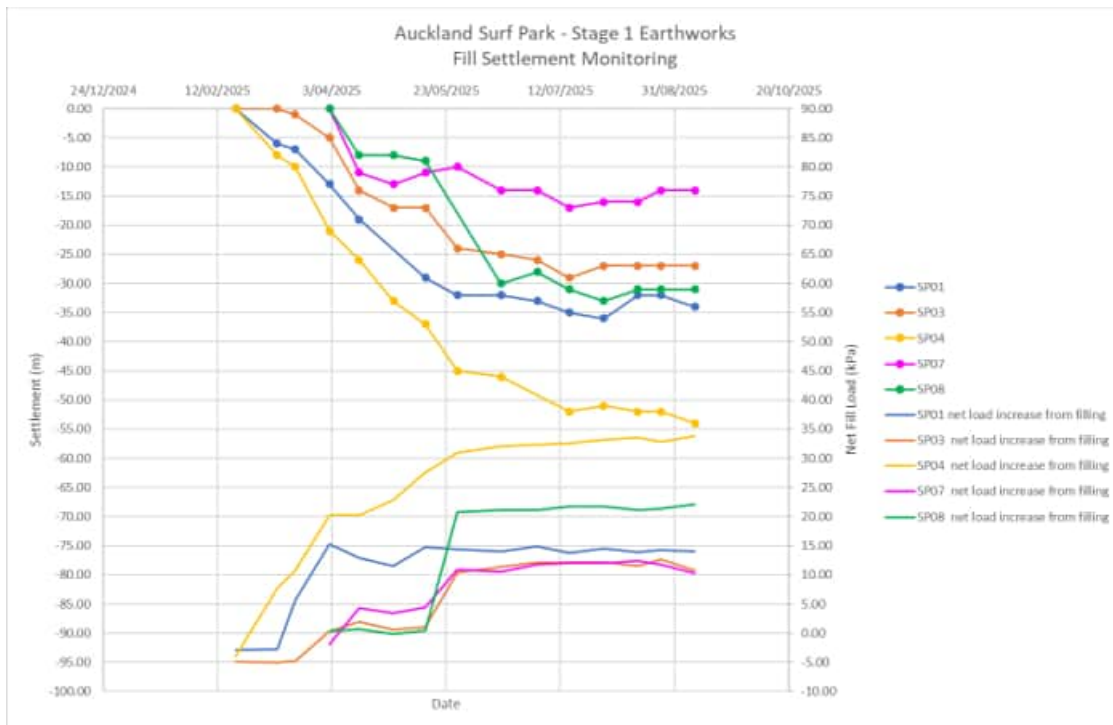
**Figure 7-3: Existing settlement plate monitoring data**

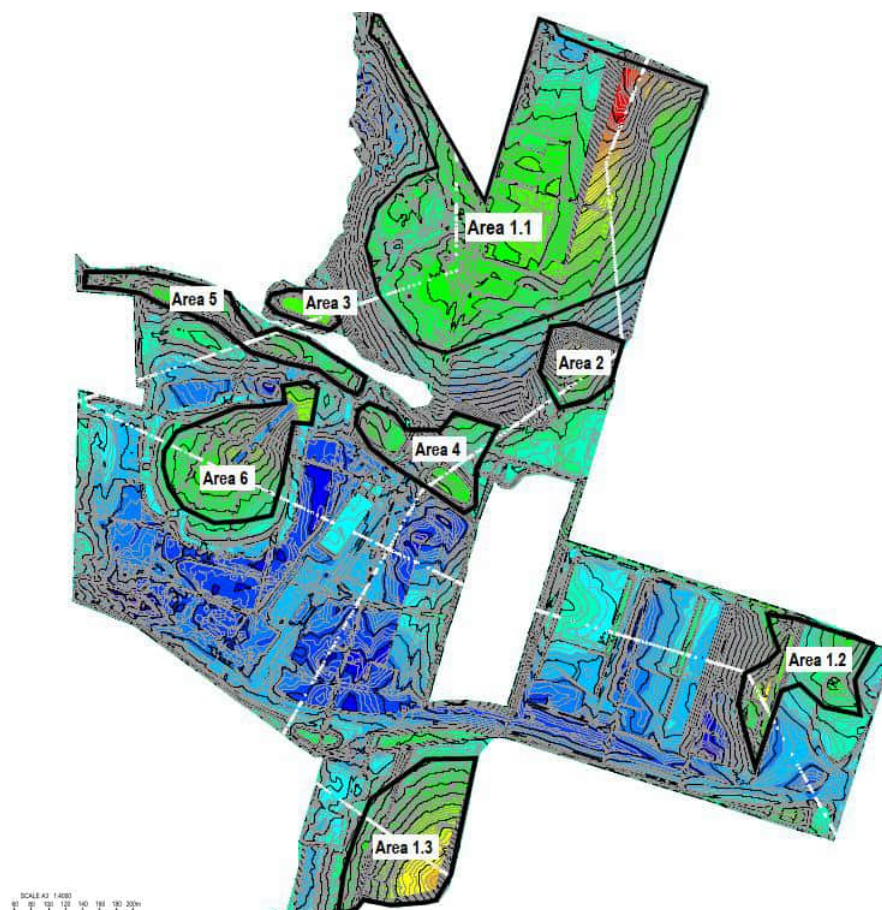
**Figure 7-4: Delineation of bulk cut areas > 1m in depth. (Note: Green/yellow/red denotes net cut, turquoise/blue denotes net filling)**

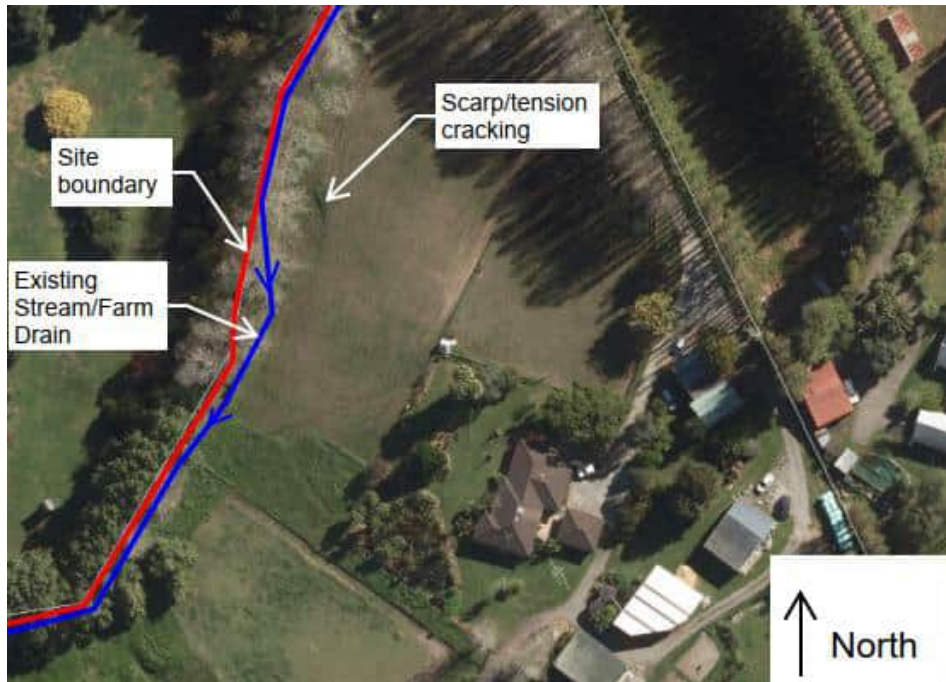
**Figure 7-5: Existing slumping observed adjacent to western boundary**

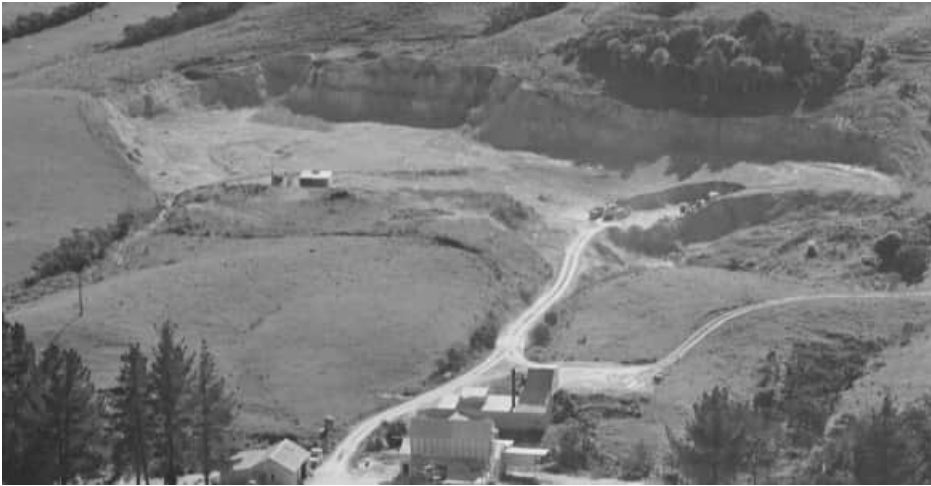
**Figure 7-6: Image of Redvale Limestone Quarry. Source: (Whites Aviation, 1966)**

The Mahurangi Limestone materials at the site form part of the wider Northland Allochthon which, due to its emplacement, can be highly fractured and pervasively sheared. Other subsets of Northland Allochthon (e.g. Hukerenui Mudstone) are known to have a high risks of instability at gentle slope angles (i.e. less than 1V:4H) either within the rock mass or at the interface between weathered soils and rock. However, compared with other Northland Allochthon materials, Mahurangi Limestone typically has a much lower stability risk and natural hills are commonly observed stable at grades of 20° or greater<sup>23</sup>. Steep cuts within Mahurangi Limestone also commonly remain stable as demonstrated by the highwall cuts shown on Figure 7-6 of the former Redvale quarry, located approximately 1km south-west of the project site. The existing site investigations and public investigations across the wider area indicate it is likely the site is underlain by a relatively thick and continuous deposits of Mahurangi Limestone. However, across the wider Auckland/Northland region, rapid spatial lithological heterogeneity within Allochthon does occur due to the chaotic emplacement of the geological unit. It will therefore be important that cuts into this unit are mapped and monitored by a Geologist during excavation/earthworks.

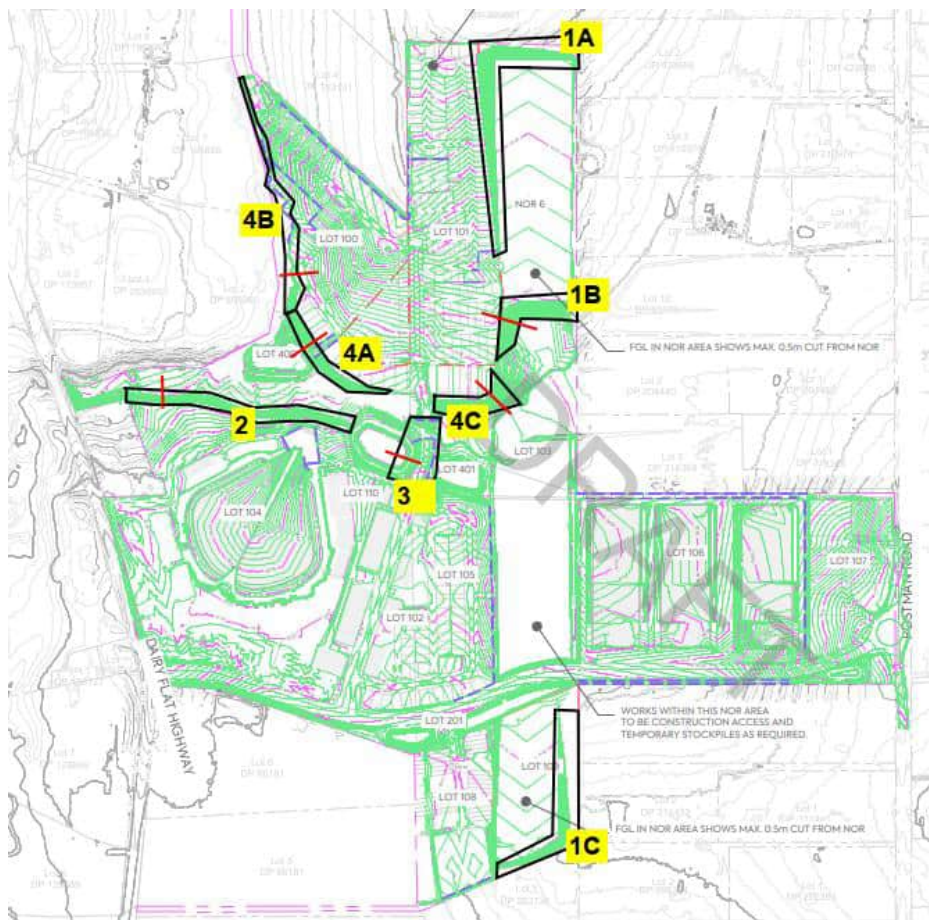
**Figure 7-7: Preliminary Stability Analysis Zones (black box) and critical section locations (red lines)**

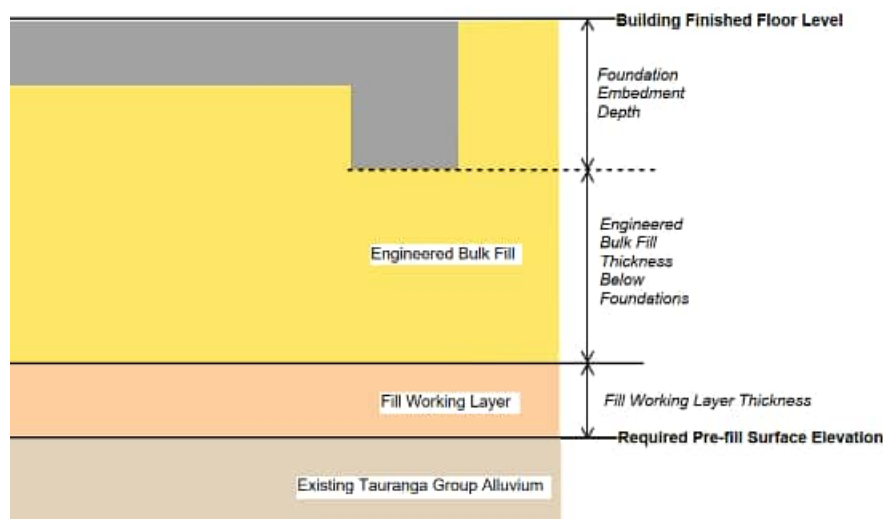
**Figure 7-9: Schematic of Shallow Ground Improvement Beneath Shallow Foundations**

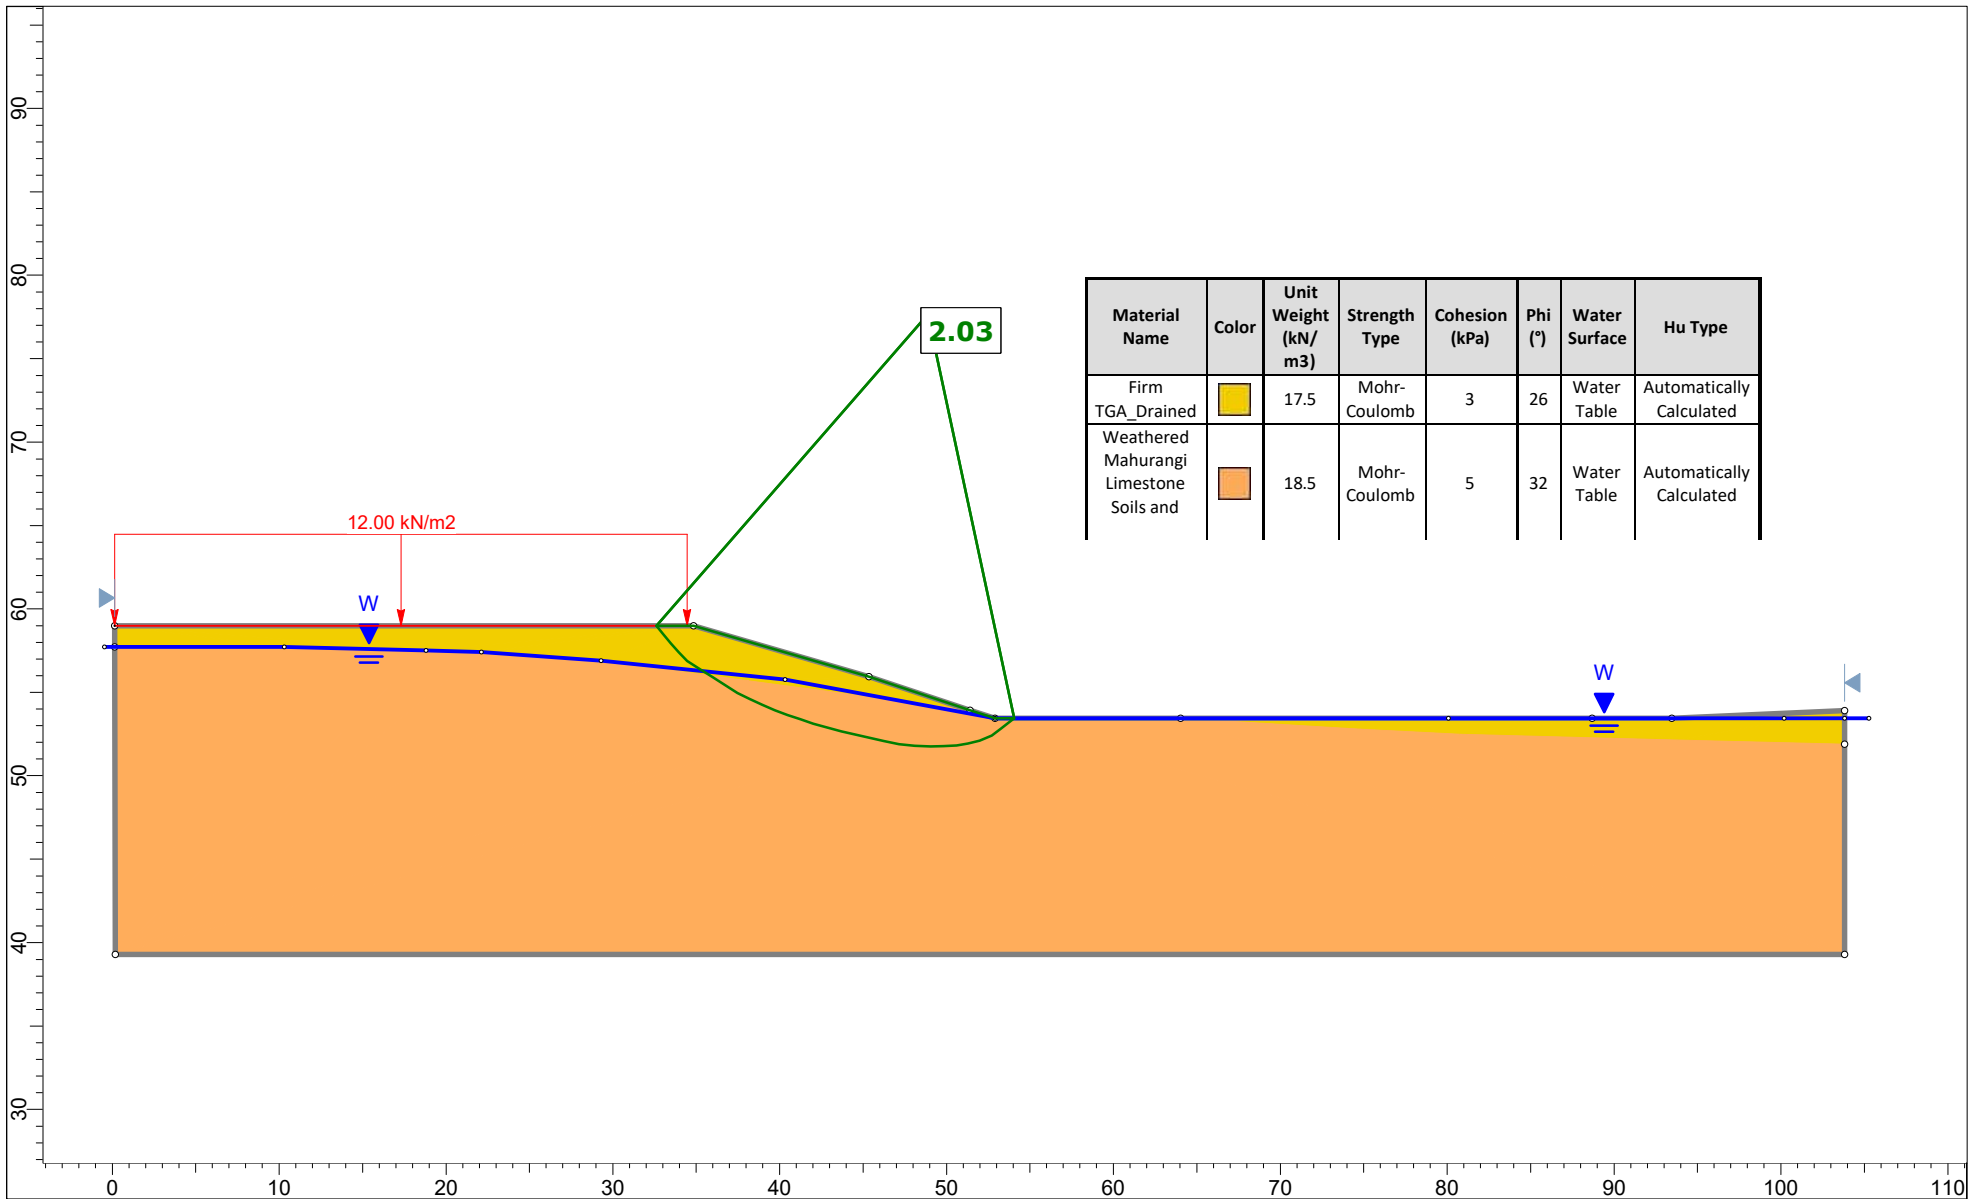
Project		ASP - Stage 2	
Analysis Description		Zone 1B - Normal Groundwater	
Drawn By	KMB	Company	Initia Ltd
Date	22/10/2025	File Name	Zone 1B.slmd

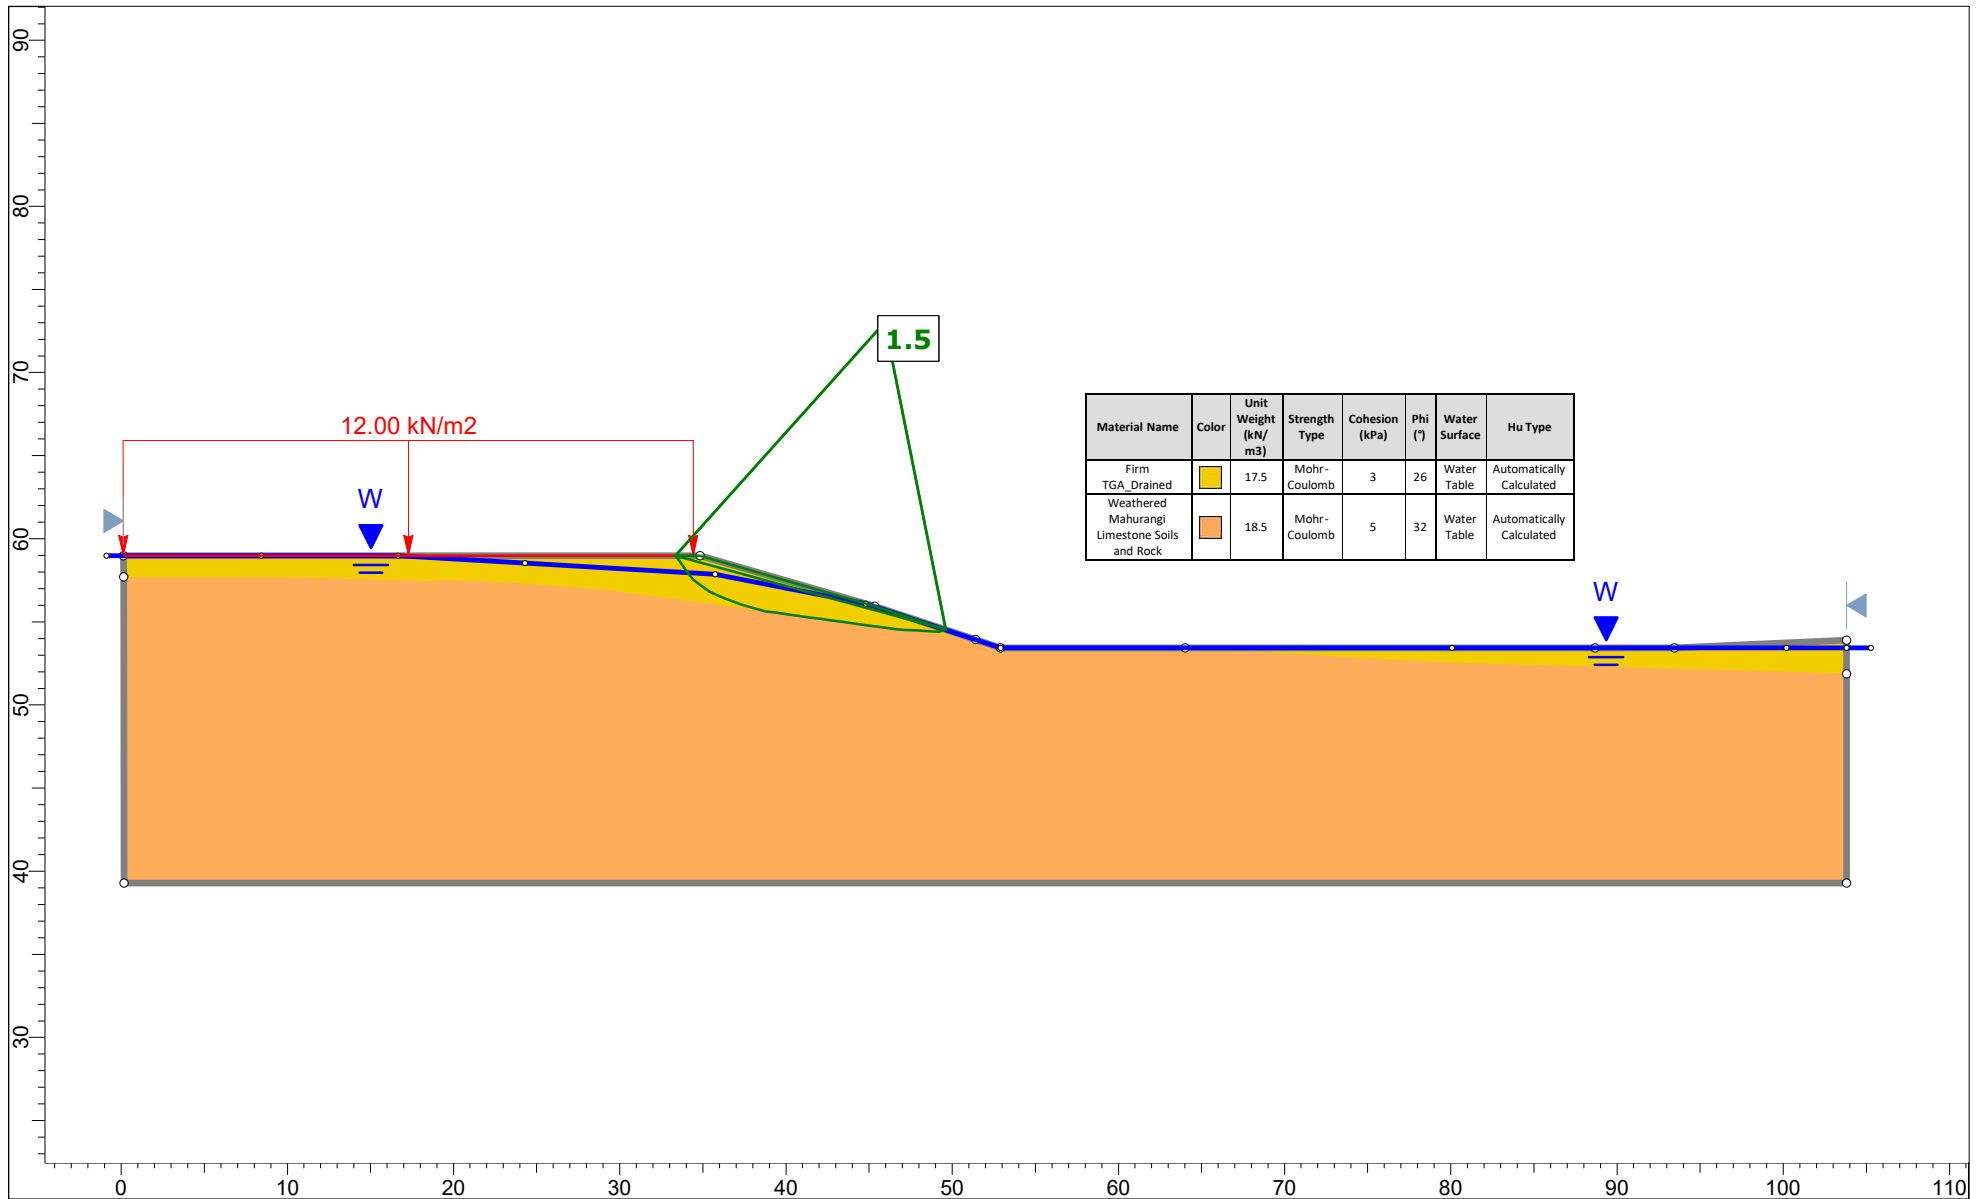
<i>Project</i>		ASP - Stage 2	
<i>Analysis Description</i>		Zone 1B - Elevated GW	
<i>Drawn By</i>	KMB	<i>Company</i>	Initia Ltd
<i>Date</i>	22/10/2025	<i>File Name</i>	Zone 1B.slmd

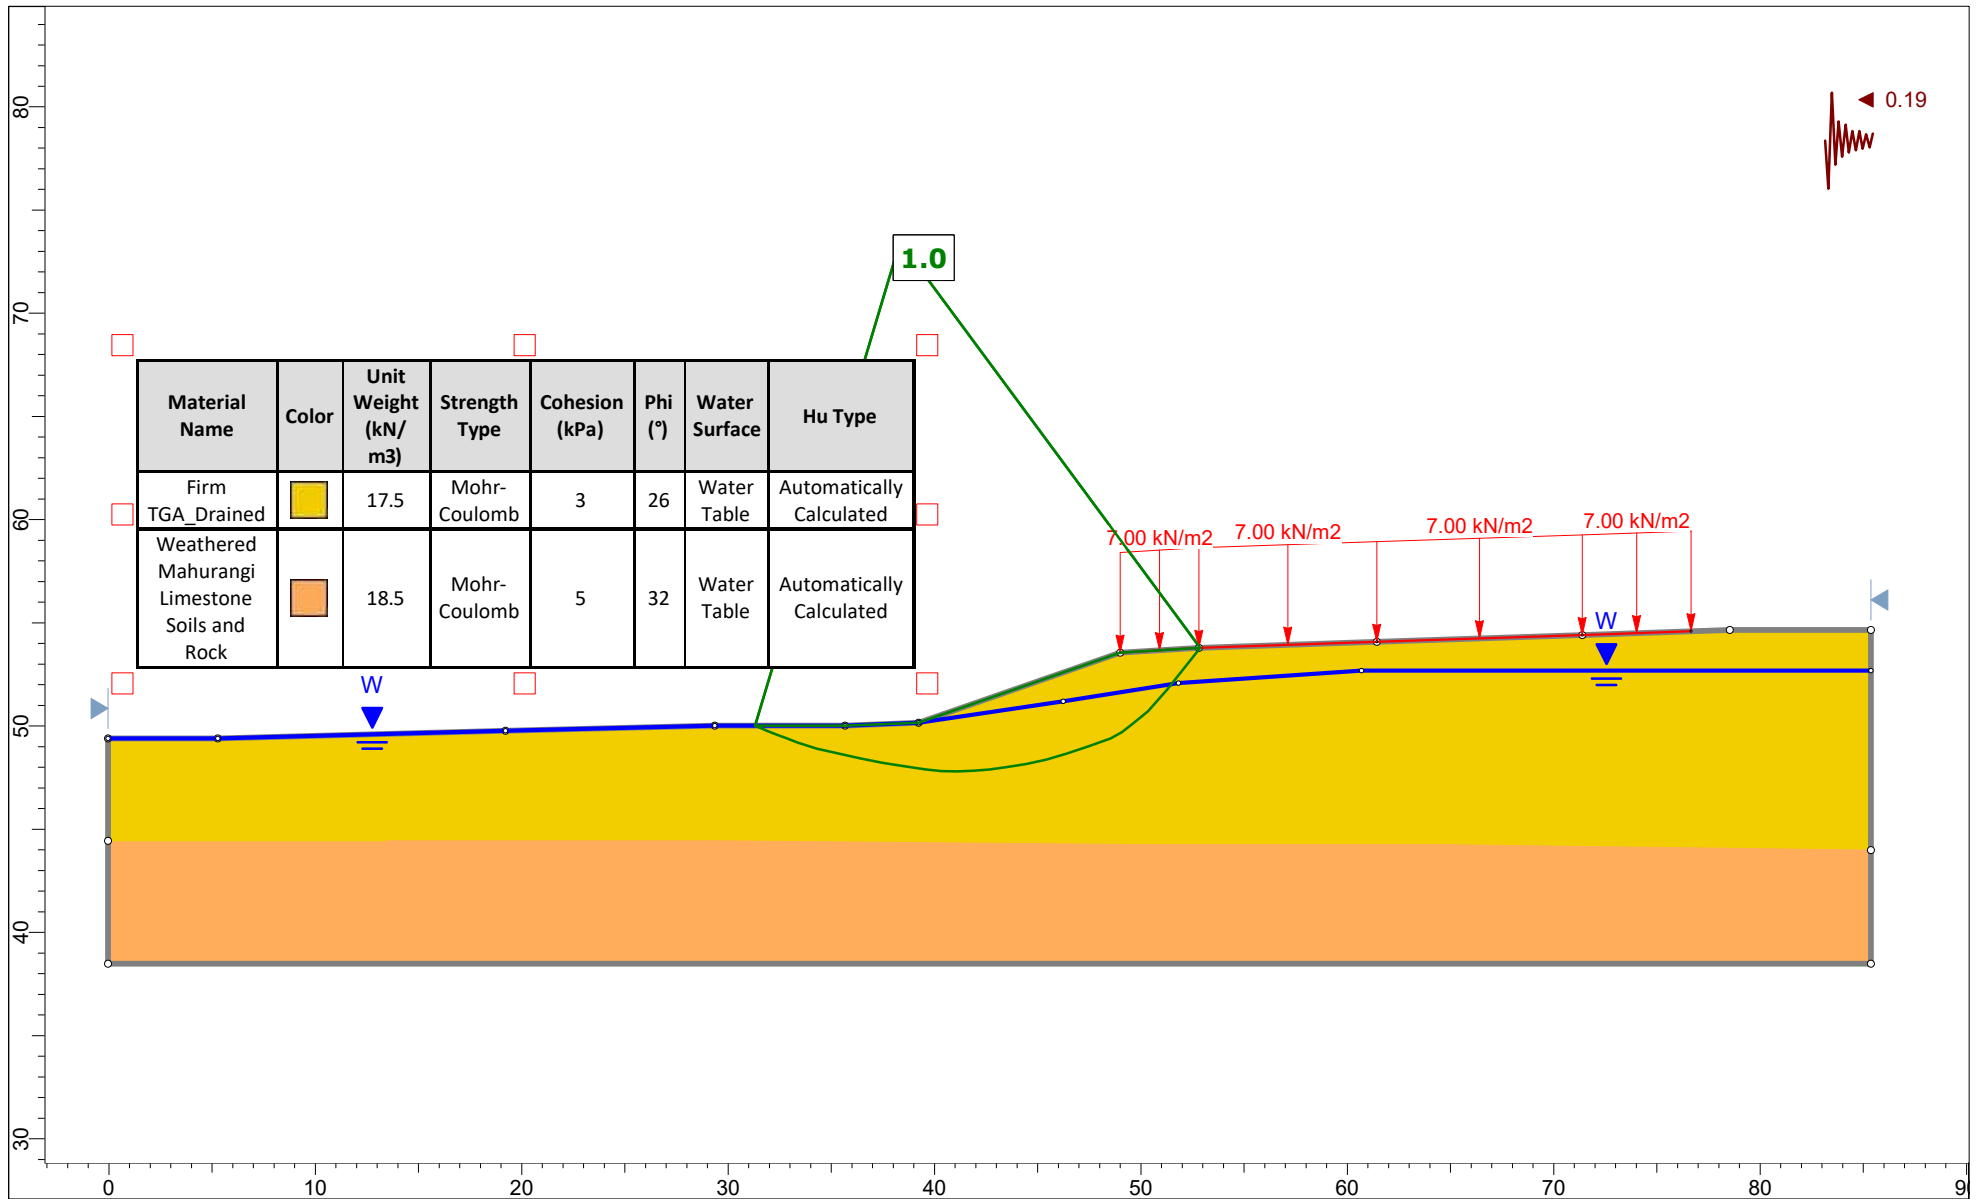
Project	ASP - Stage 2		
Group	ULS Seismic	Scenario	Zone 2
Drawn By	KMB	Company	Initia
2/11/2025	2/11/2025	File Name	Zone 2.slmd

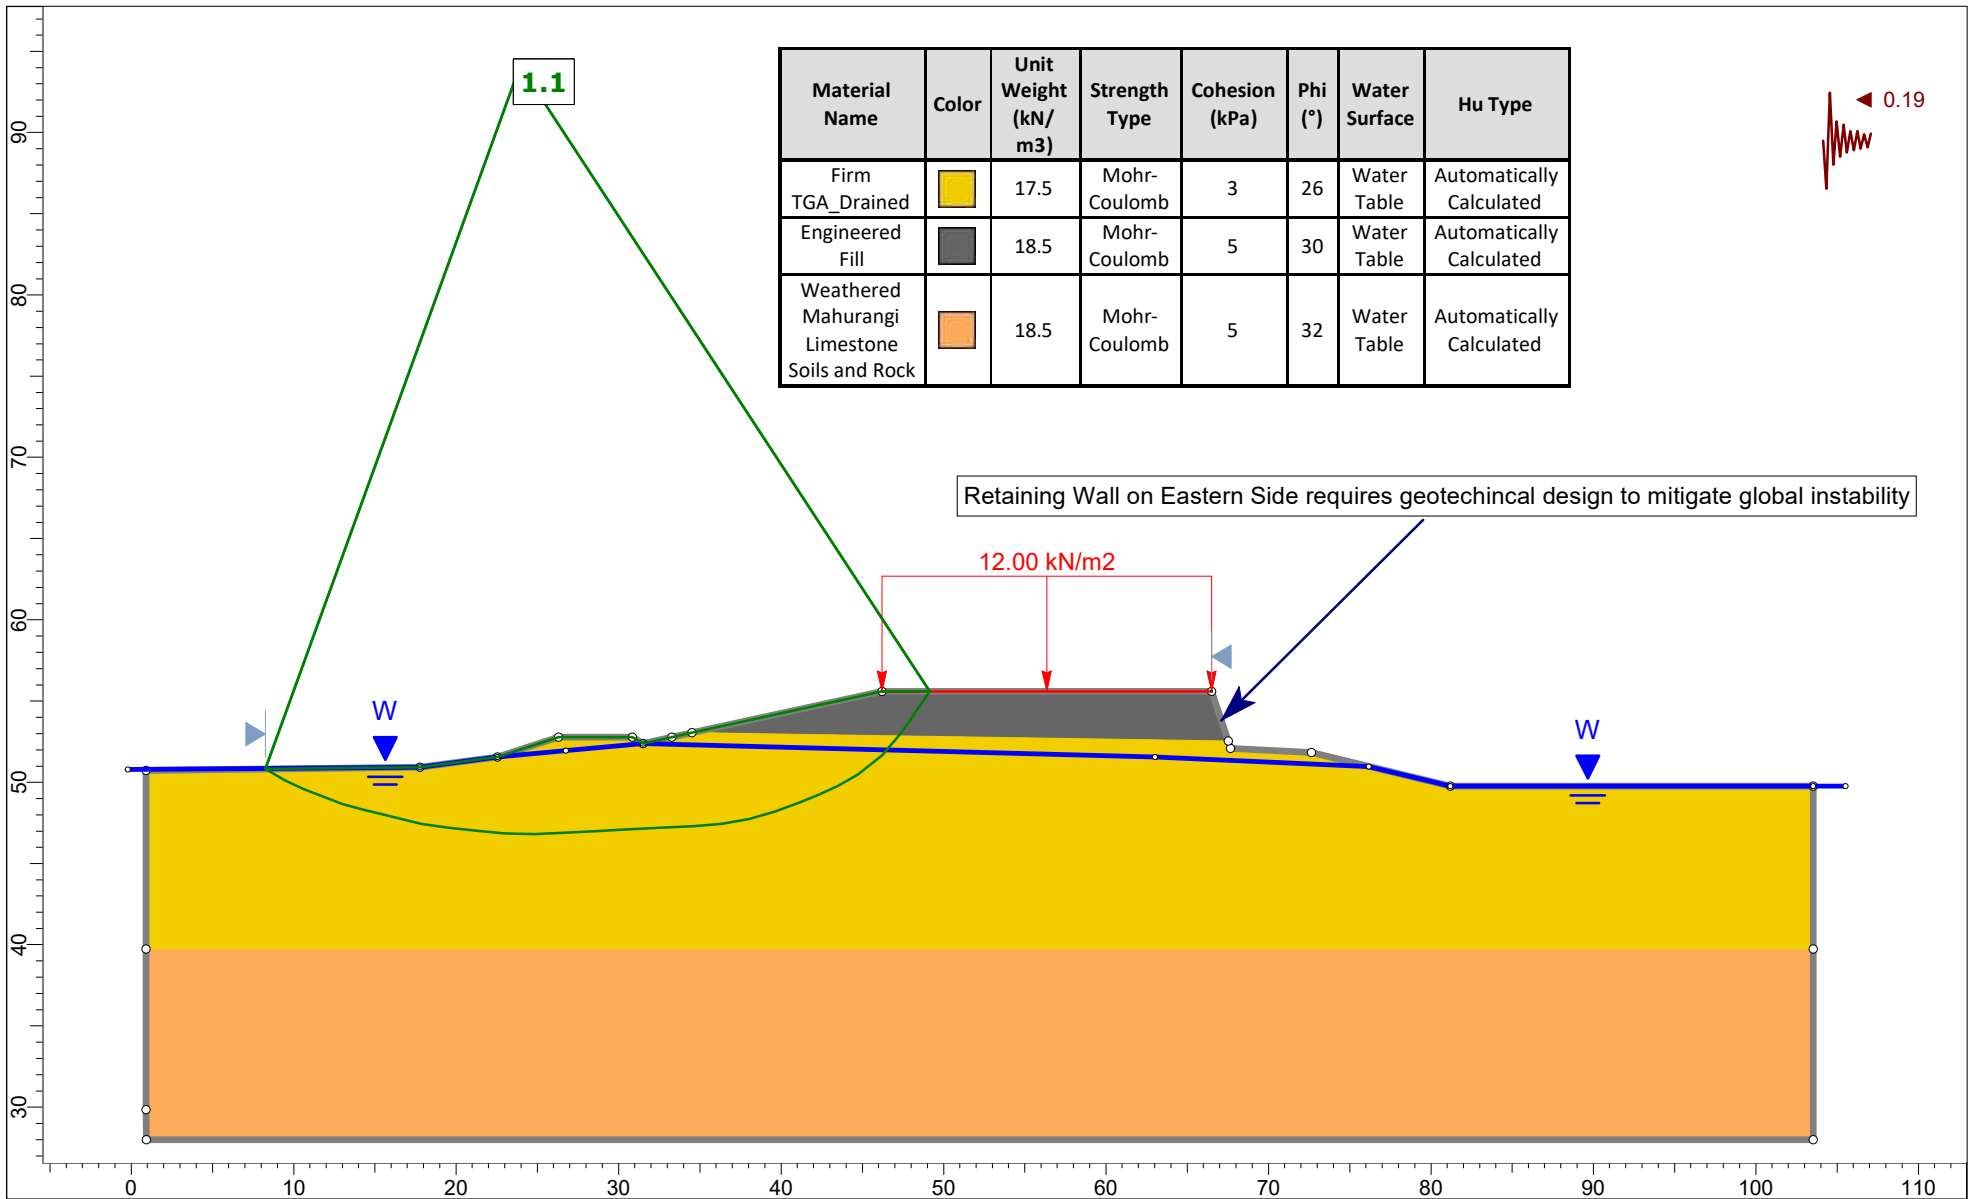
Project		ASP - Stage 2	
	Group	ULS Seismic	Scenario	Zone 3 Critical Batter
	Drawn By	KMB	Company	Initia
	2/11/2025	2/11/2025	File Name	Zone 3.slmd

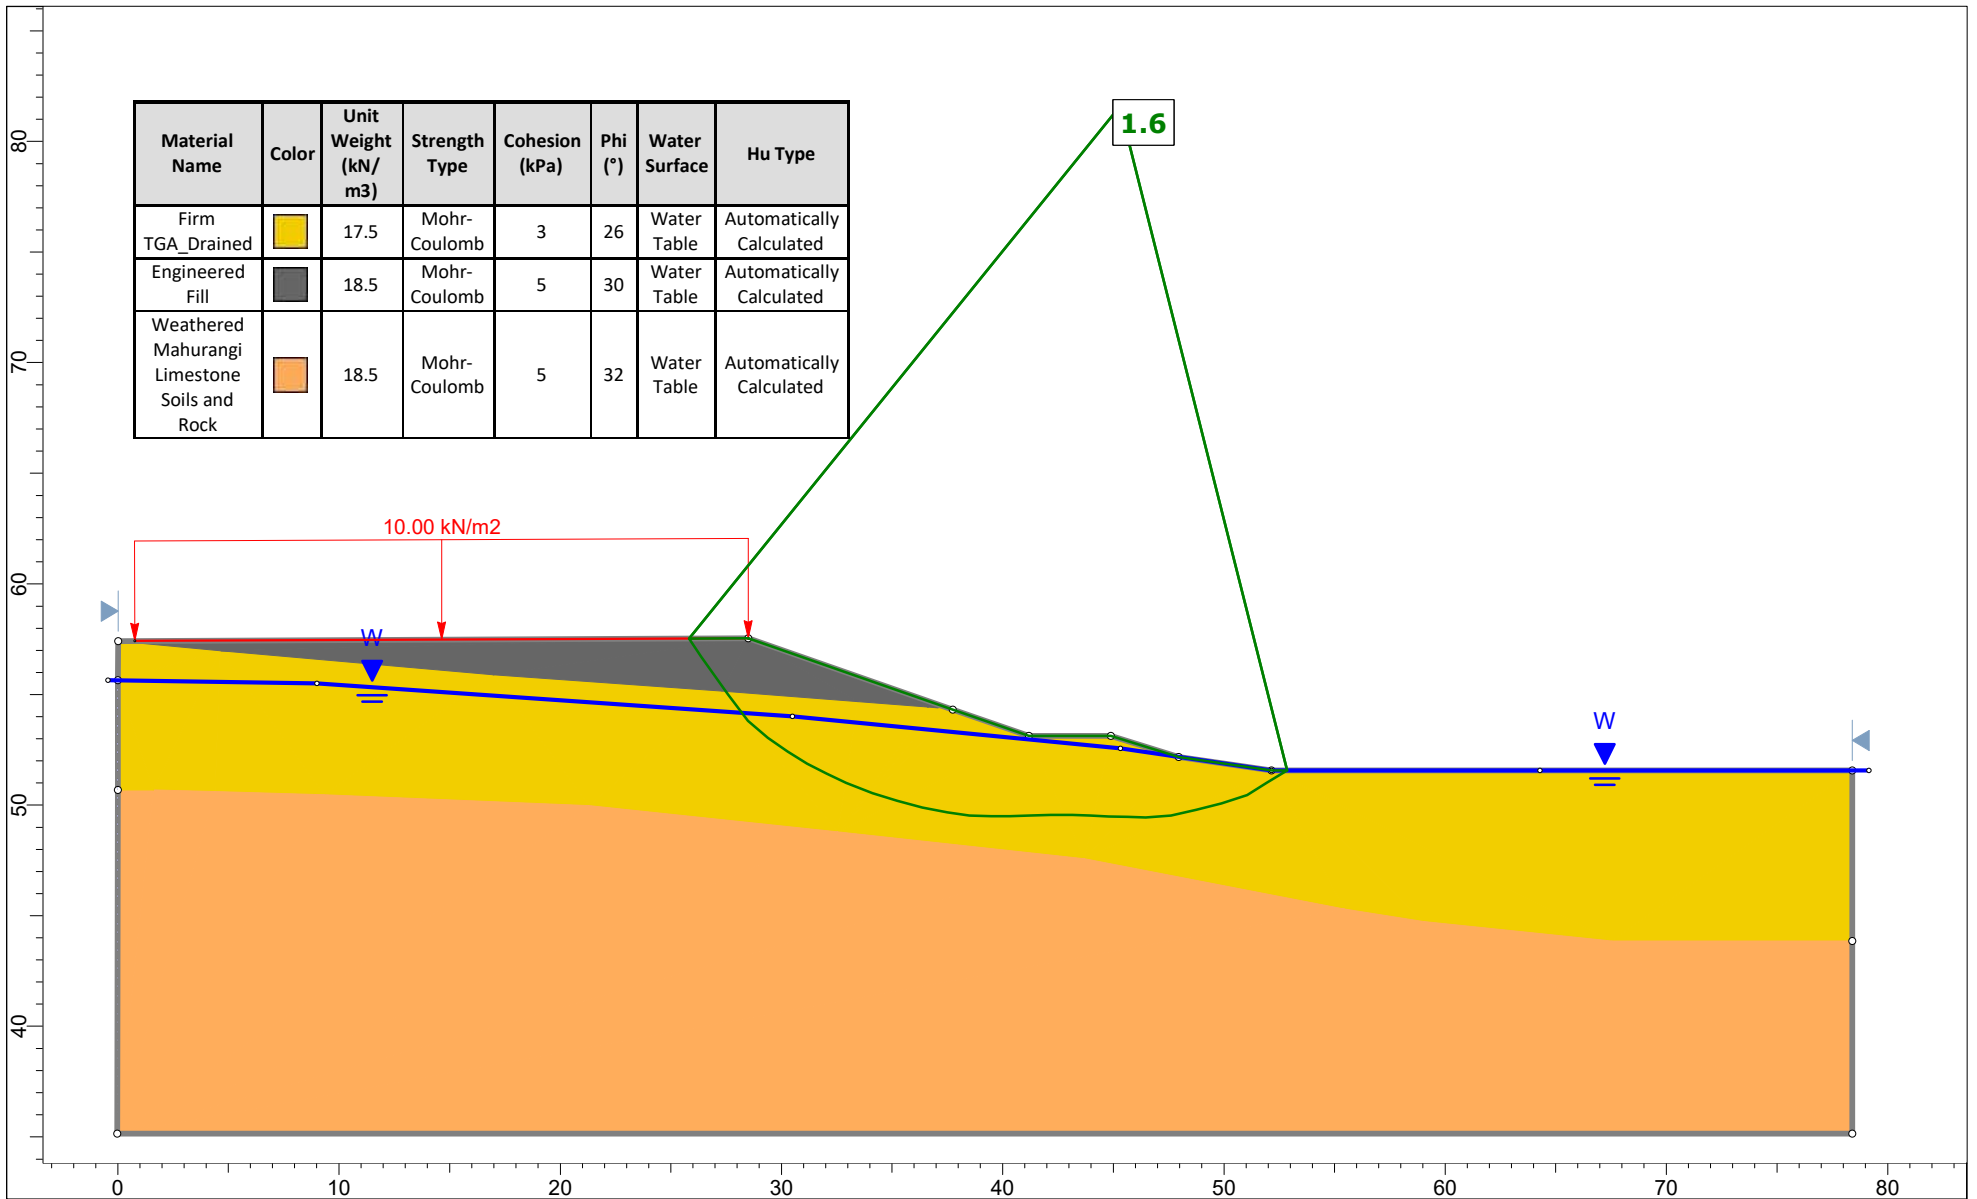
Project		ASP - Stage 2	
Analysis Description		Zone 4A - Normal GW	
Drawn By	KMB	Company	Initia Ltd
Date	22/10/2025	File Name	Zone 4A.slmd

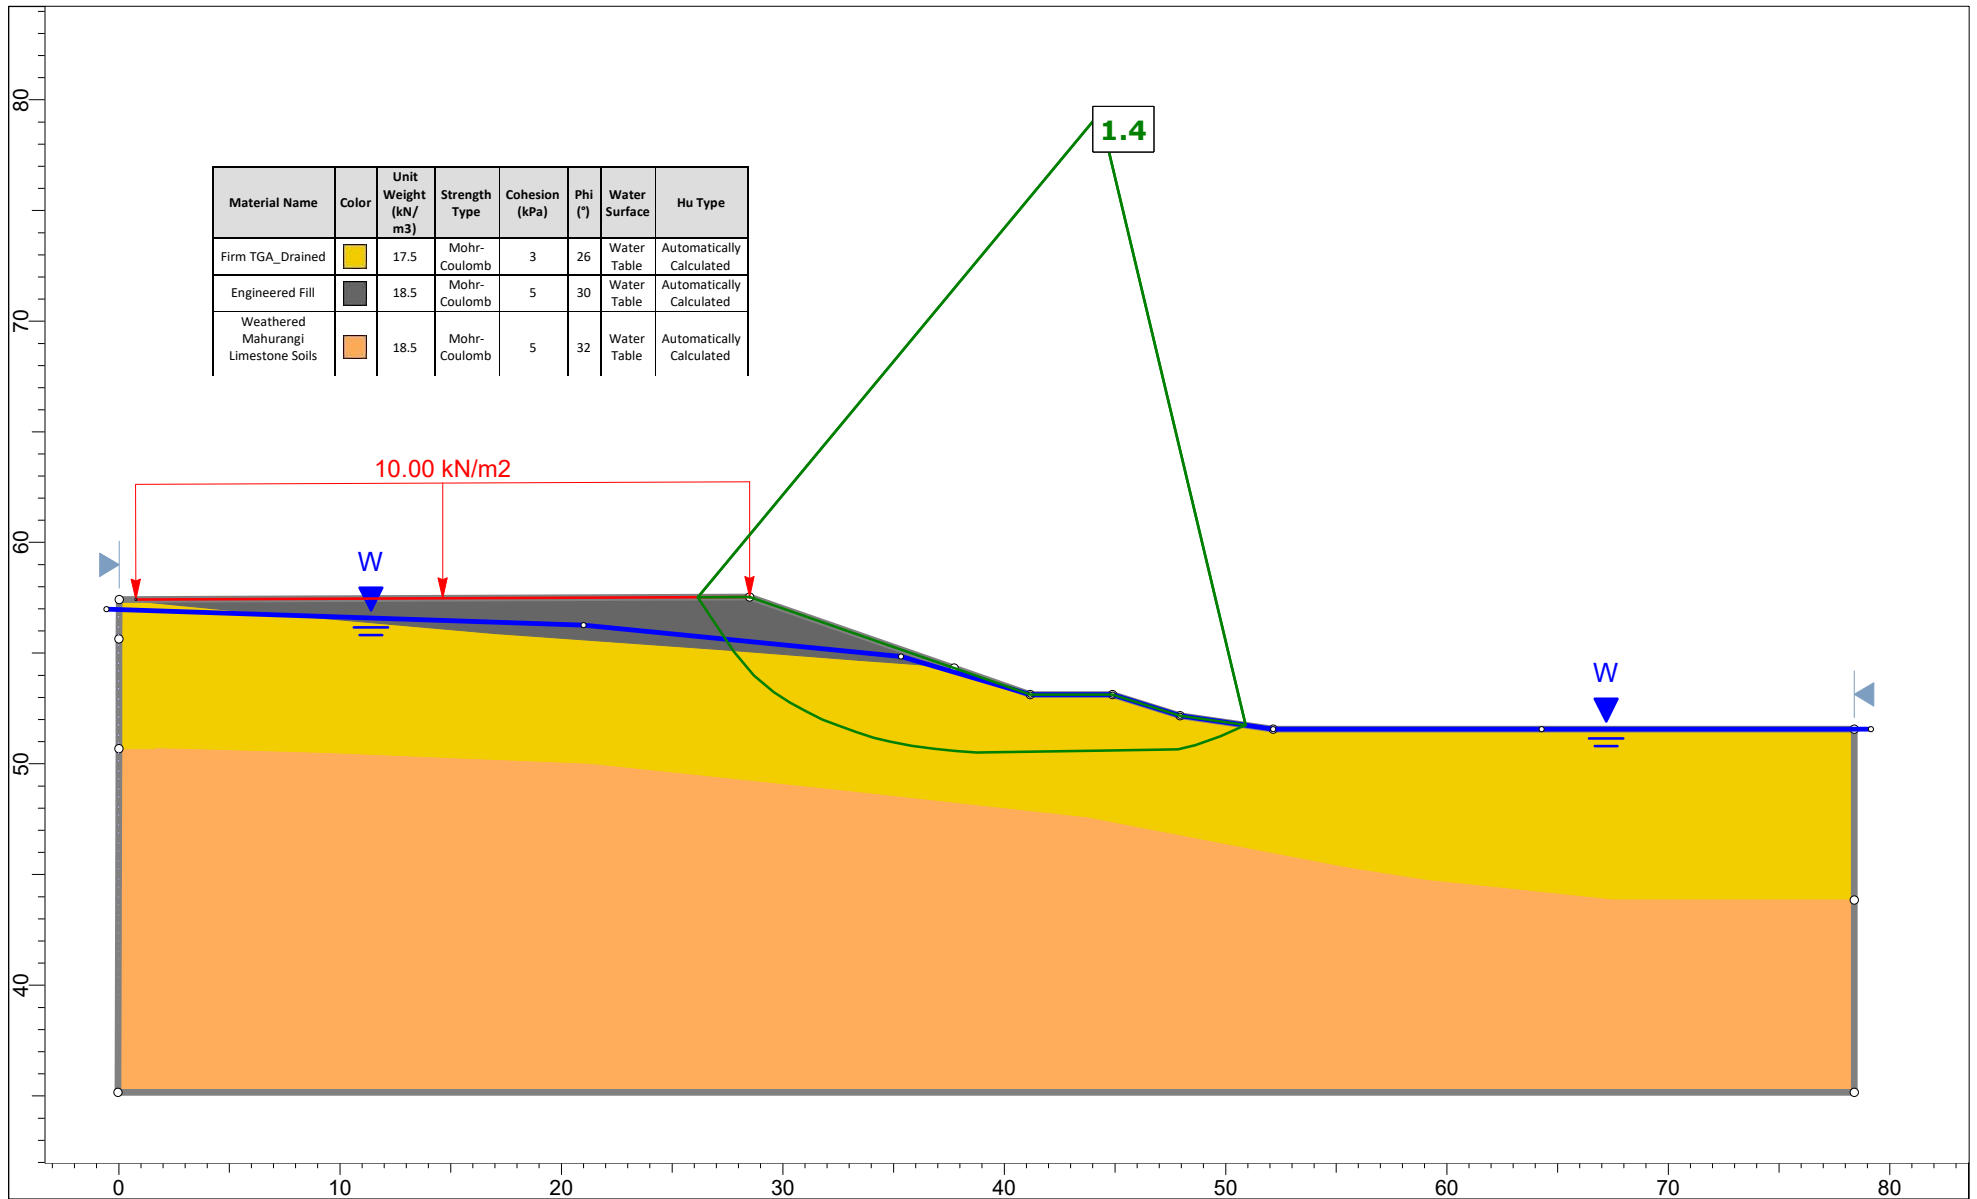
Project		ASP - Stage 2	
Analysis Description		Zone 4A - Elevated GW	
Drawn By	KMB	Company	Initia Ltd
Date	22/10/2025	File Name	Zone 4A.slmd

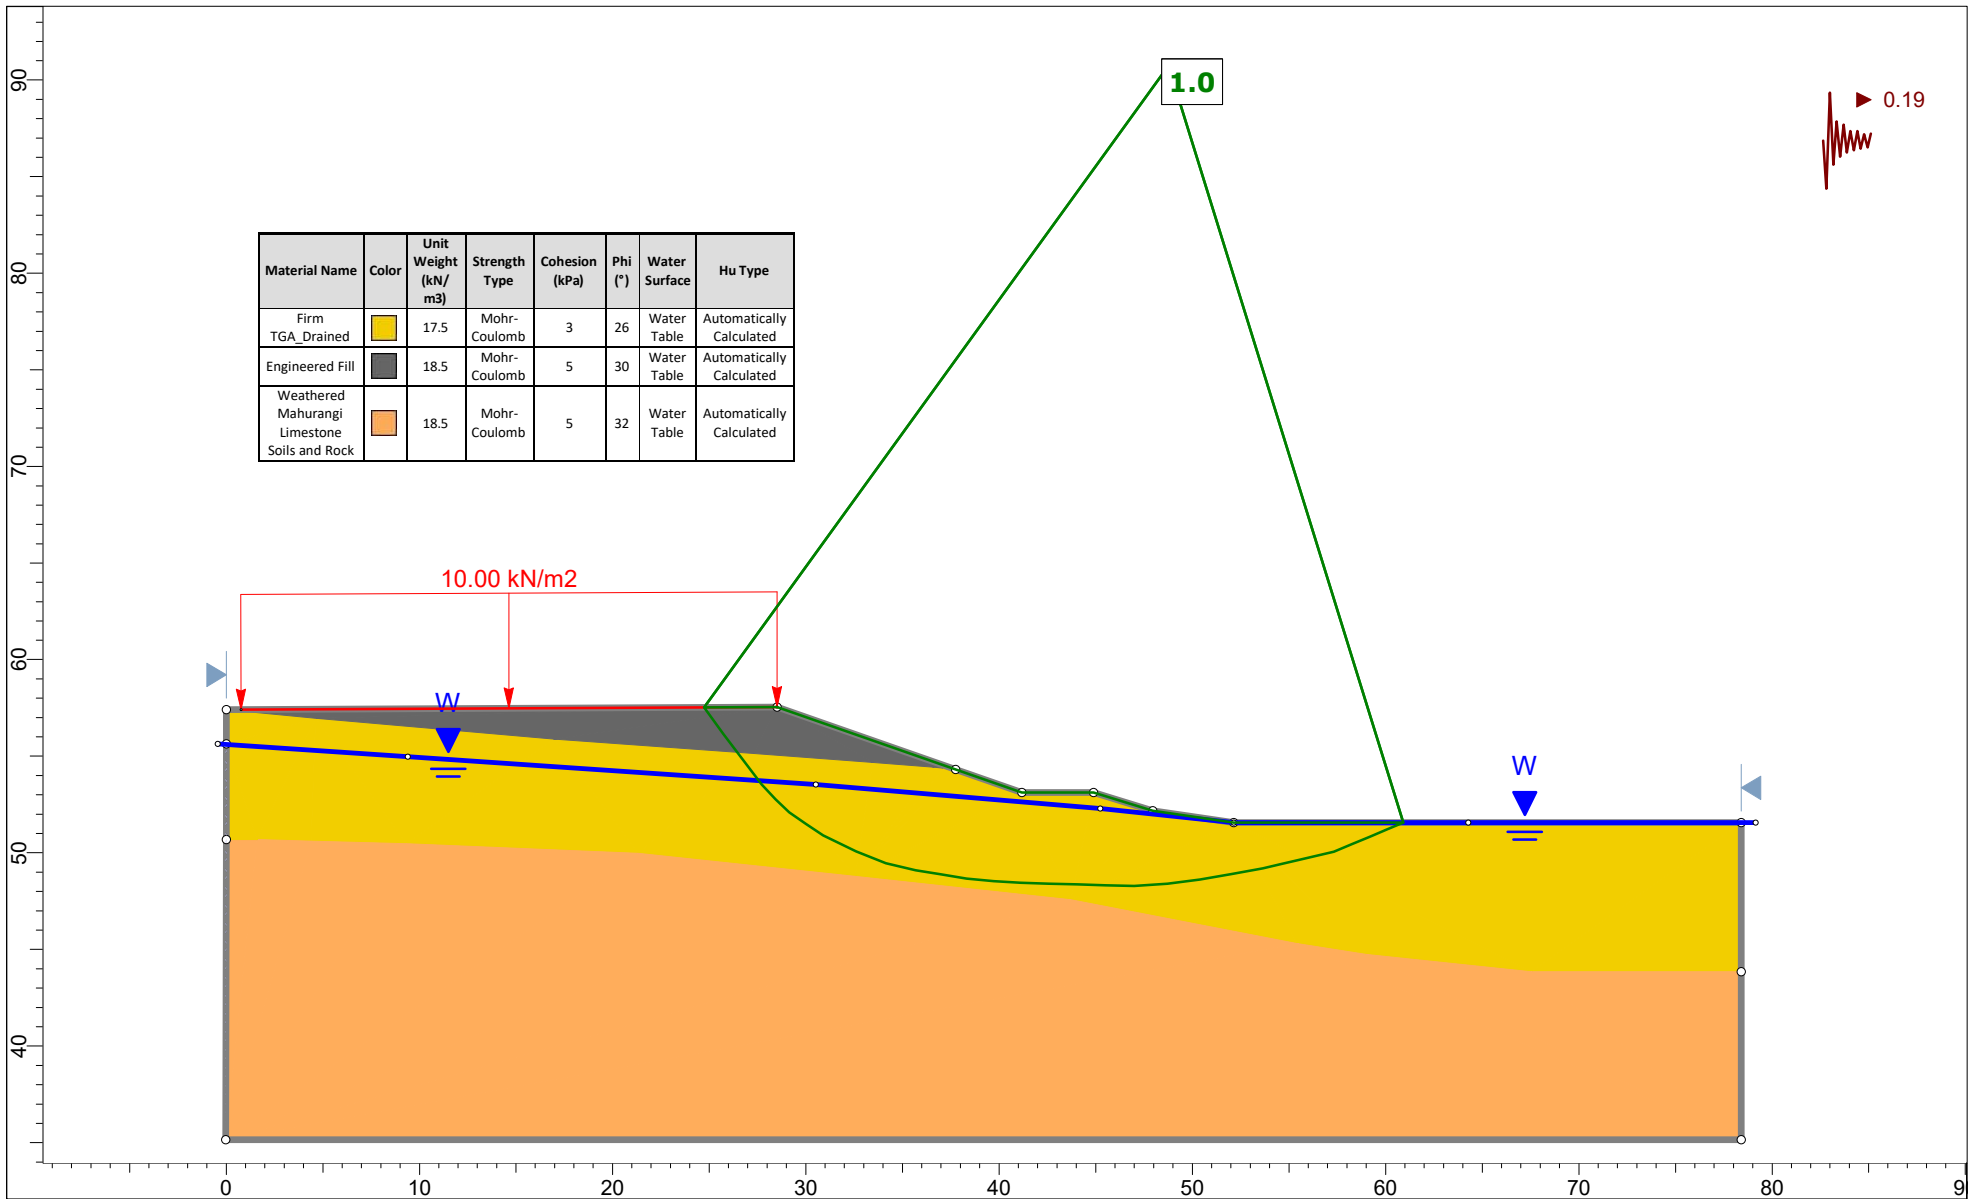
Project		ASP - Stage 2	
Analysis Description		Zone 4A - Seismic	
Drawn By	KMB	Company	Initia Ltd
Date	22/10/2025	File Name	Zone 4A.slmd
