Auckland Surf Park Community – Stage 2

Wastewater Discharge Assessment

Prepared for: AW Holdings 2021 Ltd

January 2026

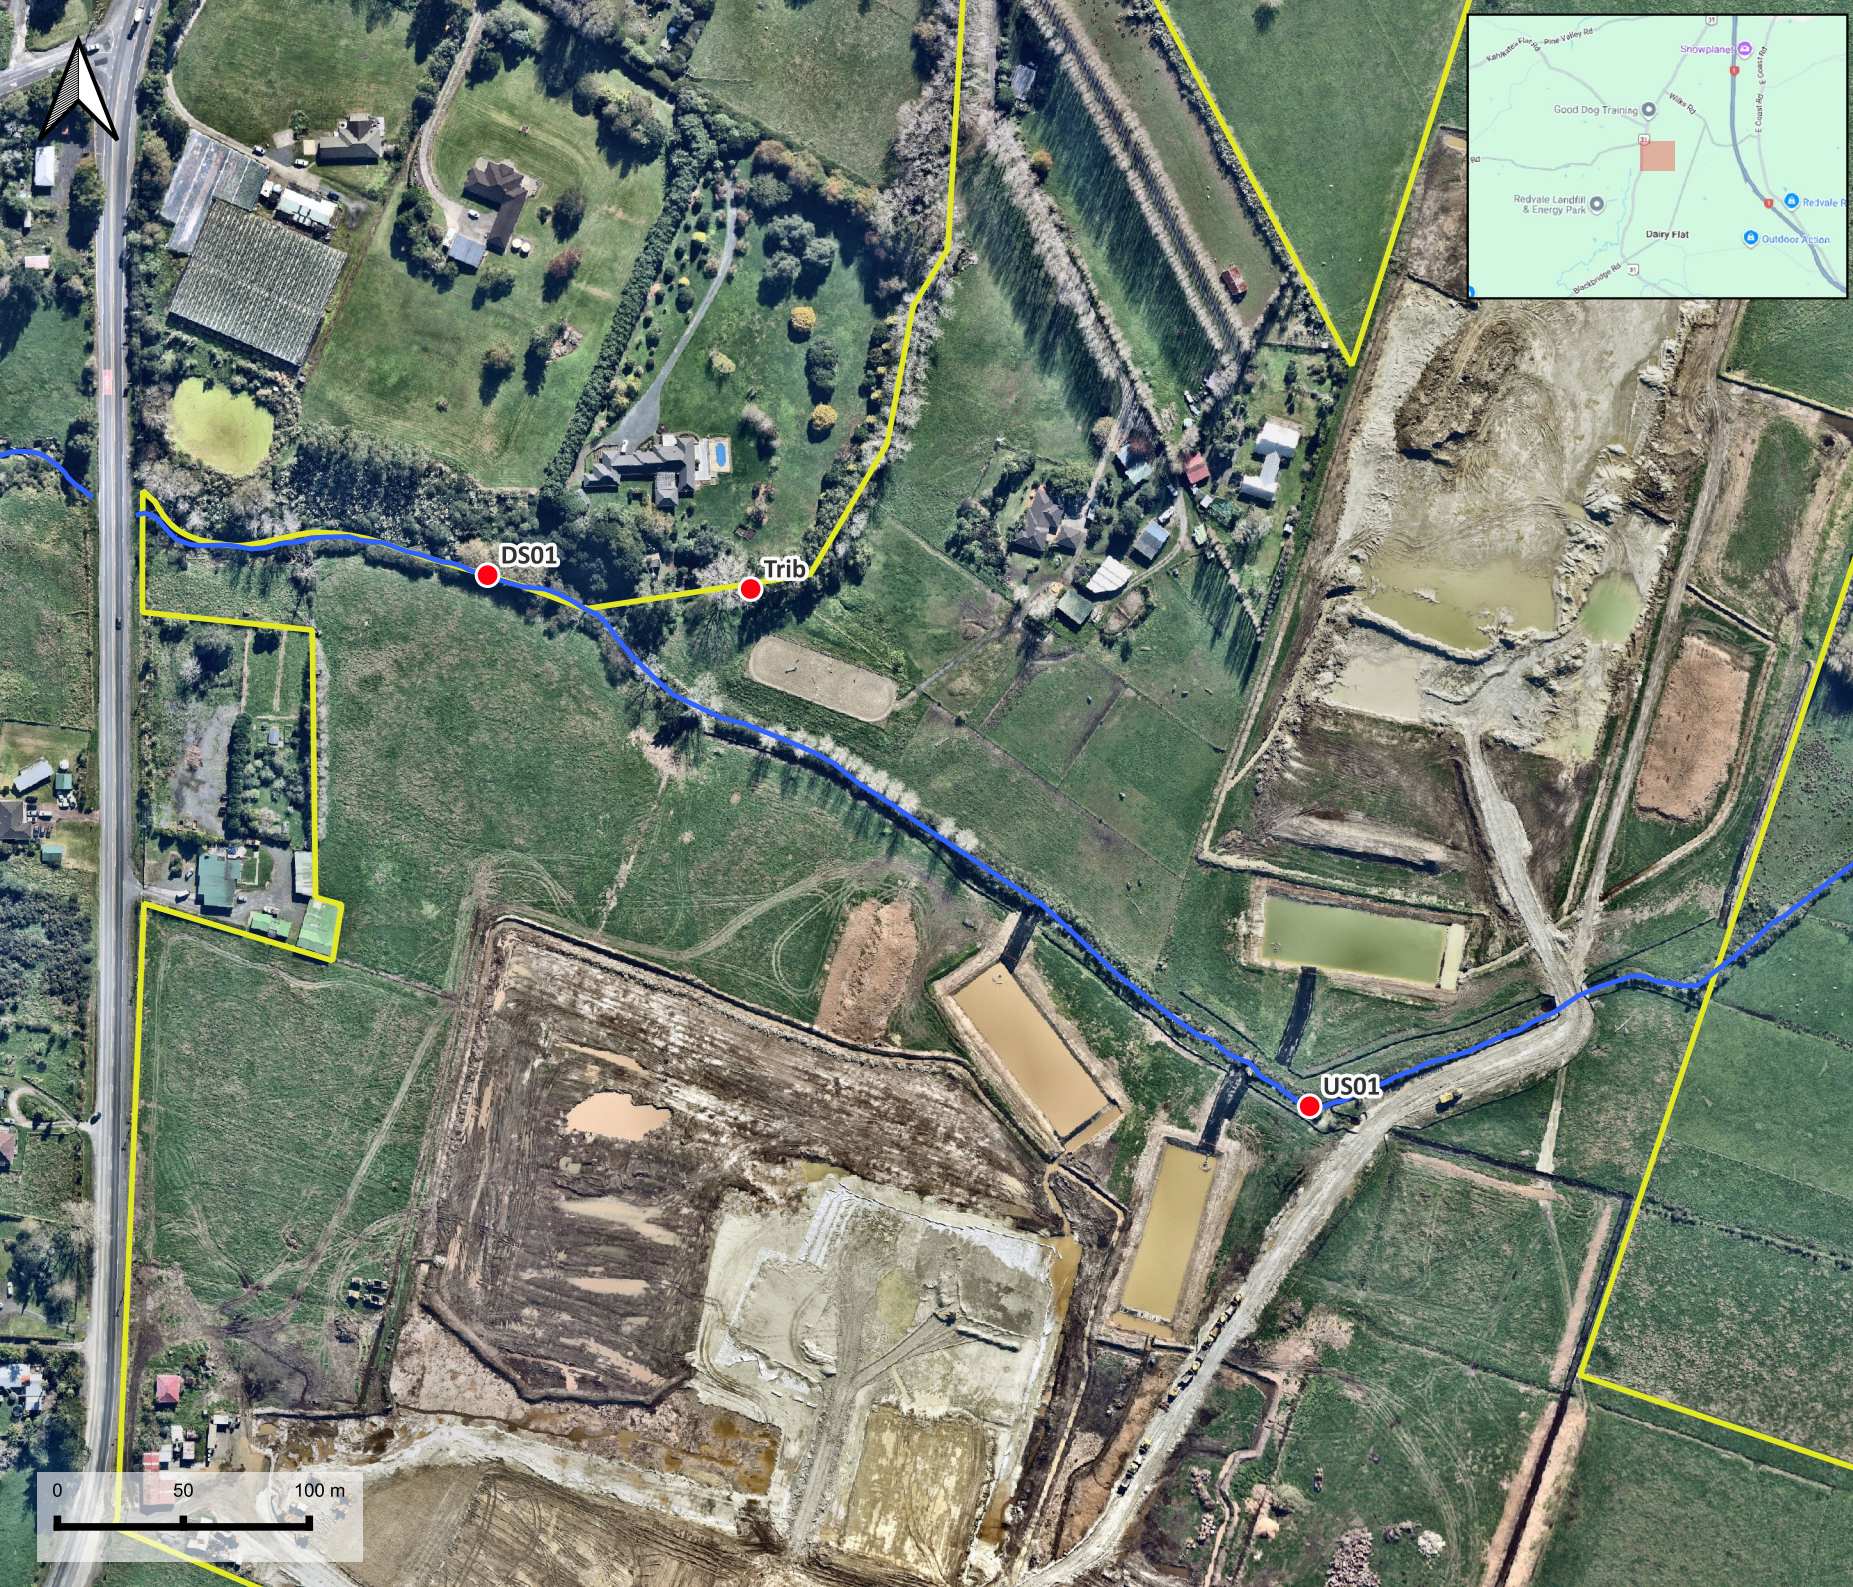
Figure 1. Site overview and monitoring sites.

- Monitoring sites
- Streams
- Site boundary

SCALE 1:3,000 @ A4

To evaluate the baseline condition of the main environmental receptor for the discharge, Viridis undertook a survey of the unnamed tributary of the Rangitōpuni Stream on 17 September 2025. Three representative sites were selected for in-stream habitat assessment, water quality monitoring and invertebrate sampling. These sites are described in Table 1 and presented in Figure 1. The monitoring sites were chosen based on the proposed location of the WWTP infiltration bed (Figure 1).

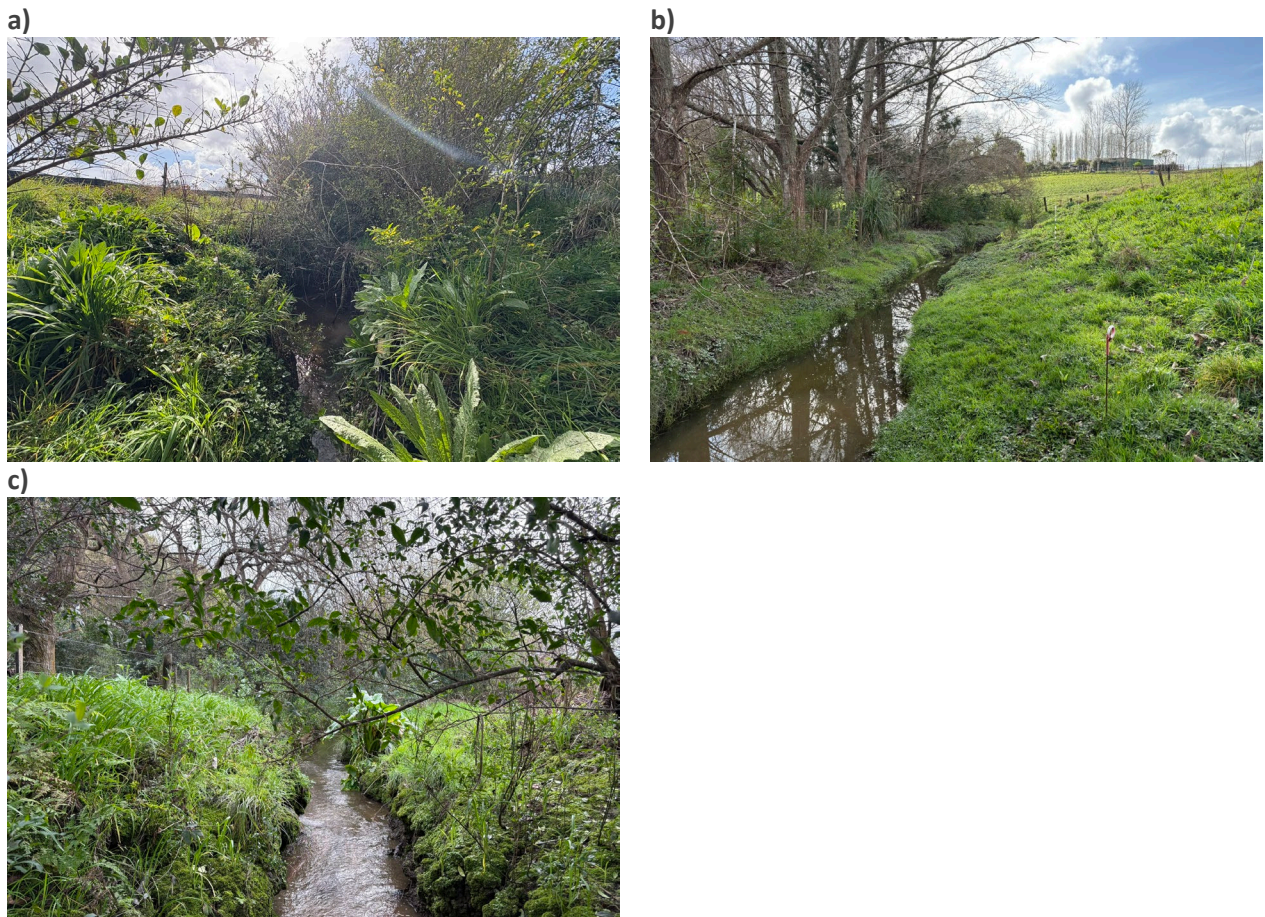
Figure 2. The unnamed tributary, facing upstream from the bottom of the survey reach at sites a) US01 b) Trib and c) DS01.

As described in Viridis (2025), the tributary exhibits clear evidence of extensive historical modification, including channel deepening and straightening, likely undertaken to improve drainage associated with the site's former pastoral land use. At the time of the site visit, representative sites within the main channel were found to be soft-bottomed, dominated by silt-sand and clay substrate. The watercourse was relatively shallow (<0.2 m), narrow (<1 m) and slow flowing. The stream had limited hydrological heterogeneity, consisting of only run habitat, of relatively uniform depth and velocity. Riparian vegetation was limited to exotic species and shrubs, which offered moderate to high shading to some reaches (Figure 2). Macrophyte growth was present at all sites, with species such as willow weed and buttercup observed. Some periphyton growth was also observed, including occasional short brown filamentous algae at sites US01 and DS01, and long green filamentous algae in the northern branch (Trib). In general, the water at each site was murky, and evidence of sediment deposition was noted.
