ASP BEI LAND CO

AUCKLAND SURF PARK COMMUNITY –  
STAGE 2 FAST TRACK CONSENT

GEOTECHNICAL ASSESSMENT REPORT

INITIA REF P-001537-2 REV C

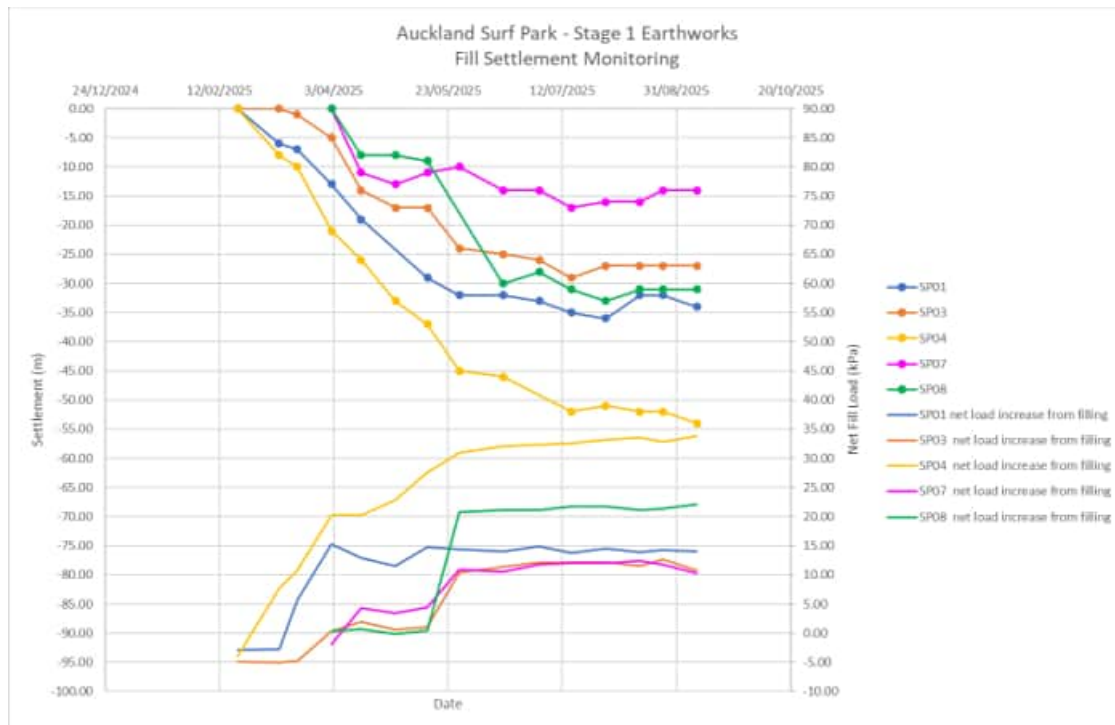
**Figure 7-3: Existing settlement plate monitoring data**

As shown on Figure 7-3, fill was placed until early April 2025 at the SP01 location and until late May 2025 for the remaining settlement plate locations. Therefore, hold periods of approximately 5 months for SP01 and 3.5 months for the remaining plates were observed between the completion of filling and the latest survey monitoring round on 9/09/2025.

Figure 7-3 below plots both the measured settlements and the net applied load over time.

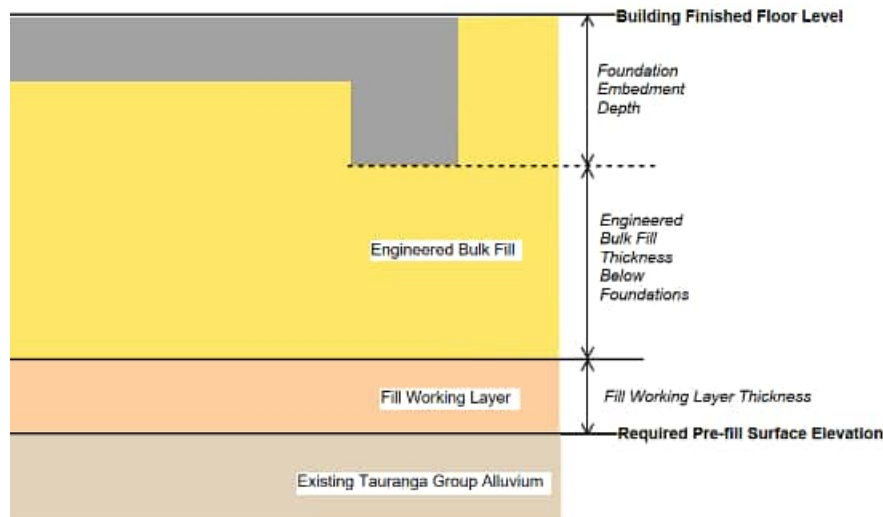
**Figure 7-9: Schematic of Shallow Ground Improvement Beneath Shallow Foundations**

Figure 7-9 below presents a typical schematic of the fill crust build up. Table 7-9 summarises preliminary thicknesses of each component within the crust. These thicknesses may be used for planning purposes, however, further specific assessment should be undertaken to confirm appropriate pre-fill surface elevations prior to placing bulk fill beneath building platforms. Fill crusts will need to extend laterally approximately 1 m beyond the perimeter of foundations.
