## Mt Wellington Station Ecology

Ecological values, effects and effects management

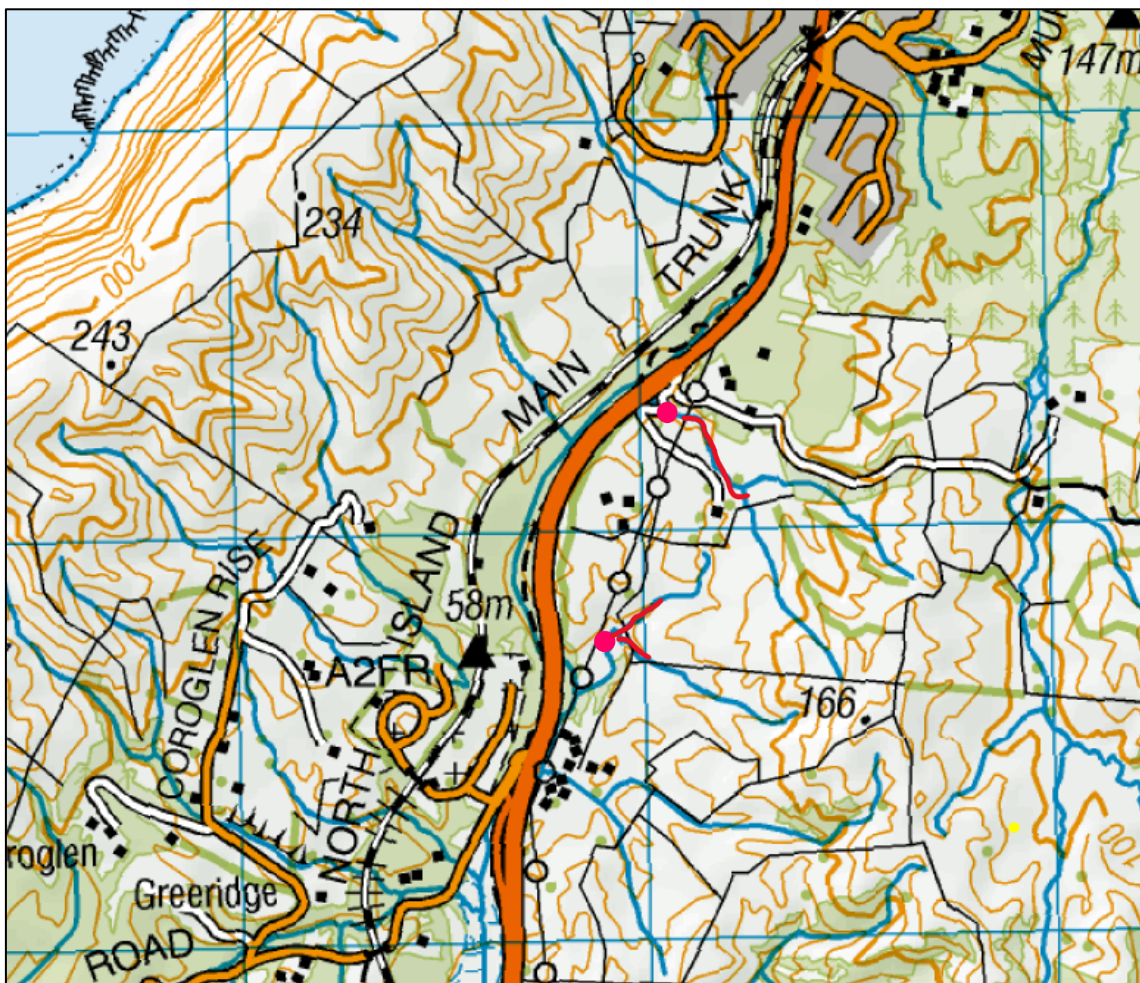
Figure 8. Northwestern eDNA sample and the Southwestern systems eDNA sample site (red dots).

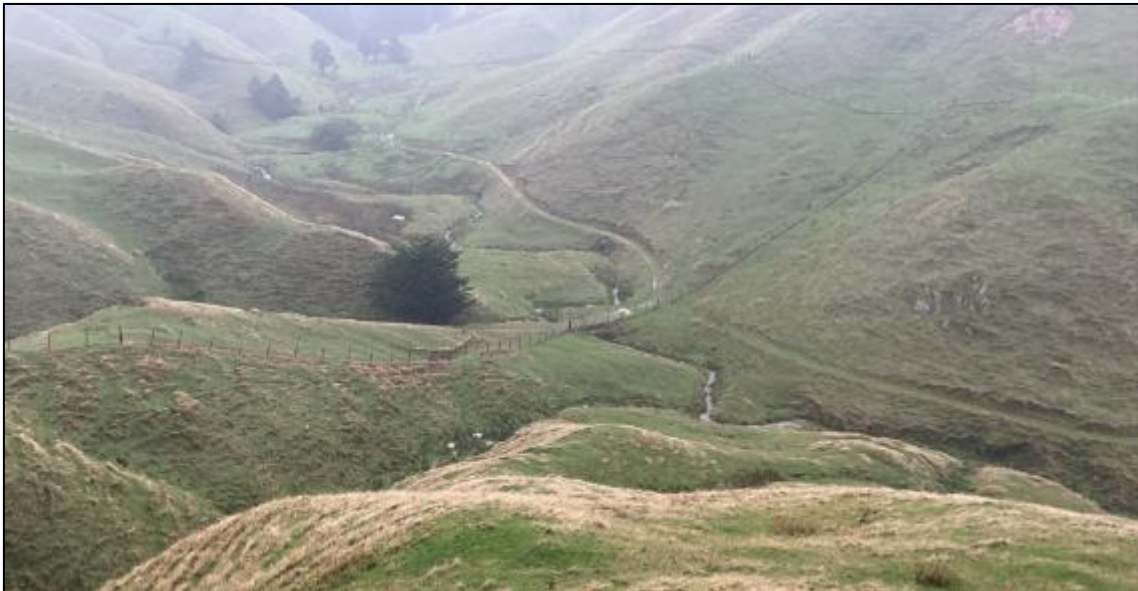
Figure 10. Landscape photos of the Kakaho east main stems showing the settings.

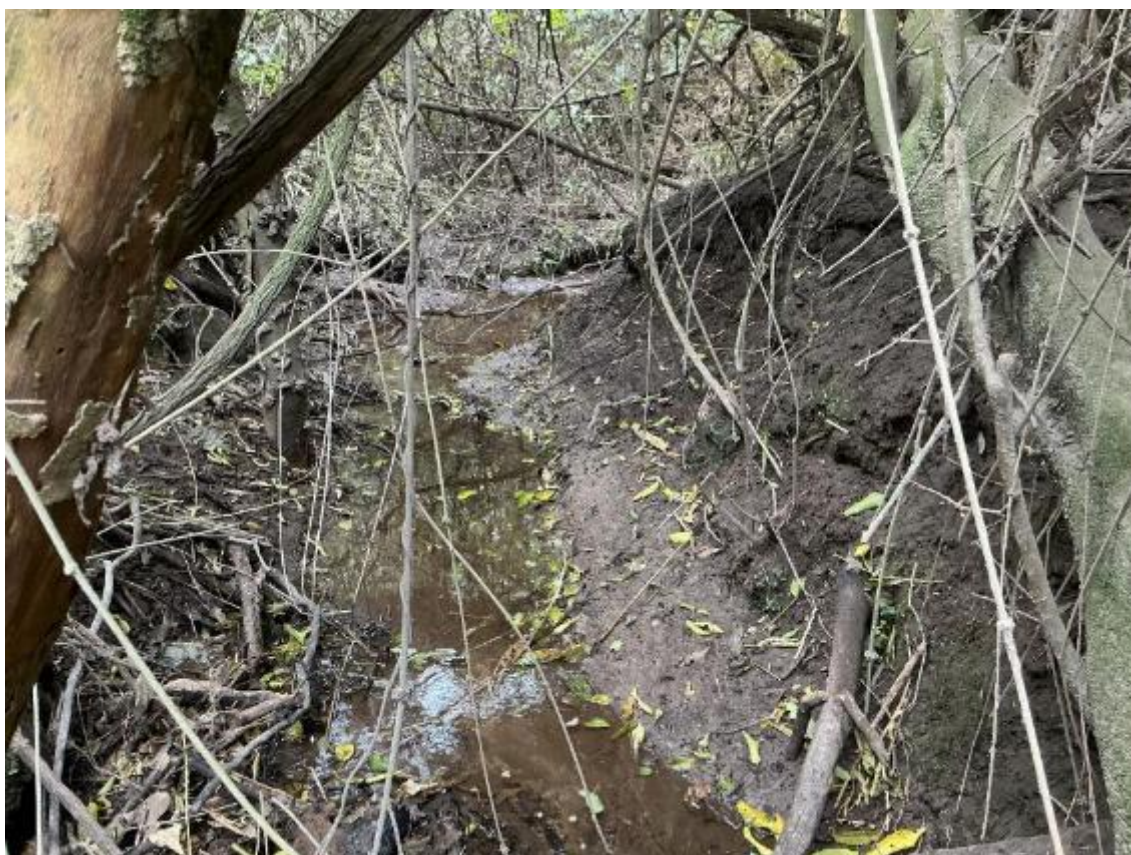
*Figure 15. Eastern tributary that passes under SH 59 to join the Taupo Creek.*

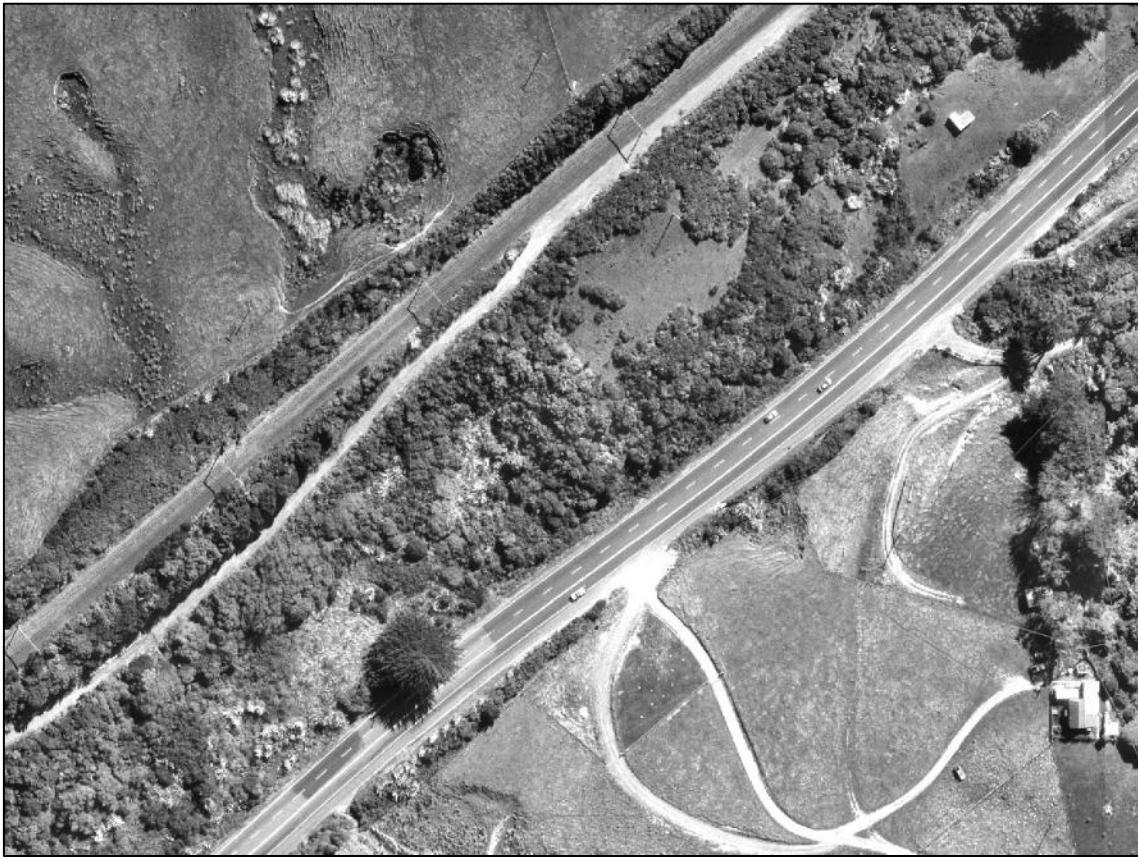
*Figure 19. 1995 Retrolens aerial photograph of the entrance to the property. Note no public walkway through SNA 027 as yet and many open areas.*

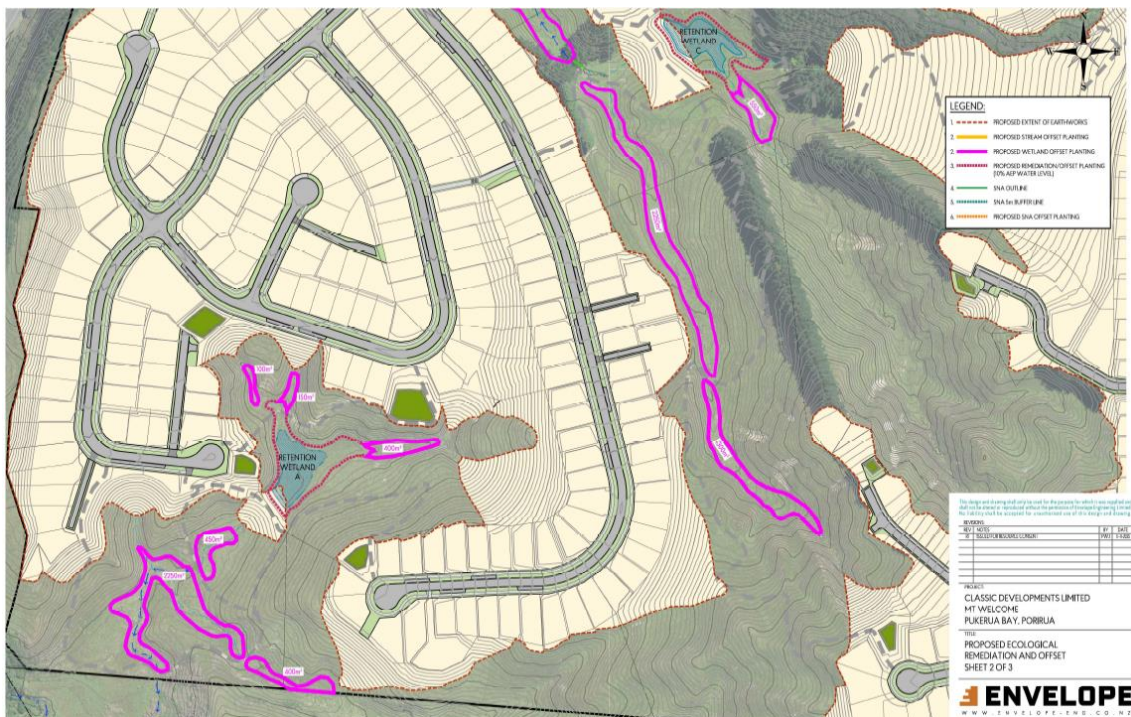
Figure 26. One of the areas for the offset wetland creation / enhancement options. Above and below the south-western retention feature. approximately. 0.51 ha.

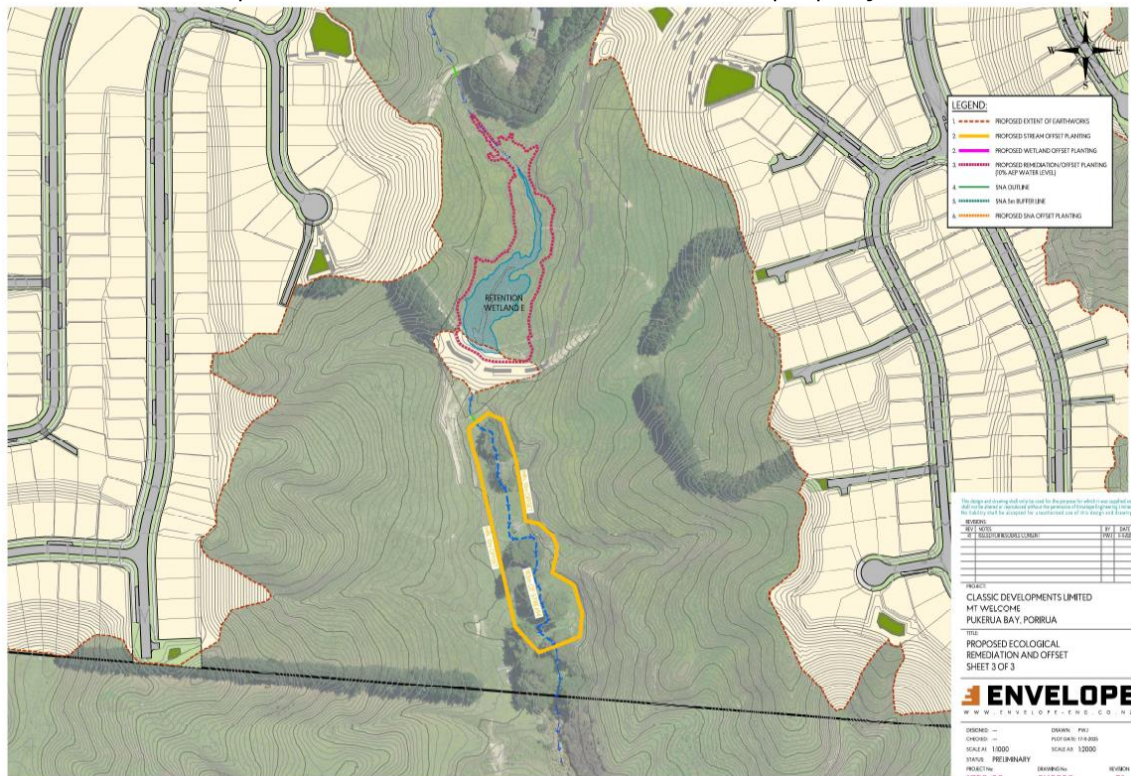
Figure 28. Taupo stream effects offset location in the lower (below retention wetland) Kakaho West main stem.

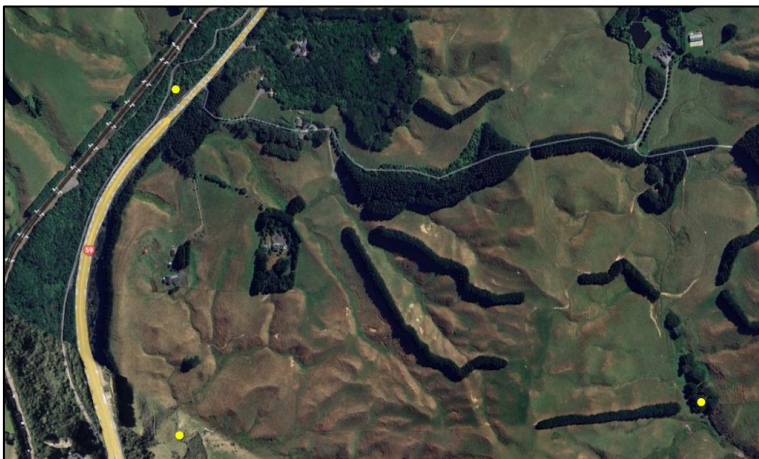
Figure 30. Pre earthworks reaches for base line substrate and macrophyte cover measures.

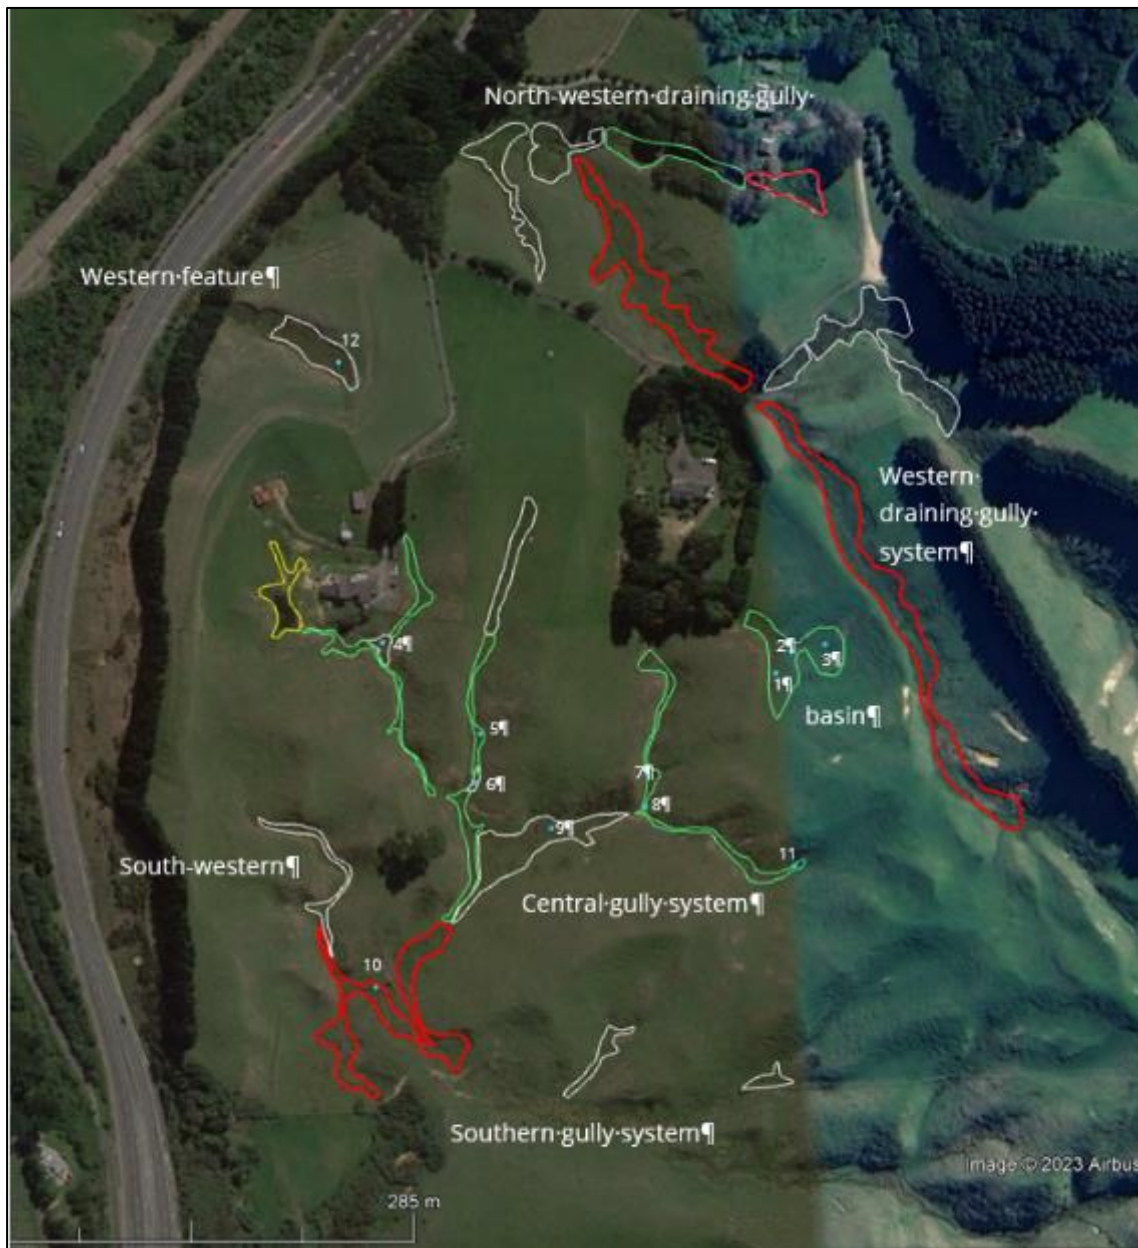
Figure 32. Wetland delineation vegetation Plot locations and labels (#) shown above. Wetlands shown as red - assessed rapid natural inland wetlands, green possible natural inland wetland and white unlikely natural inland wetland, yellow excluded as a natural inland wetland.

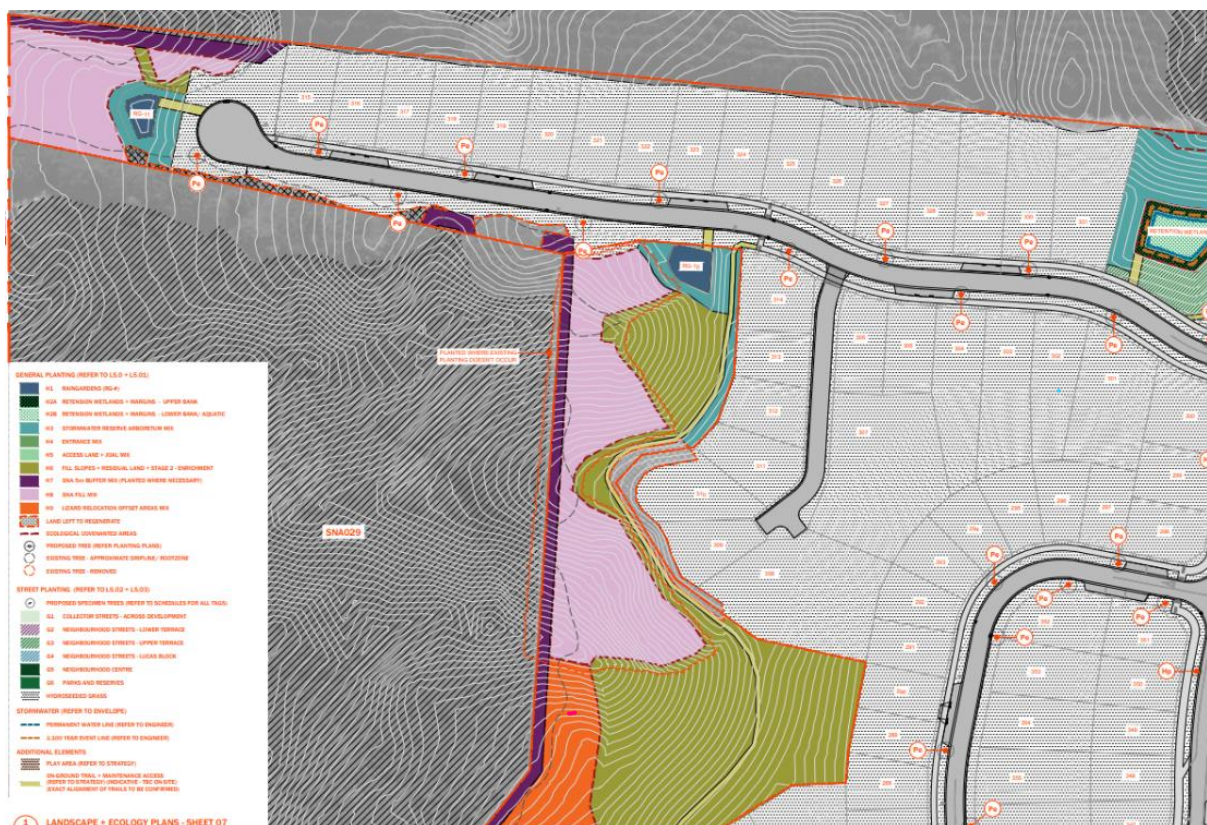
Figure 34. Red is SNA 029 5m buffer planting. Blue is wetland restoration assistance; Yellow is buffer and ecological offset revegetation.
