**Auckland Surf Park Community – Stage 2**

# **Wastewater Discharge Assessment**

**Prepared for: AW Holdings 2021 Ltd**

**January 2026**

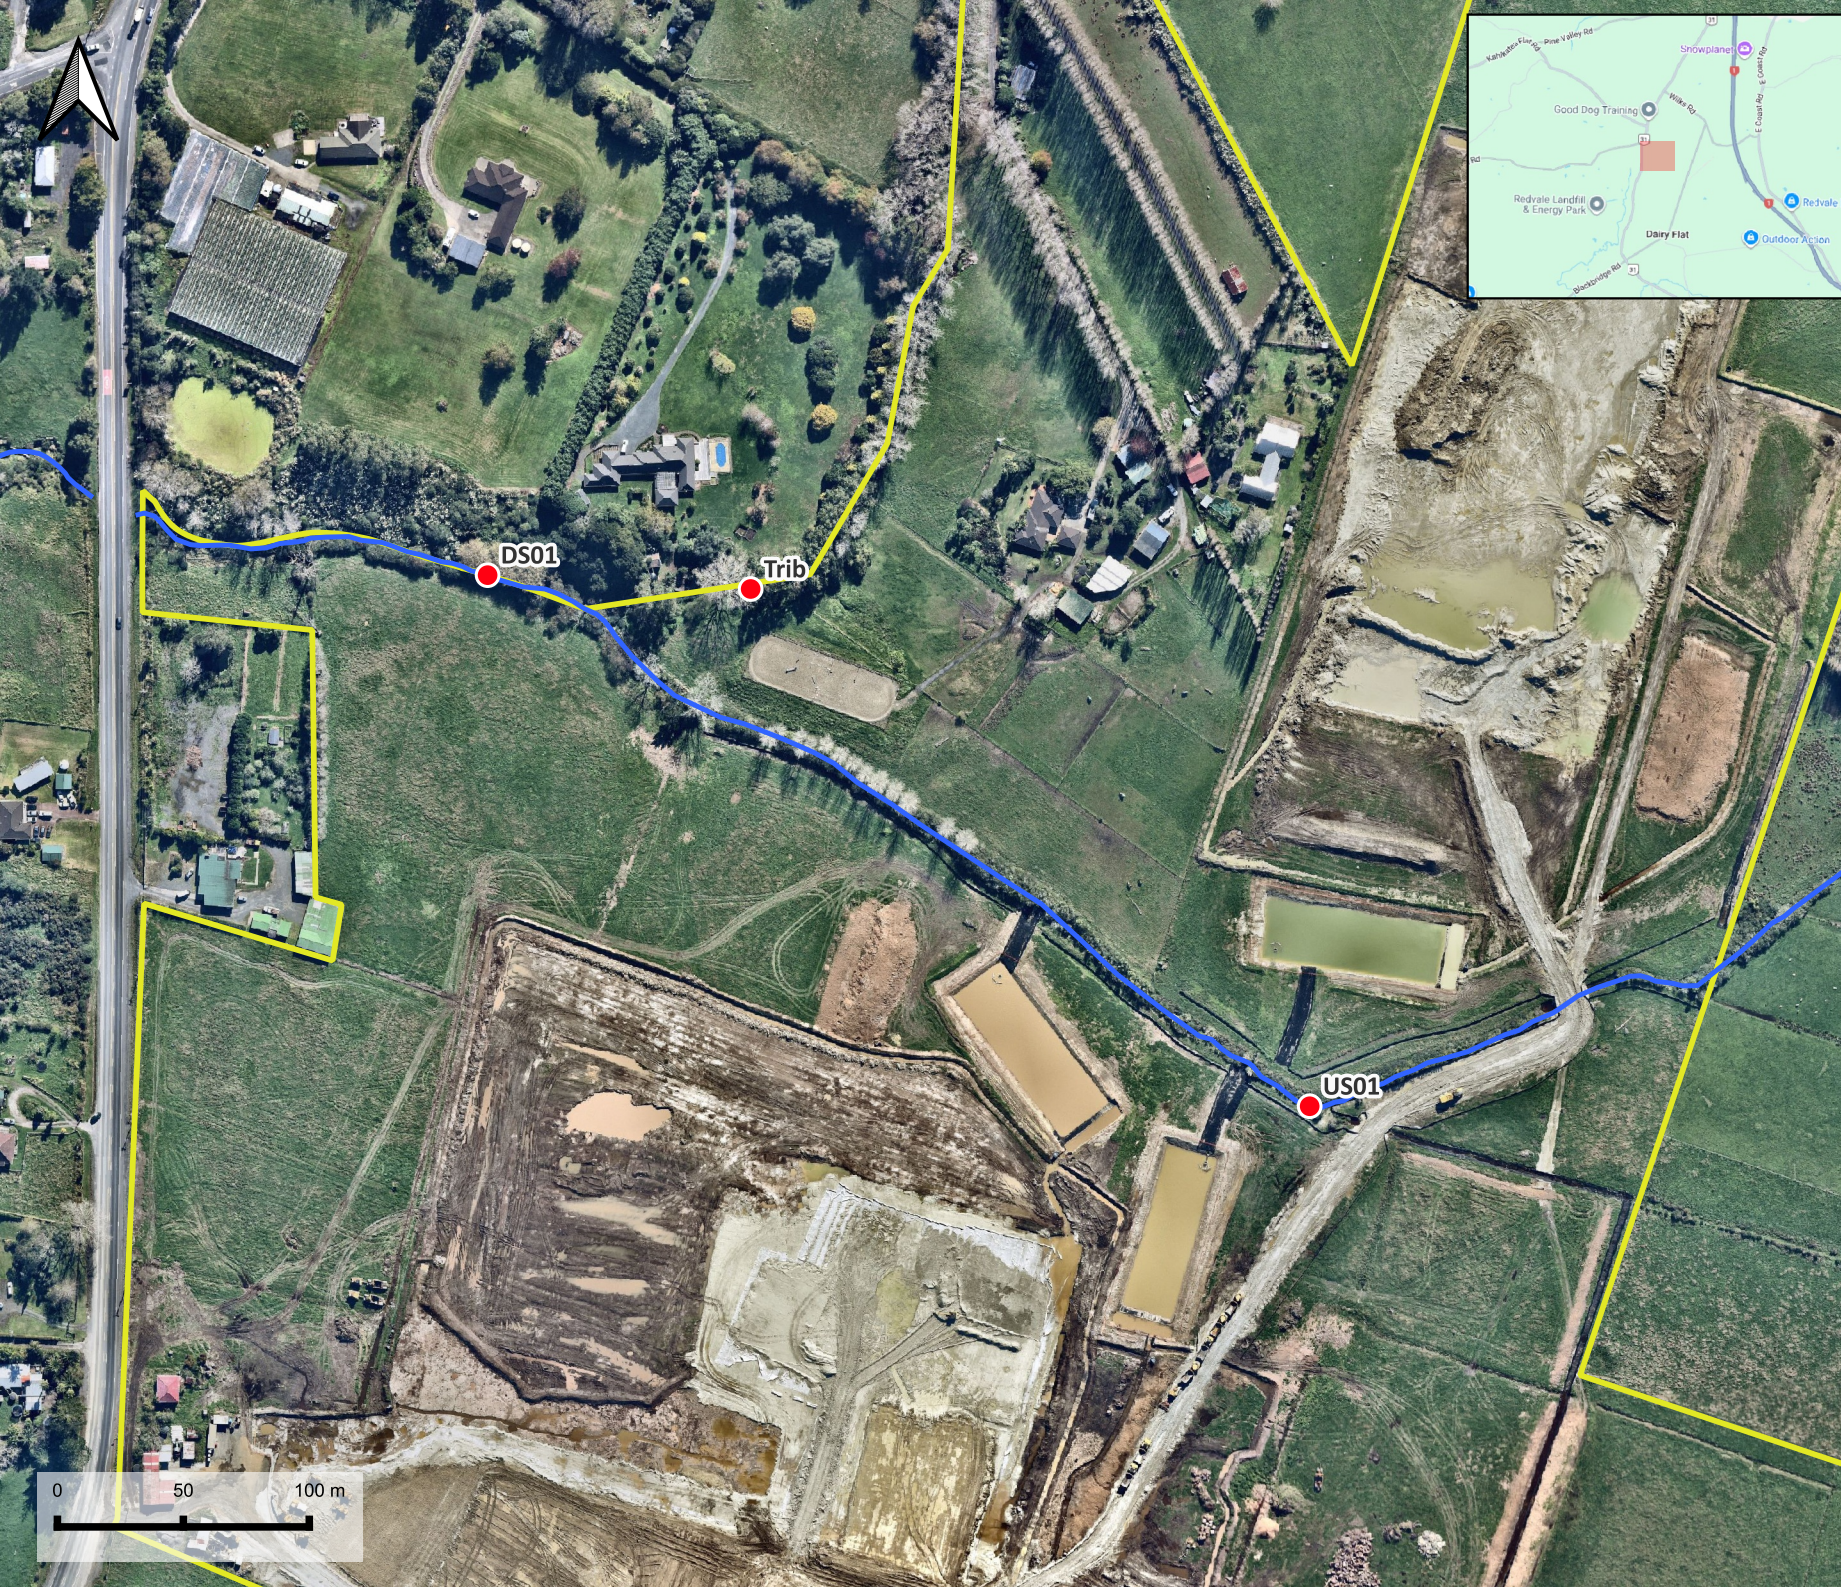
**Figure 1. Site overview and monitoring sites.**

To evaluate the baseline condition of the main environmental receptor for the discharge, Viridis undertook a survey of the unnamed tributary of the Rangitōpuni Stream on 17 September 2025. Three representative sites were selected for in-stream habitat assessment, water quality monitoring and invertebrate sampling. These sites are described in Table 1 and presented in Figure 1. The monitoring sites were chosen based on the proposed location of the WWTP infiltration bed (Figure 1).

| Site | Type | Description |
|---|---|---|
| US01 | Control | Situated within the main tributary branch, approximately 400 m upstream of its confluence with the main stem. |
| Trib | Control | Located on the tributary's northern branch, approximately 50 m upstream of its confluence with the main stem. |
| DS01 | Impact | Situated approx. 50 m downstream of the stream's confluence with the northern branch. |

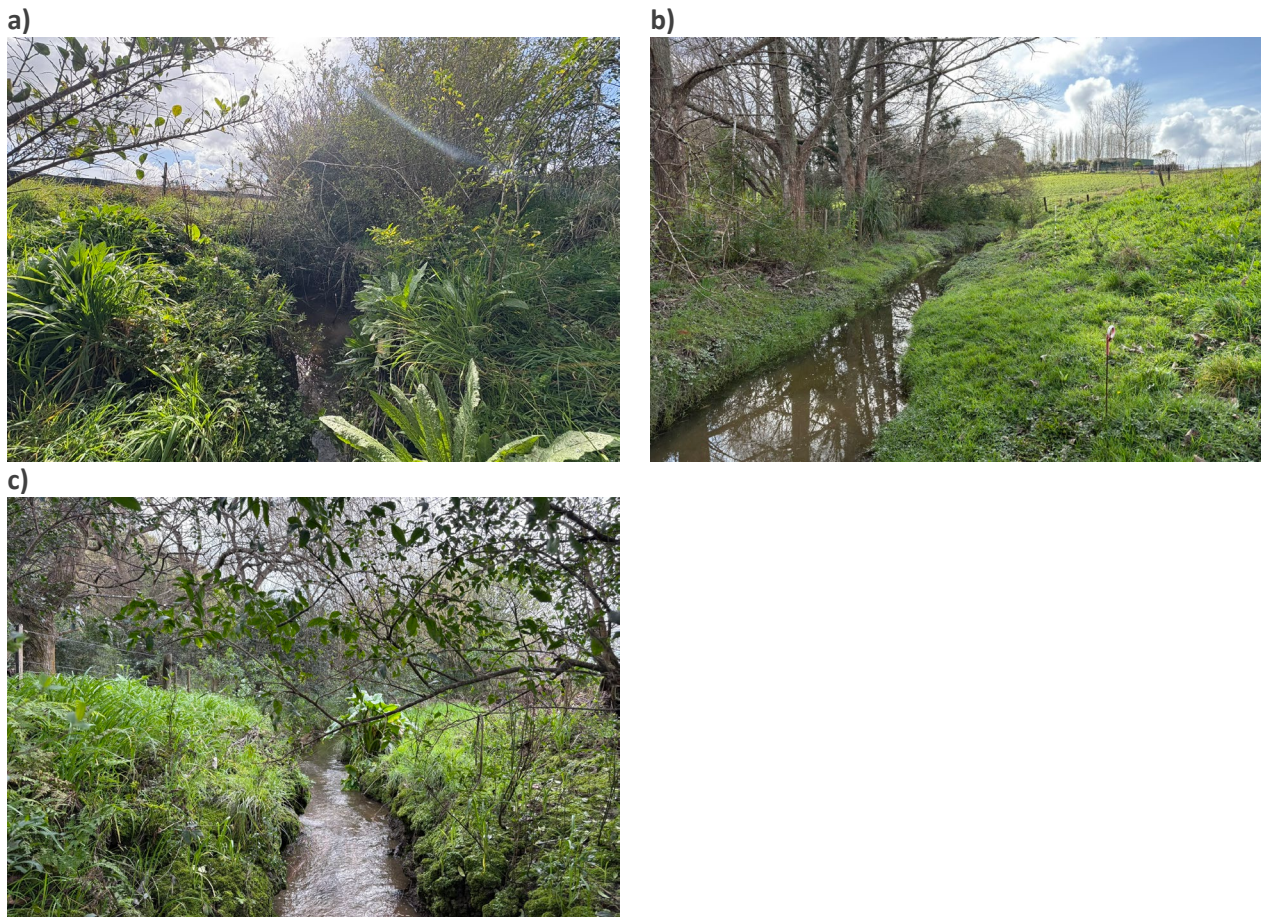
**Figure 2. The unnamed tributary, facing upstream from the bottom of the survey reach at sites a) US01 b) Trib and c) DS01.**

As described in Viridis (2025), the tributary exhibits clear evidence of extensive historical modification, including channel deepening and straightening, likely undertaken to improve drainage associated with the site's former pastoral land use. At the time of the site visit, representative sites within the main channel were found to be soft-bottomed, dominated by silt-sand and clay substrate. The watercourse was relatively shallow (<0.2 m), narrow (<1 m) and slow flowing. The stream had limited hydrological heterogeneity, consisting of only run habitat, of relatively uniform depth and velocity. Riparian vegetation was limited to exotic species and shrubs, which offered moderate to high shading to some reaches (Figure 2). Macrophyte growth was present at all sites, with species such as willow weed and buttercup observed. Some periphyton growth was also observed, including occasional short brown filamentous algae at sites US01 and DS01, and long green filamentous algae in the northern branch (Trib). In general, the water at each site was murky, and evidence of sediment deposition was noted.
