Memo: Response to Geomorphic Risk Assessment Information Gap

Subject: Response to Request for Geomorphic Risk Assessment

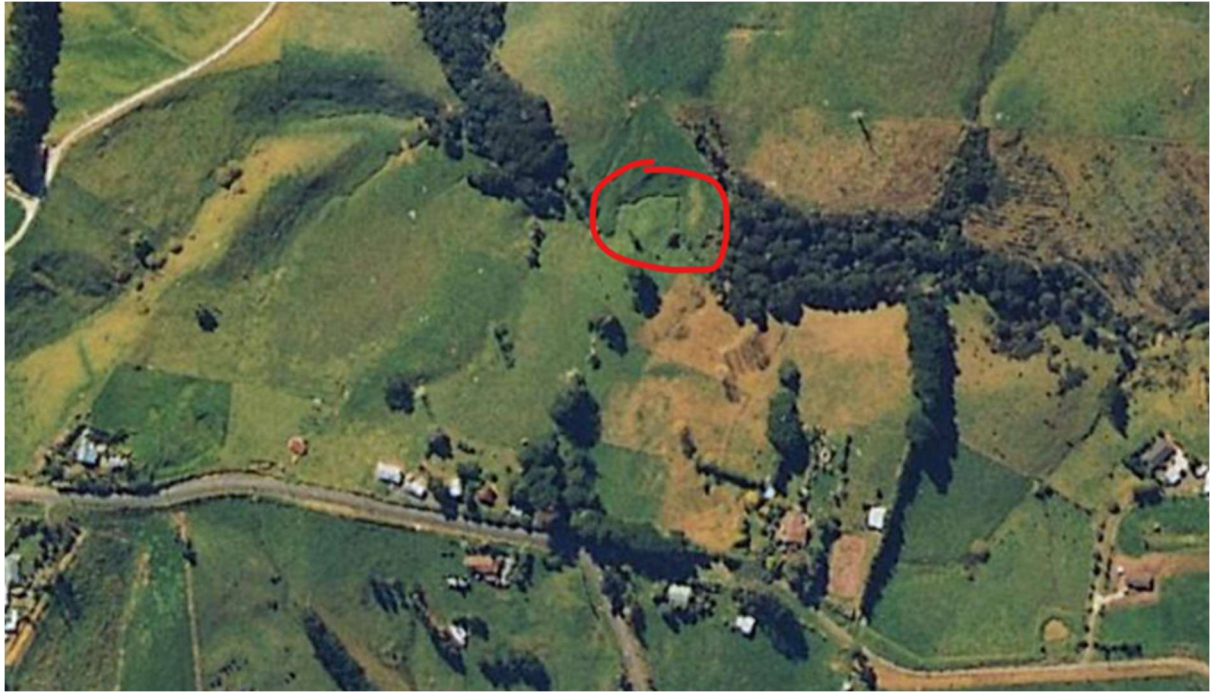
Figure 1- 1996 aerial photograph of Delmore site. Source: Auckland Council GIS

Historical aerial imagery shows no evidence of stream meandering or lateral channel migration over the last 30 years. The channels exhibit long-term stability under current hydrological regimes. Aerial data does not show signs of migration of streams. This is with the site being largely pastoral land, which is different to the proposed stream margins which will be planted with native vegetation, ie less prone to erosion than the current state. If there was risk of streams migrating, which would require an additional width of riparian zone, then you would expect to see the streams in noticeably different locations 30 years ago.

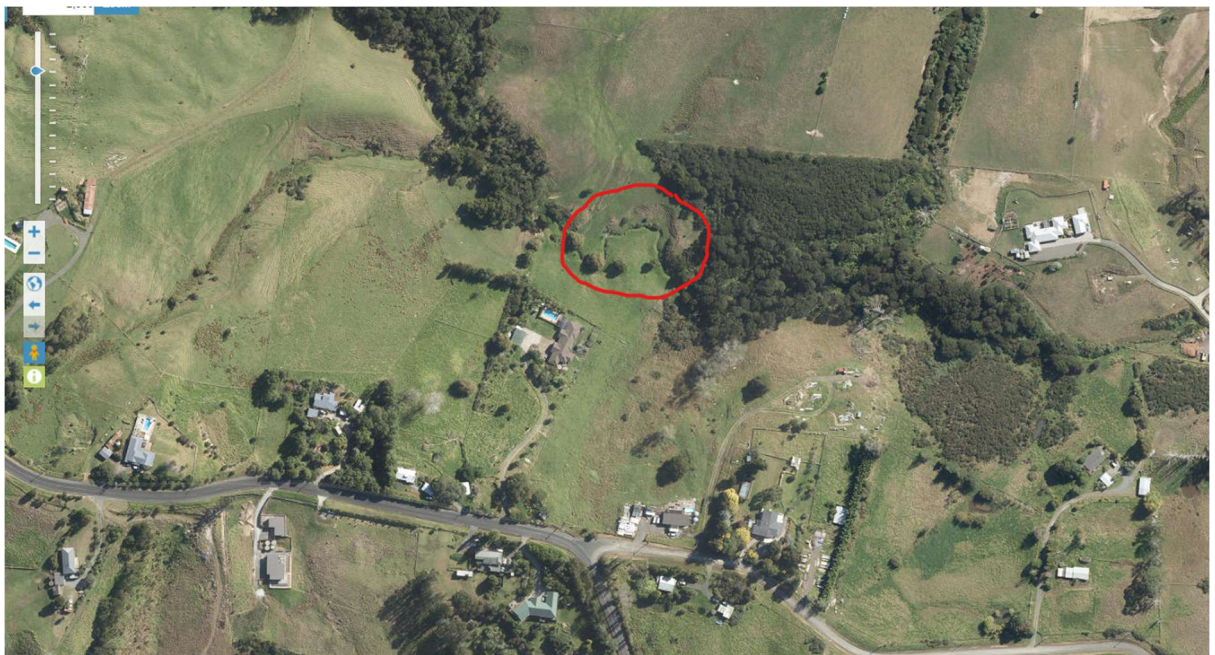
Figure 2 - 2025 image of Delmore site. Source: Auckland Council GIS

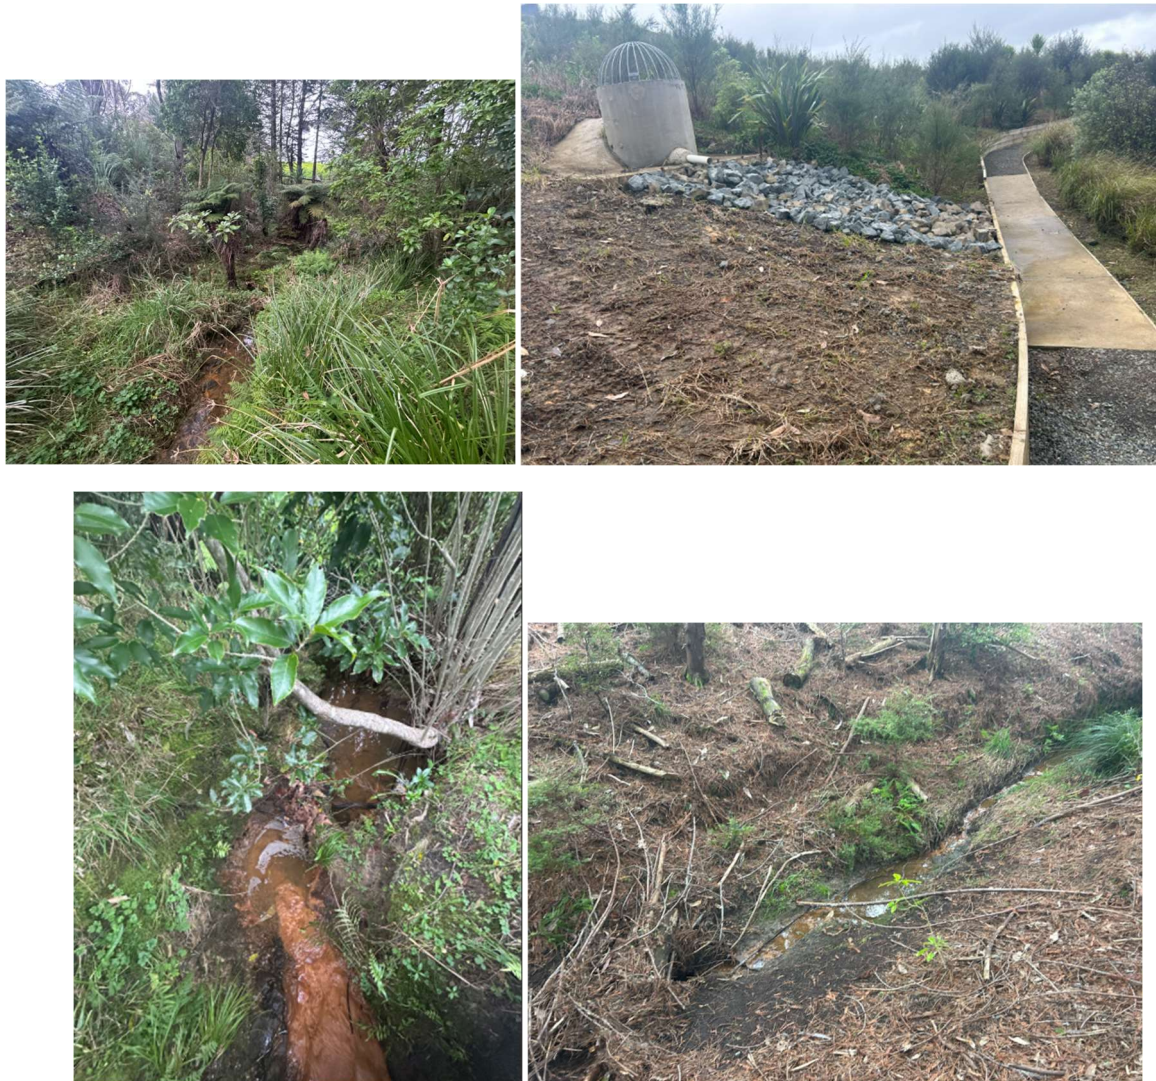
*Figure 3 - Streams in Ara Hills catchment, showing no significant signs of meandering and erosion where inspected.
Source: McKenzie & Co site visit, June 2025.*

A site visit to the Ara Hills development (undertaken June 2025), which shares similar soils, topography, and geotechnical context, found no visible evidence of stream significant erosion. This supports expectations of similar behaviour on the subject site.
