STORMWATER MANAGEMENT PLAN

Arataki Project

CDL Land New Zealand Limited

86, 108 & 122 Arataki Road, Havelock North

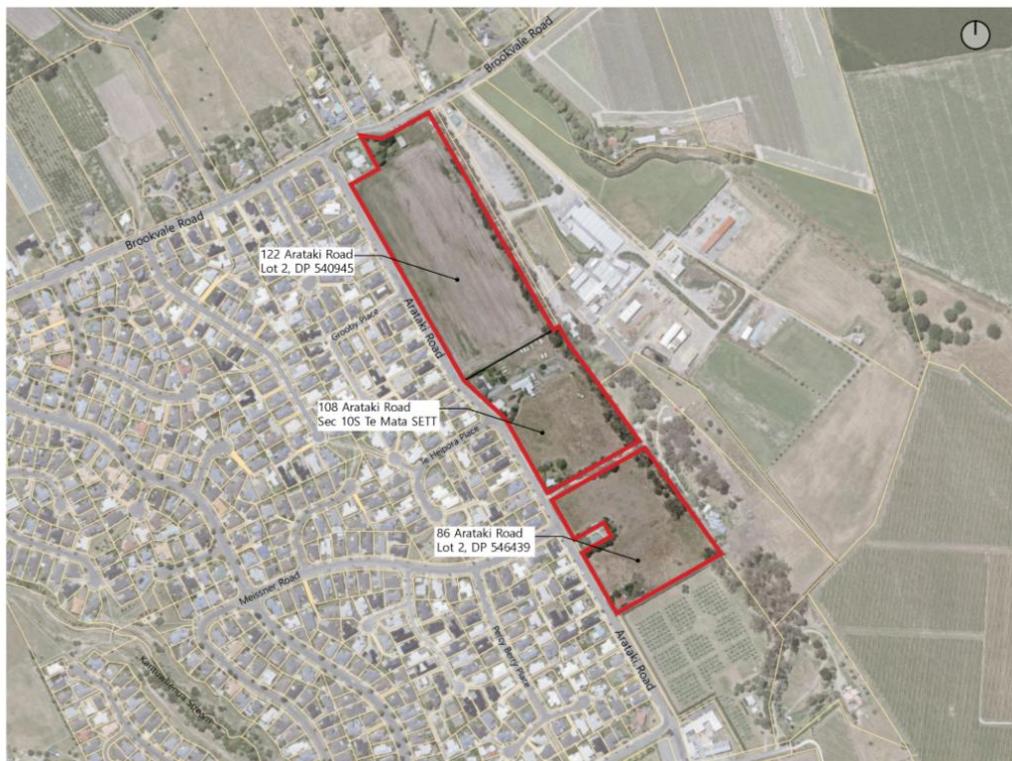
Figure 1: Existing site

The planning report prepared to support the substantive application under the FTAA provides a full site description. Sections 3.2 to 3.10 below outline site specific features relating to stormwater.

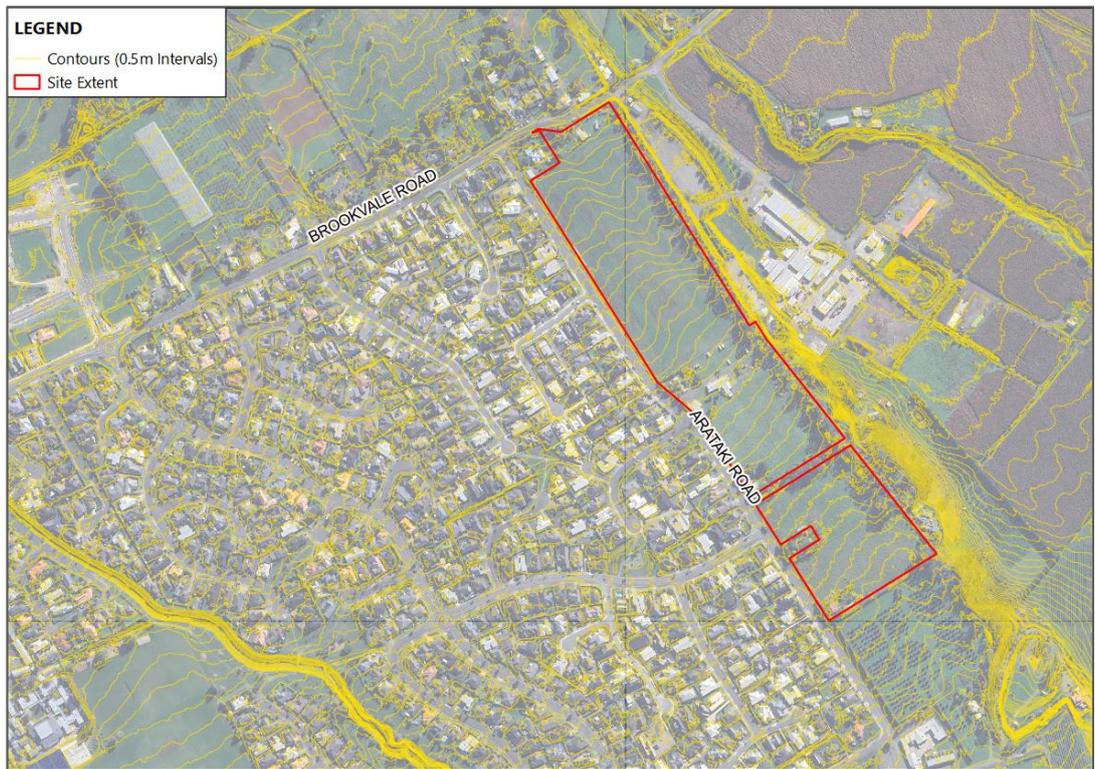
Figure 2: Existing topography

The site has a gentle crossfall from south to north (Figure 2) with contours dropping from 32mRL to 14mRL. The site is on a natural terrace and the landform is elevated above the rural property to the east by approximately 6m.

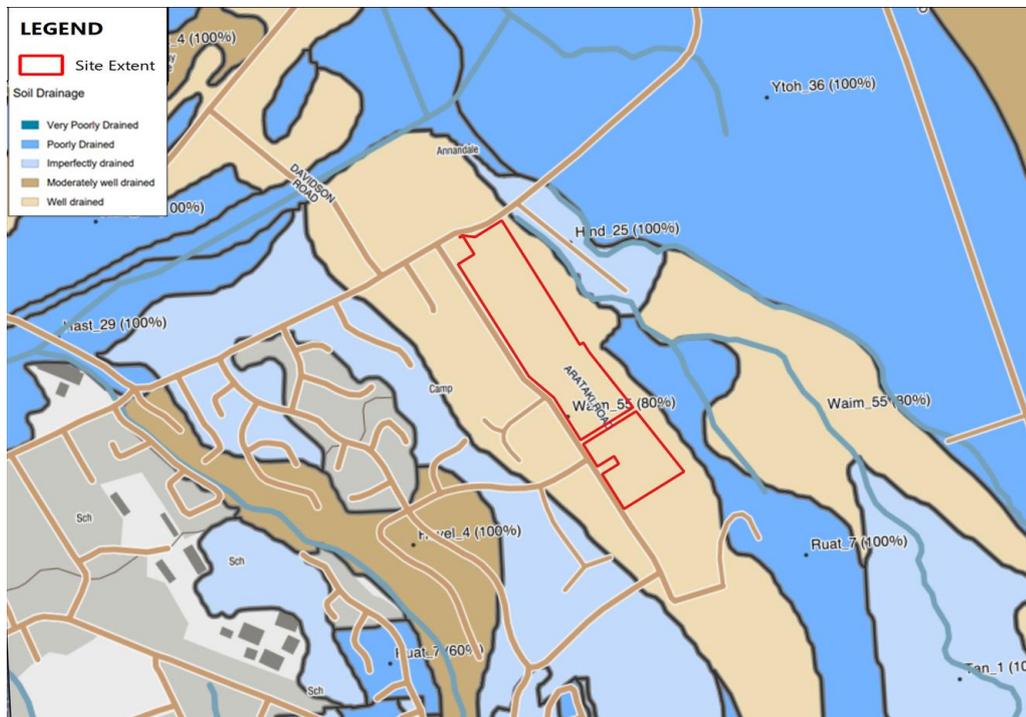
Figure 3: Soil drainage (Source: S-map)

Published drainage maps of the site obtained from the S-map indicate the site area's drainage capacity. The site is contained within well-draining soils, as shown in Figure 3.

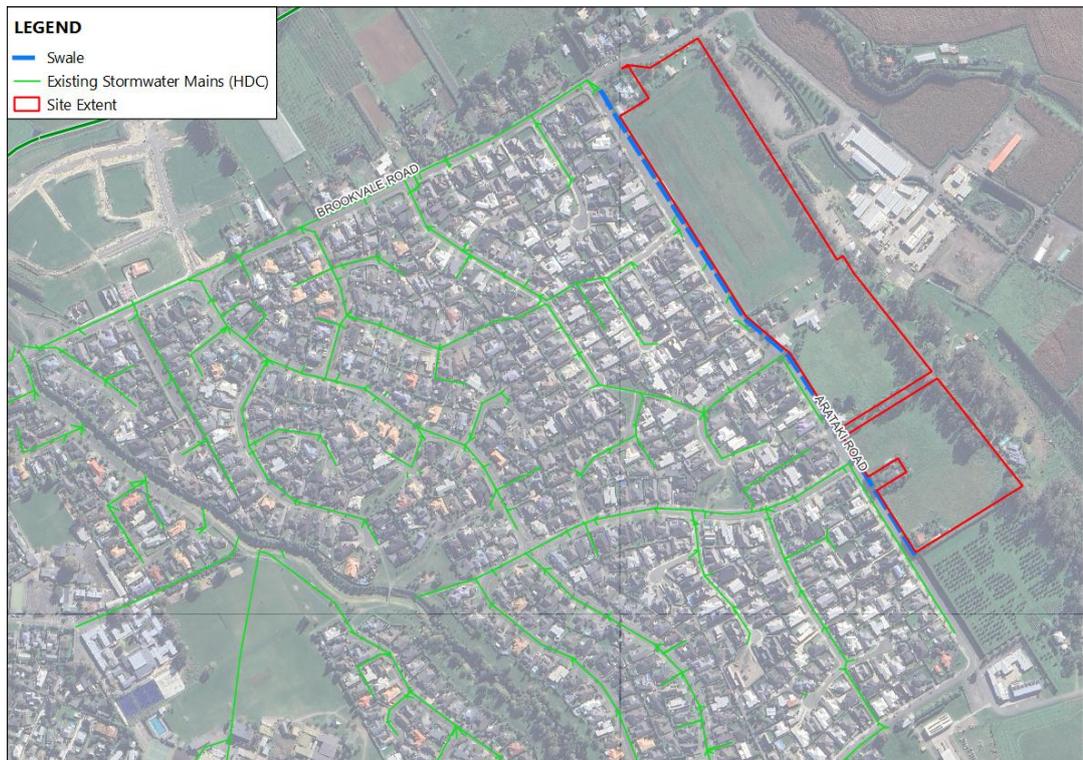
Figure 4: Existing stormwater network (Source: HDC online maps)

It is noted that the section of Arataki Road adjoining the site has been partially urbanised and a roadside swale conveys stormwater to the reticulated network at the intersection of Arataki Road and Brookvale Road. On the western urbanised side of Arataki Road is a kerb and channel. These features are shown in Figure 5.

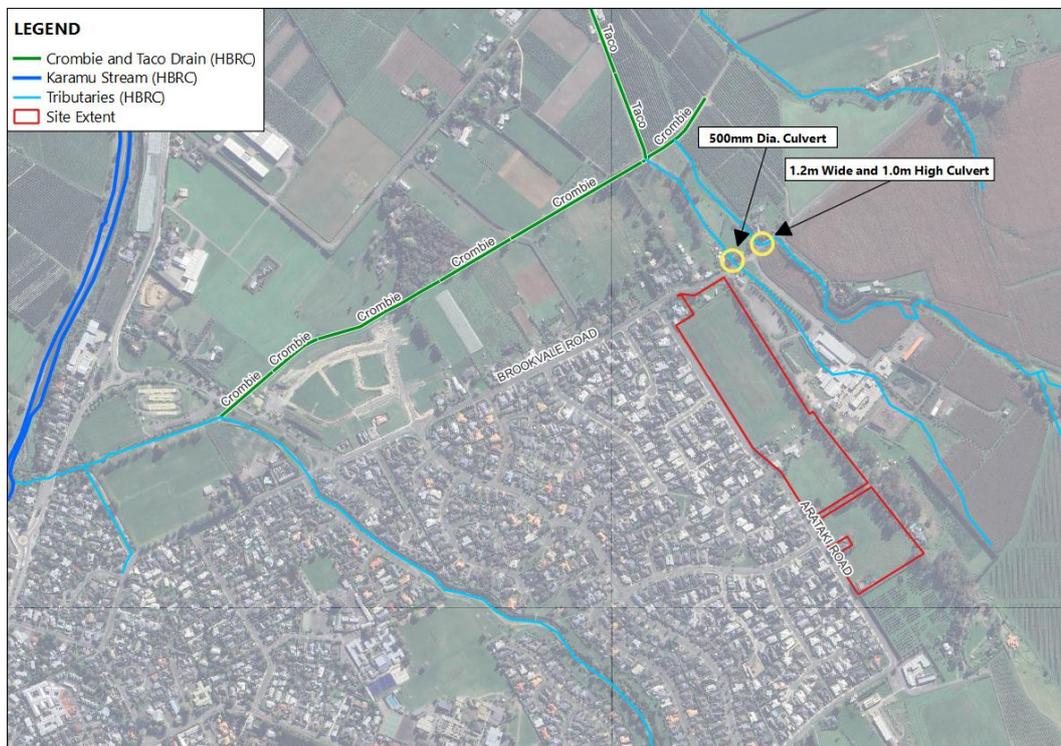
Figure 6: Site adjacent drainage

There are two watercourses to the east of the site as shown in Figure 6. They flow from south to north, crossing Brookvale Road, via two culverts, and discharge to Crombie and Taco Drains located downstream. The watercourses are mainly grassed downstream of Brookvale Road. Some bank slumping has been observed at the culvert outlet of the far eastern watercourse indicating ongoing erosion.

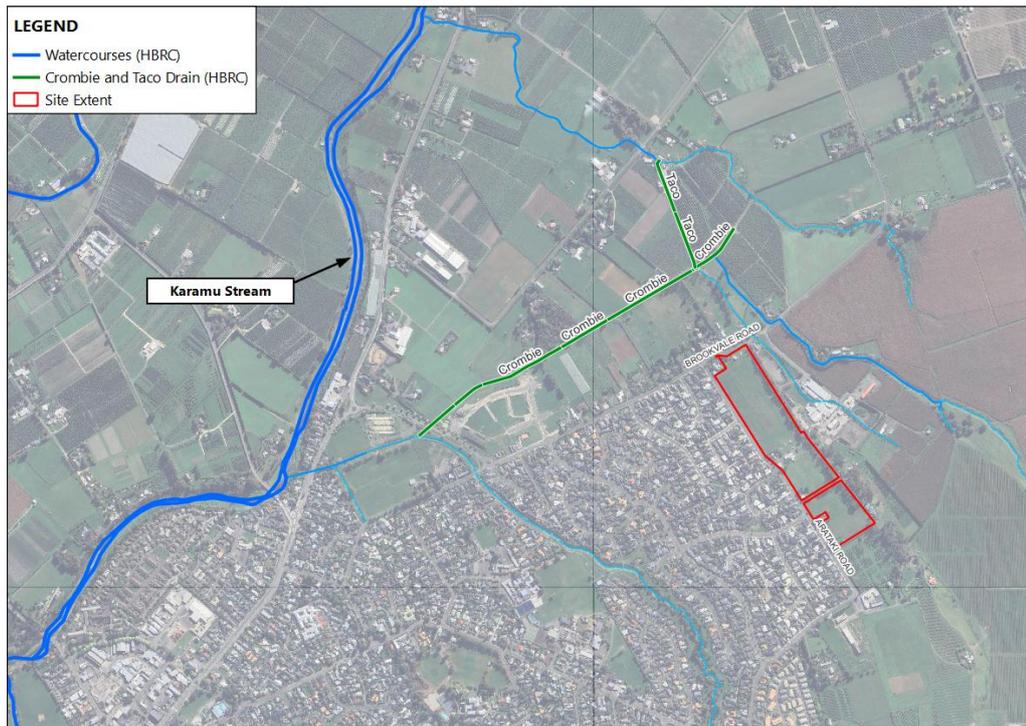
Figure 7: Catchment drainage

It is noted that both Crombie and Taco drains are part of HBRC's drainage schemes for Havelock North that ultimately discharge to the Karamu River as shown in Figure 7.

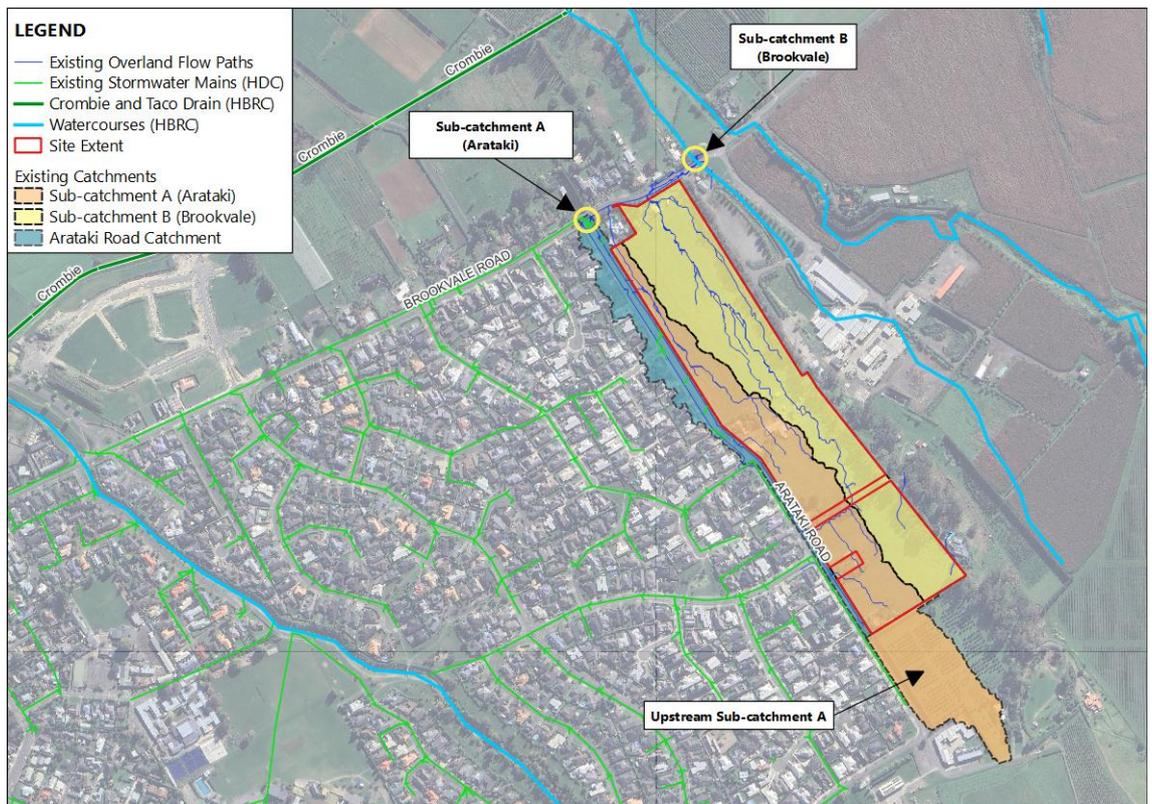
Figure 8: Existing catchments and overland flows

Figure 8 indicates the extents of the catchments and outlines the discharge points.

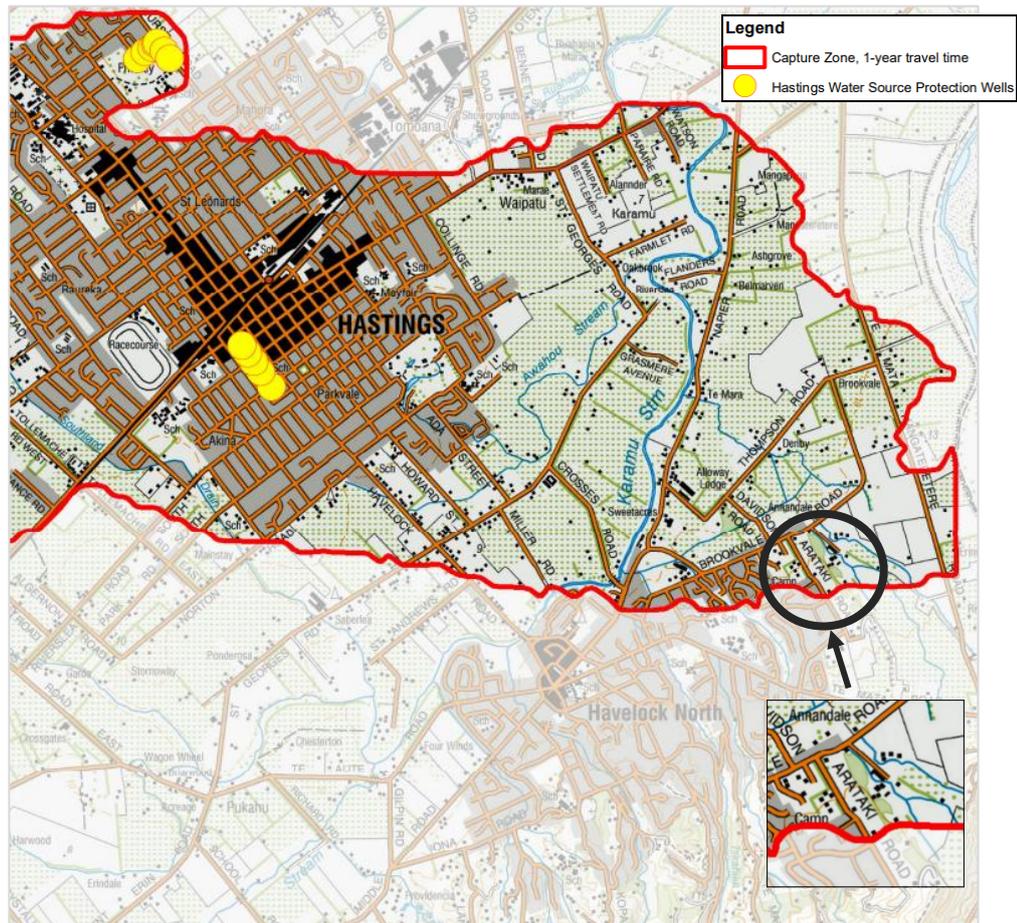
Figure 9: Source Protection Zone (Hastings District Council)

As per HBRC guidelines, for development in this zone, measures should be put in place to prevent potential contamination of drinking water sources. It is noted the northern approximately 80% of the site, north of driveway at #104 Arataki Road, falls within the Hastings Source Protection Zone identified within the TANK Plan Change.

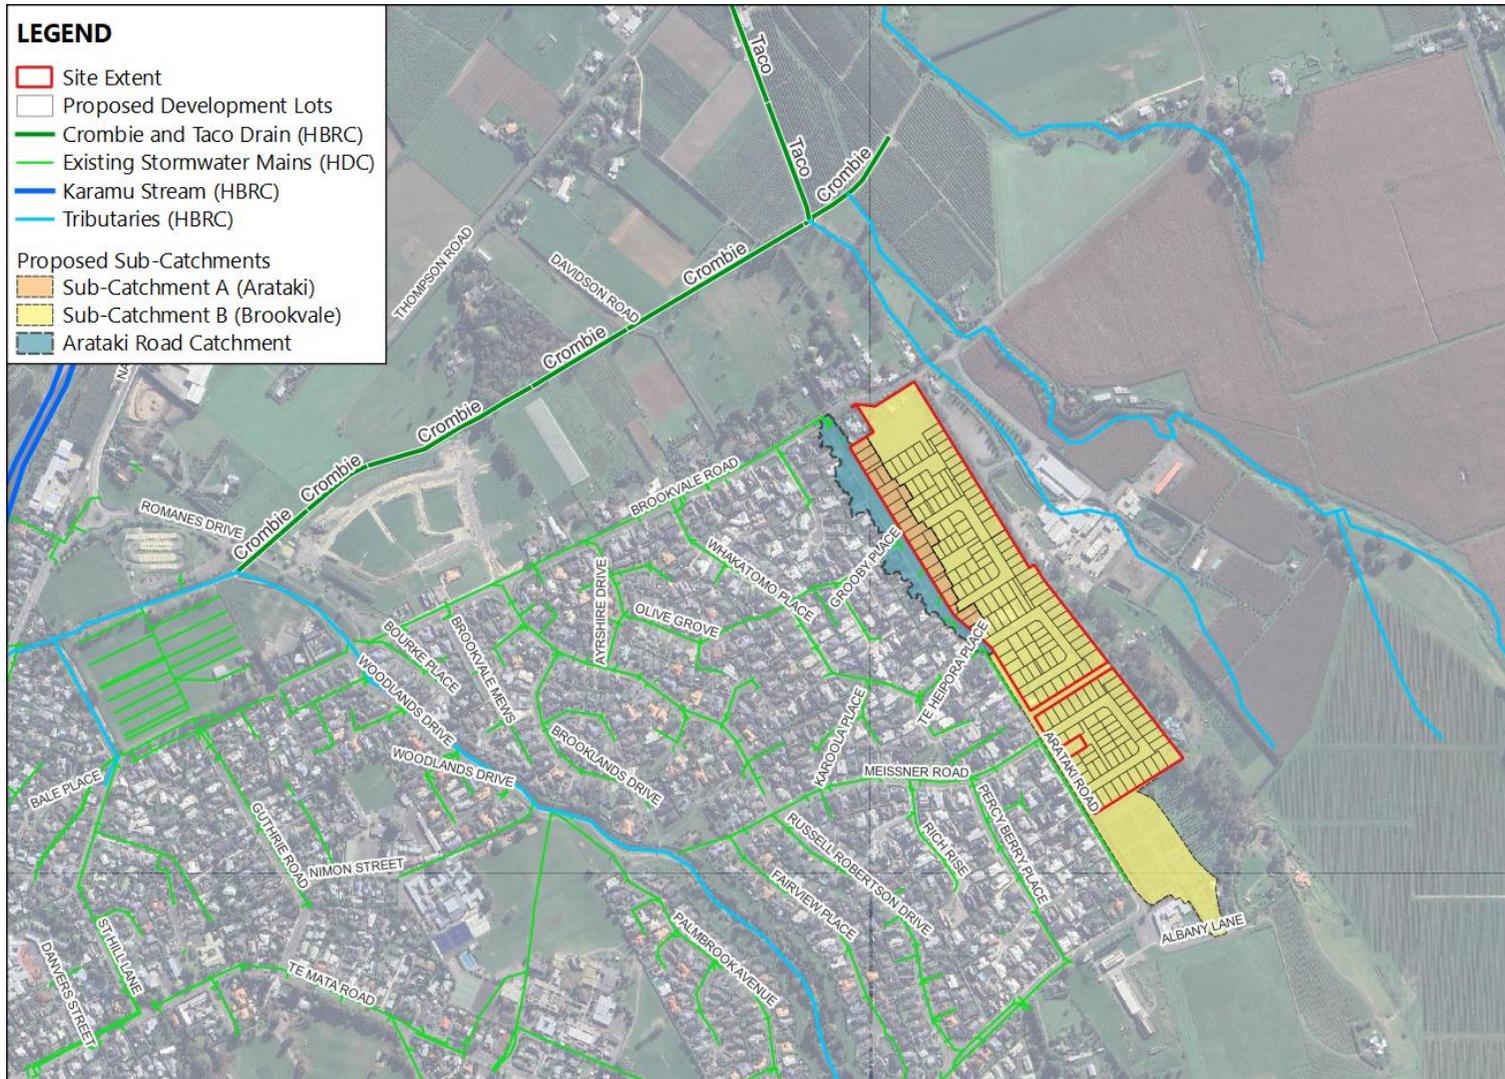
Figure 11. Proposed Stormwater Management Strategy

The revised post development boundaries are shown in Figure 11 with a summary of how these catchments will be managed shown in Figure 12. Additional details are provided in the subsequent sections of this report.

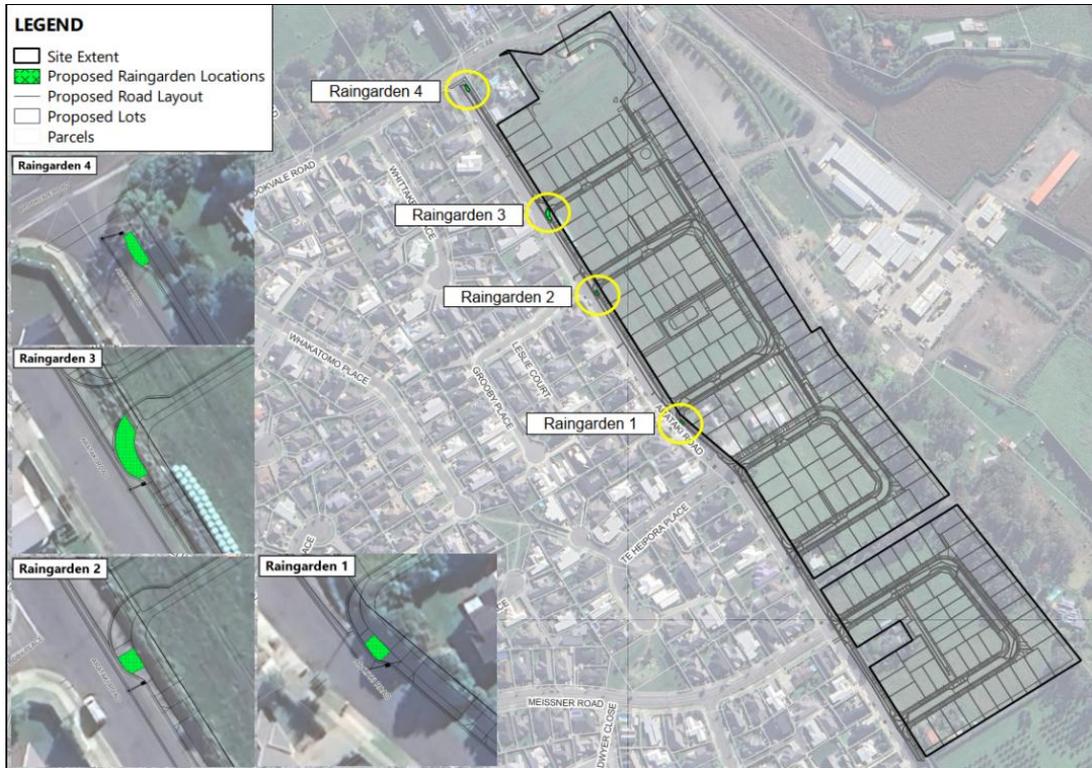
Figure 13: Indicative raingarden locations

The locations of the proposed raingardens are shown in Figure 13, with a summary of the areas provided in Table 4. The associated calculations are included in Appendix B for reference.

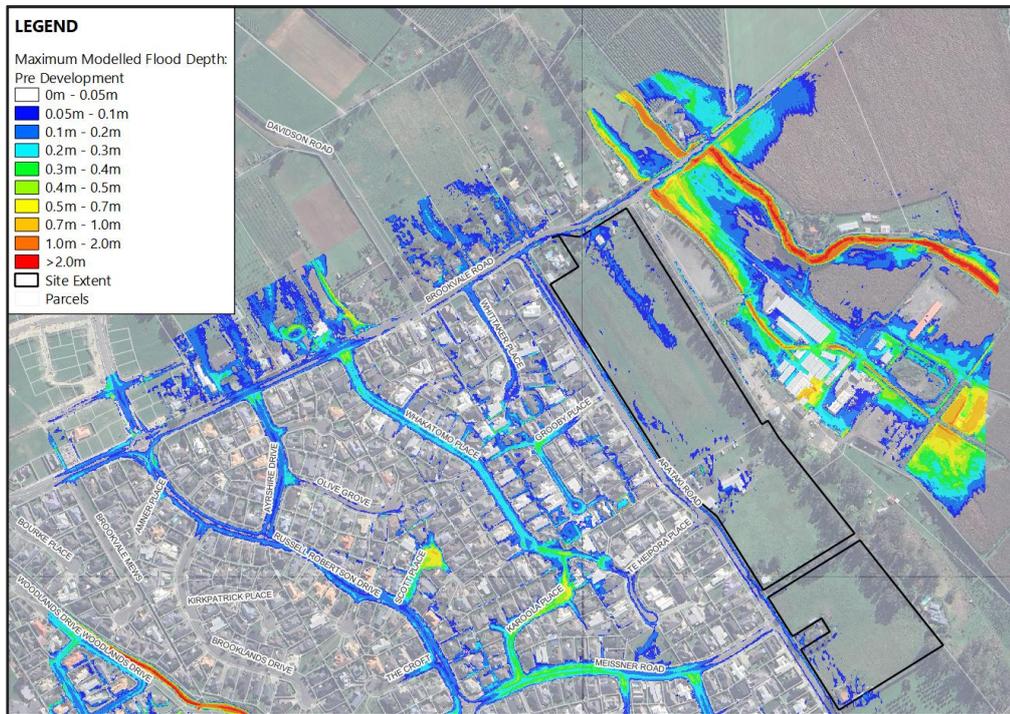
Figure 14: Pre-development flood extent – 100-year + RCP 6.0

The pre-development and post-development flood model results for the 100-year results are shown in Figure 14 and Figure 15.

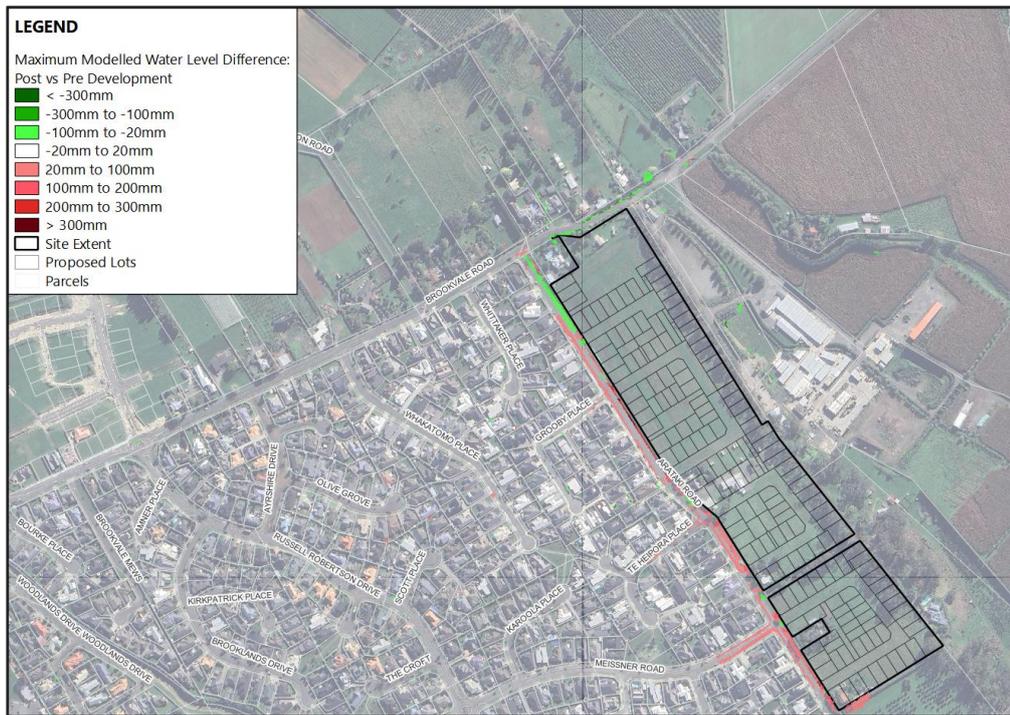
Figure 16: Water level difference plot - 100-year + RCP 6.0

The resulting 100-year water level difference plot is shown in Figure 16.

The flood modelling predicts increases in flood levels along Arataki Road, Meissner Road and Te Heipora Place as shown in Figure 16. The increase in flood level observed in the model are less than 25mm and are deemed negligible and considered less than minor as the overland flows are generally contained within the road reserves and designed conveyance paths.

No third-party effects have been observed as a result of the development. No adverse effects on third-party properties or assets have been identified as a result of the proposed development. The stormwater design ensures that the level of service for surrounding properties is maintained and that any additional overland flow is appropriately managed within public infrastructure.

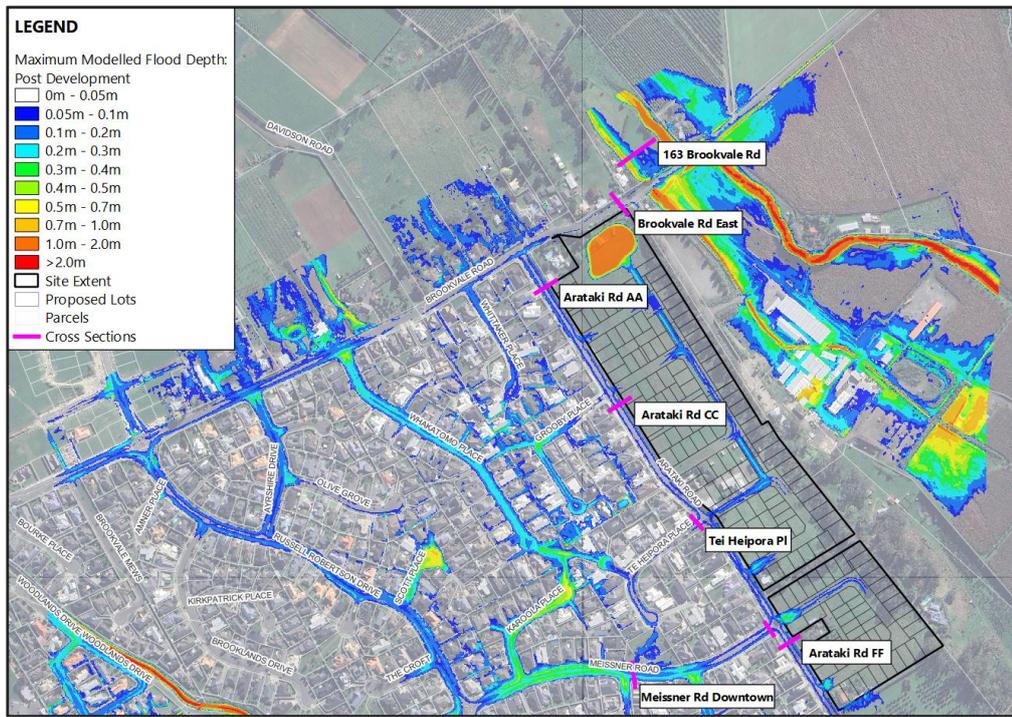
Figure 17: Locations of cross sections

The complete set of model results is included in Appendix C; however, a selected range of cross sections along Arataki Road and the adjoining roads (Meissner Rd and Te Heipora Pl) is included in Figure 18, Figure 20 and Figure 20.

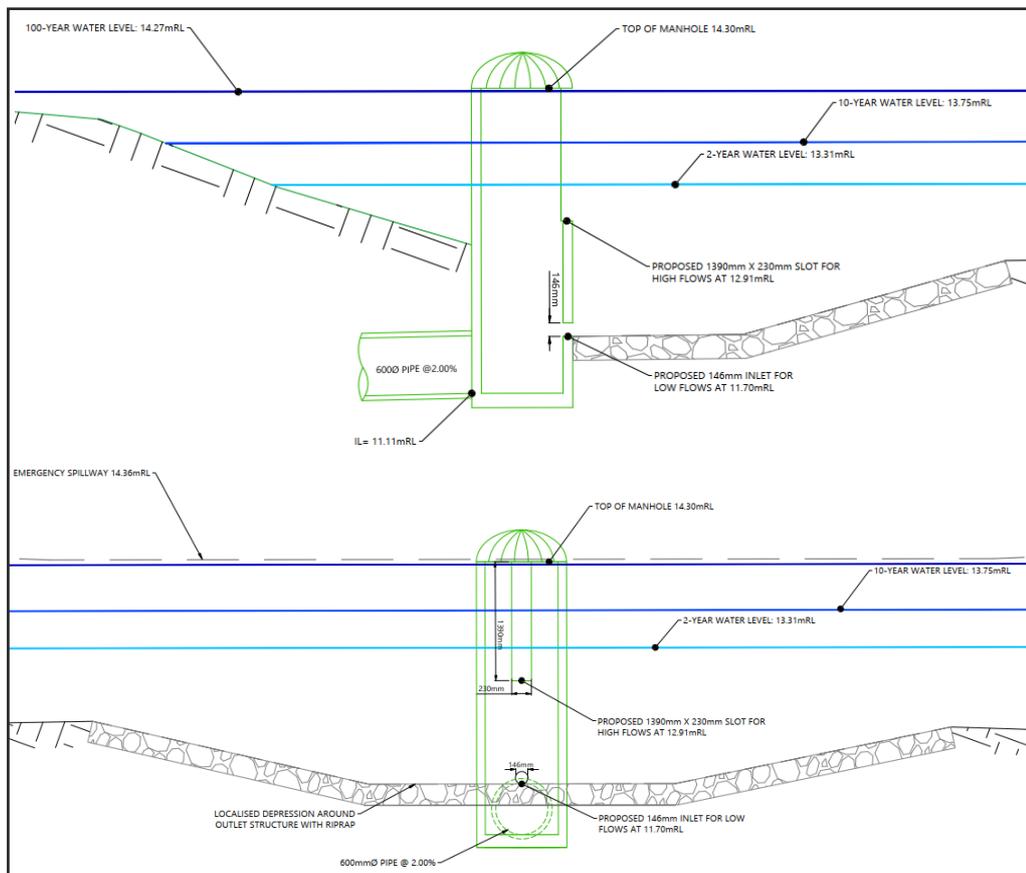
Figure 21: Discharge control design summary

Item	Dry Basin
Basin Invert Level	11.7mRL
EDV Orifice Diameter	146mm
Orifice invert	11.7mRL
Vertical slot width	230mm
Vertical slot level	12.91mRL
Maximum rim elevation	14.36mRL
Emergency spillway width	20.0m
Emergency spillway elevation	14.36mRL
Basin embankment level	14.84mRL

As discussed earlier, the emergency spillway is not activated under normal operating conditions. The design memo included in Appendix C discusses an assessment that has been undertaken where the primary outlet is completely blocked in the 100-year event. The assessment concludes that in this scenario, the 20m spillway will discharge flows out of the basin. It is designed as a precautionary safety feature with the likelihood of the basin embankment failing to be extremely low. Even in the very rare event that the spillway is activated, it has been engineered to safely convey flows in a controlled manner, without creating flooding or risk to downstream properties. Given the high level of design safety and minimal residual risk, a further assessment for Probable Maximum Flood (PMF) (extremely rare storm events) is not required.

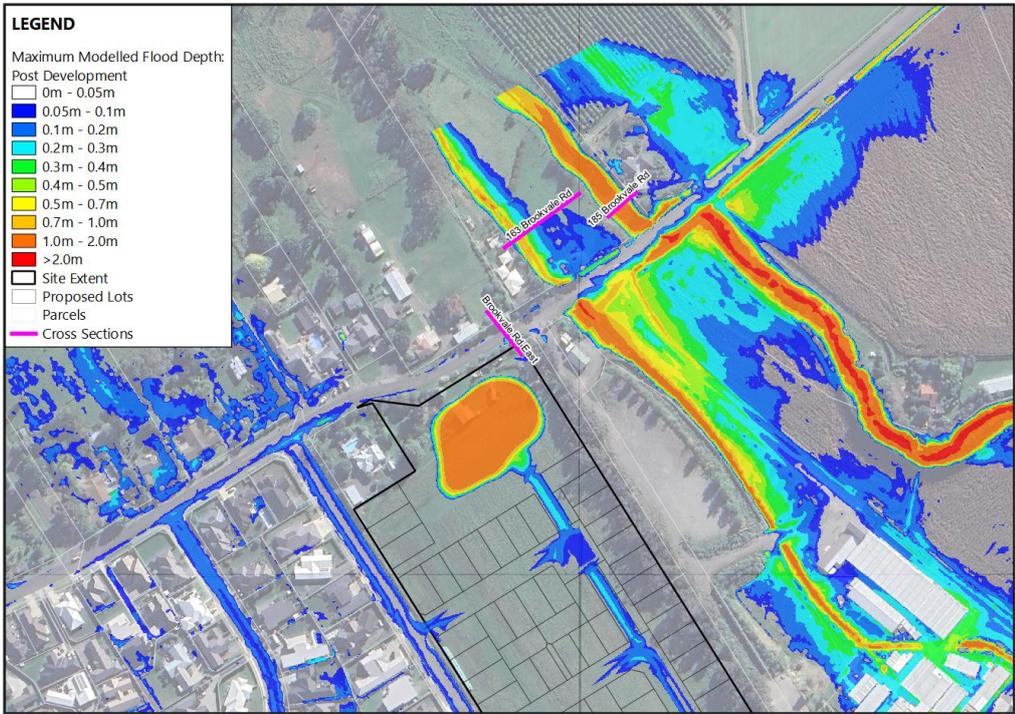
Figure 24: Cross sections along Brookvale Road and streams

Cross sections taken from the model are shown in Figure 24 with the locations of the cross sections shown in Figure 26.

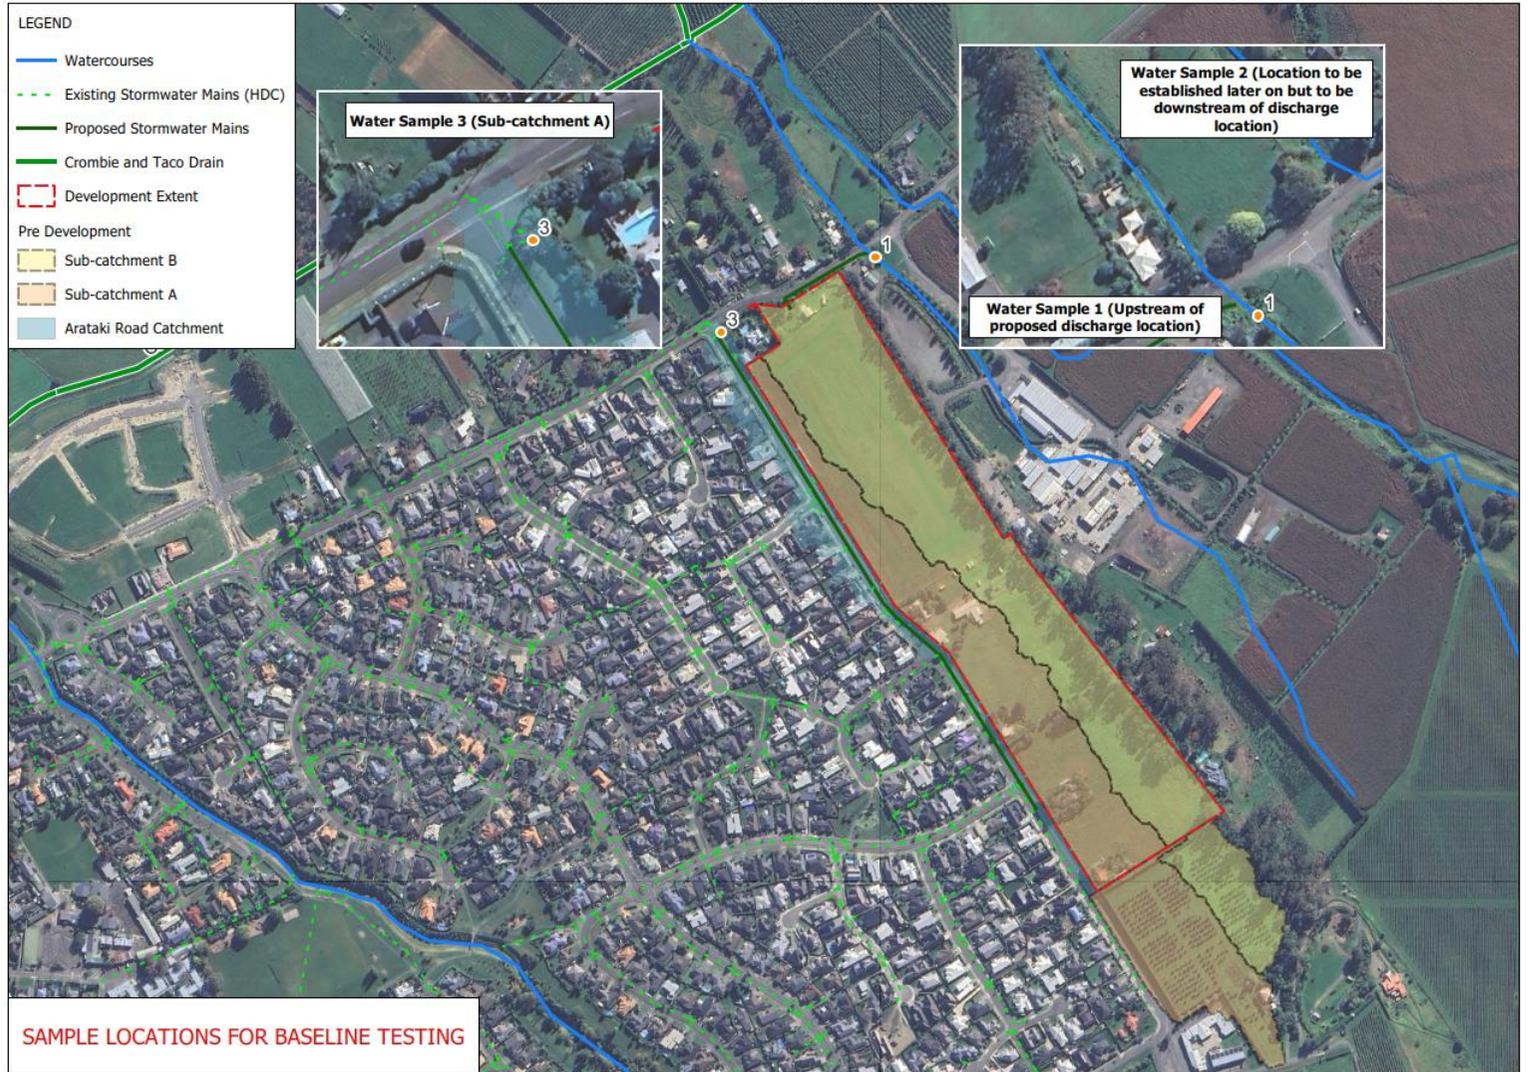
The water quality sampling location plan can be found in Figure 27. Water Quality Sampling Locations below.

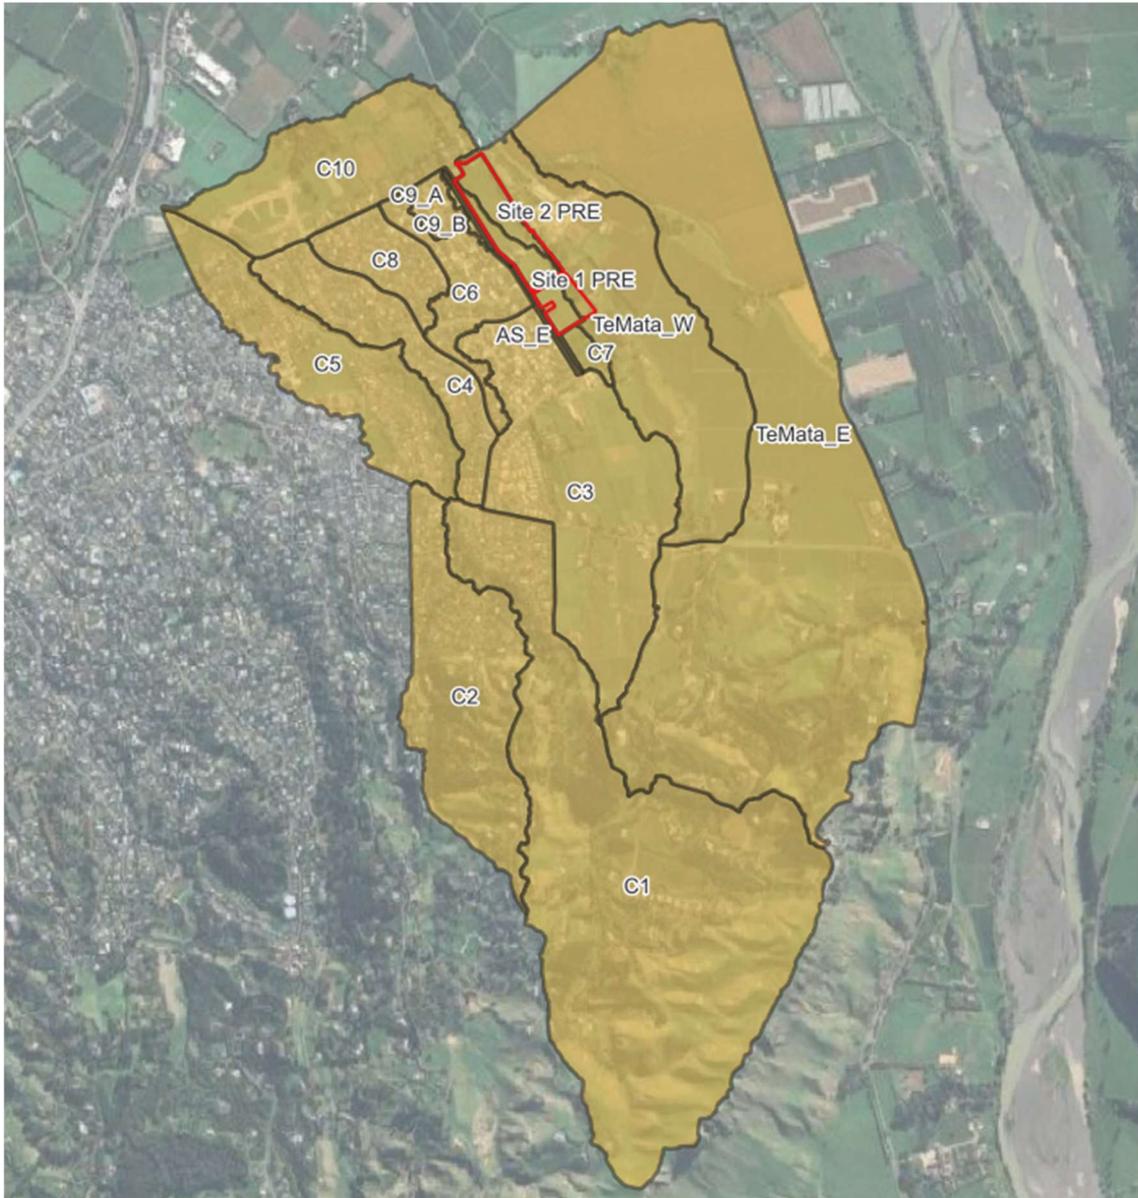
Figure 2: Catchment Extent

Using a digital terrain model (DEM) from LINZ and applying QGIS and SAGA tools, a catchment analysis was undertaken to determine the sizes of the subcatchments around the development and the flows they generate in the pre and post development scenarios. In the predevelopment scenario the site survey was merged with the DEM while for the post the proposed design surface was used. The catchment analysis extent is shown on Figure 2.

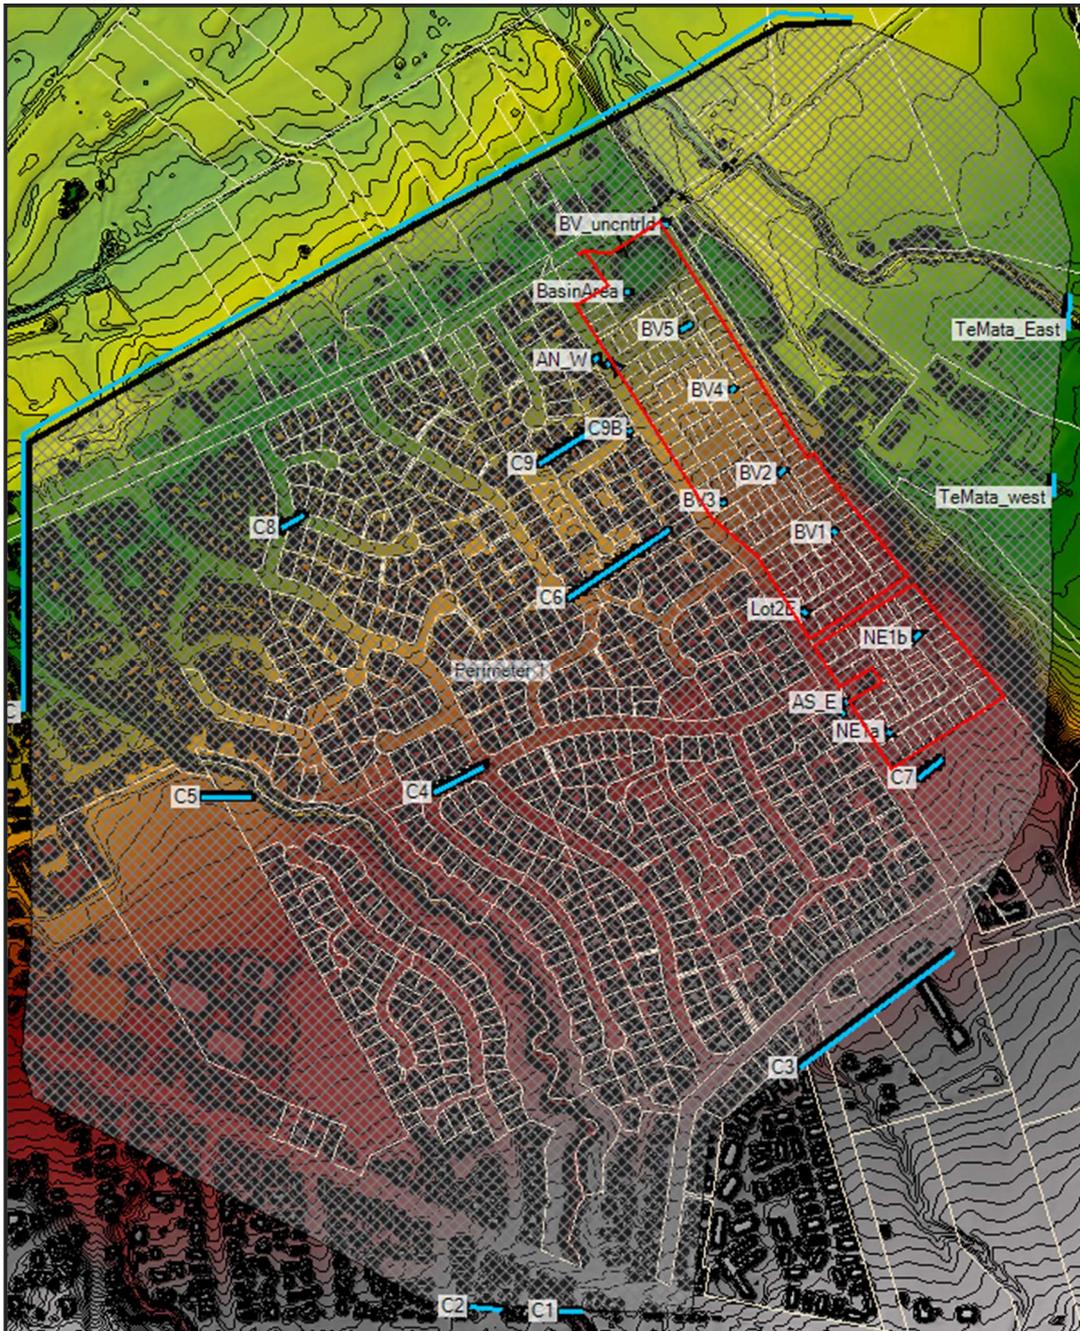
Figure 3. Model Extents (shows post development internal catchment)

Hydrographs generated from the HEC-HMS model for the 100-year ARI event were used as inflows for the various subcatchments in the study area. A downstream boundary was set as a normal depth.

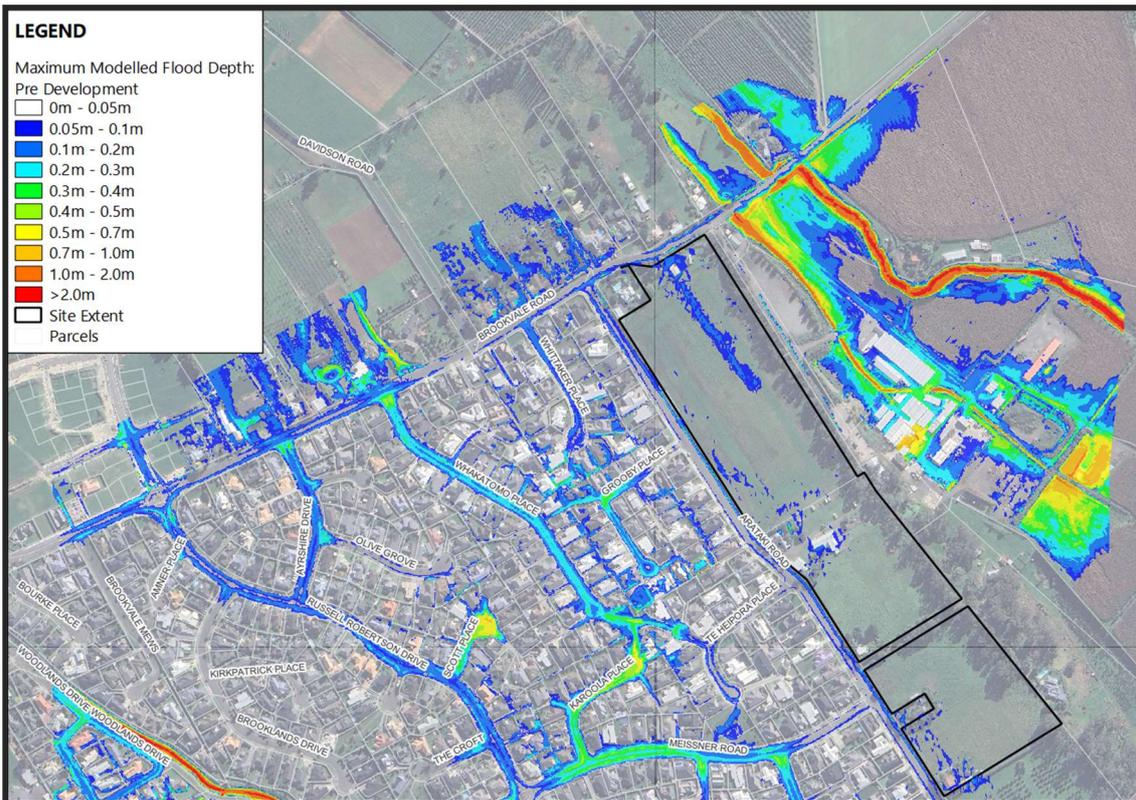
Figure 4: Predevelopment flood extent

The model was run for a 24-hour period at computational intervals of 1s and output at the 10-minute interval using shallow water equations. Modelling results indicate that overland flows will be contained within the road corridors. Figure 4 and Figure 5 indicate the flooding extents in the predevelopment and post development scenarios (also in Attachment 1). Runoff generated onsite flows to both Arataki Road and Brookvale Road in the predevelopment scenario. In the post development, given the changes in the landform (including the incorporation of the basin) the runoff will continue to flow to both Arataki Road and Brookvale Road however to varying quantities and with differing effects. This is discussed in detail in the next section.

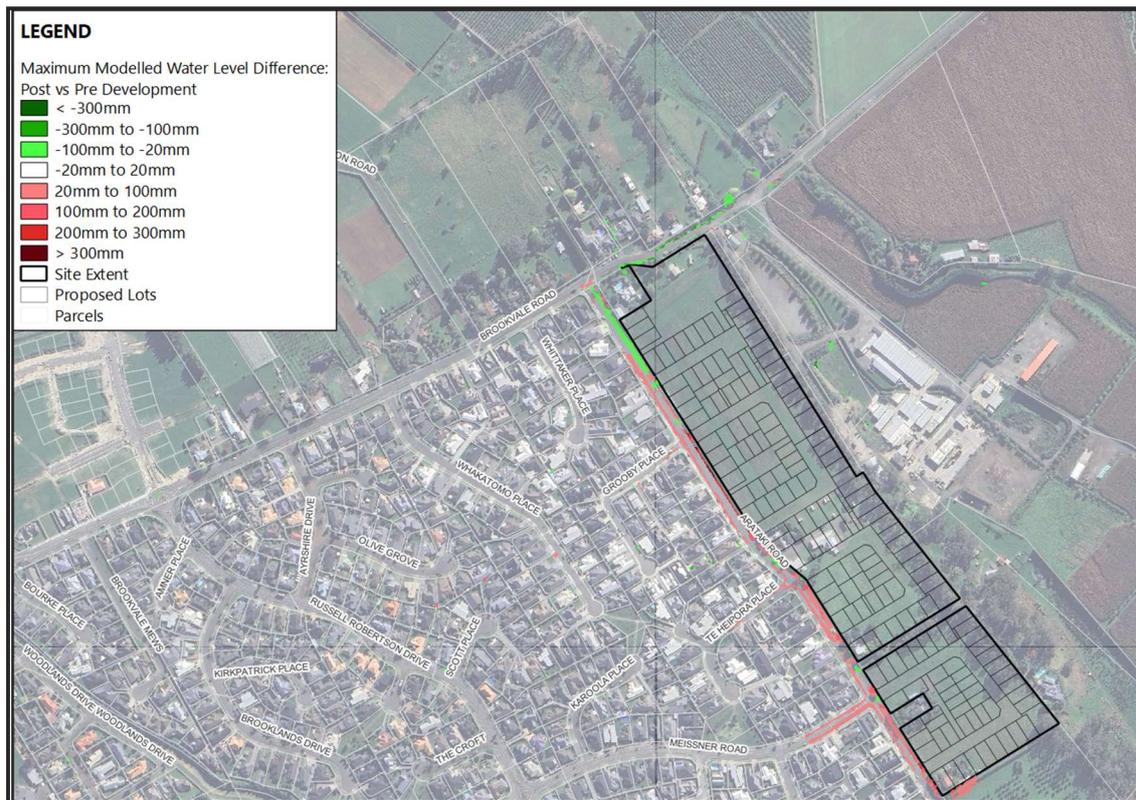
Figure 6: Water level difference (pre vs post)

The integrated stormwater management approach adopted in this design combines landform modifications, engineered upgrades to the Arataki Road corridor, and the incorporation of a hydraulically engineered dry basin. Collectively, these measures provide a robust and effective framework for managing post-development runoff. The design ensures that flow rates and volumes are appropriately attenuated and controlled prior to discharge, thereby mitigating potential adverse effects on the receiving catchment. This approach aligns with best practice stormwater management principles and is considered sufficient to maintain the hydraulic neutrality of the site within the wider catchment.

The results (mapping and cross section extracts) indicate that between the pre- and post-development scenarios, there will be a minor increase in flood depths along Arataki Road as well as Te Heipora Place and Meissner Road. The removal of the roadside swale did not affect the conveyance capacity of the road noting that a portion of the predevelopment catchment was diverted to Subcatchment B. No adverse effects were observed to third-party properties west of Arataki Road.

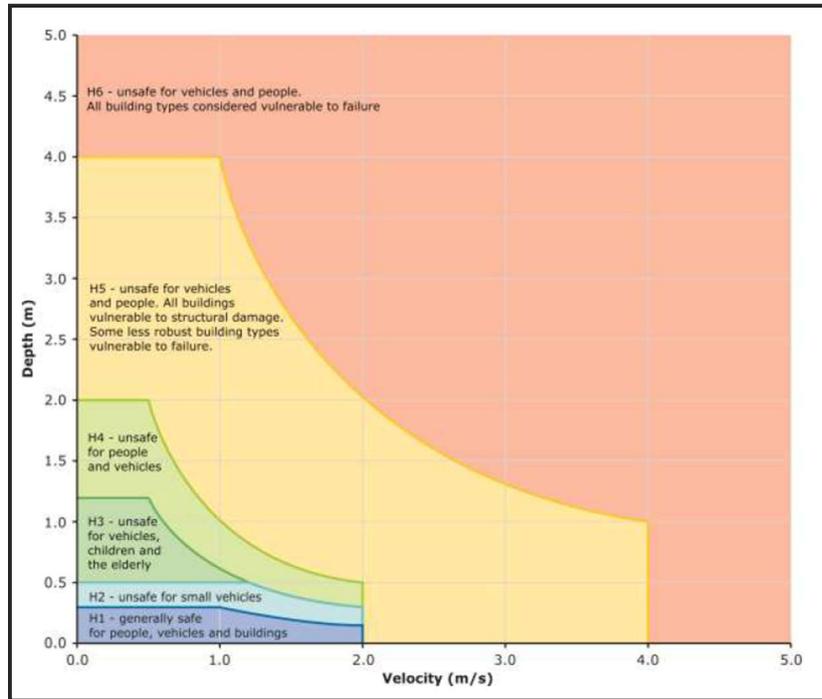
Figure 13: General flood hazard vulnerability curves.

- H1: Generally safe for vehicles, people and buildings
- H2: Unsafe for small vehicles.
- H3: Unsafe for vehicles, children and the elderly.
- H4: Unsafe for vehicles and people.
- H5: Unsafe for vehicles and people. All building types vulnerable to structural damage. Some less robust building types vulnerable to failure.
- H6: Unsafe for vehicles and people. All building types considered vulnerable to failure.

Figure 13 and Table 4, respectively, show the flood hazard vulnerability curves and criteria.
