STORMWATER MANAGEMENT PLAN

Arataki Project

CDL Land New Zealand Limited

86, 108 & 122 Arataki Road, Havelock North

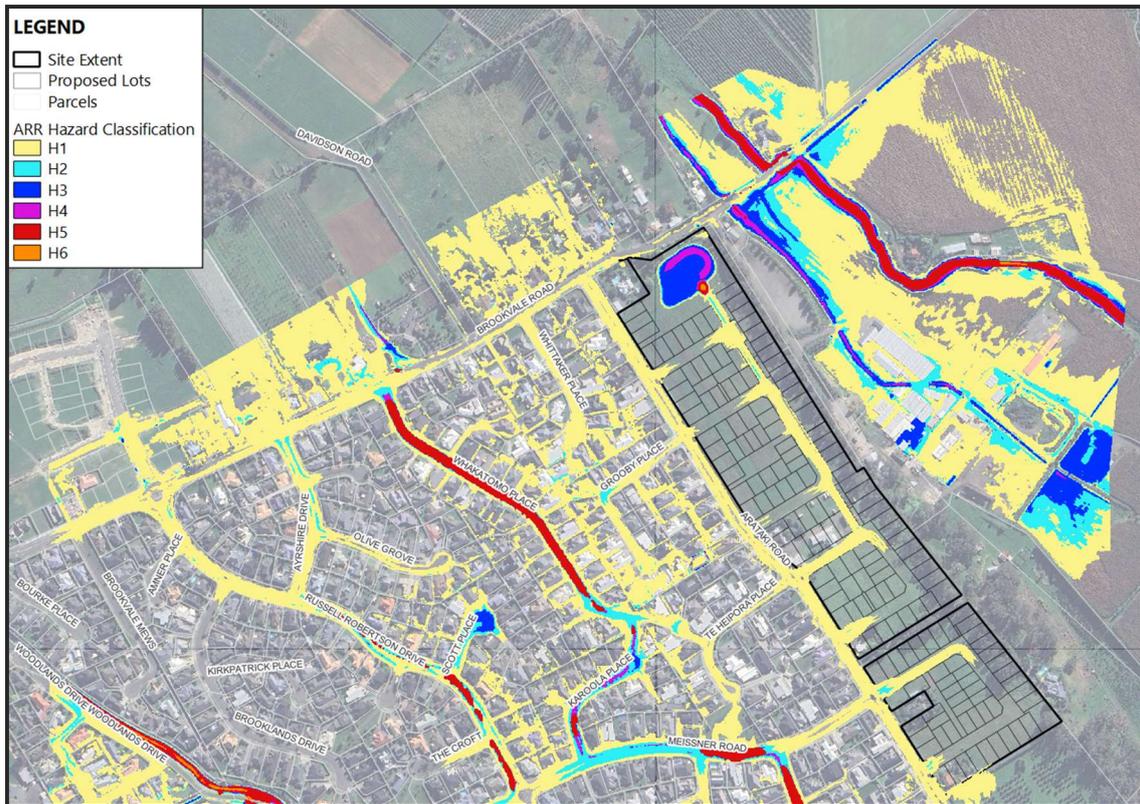
Figure 14: Modelled flood hazards

As per Figure 14 it is noted that the flood hazards on the roads within the development fall within category H1 with a very small portion of the roadway falling within H2. While category H2 indicates a mild hazard, the roads are considered trafficable during extreme events (except for small vehicles) and emergency vehicles will still have access as the hazard is isolated to a small area. The duration of this H2 threshold exceedance is approximately 10 minutes within the 24-hour design storm and does not compromise the usage of the road. The flood risk is thus considered minor. It is noted that this assessment was undertaken with the assumption that under the 100-year ARI event, the pipe network is blocked thus it can be inferred that under 50-year ARI event, the risk will be lower still.

An internal quantitative hazard assessment was undertaken using ARR guidelines to identify areas of risk within the development site. It was determined that runoff will be mainly contained within the proposed road corridors. The hazard was considered to be negligible.

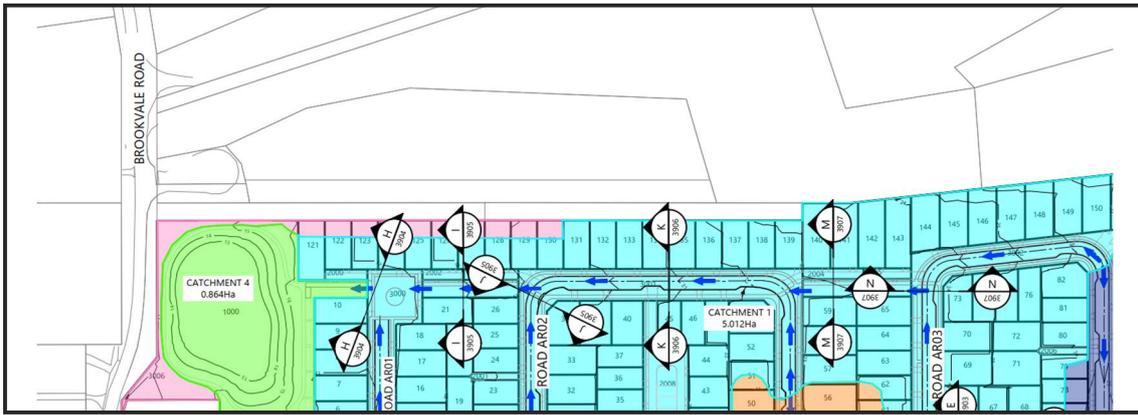
Figure 15: Select internal cross sections

In addition to the hazard assessment, some internal cross sections were extracted from the model (Figure 15 and Figure 16). These show that flow is contained within the road corridor.

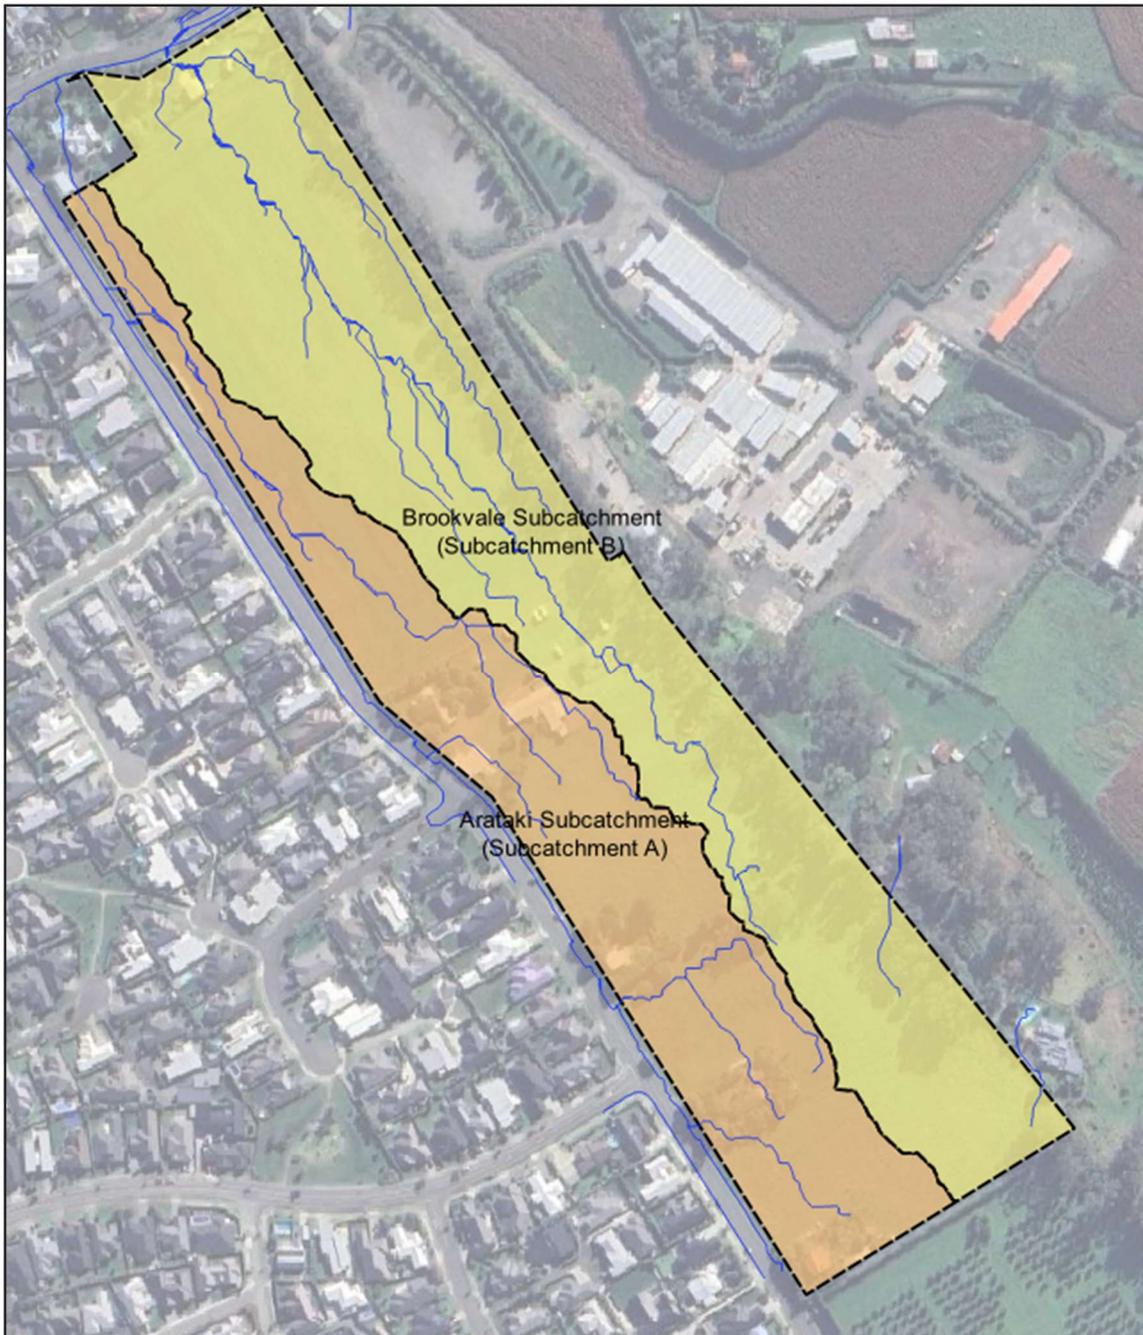
Figure 2: Sub catchment delineation for predevelopment model scenario

A catchment analysis was undertaken to determine the existing flow regime and establish allowable flows for the design of the basin. As mentioned previously, the portion of the site used to set the predevelopment levels (i.e. allowable flow rate out of the basin) has been denoted as 'Subcatchment B' as shown on Figure 2. The western side (Subcatchment A) is not utilised in the calculations.

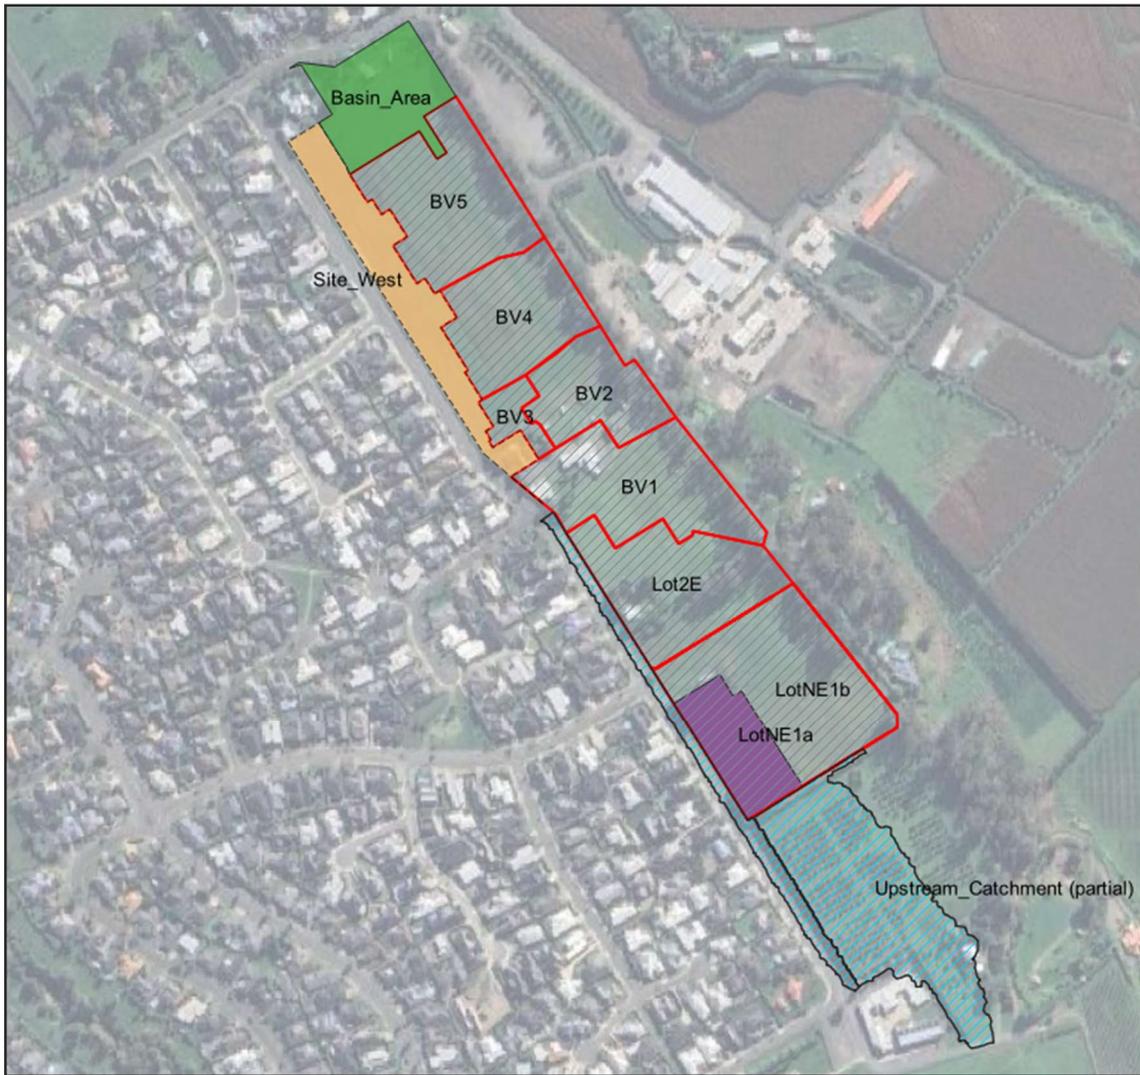
Figure 3: Subcatchment delineation for post-development model scenario

Details for these internal catchments are provided in the next section.

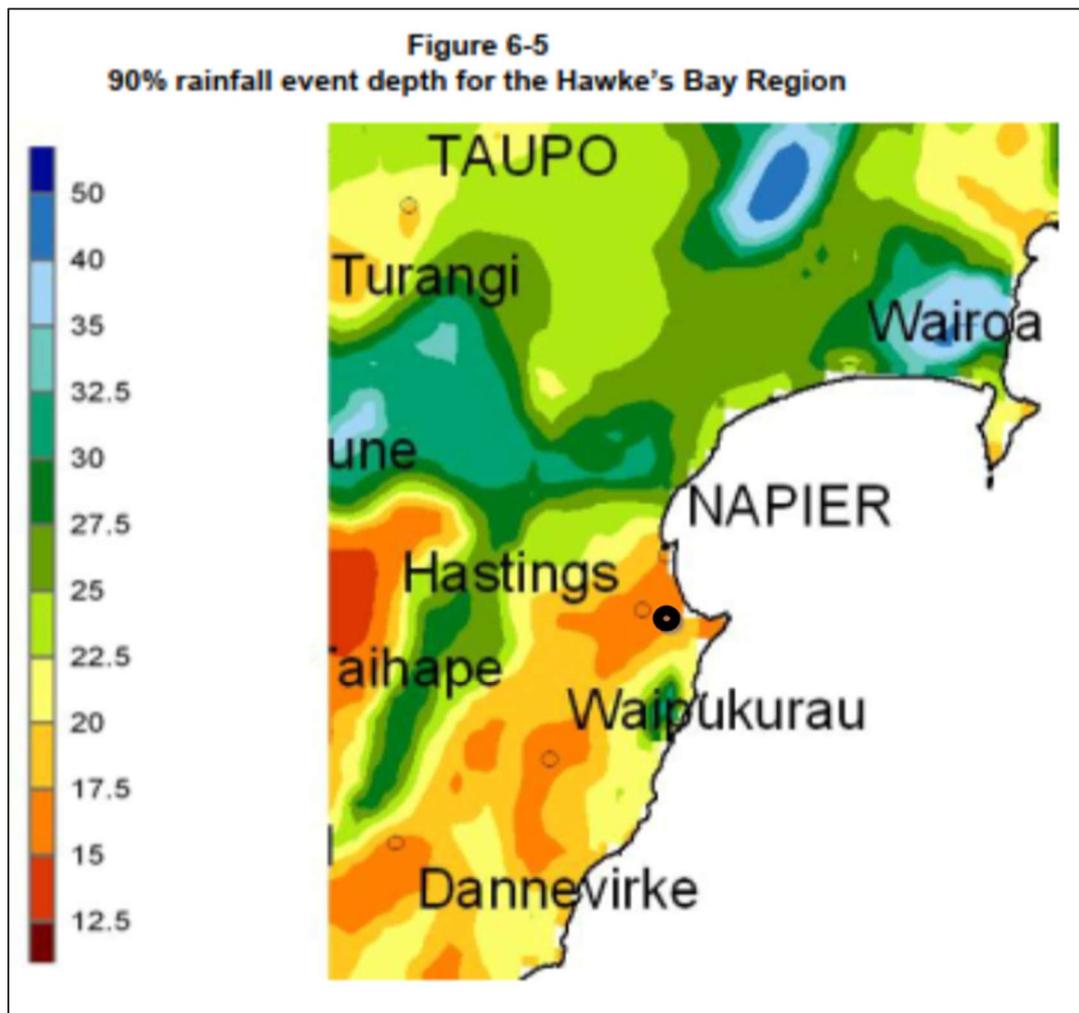
Figure 4: Hawke's Bay Region 90th percentile rainfall event depth

With respect to the determination of the extended detention volume (EDV) for aquatic resource protection, the rainfall depth is based on water quality volume (WQV) depth which is based on the 90th percentile rainfall. Based on the Hawke's Bay Waterways Guidelines for Stormwater Management Figure 6.5 (Figure 4) this was noted to be 17.5mm/24hr. The resulting WQV generated by the contributing area is multiplied by 1.2 to get the EDV as outlined in Section 3.1.

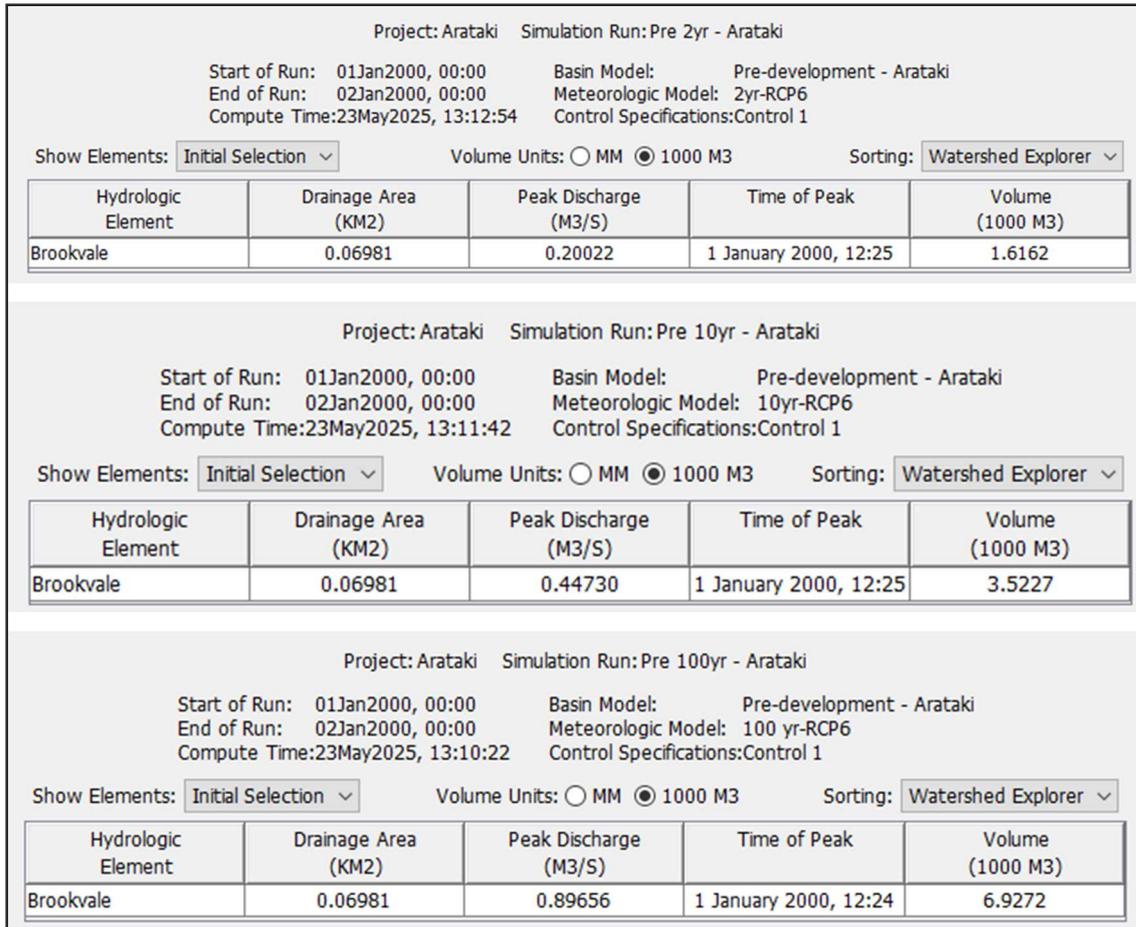
Figure 7: Predevelopment model outputs

Predevelopment flow rates were calculated for the various storms and are summarised in Figure 7 and Table 4.

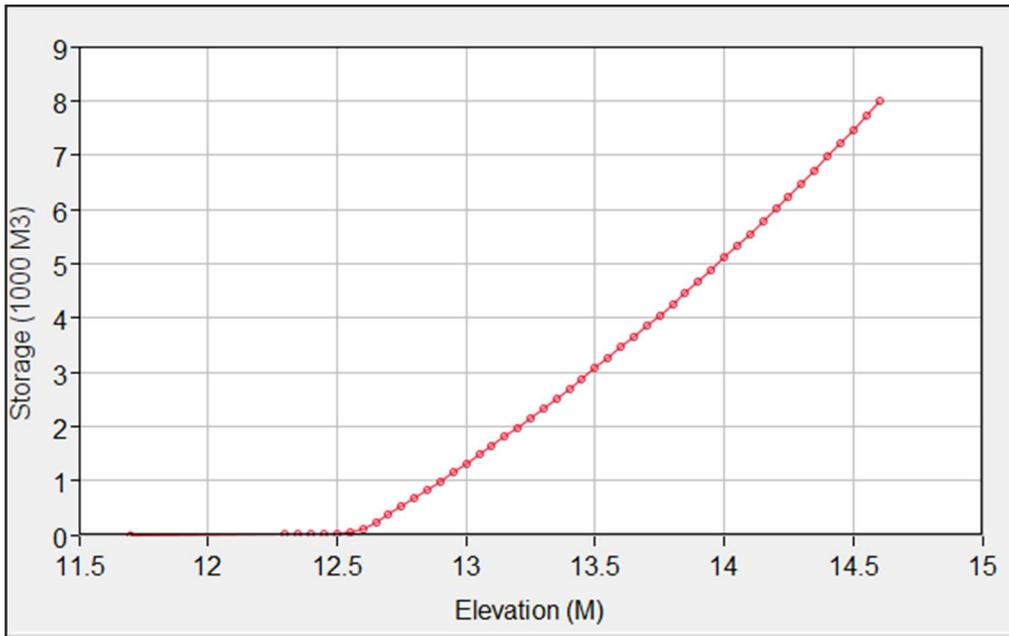
Figure 9. Dry basin stage storage

The area around the discharge structure will be lowered to allow for the orifice level to be achieved.

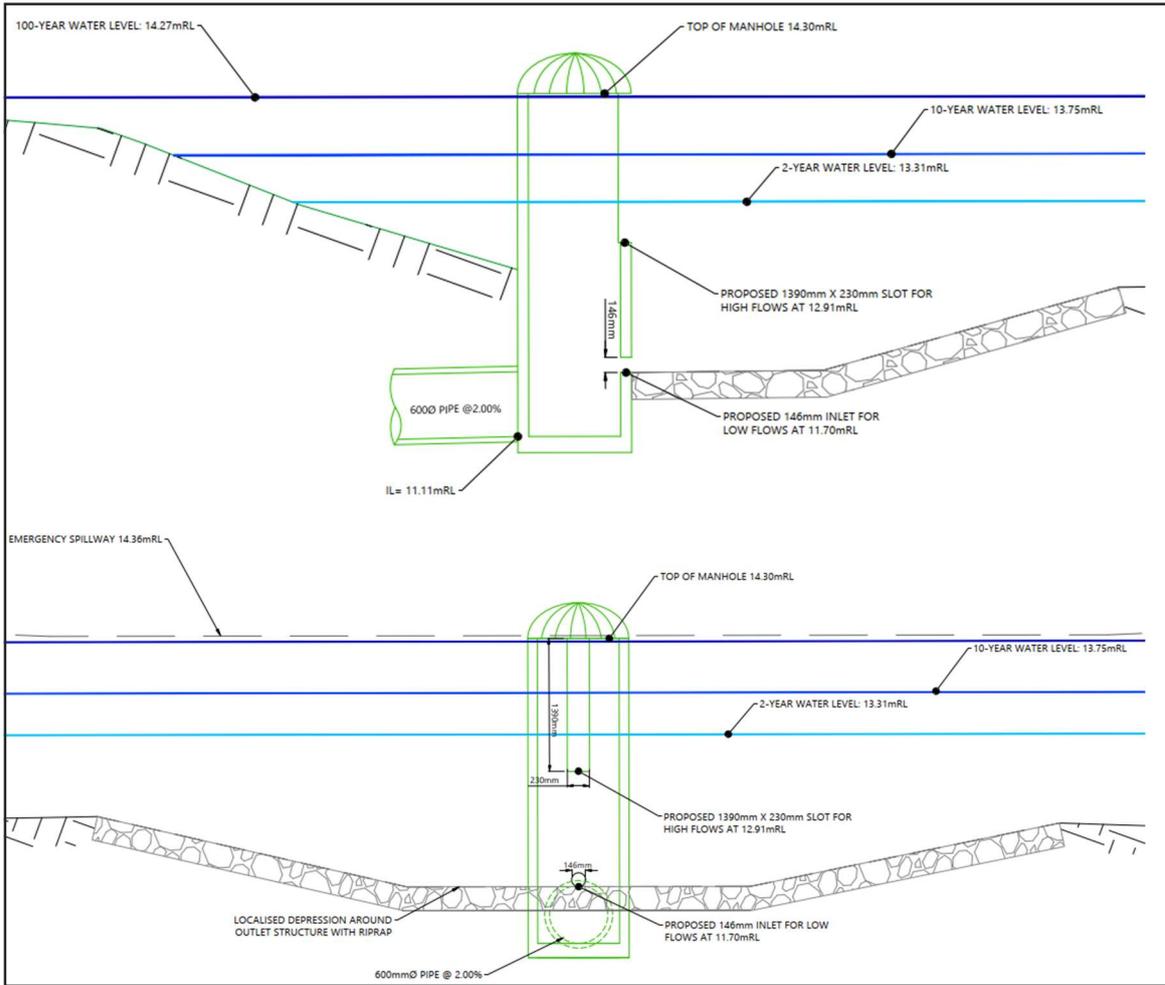
Figure 12: Outlet structure design

From the discharge control manhole, a 600mm pipe (Figure 12) will be installed to convey the managed flows from the basin to the stream. At the stream interface, a scruffy dome outlet structure will be installed with the appropriate erosion/scour protection to prevent degradation of the stream (Figure 17 and Figure 18). A low flow drainpipe is provided at the base of the structure to empty it out at the end of storm events (additional detail contained in the Infrastructure Report).

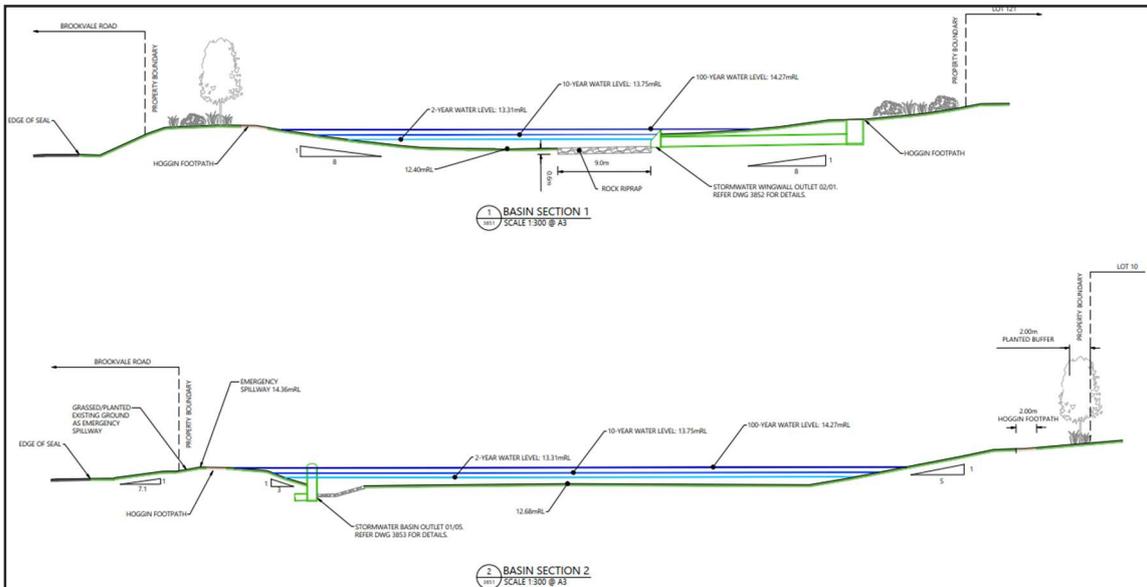
Figure 13: Basin cross sections

As discussed in the preceding section, the emergency spillway is not activated under normal operational conditions. An assessment was undertaken where the primary/service outlet is completely blocked for the 100-year ARI event. It was determined that in this situation, the 20m spillway will discharge flows out of the basin and peaking at 14.54mRL (Figure 14). The embankment level, as noted previously is 14.84mRL (Figure 15) thus a 300mm freeboard is achieved in accordance with the HBRC Stormwater Guidelines.

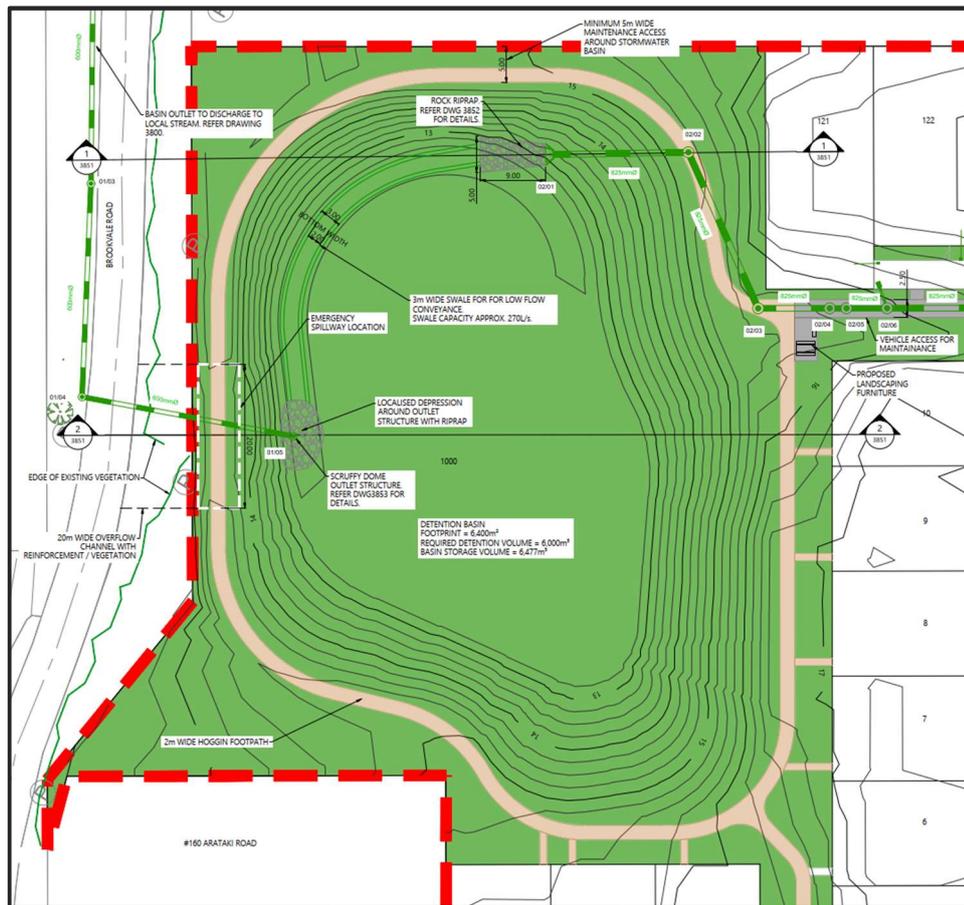
Figure 2. Dry Basin Layout Plan

The Basin is located at the Northern end of the development. A concrete access track off Creek Road provides vehicular access to the basin. The access track for the basin is shown in Figure 2, and can be referred to in drawings P24-244-00-3850/54-DR.

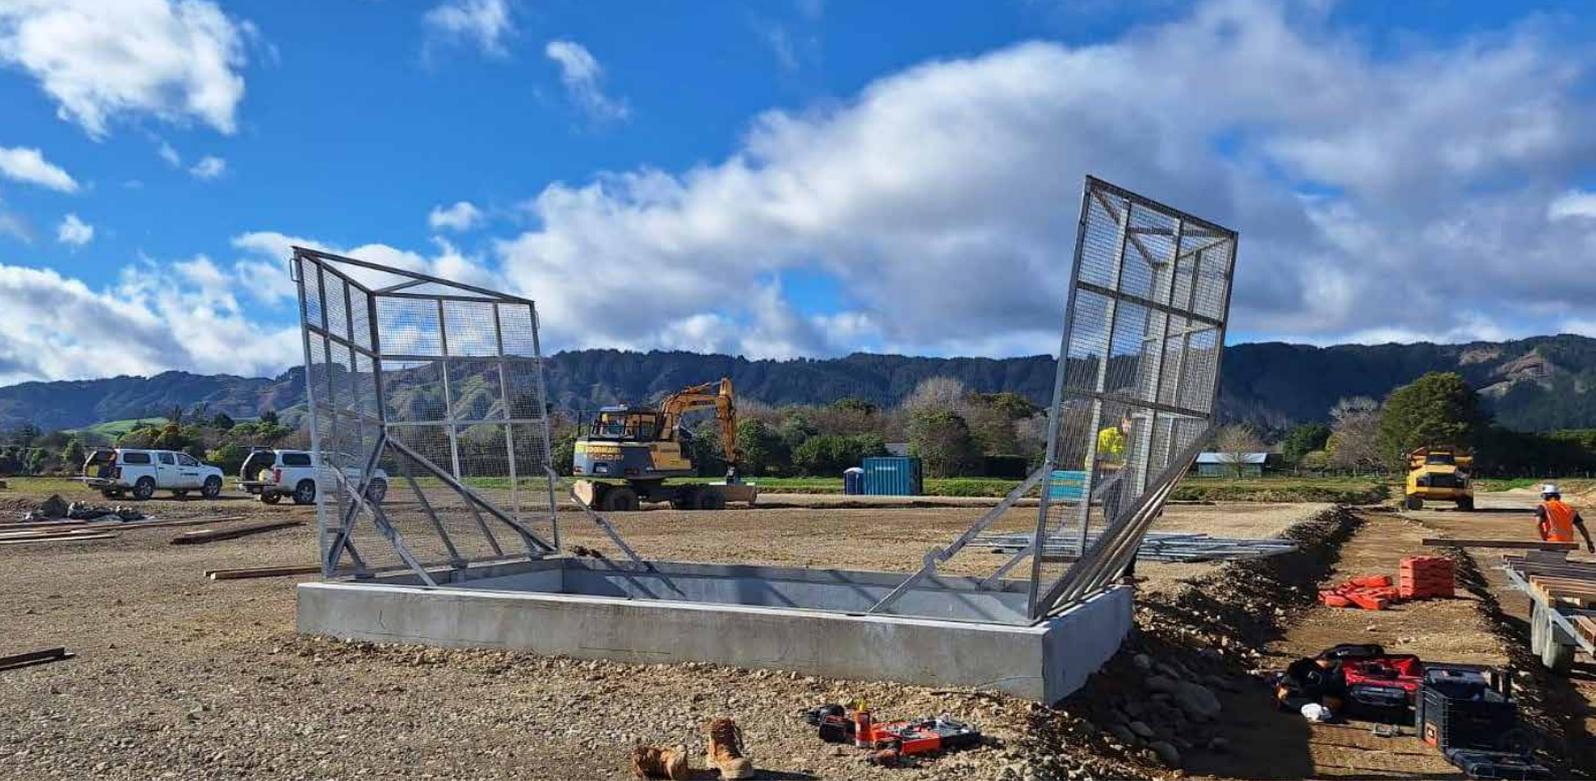
1.2 During servicing, the screen system hinges off to the side give easy access to the sediment collected in the lower chambers.
