# STORMWATER MANAGEMENT PLAN

*Arataki Project*  
*CDL Land New Zealand Limited*  
**86, 108 & 122 Arataki Road, Havelock North**

**Substantive Application**  
**Fast-Track Approvals Act 2024**  
**20 November 2025**

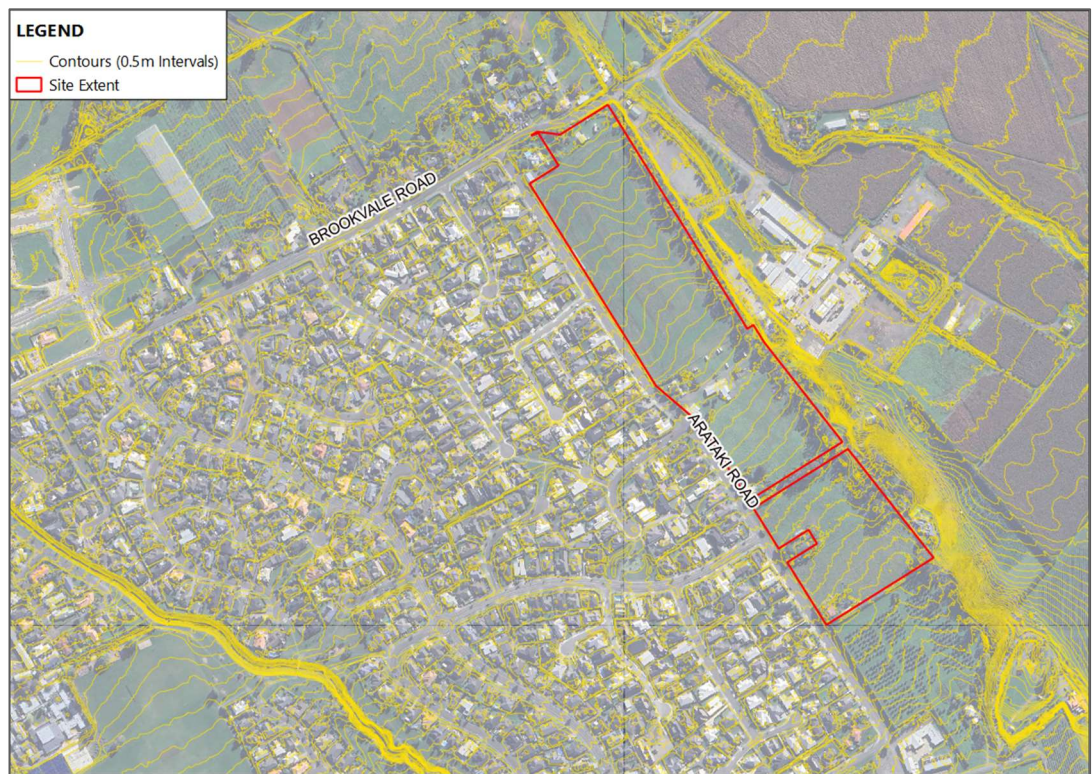
**Figure 2: Existing topography**

The site has a gentle crossfall from south to north (Figure 2) with contours dropping from 32mRL to 14mRL. The site is on a natural terrace and the landform is elevated above the rural property to the east by approximately 6m.

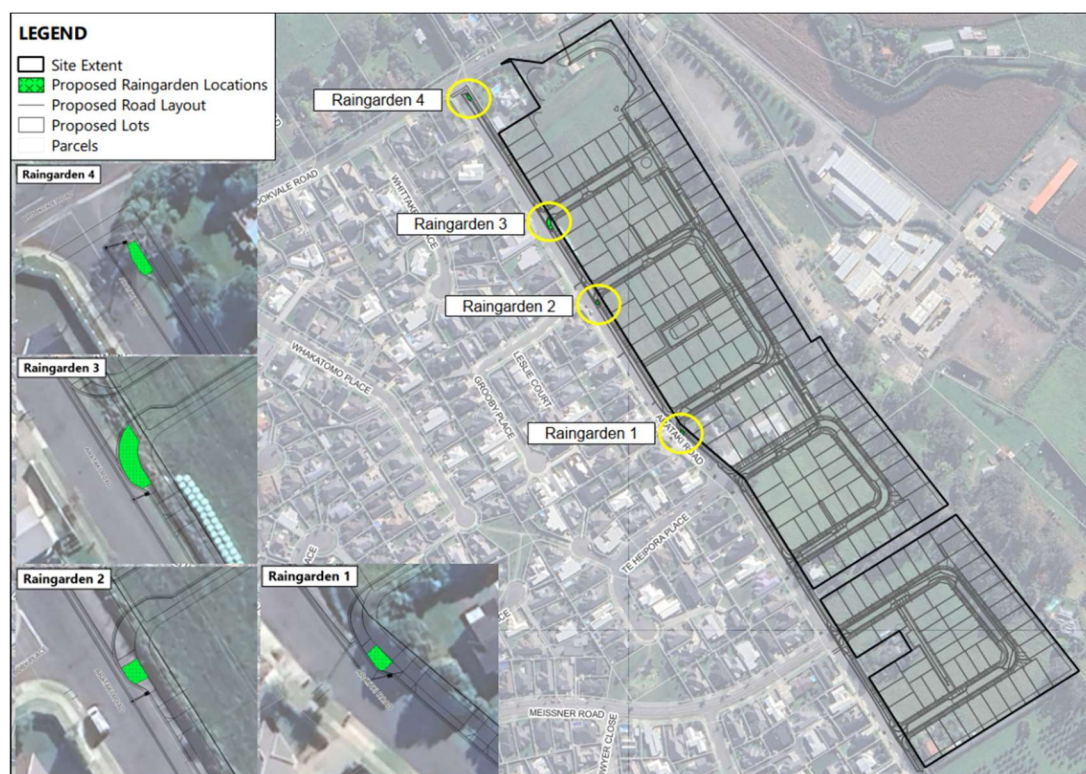
**Figure 13: Indicative raingarden locations**

The locations of the proposed raingardens are shown in Figure 13, with a summary of the areas provided in Table 4. The associated calculations are included in Appendix B for reference.

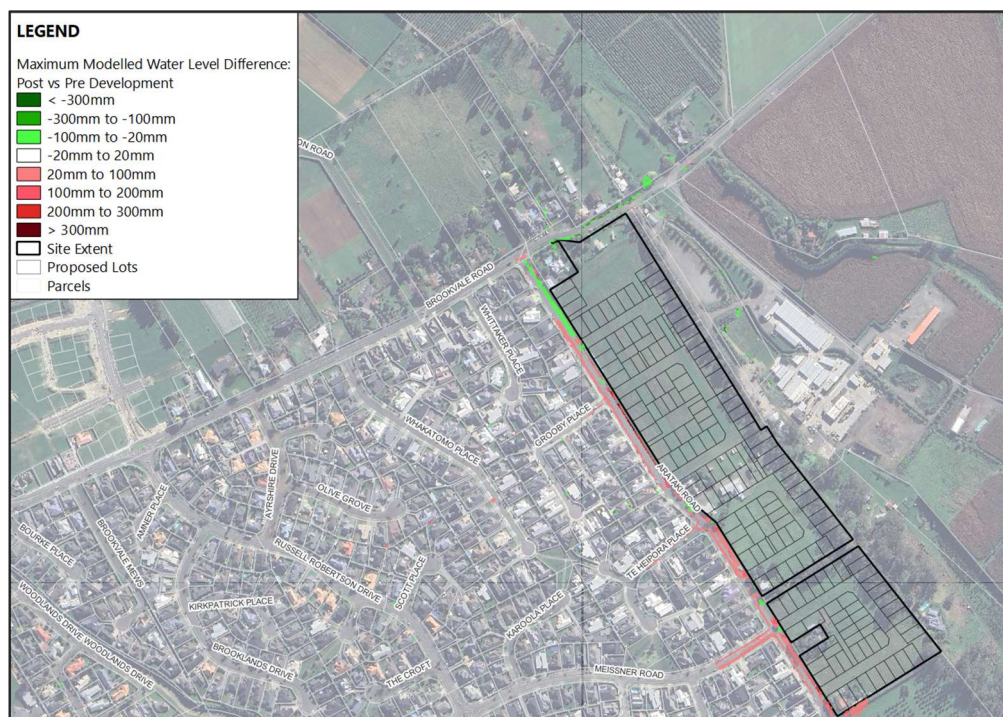
**Figure 16: Water level difference plot - 100-year + RCP 6.0**

The resulting 100-year water level difference plot is shown in Figure 16.

The flood modelling predicts increases in flood levels along Arataki Road, Meissner Road and Te Heipora Place as shown in Figure 16. The increase in flood level observed in the model are less than 25mm and are deemed negligible and considered less than minor as the overland flows are generally contained within the road reserves and designed conveyance paths.

No third-party effects have been observed as a result of the development. No adverse effects on third-party properties or assets have been identified as a result of the proposed development. The stormwater design ensures that the level of service for surrounding properties is maintained and that any additional overland flow is appropriately managed within public infrastructure.

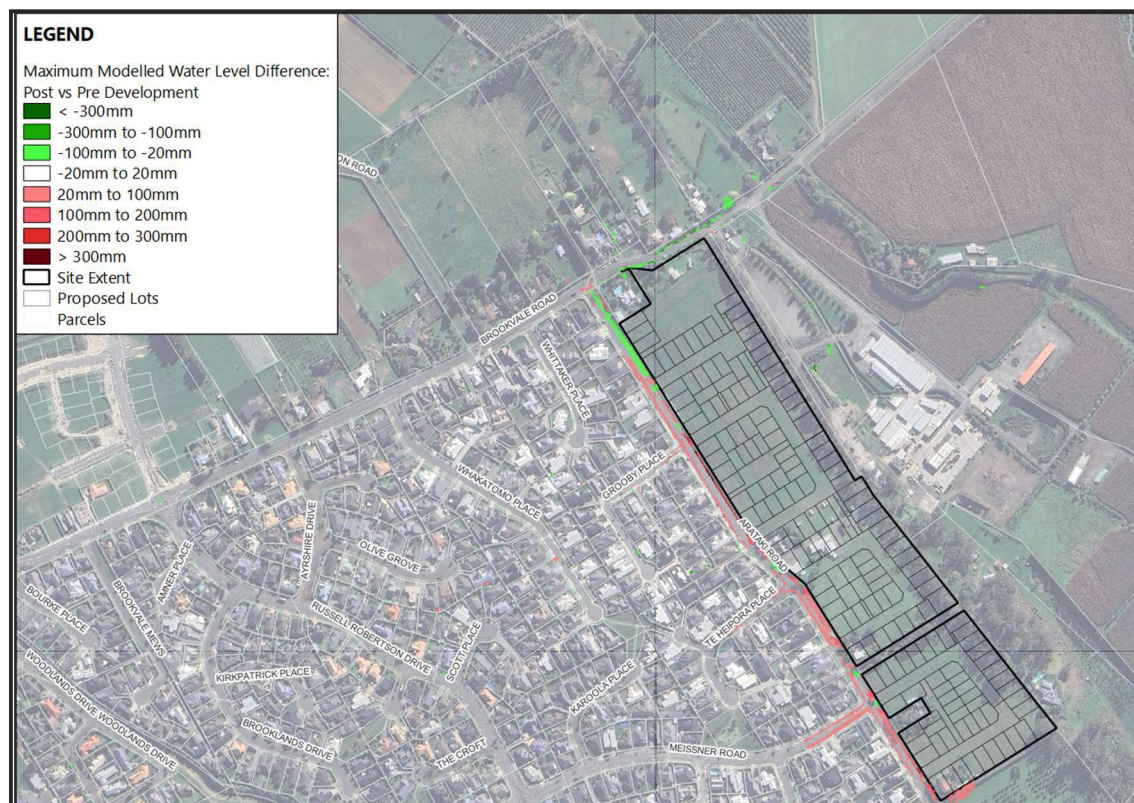
Figure 6: Water level difference (pre vs post)

The results (mapping and cross section extracts) indicate that between the pre- and post-development scenarios, there will be a minor increase in flood depths along Arataki Road as well as Te Heipora Place and Meissner Road. The removal of the roadside swale did not affect the conveyance capacity of the road noting that a portion of the predevelopment catchment was diverted to Subcatchment B. No adverse effects were observed to third-party properties west of Arataki Road.

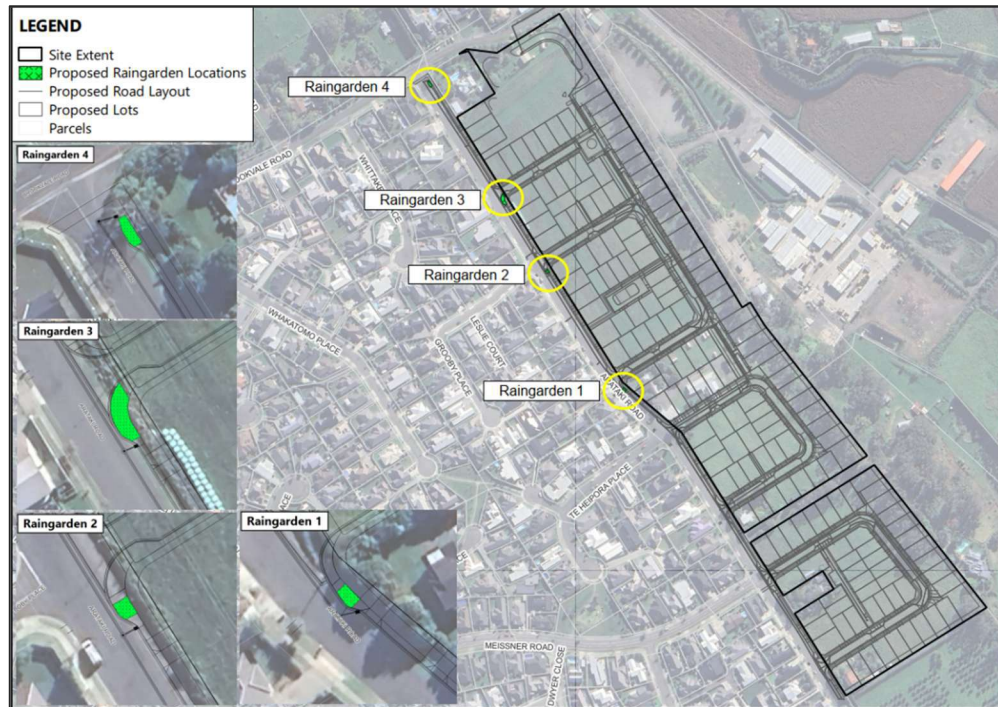
This operations and maintenance (O&M) manual details the proposed raingarden design for the Arataki development by CDL Land New Zealand Limited (CDL). The raingarden locations are shown in Figure 1.

*Figure 1: Proposed raingarden locations*

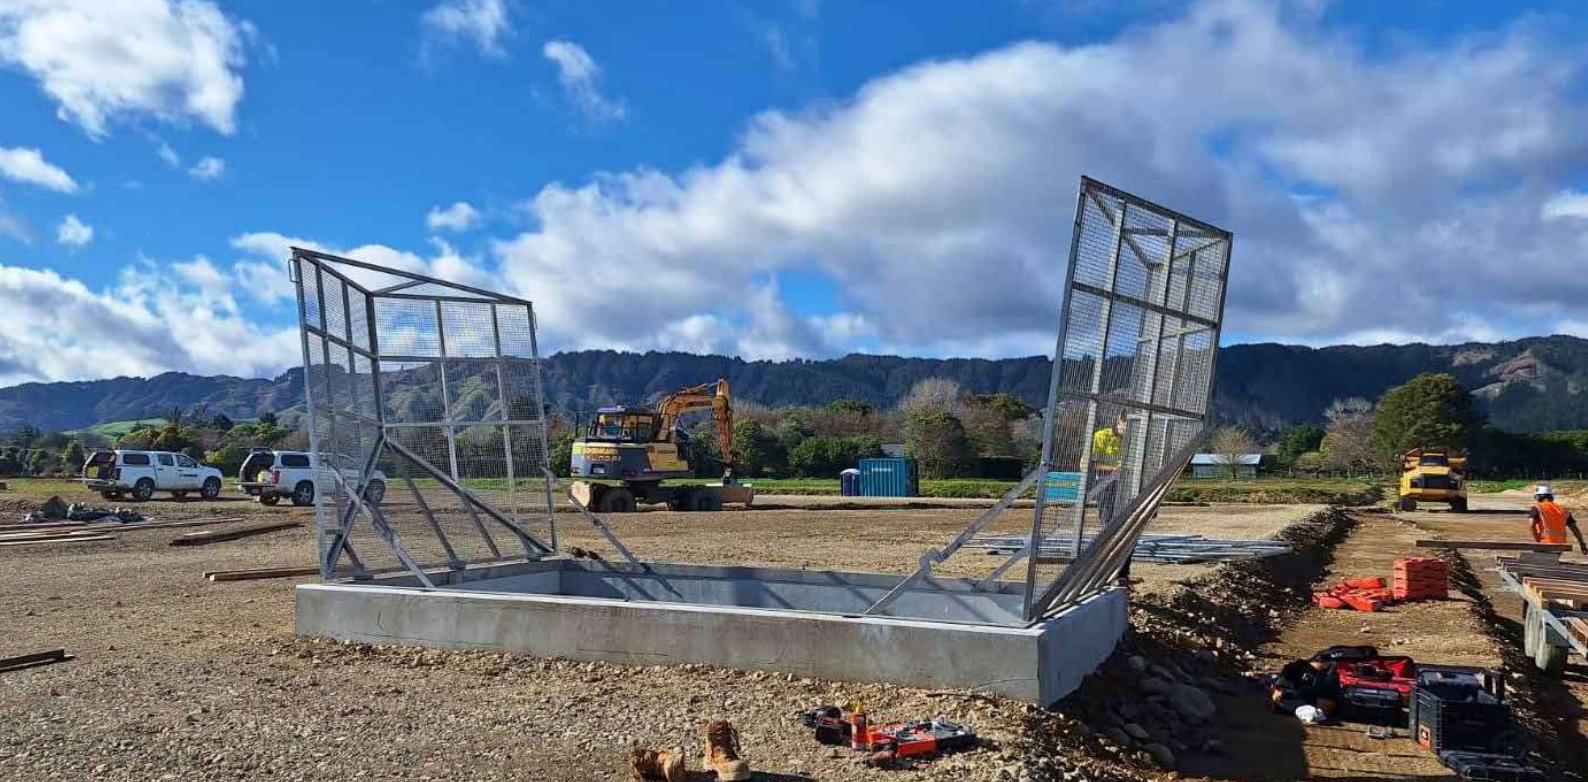
1.2 During servicing, the screen system hinges off to the side give easy access to the sediment collected in the lower chambers.
