**Remedial Action Plan**

**270 – 292 Dukes Road North  
Mosgiel**

**for  
Southern Link Property Limited**

**April 2026**

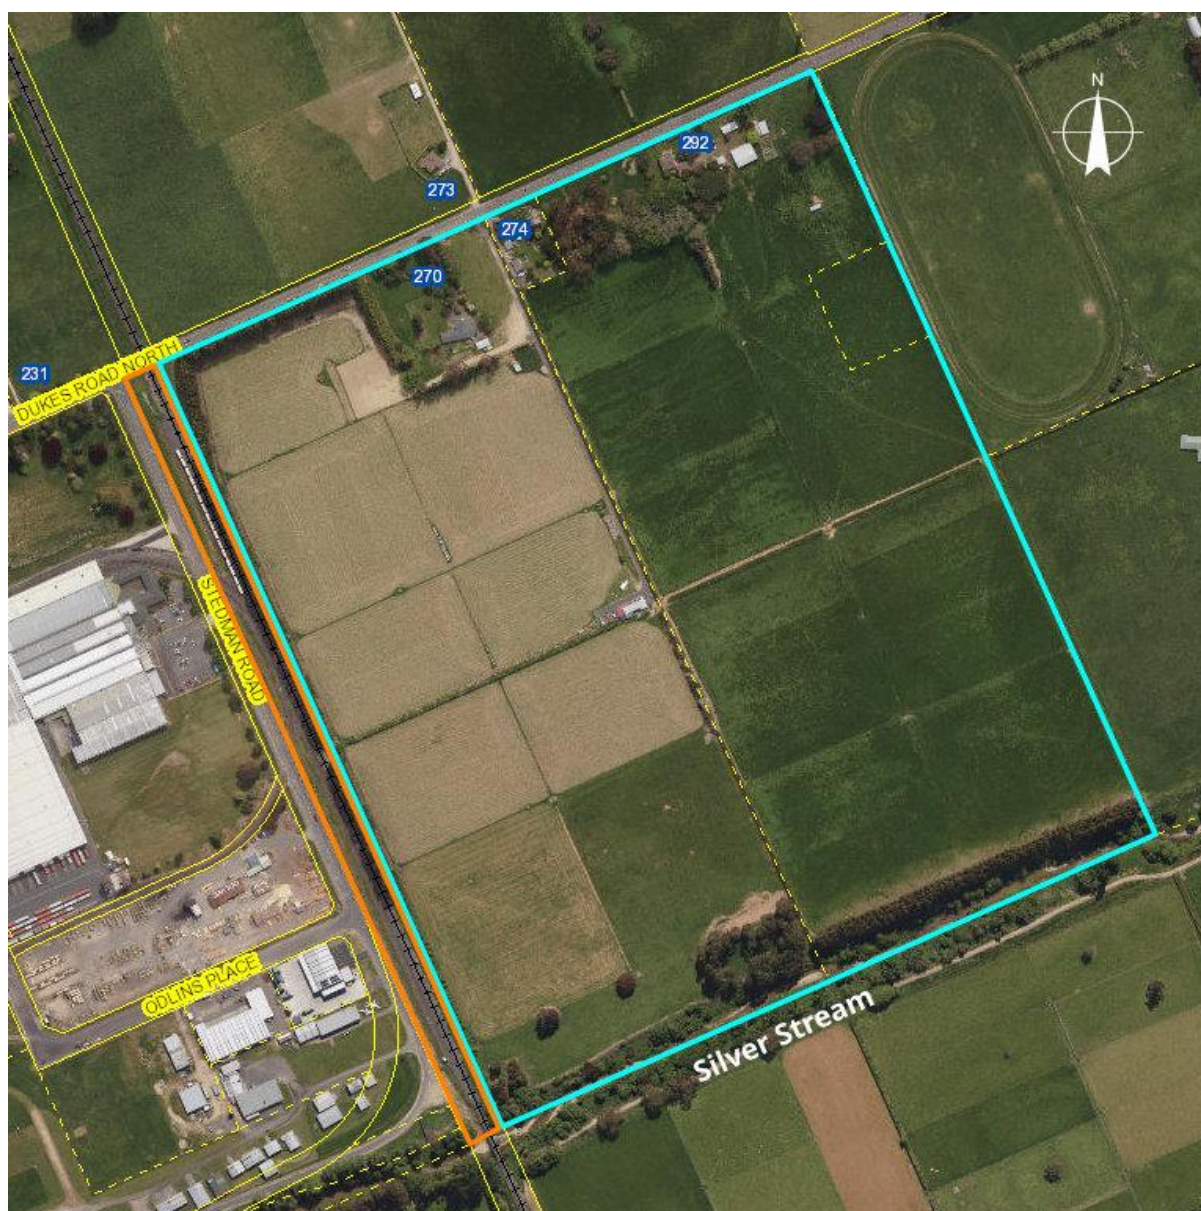
Figure 2: The Site extent at 270 – 292 Dukes Road North outlined in turquoise with the KiwiRail Corridor outlined in orange (DCC GIS | 2023-2024. Copyright DCC/ORC, CC BY 4.0).

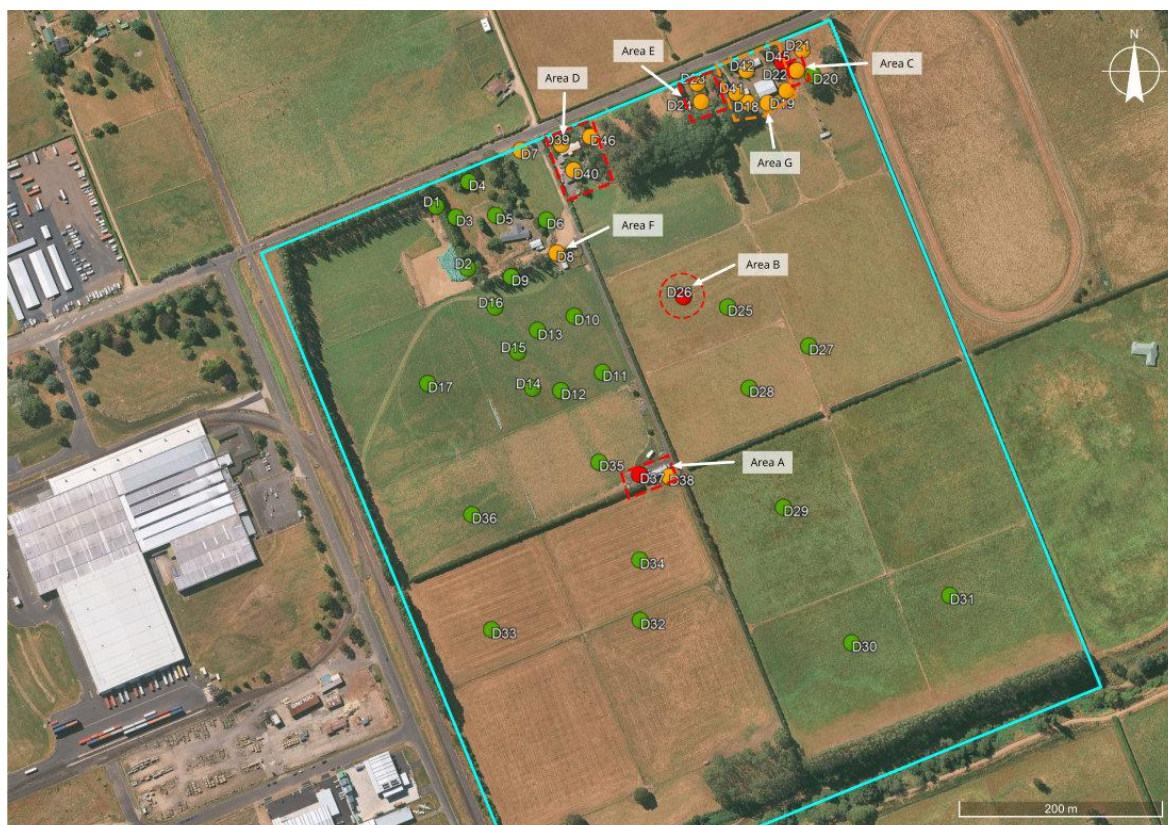
Figure 6: Sampling locations from the DSI. Red indicates samples that exceed the Commercial/Industrial SCS/SGV, and orange indicates samples above background but below the Commercial/Industrial SCS/SGV. Green indicates samples consistent with predicted background. Areas outlined in red indicate verified HAIL sites and areas outlined in orange indicate unverified HAIL sites (Google Earth, Image © 2025 Airbus).

These results indicate that HAIL activities have occurred across various parts of the Site. The results from the DSI are highlighted in Figures 6, 7 and 8, where locations reporting exceedances of the *Commercial/Industrial* Soil Contaminant Standards (SCS)/Soil Guidelines Values (SGV) are denoted in red, and locations reporting elevations above the predicted background level but below the *Commercial/Industrial* SCS/SGV are denoted in orange. Locations found to be consistent with predicted background levels are coloured green. Verified HAIL sites are outlined in red, and unverified HAIL sites outlined in orange. A conceptual site model is included in the DSI.

Prior to earthworks commencing, the areas affected by contamination, as shown in Figures 6 – 8, will be clearly marked, and the extent of the contamination will be confirmed via additional sampling where required. This is to ensure that no accidental cross-contamination occurs between clean and contaminated soils. The remediation works may be undertaken in stages concurrent with the staged development of the inland port, however areas of contaminated soils must be protected from disturbance if adjacent to access routes for other stages of the development.

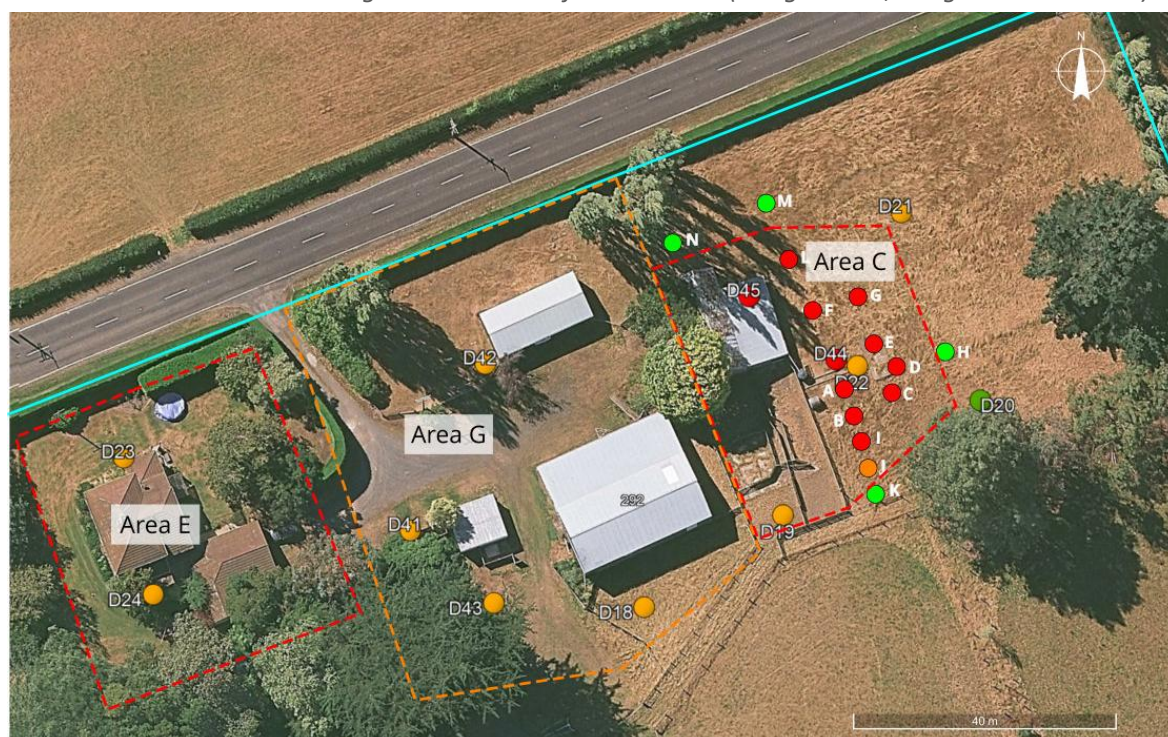
Figure 7: Sampling locations across the northeastern end of the Site. Red indicates samples that exceed the Commercial/Industrial SCS/SGV, and orange indicates samples above background but below the Commercial/Industrial SCS/SGV. Green indicates samples consistent with predicted background. Areas outlined in red indicate verified HAIL sites and areas outlined in orange indicate unverified HAIL sites (Google Earth, Image © 2025 Airbus).

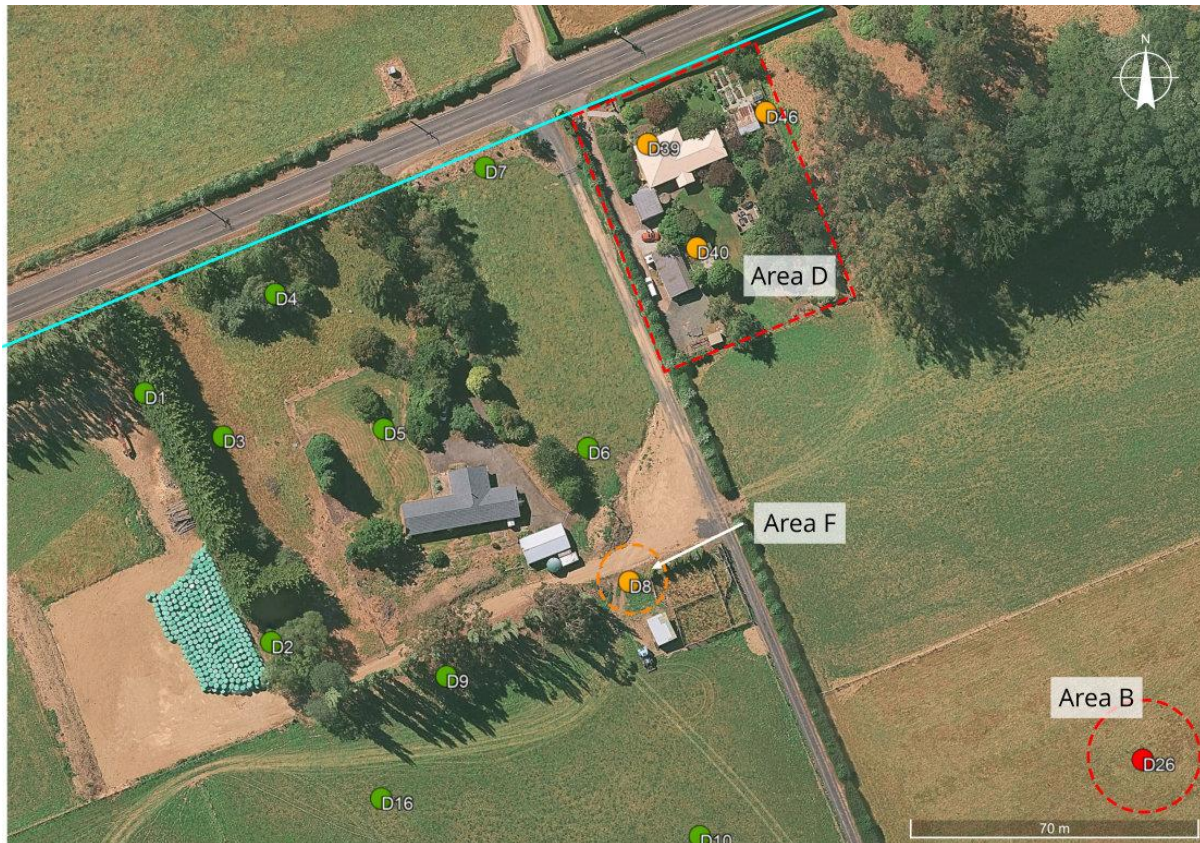
Figure 8: Sampling locations across the northern end of the Site. Red indicates samples that exceed the Commercial/Industrial SCS/SGV, and orange indicates samples above background but below the Commercial/Industrial SCS/SGV. Green indicates samples consistent with predicted background. Areas outlined in red indicate verified HAIL sites, and areas outlined in orange indicate unverified HAIL sites (Google Earth, Image © 2025 Airbus).

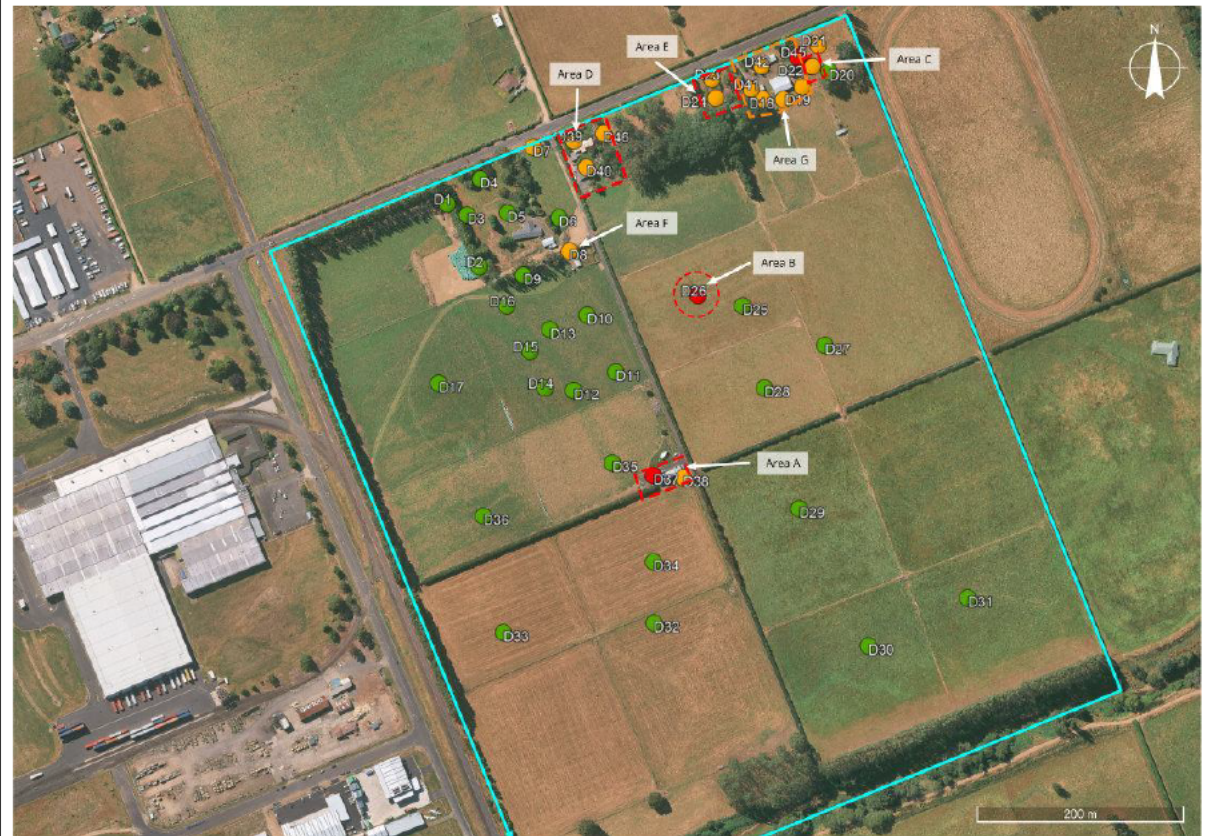
Figure 1: The properties at 270-292 Dukes Road North outlined in turquoise showing Areas A – G containing heavy metal contamination (DCC GIS | 2023-2024. Copyright DCC/ORC, CC BY 4.0).

| Known/<br>potential<br>contaminants | <p>Heavy metal concentrations were found to be elevated at the five verified HAIL sites (Areas A – E) and two unverified HAIL sites (Areas F &amp; G) identified in Figure 1.</p> <p><u>Concentrations of arsenic in Areas A - C exceed the Commercial/Industrial guidelines and are a risk to workers.</u></p> <p>Concentrations of arsenic and/or zinc within all 7 areas exceed the environmental guidelines.</p> |
