# MP4-FT – Camp Creek Dam and Reservoir

## Archaeological Management Plan

Rev. 0 – August 2026

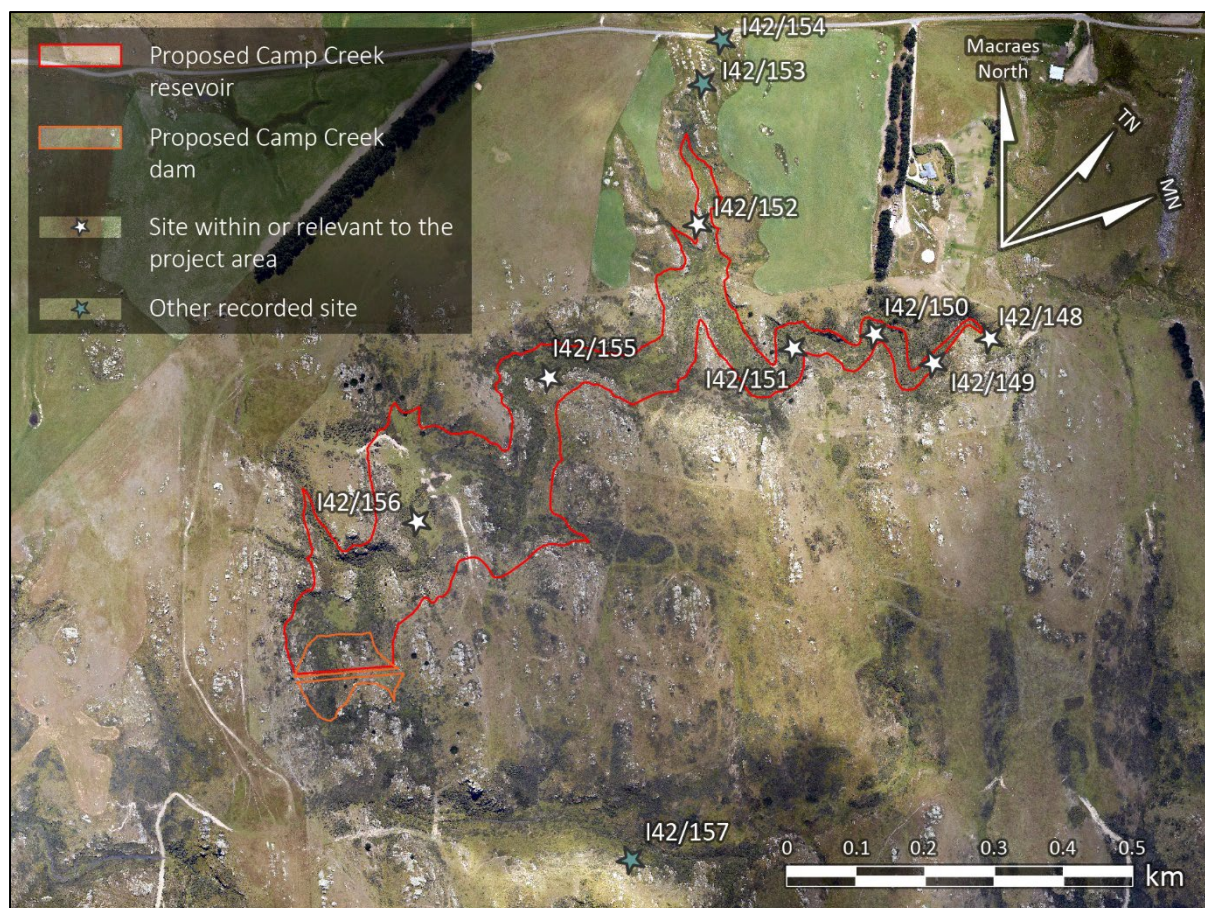
Figure 1. Locations of recorded archaeological sites in and around the project area.

This Archaeological Management Plan (AMP) will guide the archaeological work required as part of the construction of the Camp Creek dam and reservoir by Oceana Gold (New Zealand) Limited under archaeological authority #####/### (OGNZL; Figure 1). Historically, this area of these works was occupied and utilised by Māori and Europeans, and their archaeological sites remain across the landscape.

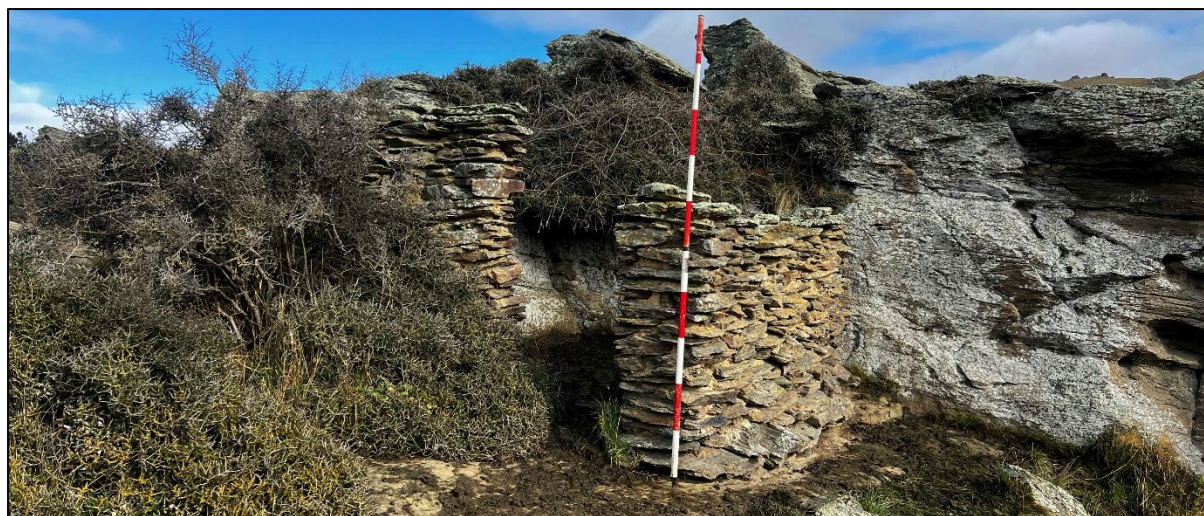
Figure 2. Harry's Hut (I42/153), looking west.

To provide some offset to the destruction of these sites, the ruins of Harry's Hut (I42/153; Figure 2) should be assessed by a suitably qualified stonemason with a brief for providing maintenance recommendations.

This Archaeological Management Plan should be updated with their recommendations, as they become available, and the required maintenance carried out prior to the destruction of the Camp Creek sites.

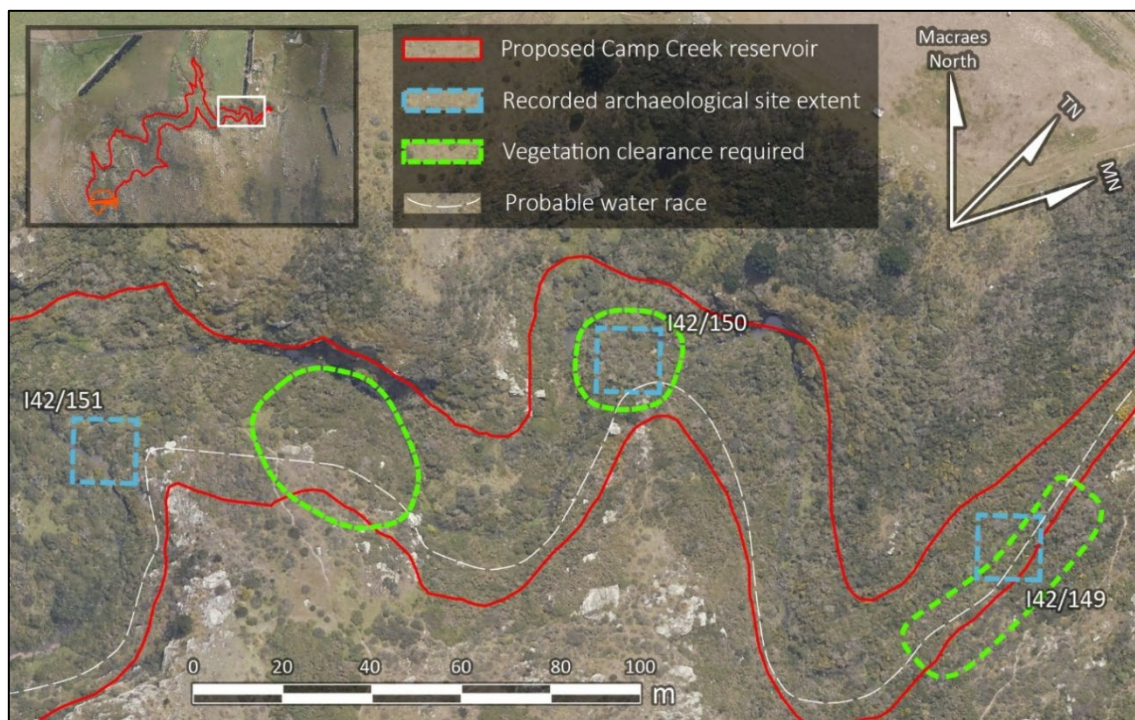
Figure 3. Areas for vegetation clearance around sites I42/149, I42/150, and I42/151.

Several previously identified sites were unable to be relocated during the assessment due to vegetation growth. These must be cleared prior to project works proceeding to allow their recording. The areas where vegetation clearance is required are shown in Figure 3-Figure 4. This is relevant to sites: I42/149 – Water race; I42/150 – Prospecting pit; I42/151 – Water race; and I42/155 – Water race and workings.

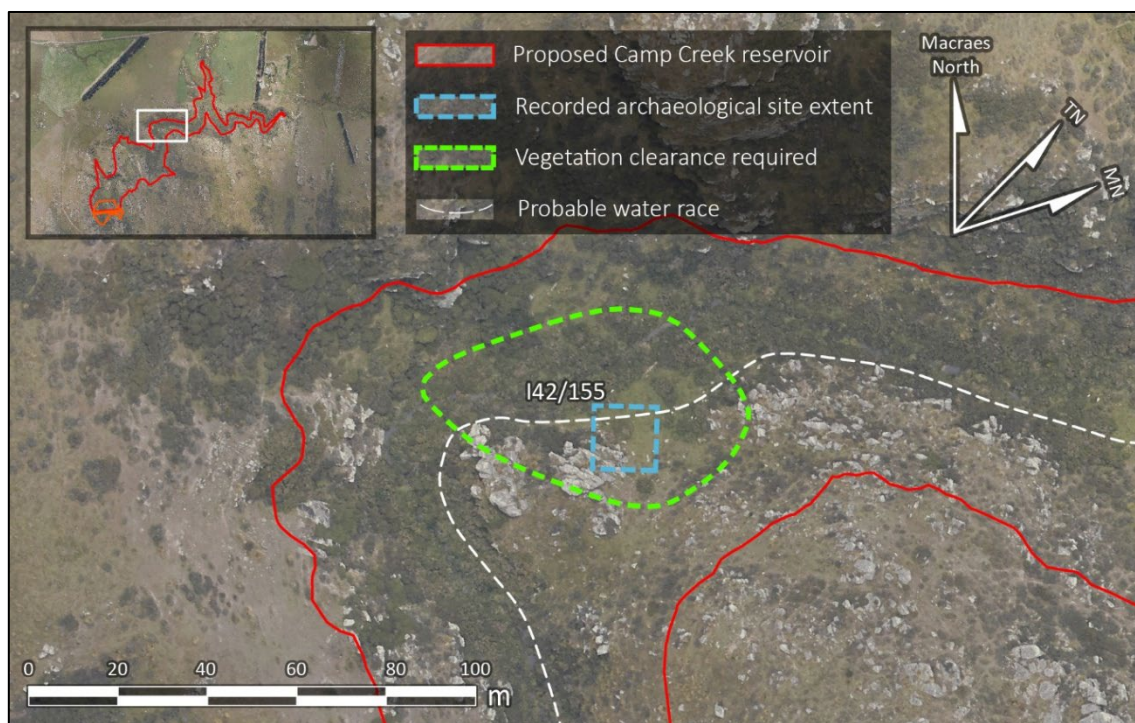
Figure 4. Area for vegetation clearance around site I42/155.

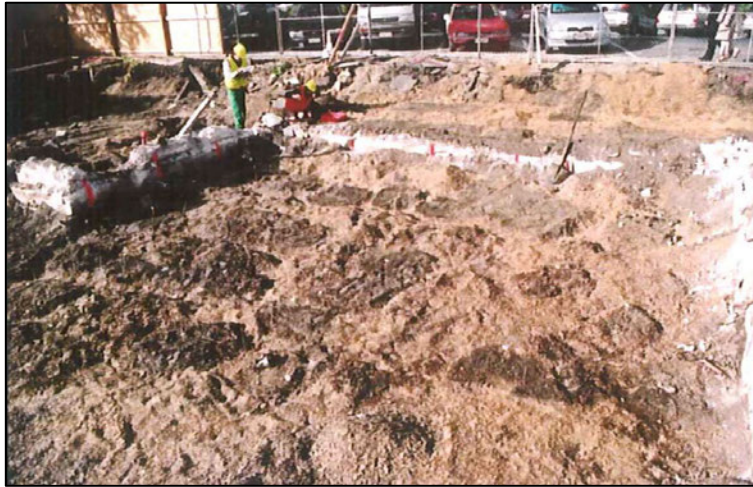
Concentrations of historic  
refuse or other finds in  
one spot. Usually sitting  
within a different fill  
type/colour.

Refuse pits (the darker features) in Queenstown (P. Petchey).

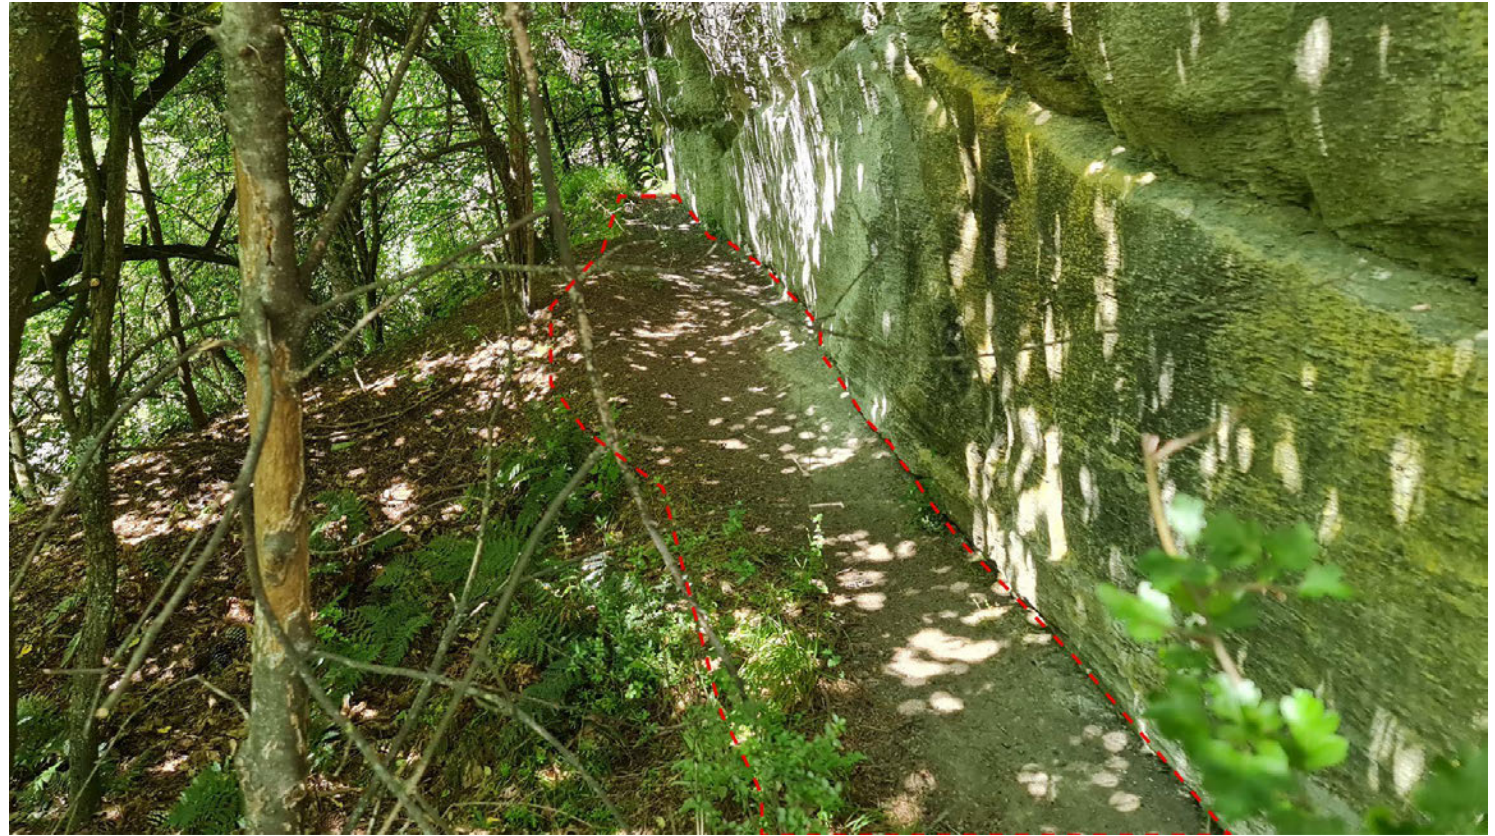
Usually a very different look and feel from the layer above. Historic road materials can include gravel (often of an irregular grade) compacted mud, irregular timber pieces, as well as stone and timber cobbling.

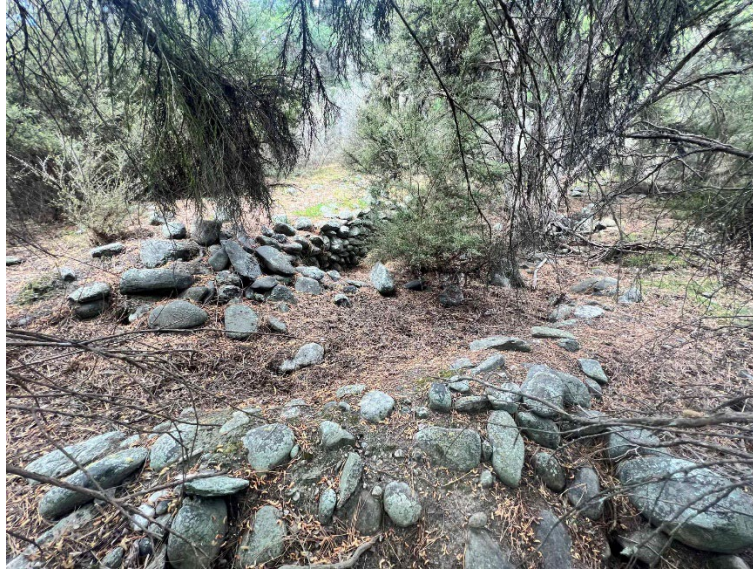
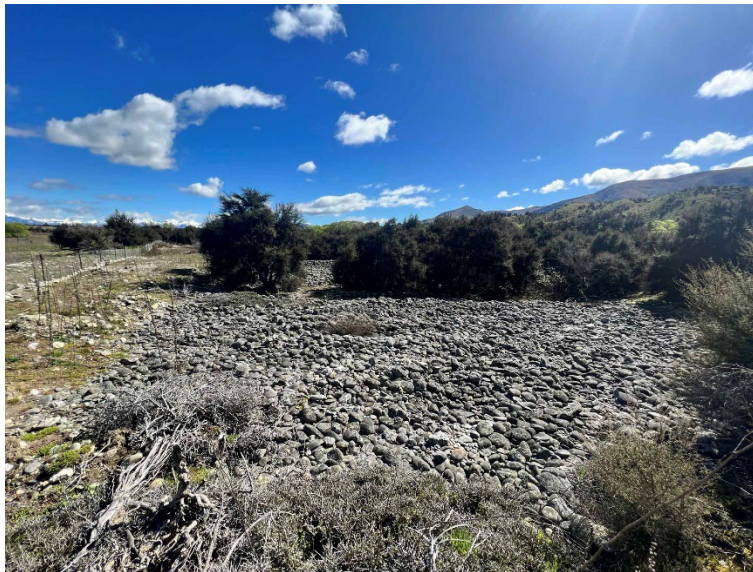
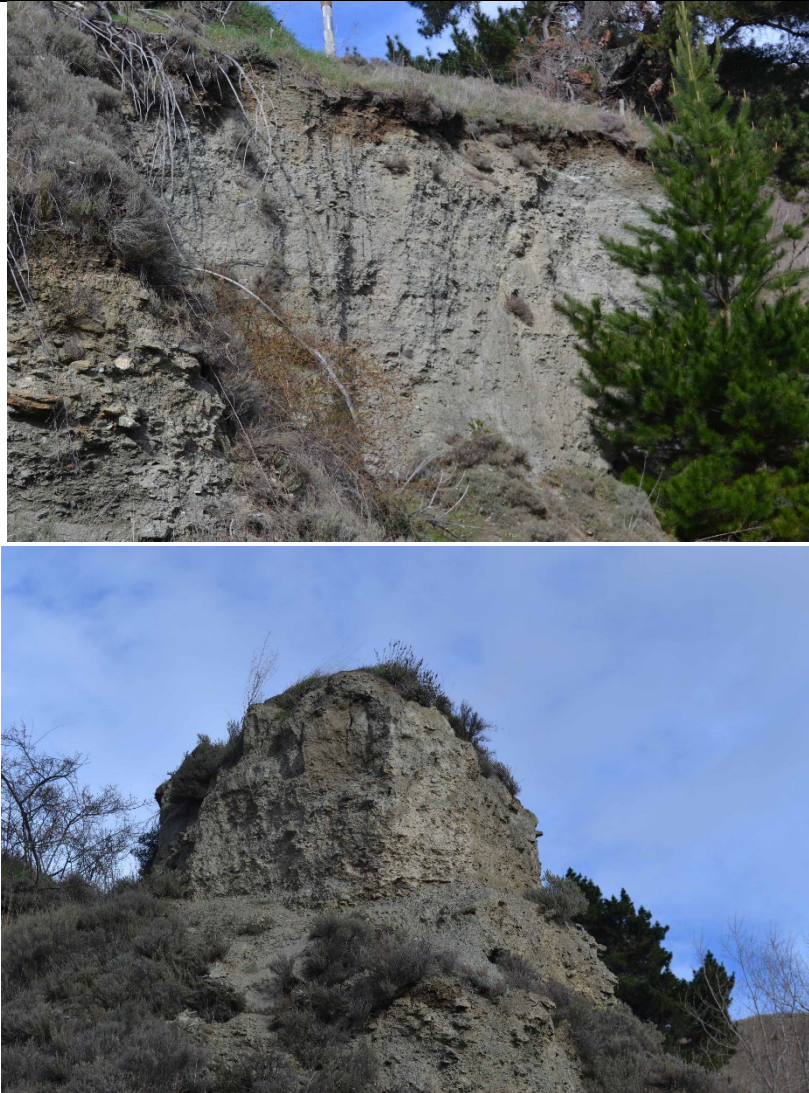
Distinct archaeological features left behind by historic mining.

Tailings are usually large collections of rocks spread over a large area or in recognisable rows created as a byproduct of mining.

Sluicing is the process of high-pressure water being fired at a rock face to wash away gold bearing gravel so it could be collected, it leaves distinctive flat surfaces or pillars.

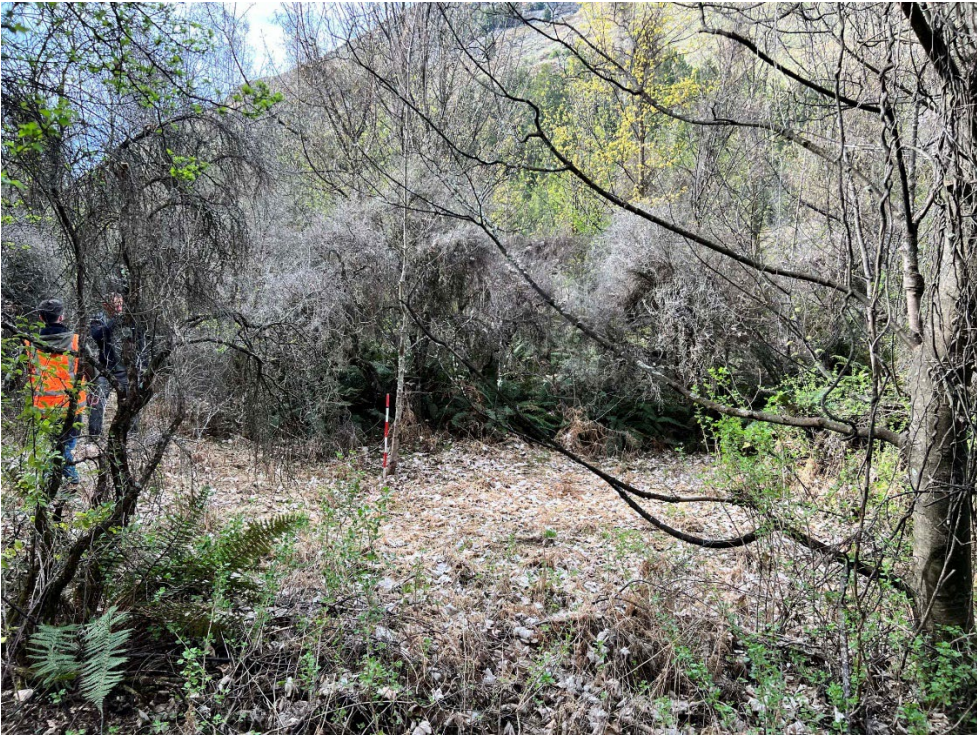
| <p><b>Building platforms</b></p> <p>Some early buildings like mining huts are known to be in the area. However, most will have decayed or collapsed by now, leaving a small, levelled platform. Often creating a small clearing within trees.</p> | A photograph showing a forest clearing. A person wearing an orange safety vest and a dark jacket is standing on the left side of the frame, looking towards the clearing. The ground is covered with dry leaves and some green ferns. The background is filled with dense trees and foliage, with some bare branches in the foreground. The clearing appears to be a small, levelled area within a wooded area, consistent with the description of a building platform. |

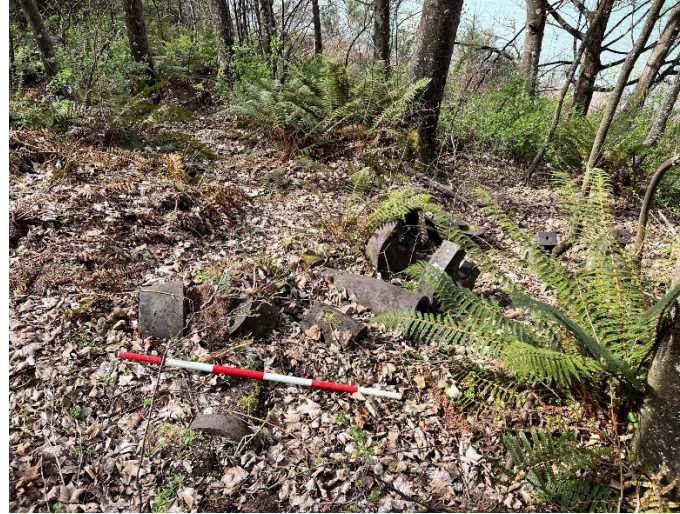
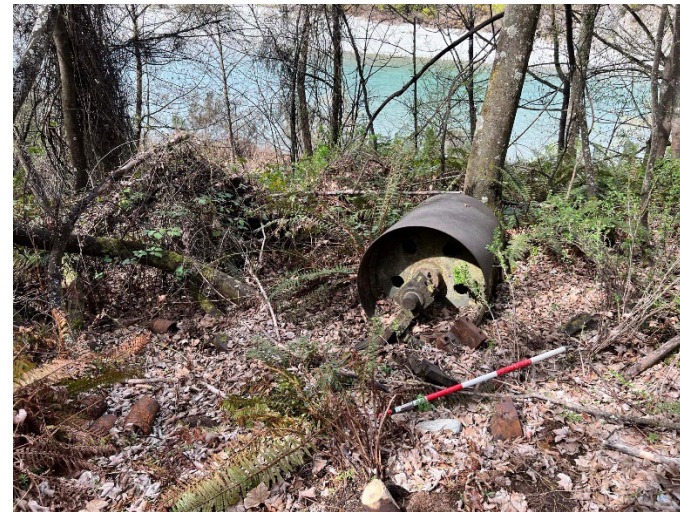
Sometimes it was not worth the trouble to remove the mining equipment when the claim was abandoned and it was left behind.

Metal cables, oil drums and large pieces of scrap metal were often left behind.

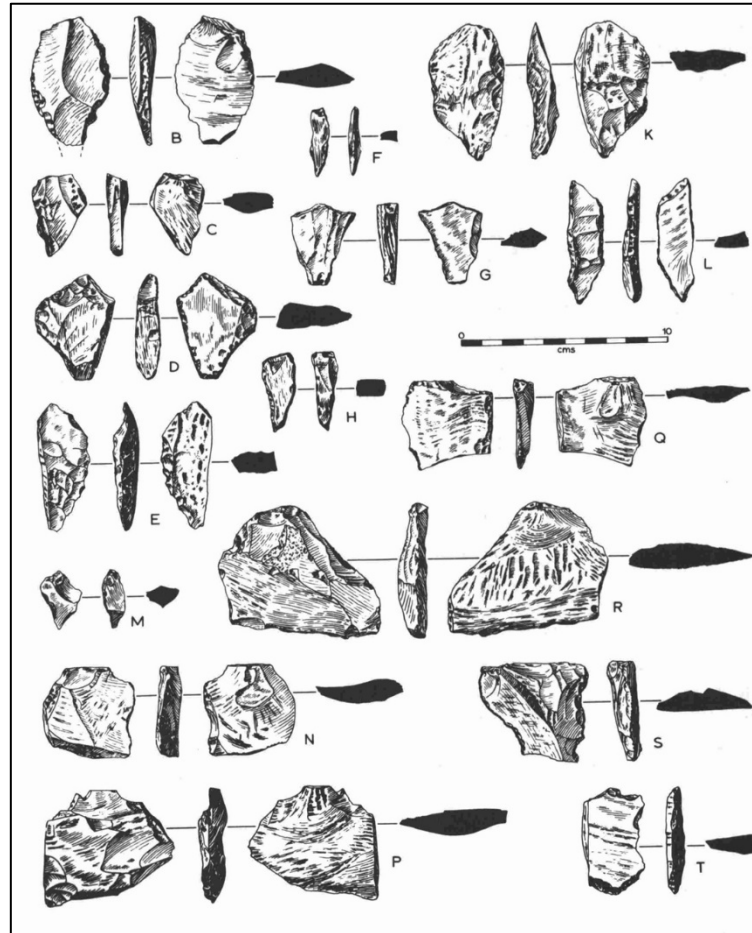
Drawings of flaked stone tools found near Nelson (A. Challis).

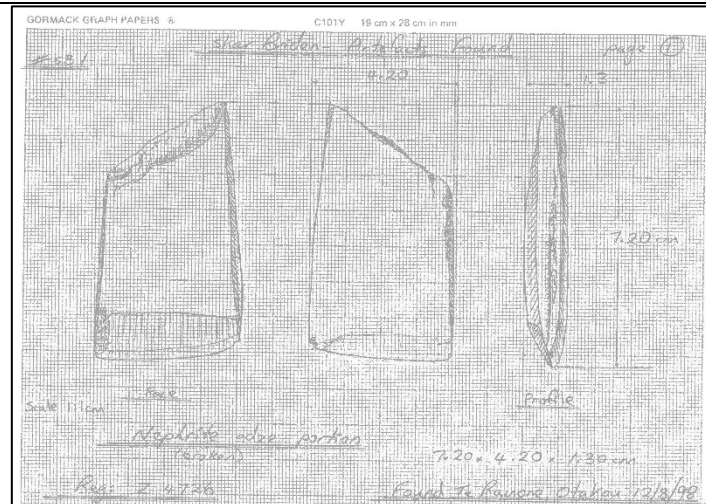
Drawing of a stone adze fragment found on Te Rauone Beach on the Otago Peninsula (S. Briden).

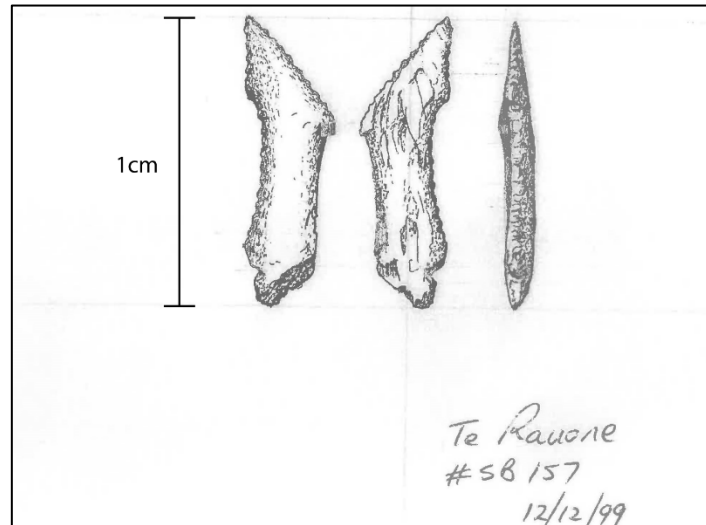
Drawing of a bone point found on Te Rauone Beach on the Otago Peninsula.
