Remediation Action Plan

**Maitahi Subdivision
7 Ralphine Way, Nelson**

CCKV MAITAI DEV CO LP

July 2025

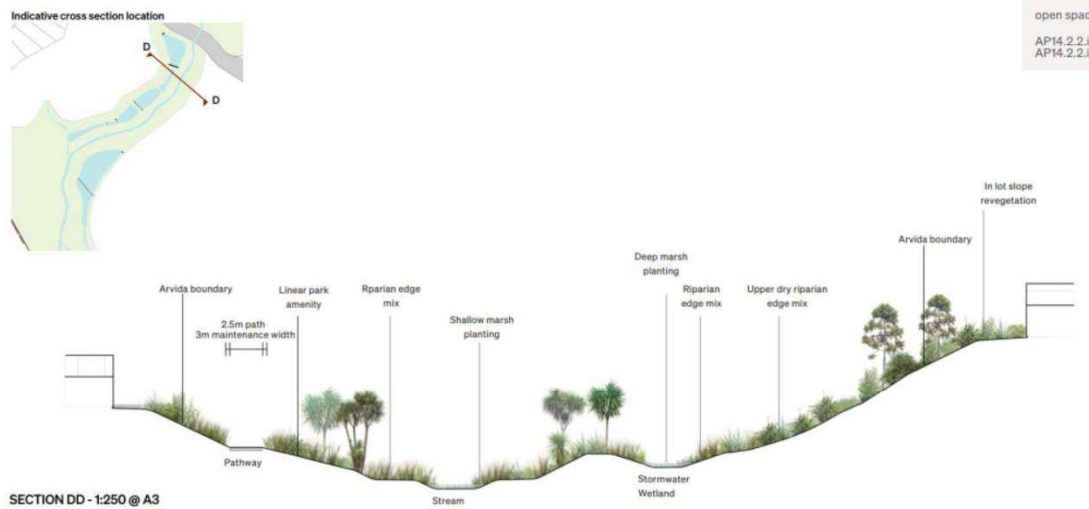
Figure 1: Indicative cross section through the proposed Kākā Stream and Linear Reserve

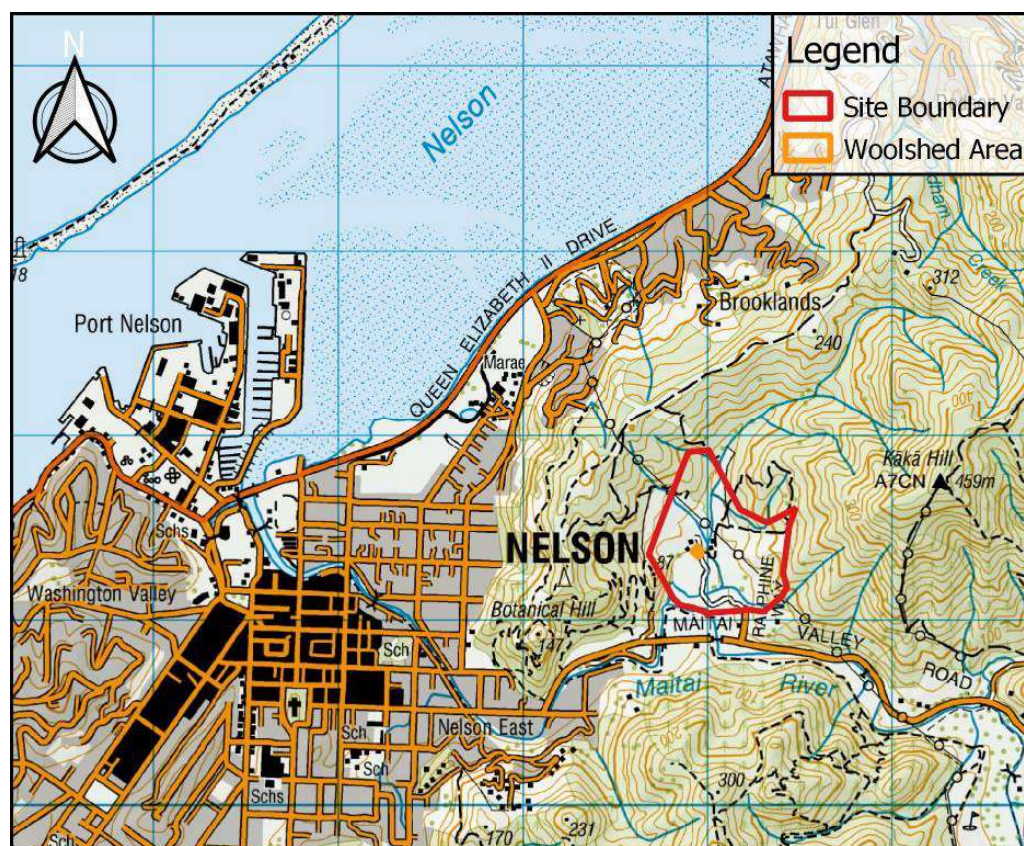
Figure 2 - Site location

The location and layout of the site are shown in Figures 2 and 3. Proposed development plans are presented in Appendix A.

Topsoil from the southern paddock and former homestead (the proposed high-density residential areas – refer Figure 2) exceeds NCC recognised background values. Marginally elevated concentrations of copper, nickel and chromium are associated with ultramafic rock formations (i.e. naturally elevated) and not considered to pose a risk to receptors.

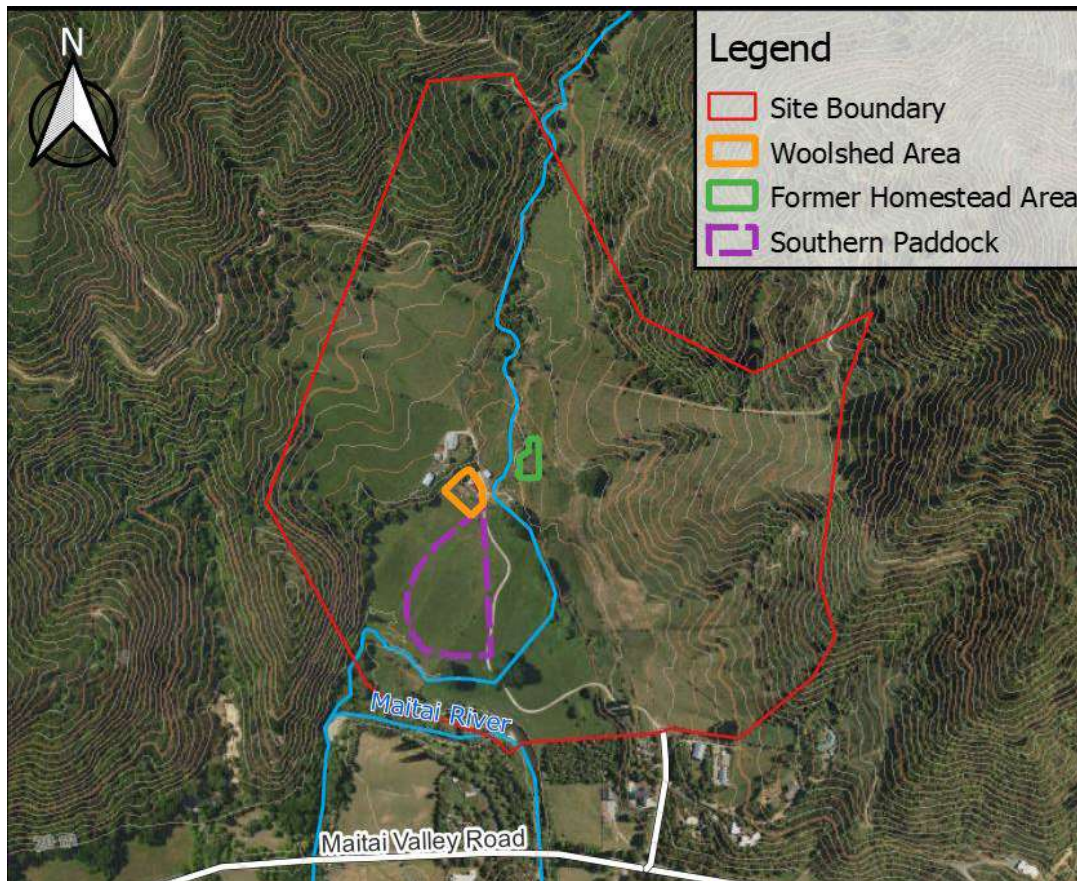
Figure 3 - Site layout

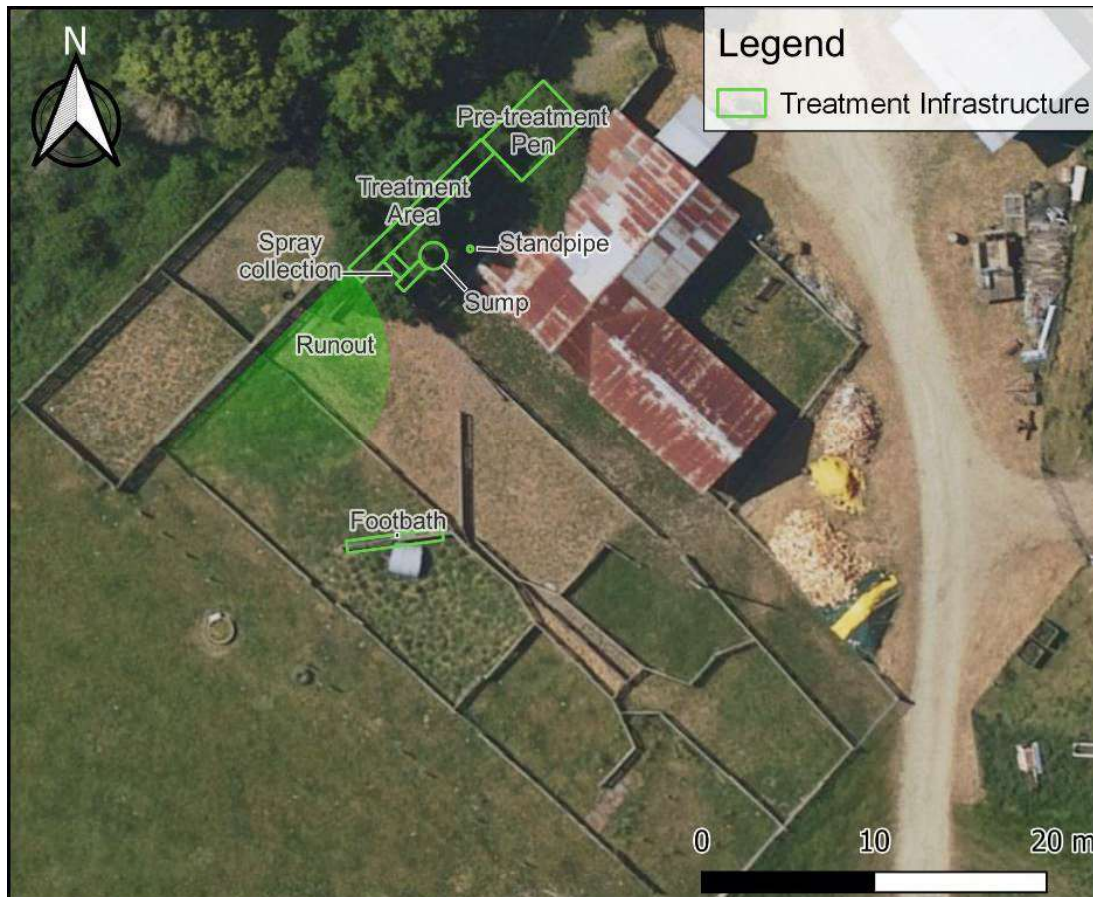
Figure 4 – Treatment infrastructure layout

An inspection of the area west of the woolshed revealed historical sheep treatment infrastructure including holding pads, chemical draining infrastructure and sump, and a standpipe which may have been used for water supply. A footbath was also observed towards the south of the woolshed. These features are shown on Figure 4.

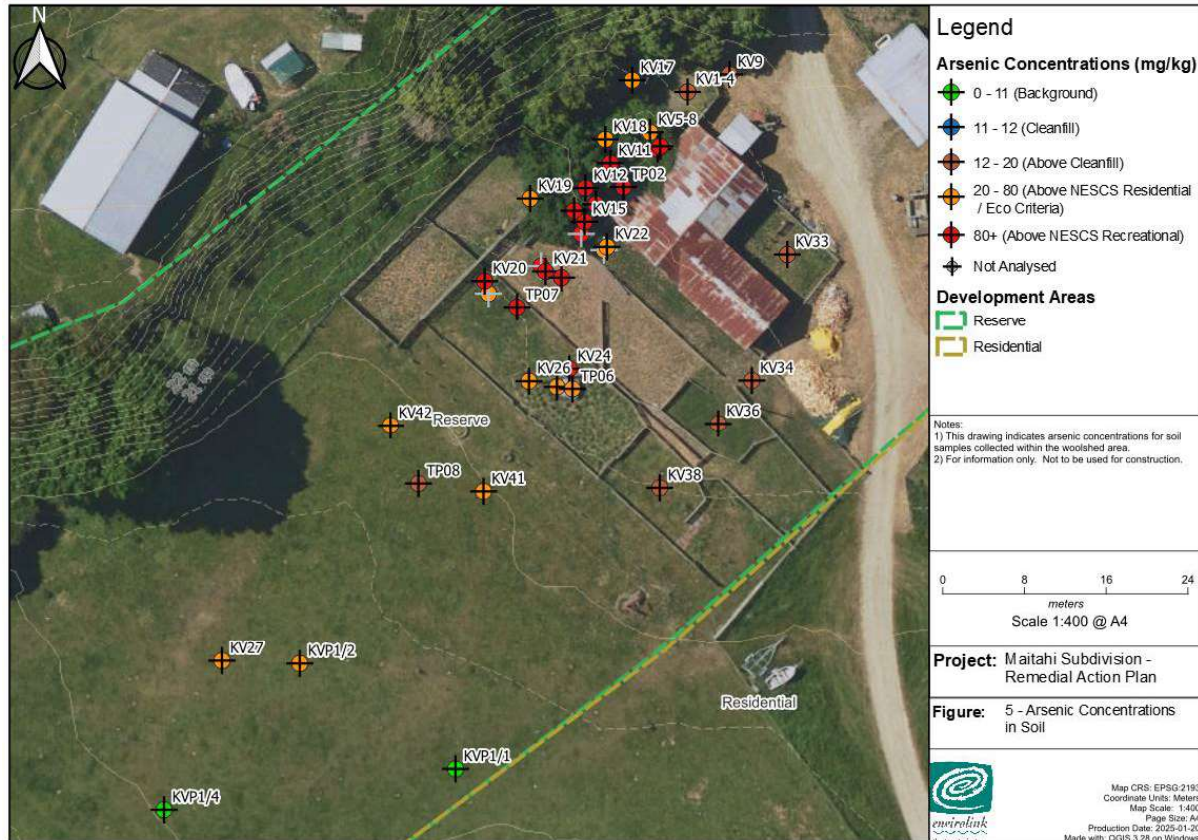
Figure 5 – Summary of arsenic results in soil within the proposed Esplanade Reserve

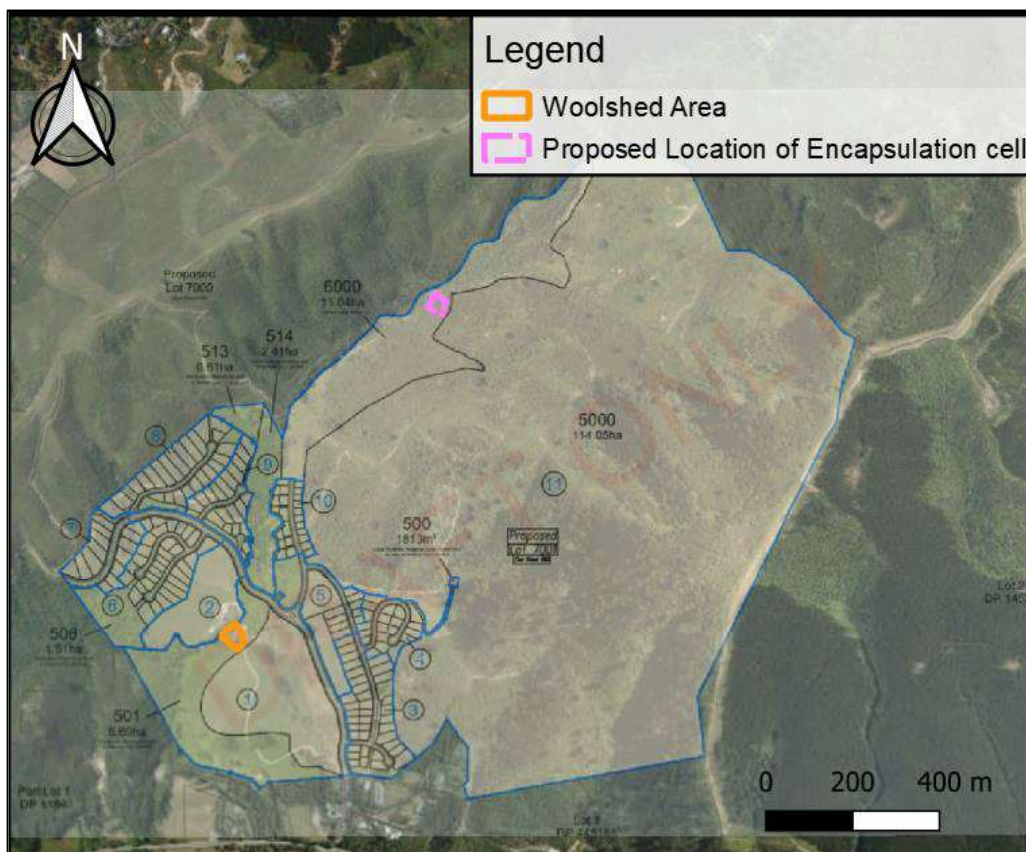
Figure 6 – Indicative location of the Encapsulation Cell

It is proposed that an encapsulation cell will be formed in this general fill area to enable the retention of significantly contaminated soils on site (approximate capacity of 300-500m³).

The approximate location is presented in Figure 6 below. The encapsulation cell will be designed to provide environmental protection (liner and appropriate cap). The exact location of the cell will be confirmed once the quantity of soil requiring encapsulation has been determined and a full engineering design has been approved. Following encapsulation this area will be landscaped and / or regenerated with native vegetation. This area is not proposed for any future development and will be legally protected through a formal land covenant, consent notice or similar.

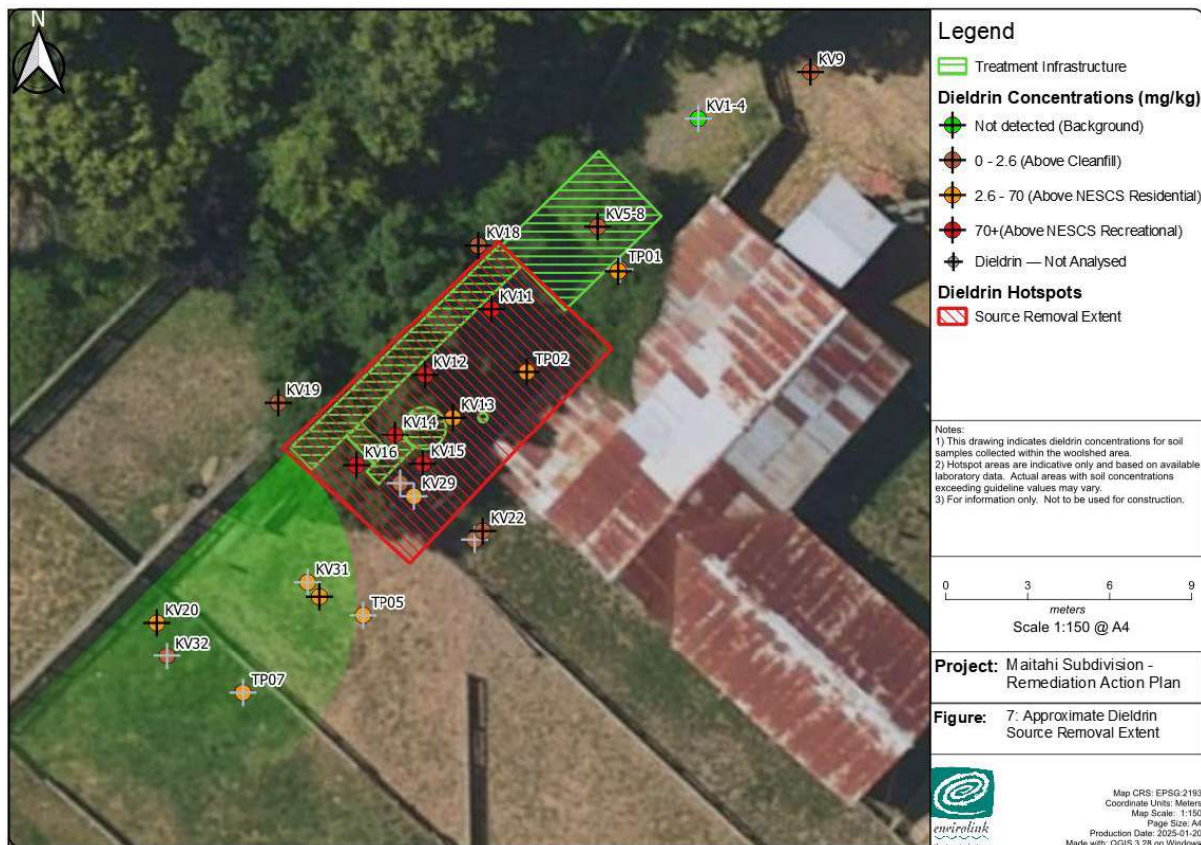
Figure 7 – Approximate dieldrin source removal extent (red hash)

- Pump out any residual liquid in the sump and place it in an IBC for testing to determine disposal or storage requirements;
- Remove sump and associated infrastructure;
- Mark out the proposed remedial extent;
- Strip the topsoil layer (silt) from the remedial area until the underlying material is identified (sand and gravel) at a depth of around 0.5 m;
- Place soil directly into bags for temporary storage in shipping containers;
- An XRF should be used as an additional tool to guide the soil remedial extents and depths in real time (generally elevated concentrations of arsenic indicate higher concentrations of dieldrin);
- Validate the stripped surface and edges of the source footprint to ensure remaining soil meets the applicable low POP content threshold for dieldrin (< 50mg/kg). If further exceedances are reported additional dig out, bagging and isolation will be required.

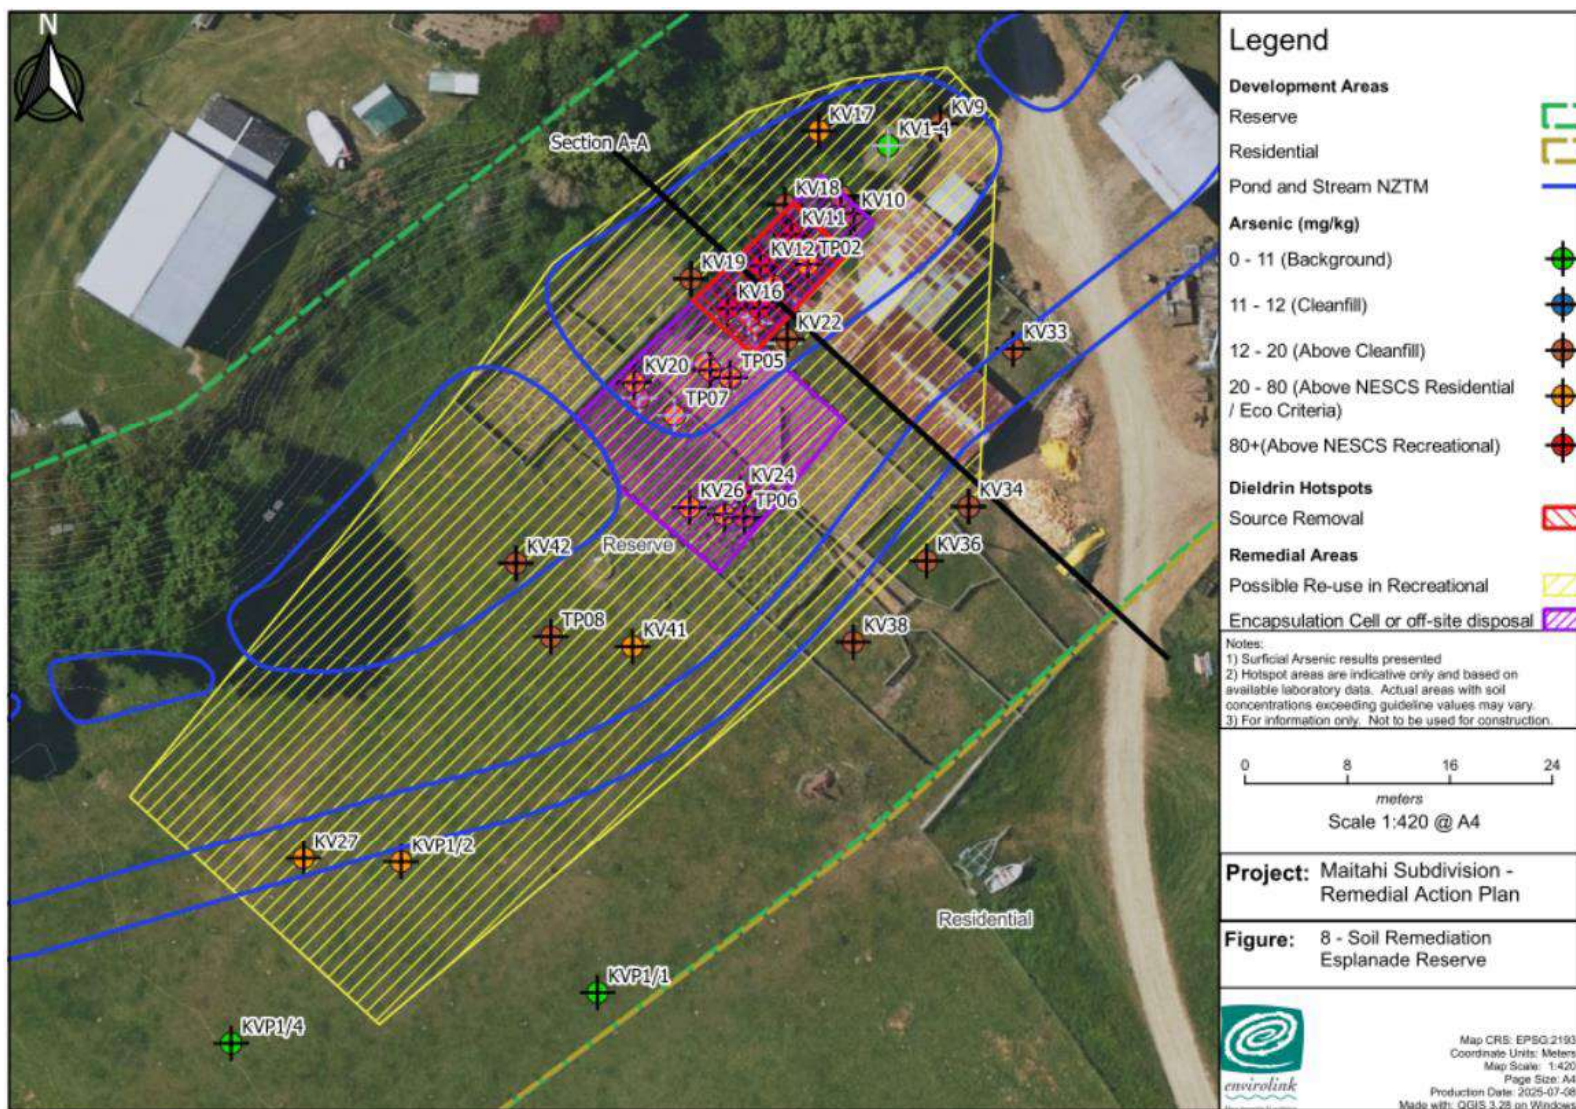
Figure 8 – Soil remediation extent esplanade reserve

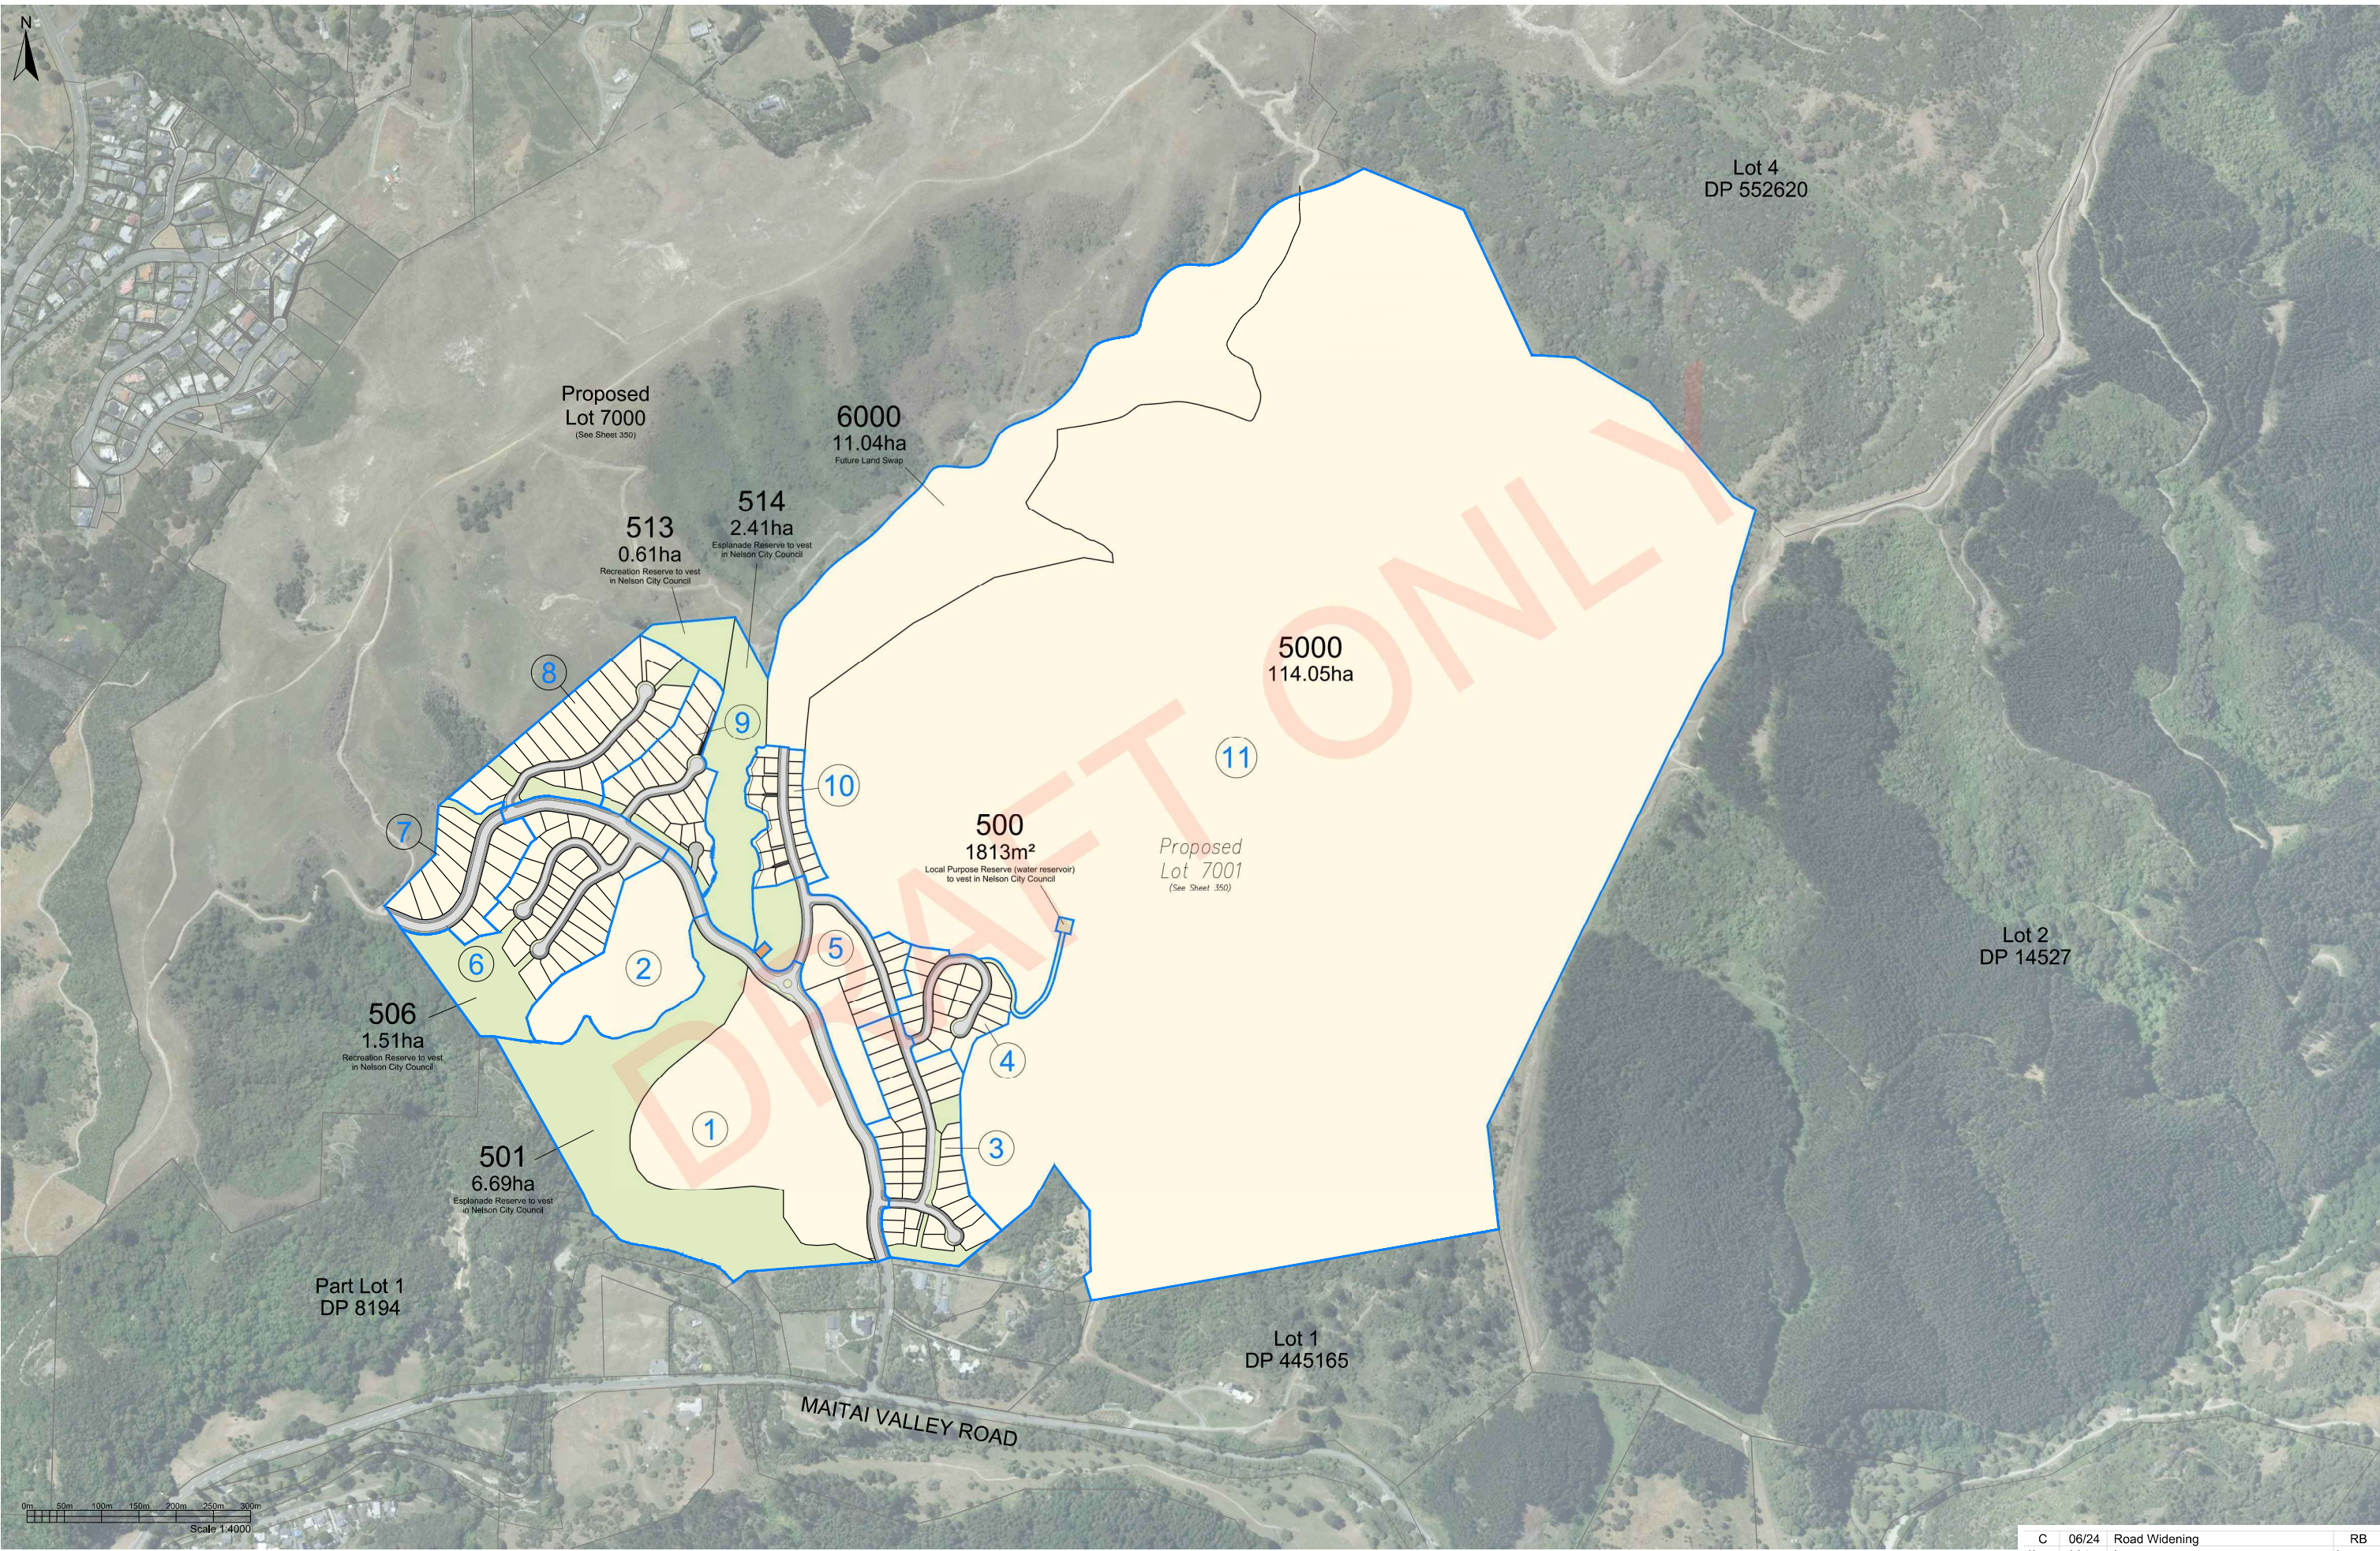
Appendix A
Proposed Subdivision Plan

CAD ref: 37470 - Scheme Plan (Issue C).dwg

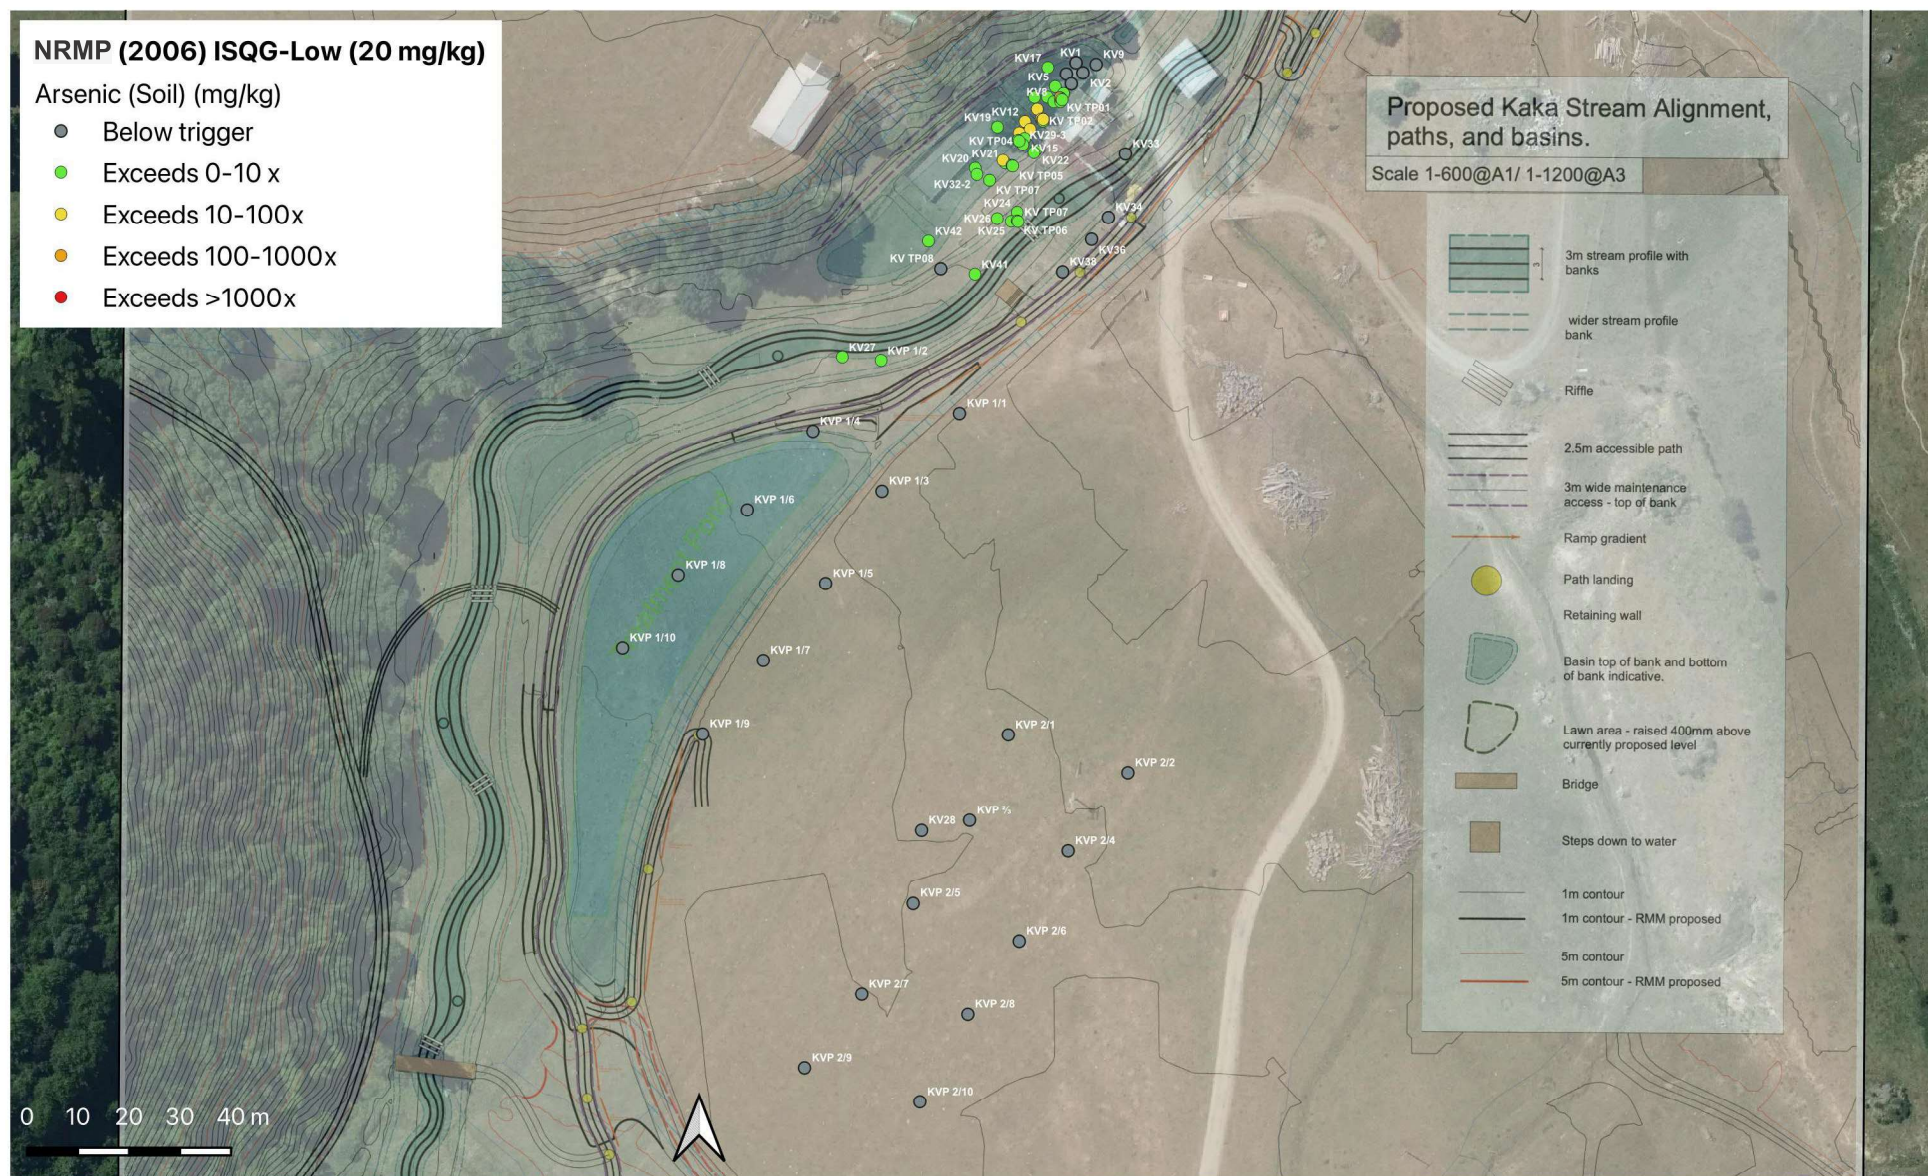
Figure 2B Overview of arsenic concentrations in soils at sampling sites in vicinity of the former sheep dip area and proposed stream realignment and esplanade reserve and the southeastern paddock. Refer to Figure 1 for an overlay of relevant features within the landscape plan.

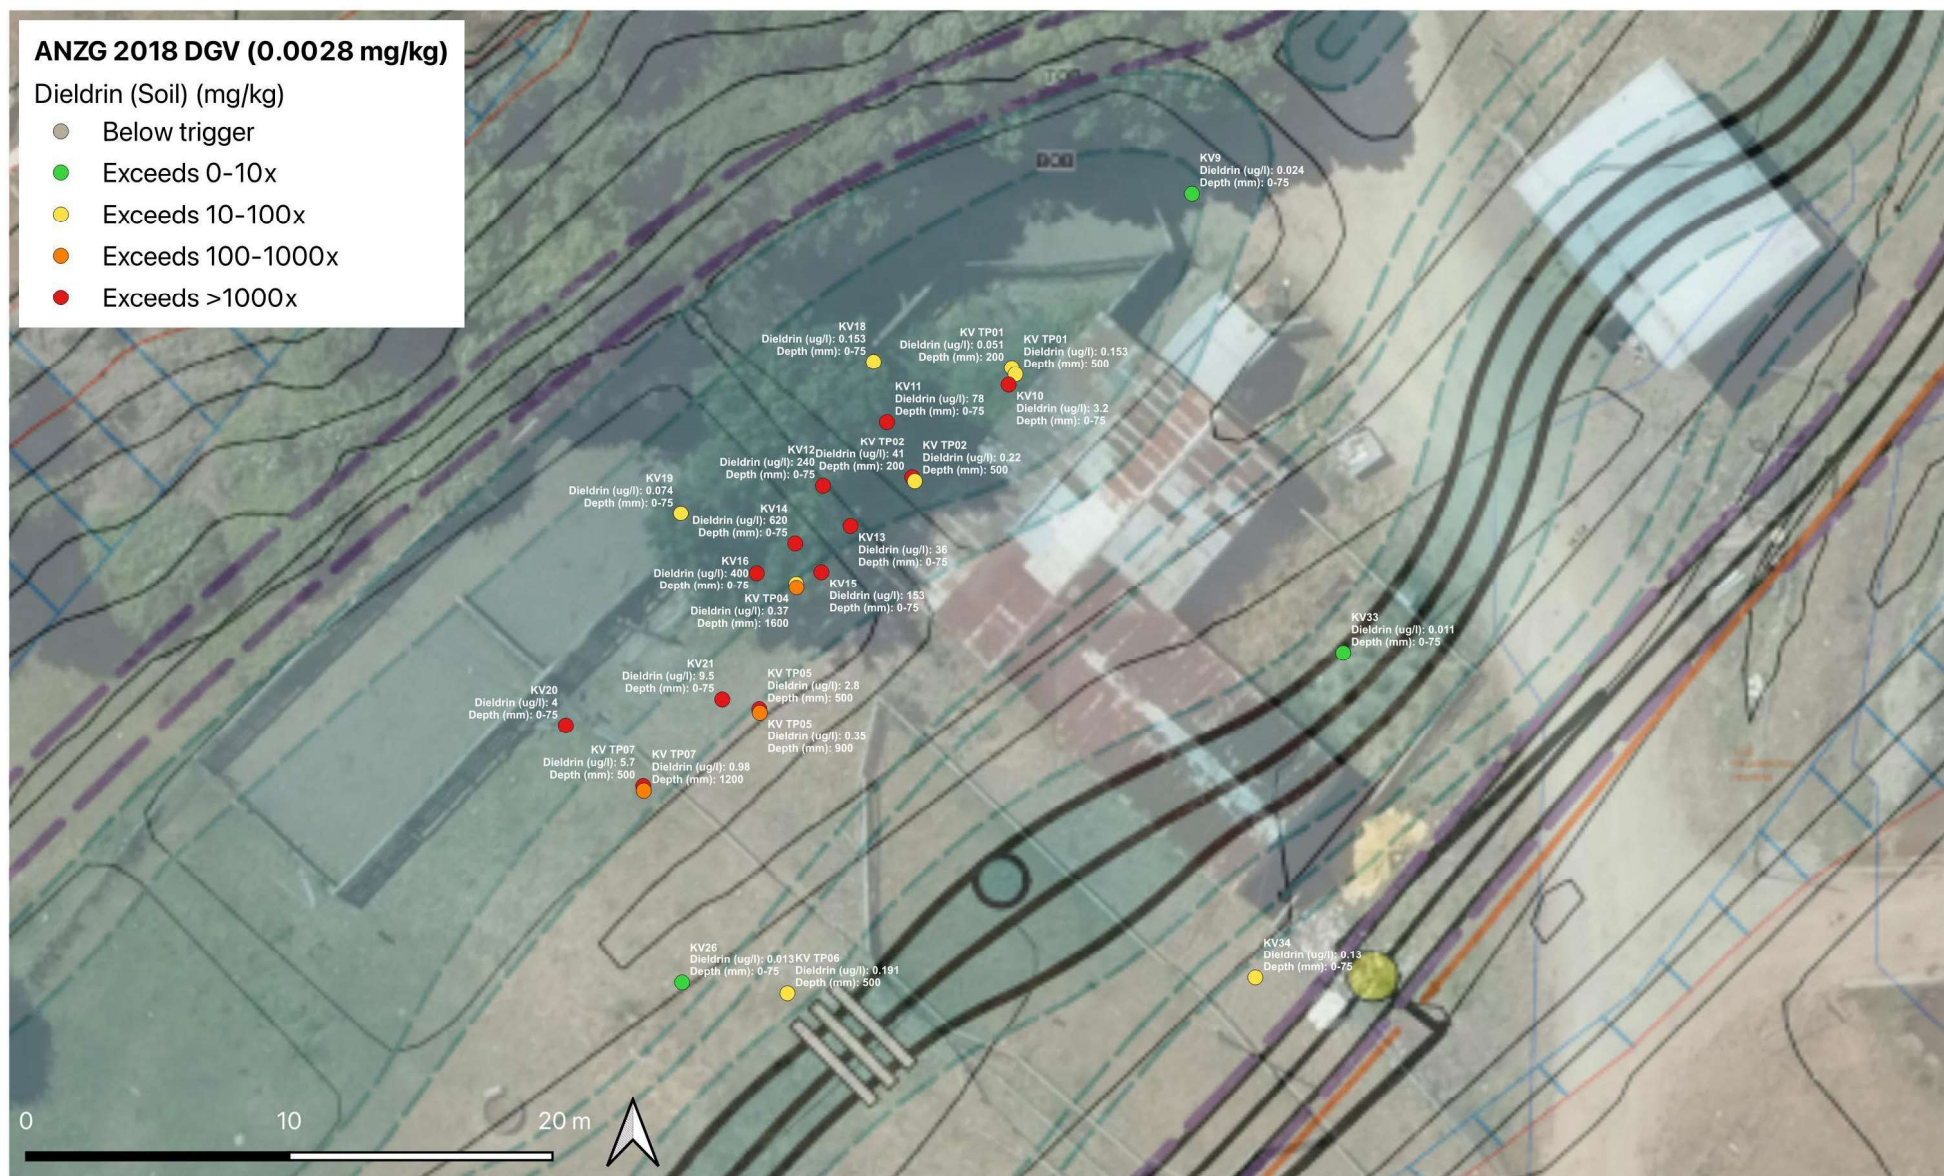
Figure 3 Deildrin concentrations in soils at sampling sites in vicinity of the former sheep dip area and proposed stream realignment and esplanade reserve. Refer to Figure 1 for an overlay of relevant features within the landscape plan.

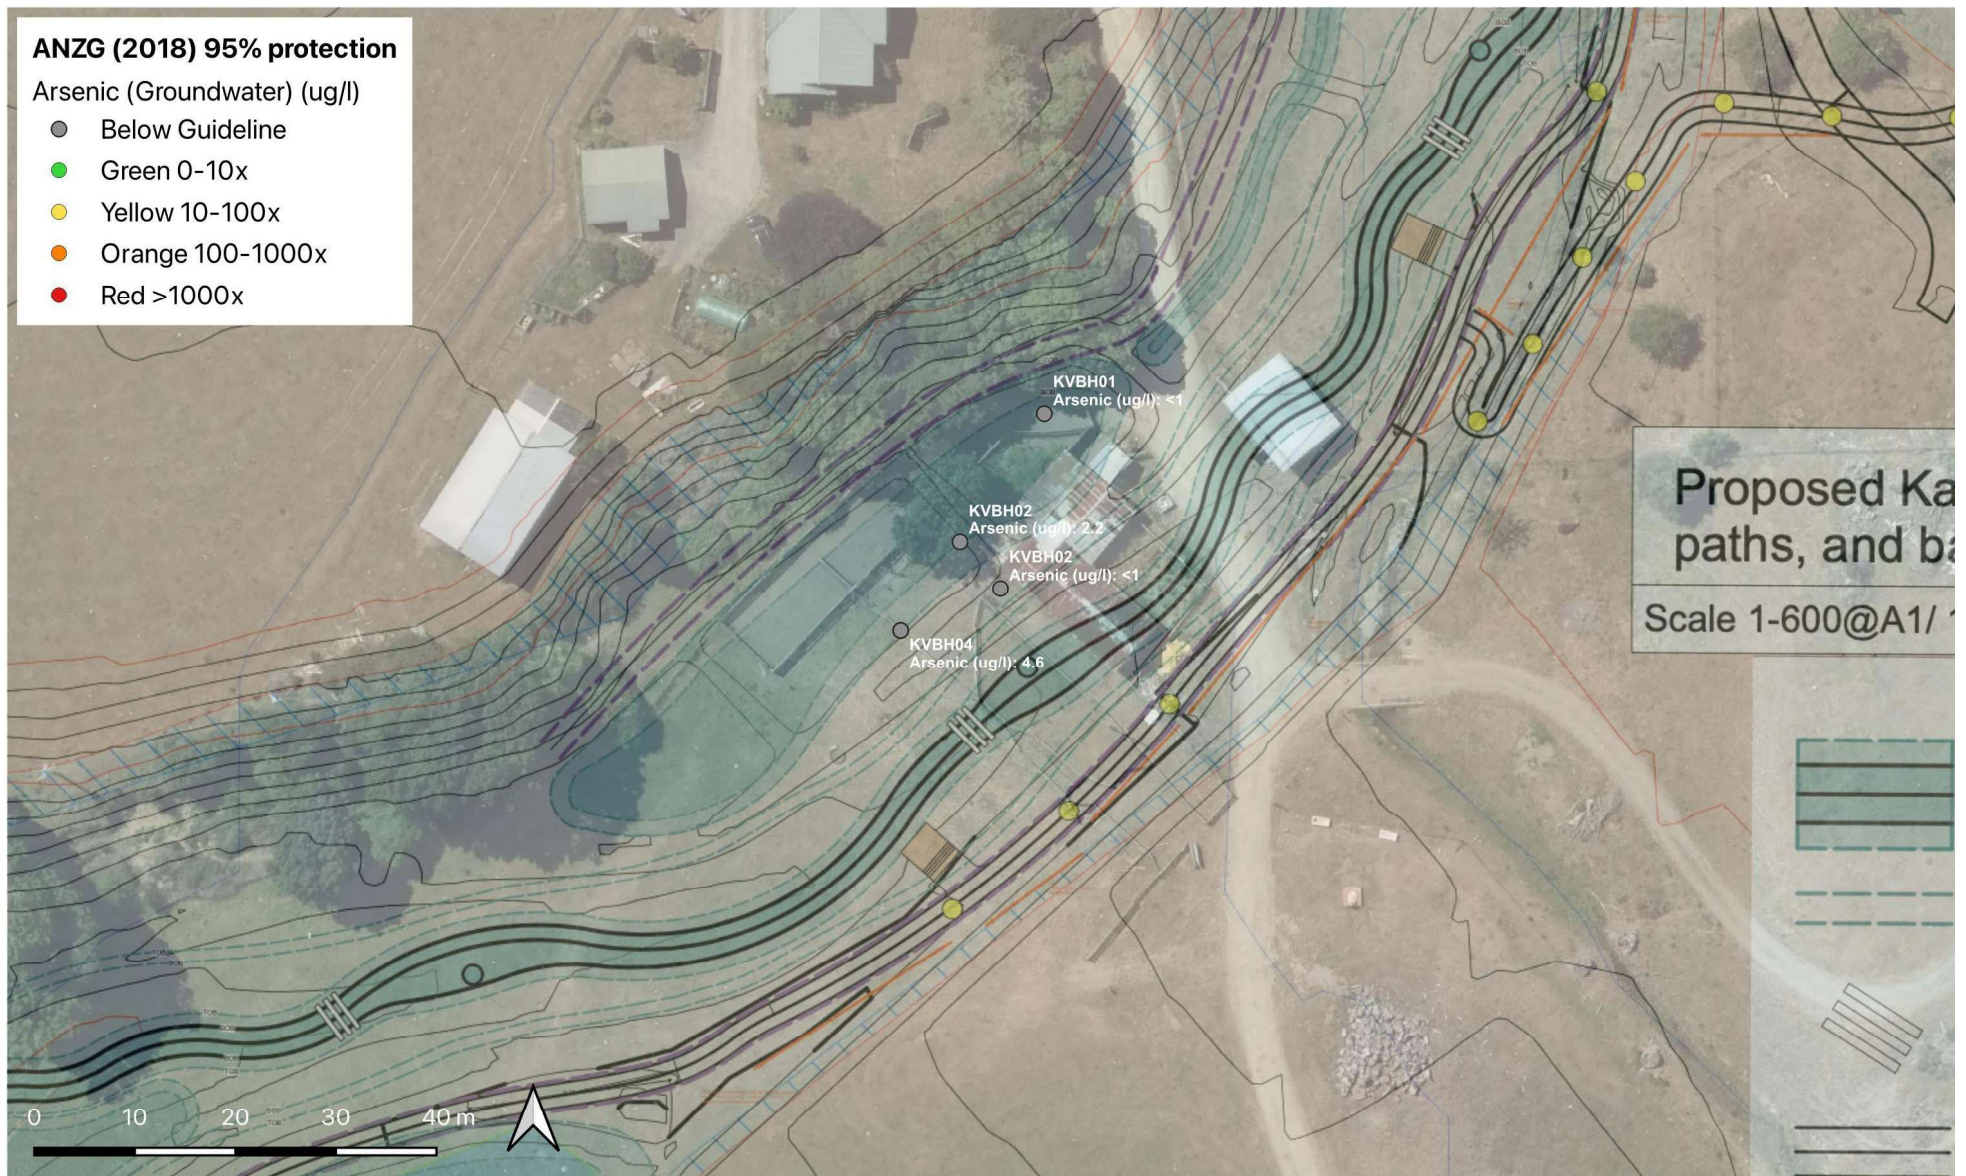
Figure 4 Arsenic concentrations in groundwater at sampling sites in vicinity of the former sheep dip area and proposed stream realignment and esplanade reserve. Refer to Figure 1 for an overlay of relevant features within the landscape plan.

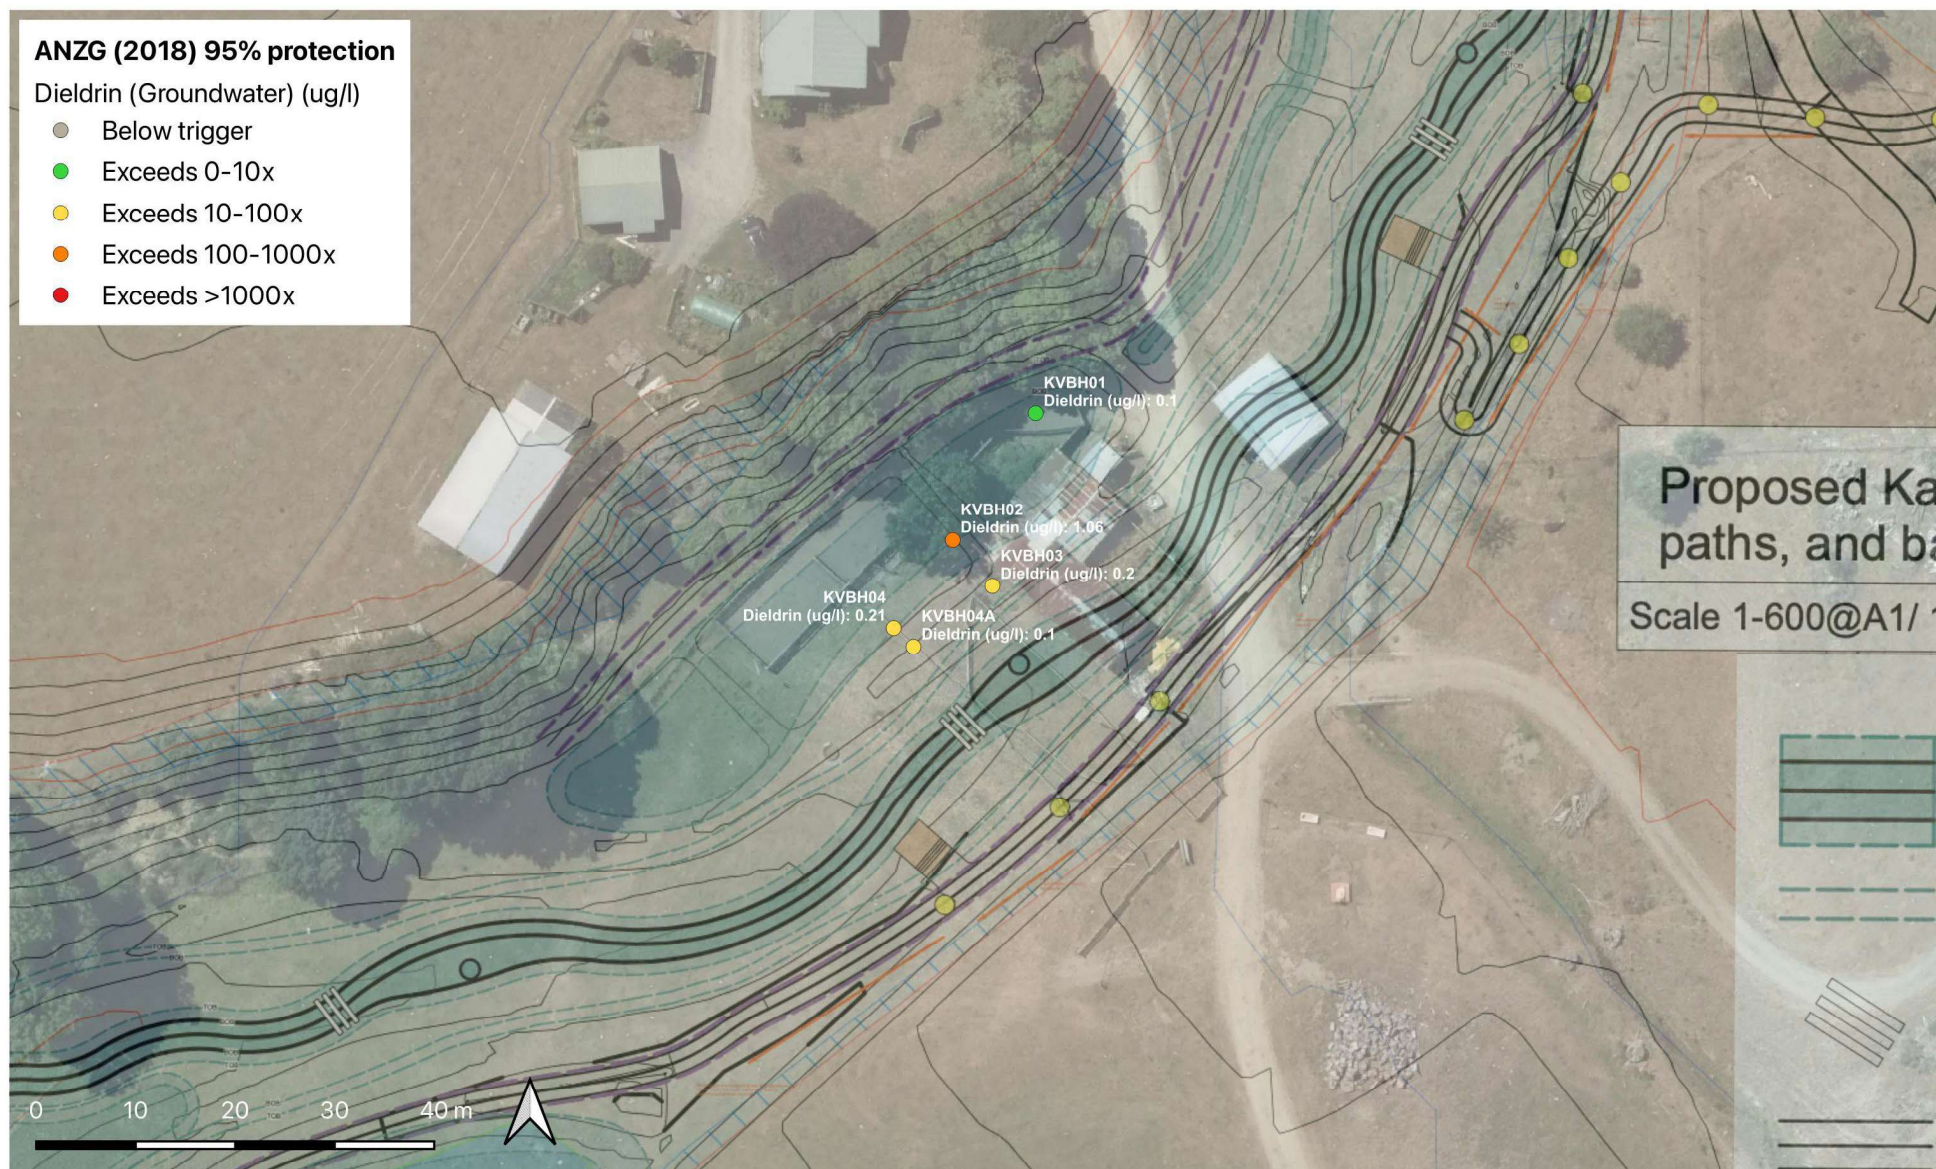
Figure 5 Dieldrin concentrations in groundwater at sampling sites in vicinity of the former sheep dip area and proposed stream realignment and esplanade reserve. Refer to Figure 1 for an overlay of relevant features within the landscape plan.
