Remediation Action Plan

**Maitahi Subdivision
7 Ralphine Way, Nelson**

CCKV MAITAI DEV CO LP

July 2025

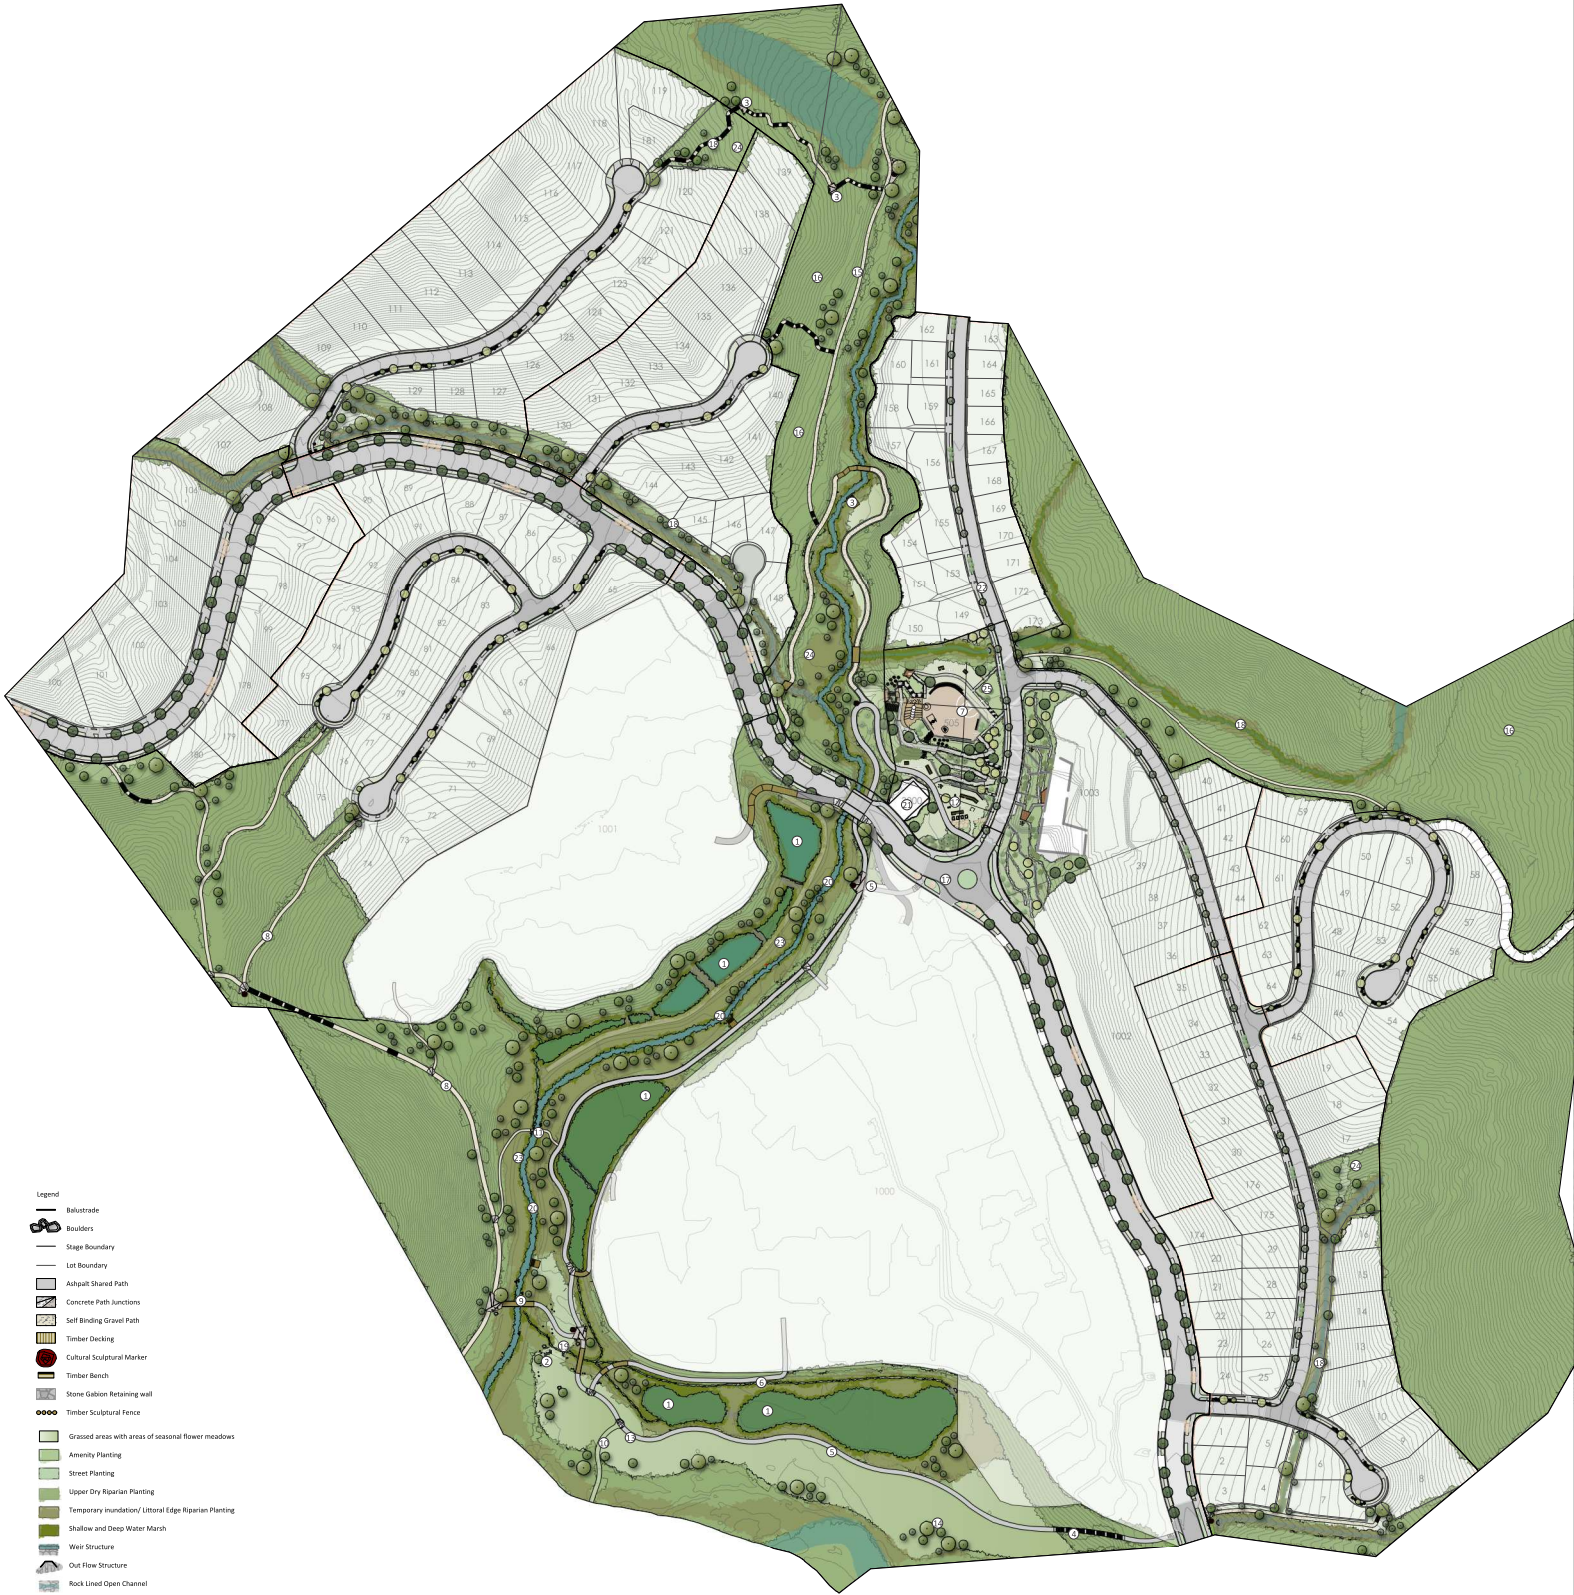
**Maitahi Development (Draft) Concept
Landscape Masterplan (RMM)**

- 1 Stormwater retention basins, planted with native rushes and sedges, Temporarily Inundated.
- 2 Informal play including stream access, boulders, planting, and balancing logs.

- 3 Pause Location with seating at outlook over stream.
- 4 Stairs to development entrance (100 steps 300mm treads and 160mm risers).
- 5 Shared Accessible Path with an average grade of 1:20/5%, with some areas including accessible ramps with handrails.

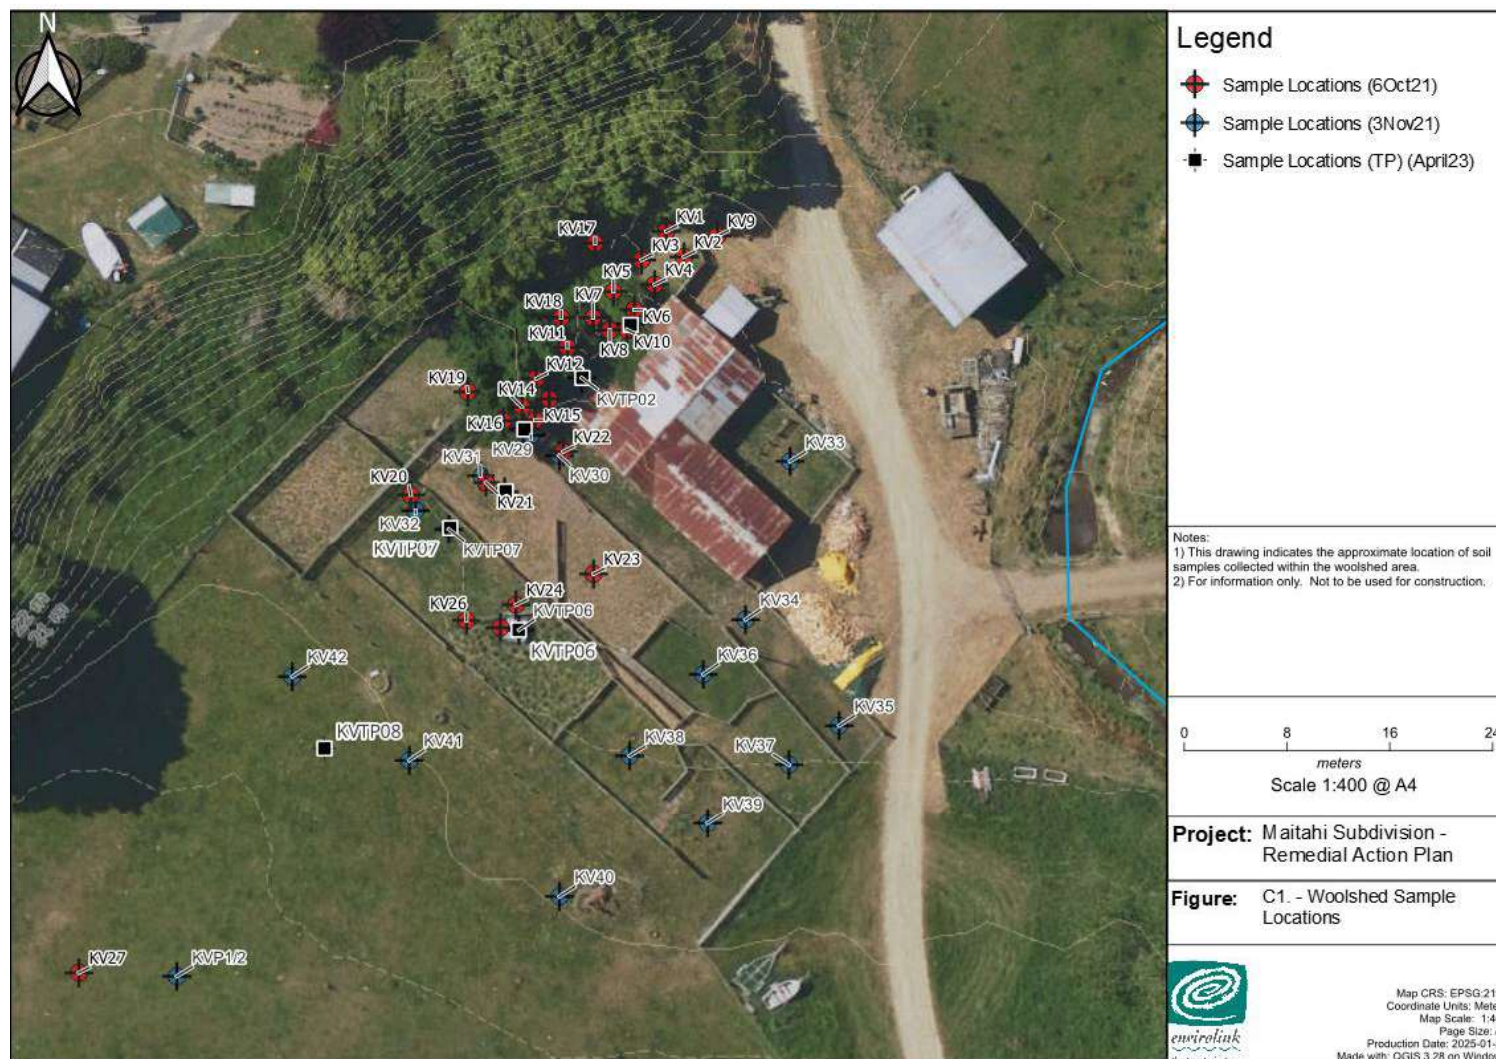
Figure C1. Woolshed Sample Locations

The proposed location of the test pits is shown on Figure C.1 below. Test pits should be advanced to the depth of groundwater, which is estimated to be at 1.5 m below ground level.

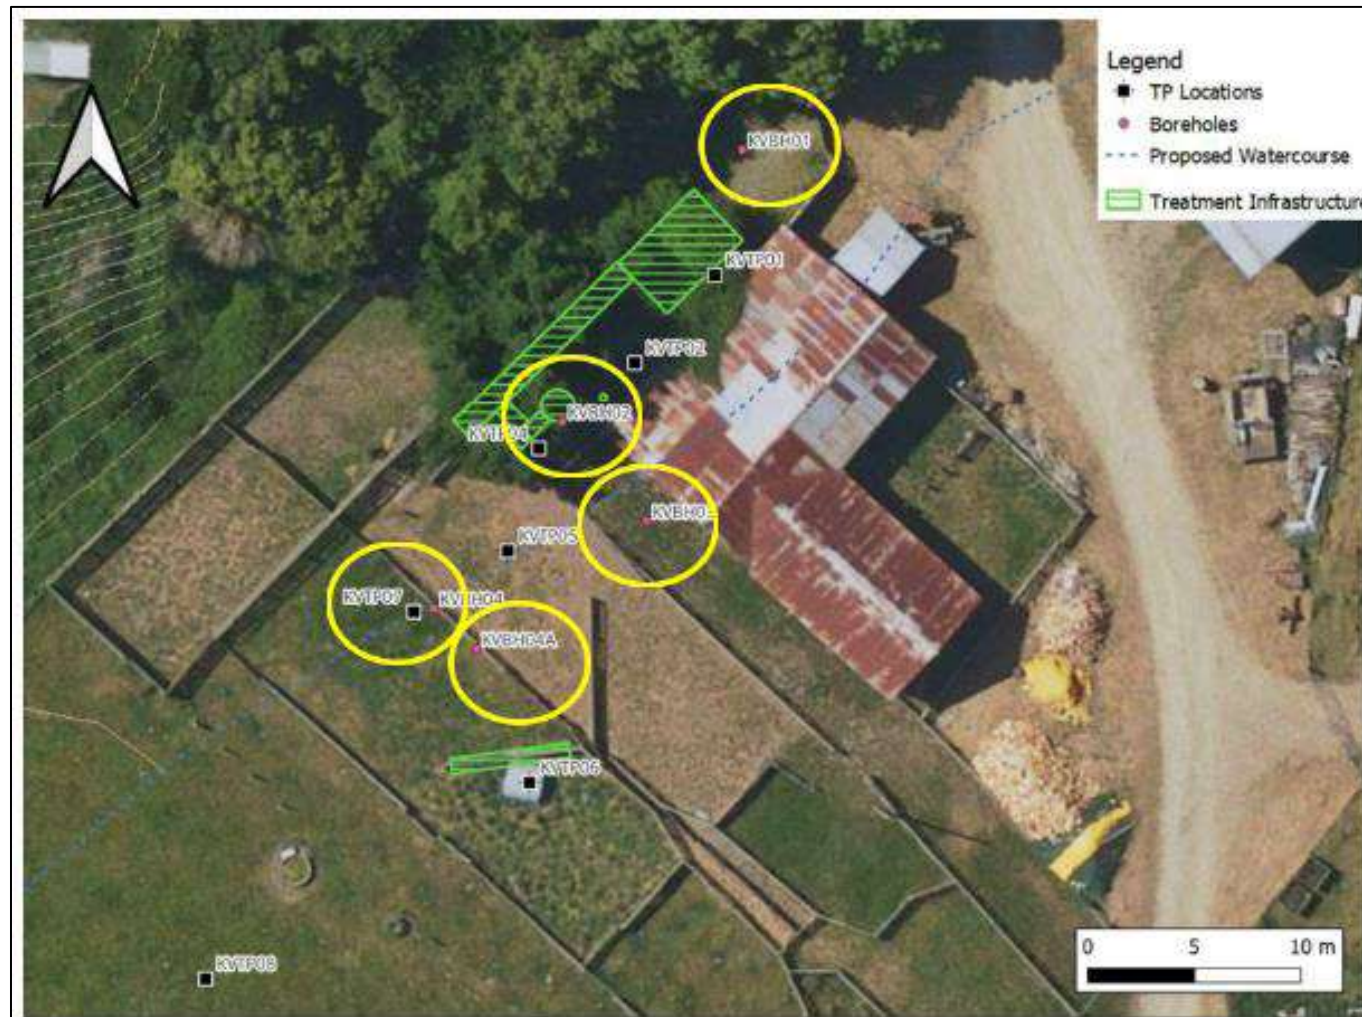
Figure C2: Bore locations

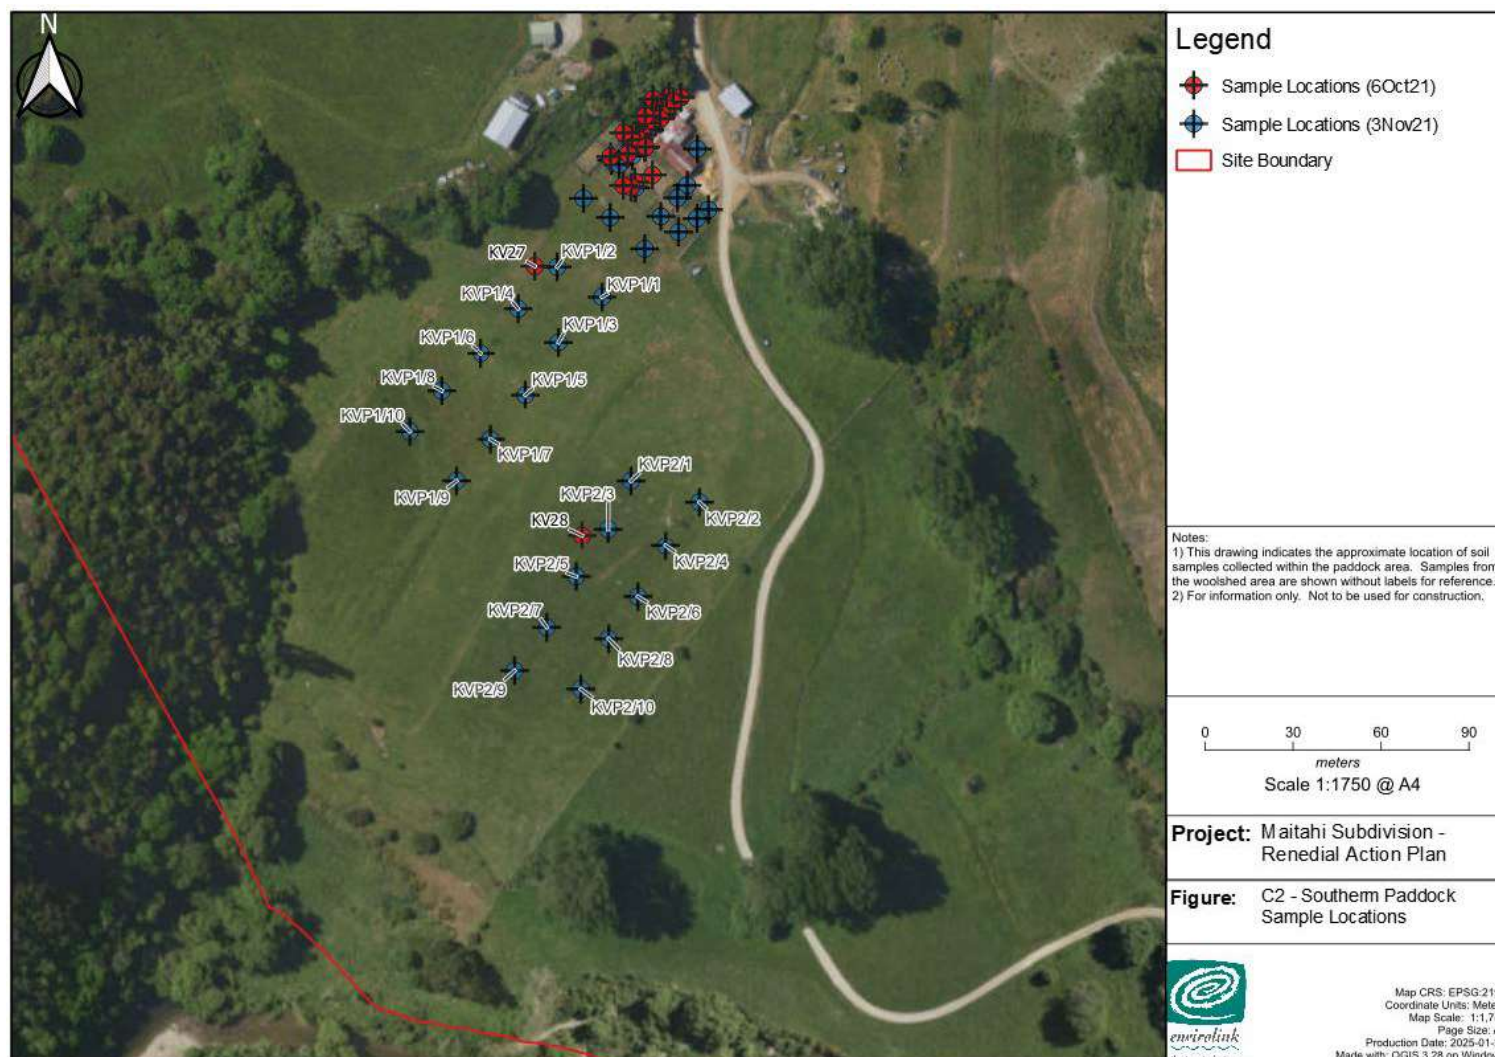
Figure C.3 Sample Locations – Southern Paddock

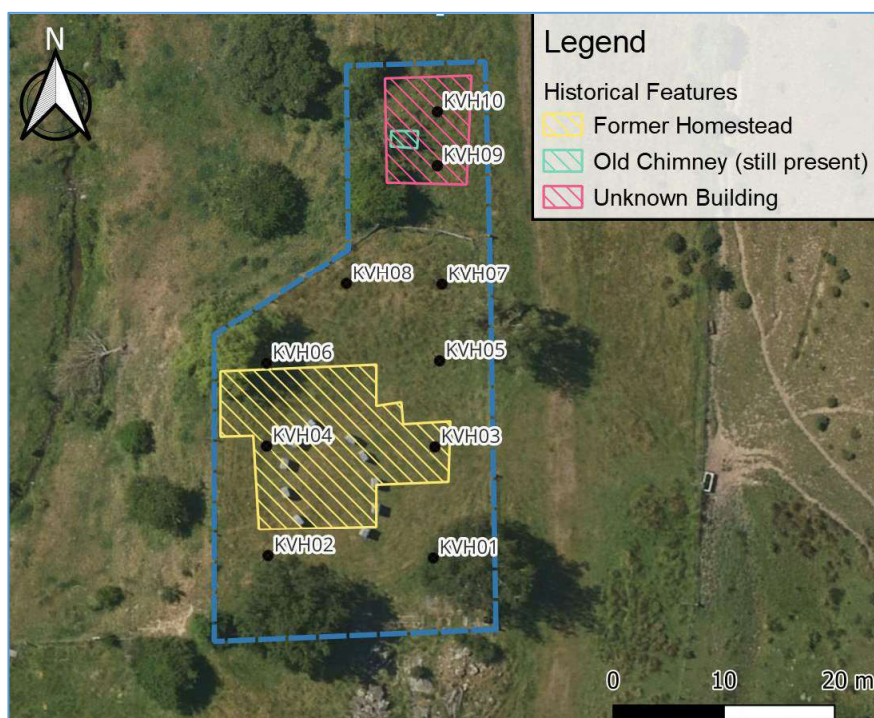
Figure C.4. Former Homestead Sample Locations

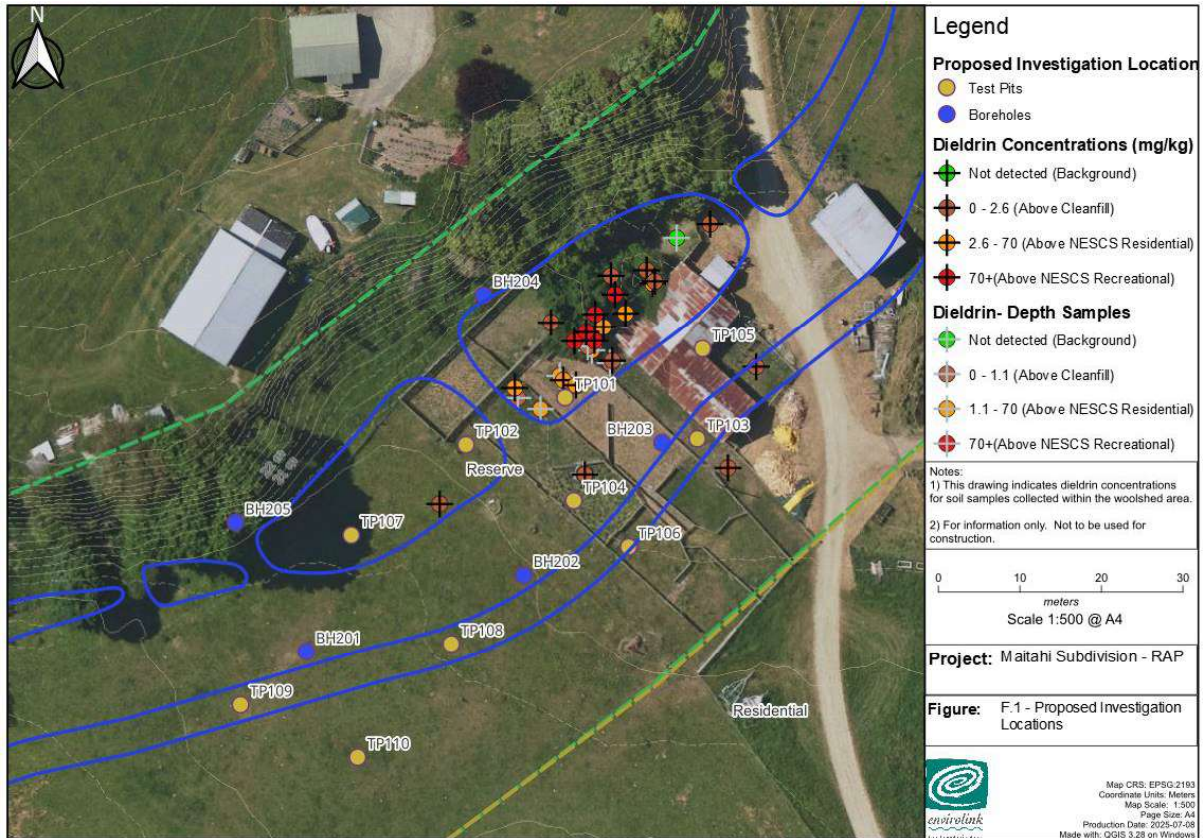
Figure F1. Indicative Location of Proposed Test Pits and Boreholes

Samples should be collected at the following depth intervals (or where any observations of contamination or changes in ground conditions are made) 0-75mm, 200-300mm, 500-600mm, 1-1.1m, and at the groundwater table. Samples should be analysed through an IANZ accredited laboratory for dieldrin and arsenic. Initially only the shallowest two samples will be analysed, the remaining samples should be held cold in the laboratory. Ultra trace methods should be used for dieldrin analysis in the laboratory.

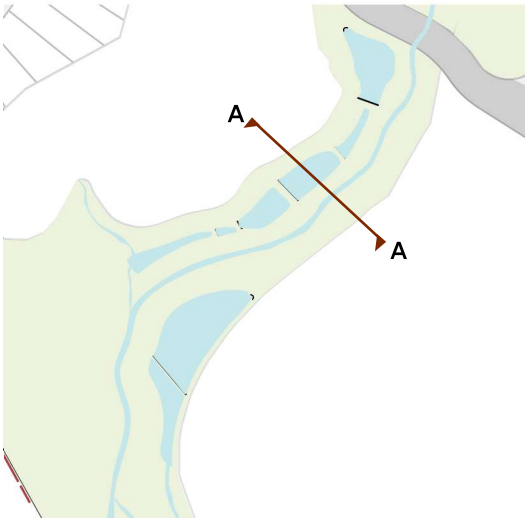
SECTION AA - 1:250 @ A3

Land Contamination Cross Section AA

Indicative Cross Section Through Kākā Stream and Linear Reserve

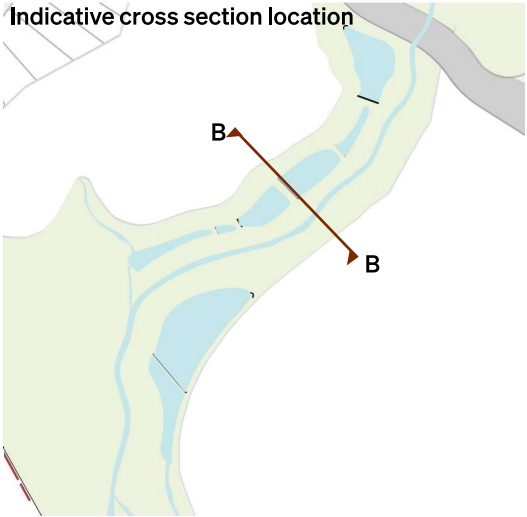
SECTION BB - 1:250 @ A3

Land Contamination Cross Section BB

Indicative Cross Section Through Kākā Stream and Linear Reserve

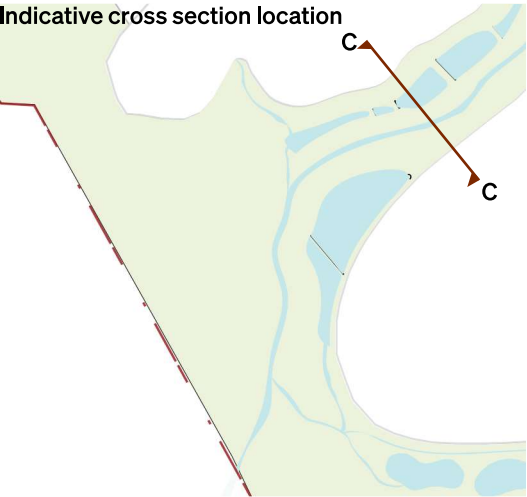
SECTION CC - 1:250 @ A3

Land Contamination Cross Section CC

Indicative Cross Section Through Kākā Stream and Linear Reserve

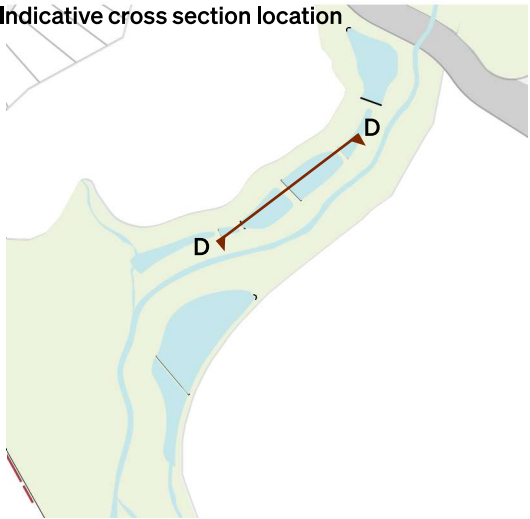
SECTION DD - 1:250 @ A3

Land Contamination Long Section DD

Indicative Cross Section Through Kākā Stream and Linear Reserve
