# Remarkable Ski Area Upgrade and Doolans Expansion Freshwater Ecological Impact Assessment

Prepared for NZ Ski  
Limited

August 2026

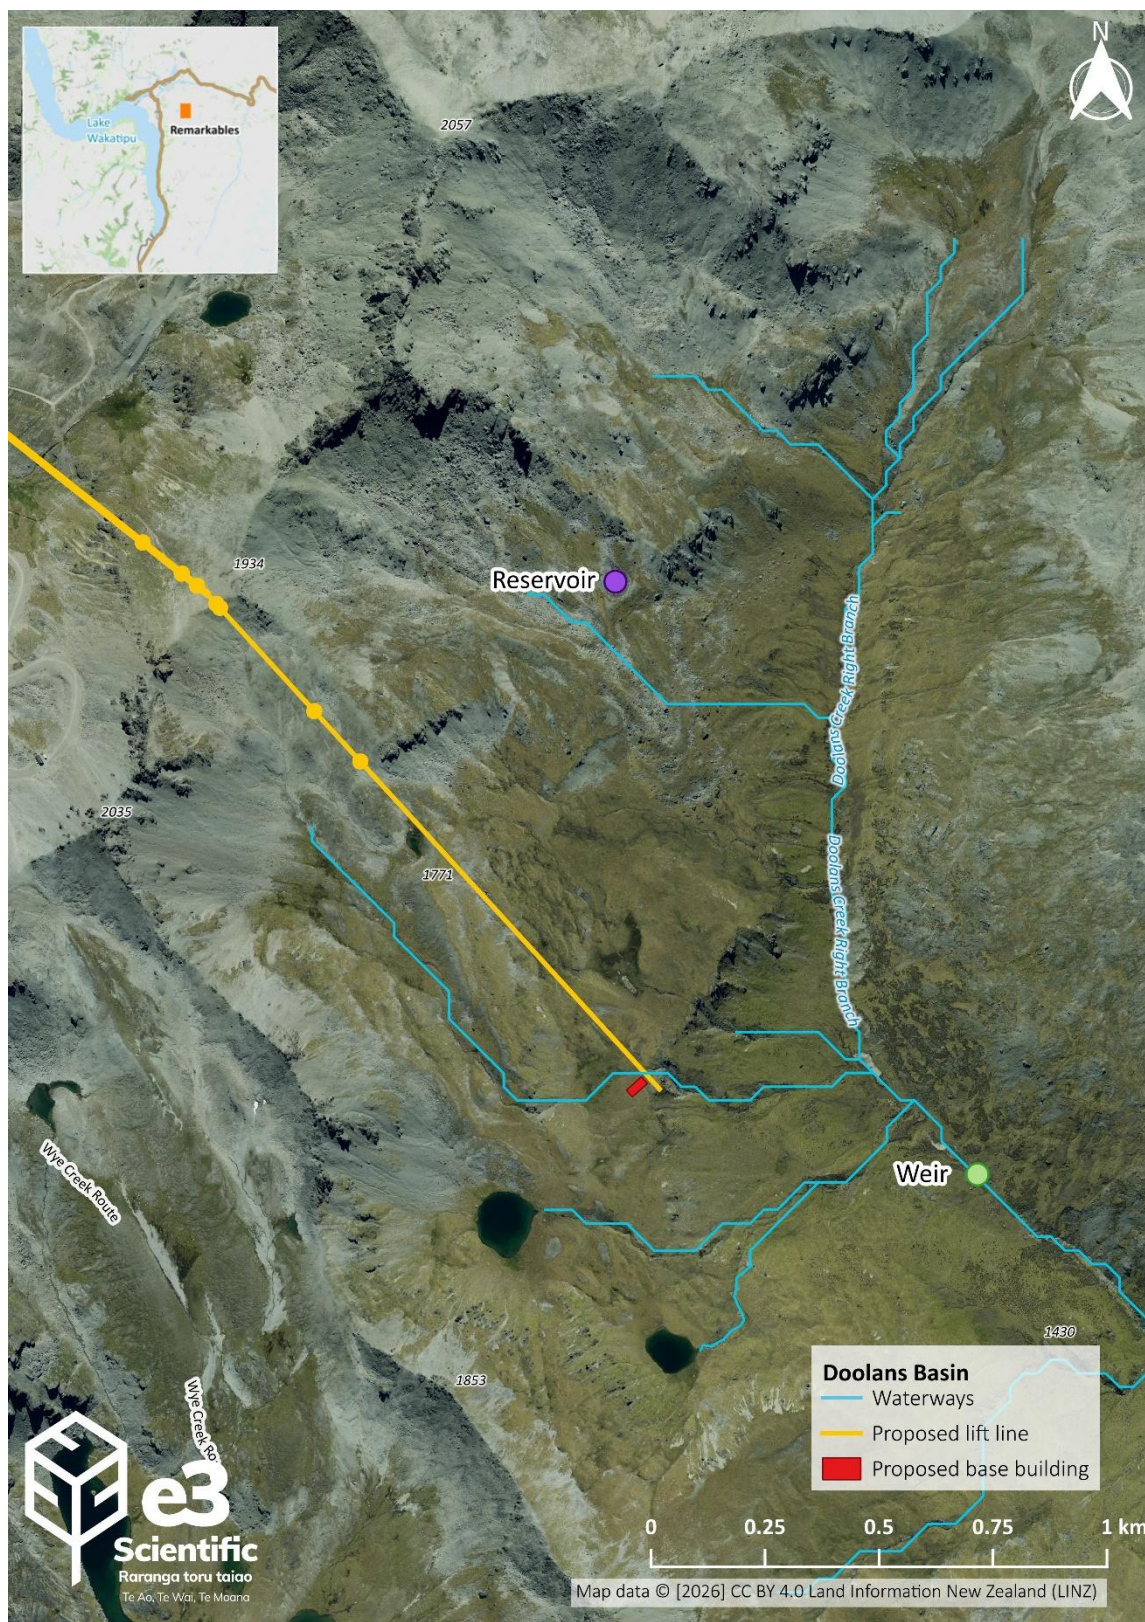
Figure 1: Study area overview, with location in inset.

NZSki are proposing to extend the Remarkables Ski field into the Doolans Basin located east of the existing ski field (Figure 1). The development of this proposed ski field requires earthworks associated with lift towers for a new lift line, a new base building and roading. Some instream earthworks and a water take associated with the development of a water reservoir for snow production is planned also. A characterisation of the freshwater ecological values present for the Doolans Creek Right Branch (hereafter called Doolans Creek) where the weir installations and water abstraction is to occur and tarn habitat where a tarn is to be reclaimed for water storage is therefore required to outline the habitat and freshwater values present within this area.

The abstracted water will then be pumped to the northernmost tarn for storage (Tarn 3) (see Figure 1). This tarn will be modified to be lined with geosynthetic liner to allow for effective water storage over the snowmaking season (e3Scientific 2026a).

A water storage reservoir with a surface area of 4,450 m<sup>2</sup> is proposed to be established at the site of an existing alpine tarn (Figure 1). The reservoir will be ~3 m deep and enable the storage of 19,000 m<sup>3</sup> of water. Earthworks will be required to establish the reservoir foundation and fill embankments and create swales to divert water around the site (Stantec, 2026). A pump station will be used to pump water from the Doolans Creek to the reservoir, and a further pump station will be located near the reservoir to pump water for snowmaking, potable water and firefighting purposes. The reservoir will be lined with impervious geosynthetic liner to ensure water is not lost from the system.

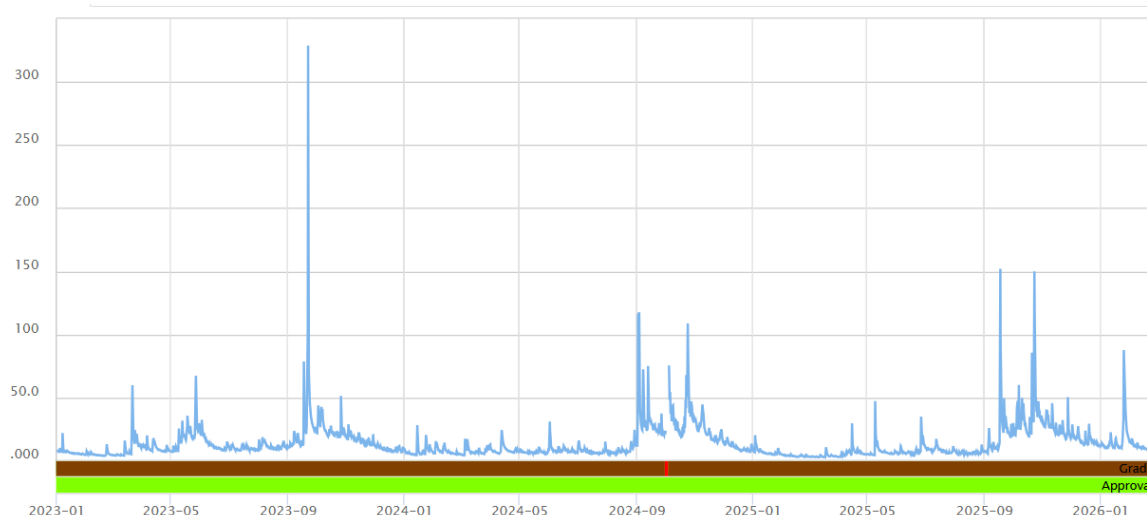
**Figure 2: Hydrograph for the Nevis River at Wentworth Station for the last 3 years (Source ORC Website accessed February 2026).**

Doolans Creek typically has a low flow period from January to August and high flow period September to November during the spring snow melt (Figure 2) (ORC Website Accessed February, 2026).

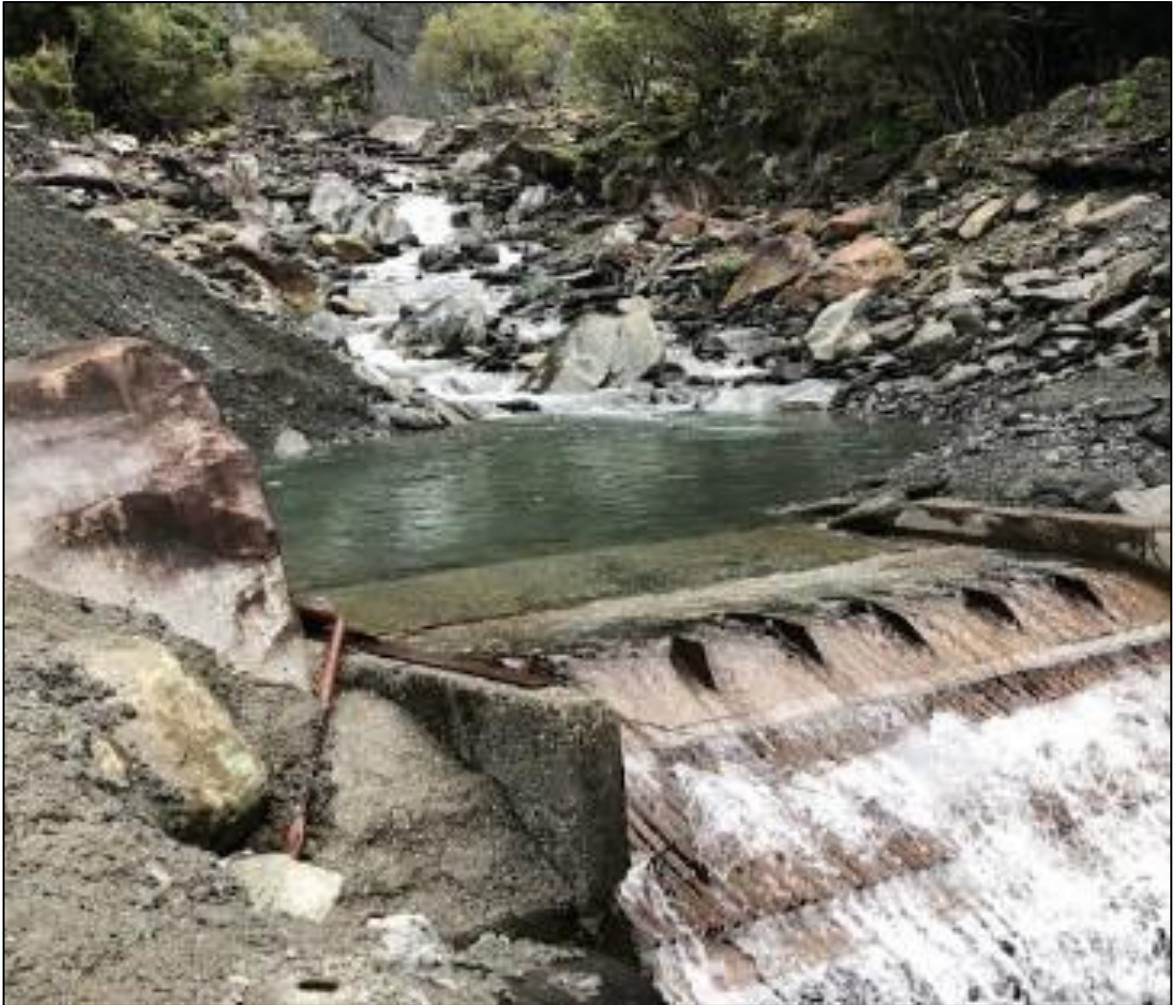
**Figure 3: Example of a Tyrolean weir (Source: Stantec, 2025).**

The Tyrolean intake design (Figure 3) allows most bed load to continue downstream while screened water passes through the slots (Stantec, 2025). The water will then be pumped to a nearby low head pump chamber. The system will have facilities to use the pumps at the pump station to back flush sediment and gravel from the sediment trap and pump chamber, back to Doolans Creek. It is anticipated this would be undertaken once per year prior to the water take operation for the winter season to remove any gravel and sediment that has accrued in the previous season. Any extra water utilised to flush the system will be returned to the Doolans Creek approximately 45 m downstream (Figure 4). The downstream flushing pipeline may lay across some wetland habitat described (and assessed) in the terrestrial ecology impact assessment (e3Scientific, 2026c). The weir will be constructed of steel, precast concrete and some *in situ* concreting to fill voids and ensure a strong foundation. Excavation of the stream will be required to install the precast flume unit. No coffer dam or stream diversion is planned, rather the excavator will undertake work within the stream during a dry period and associated low flow, best practice erosion and sediment controls will be in place and the weir will be assembled and installed onsite.

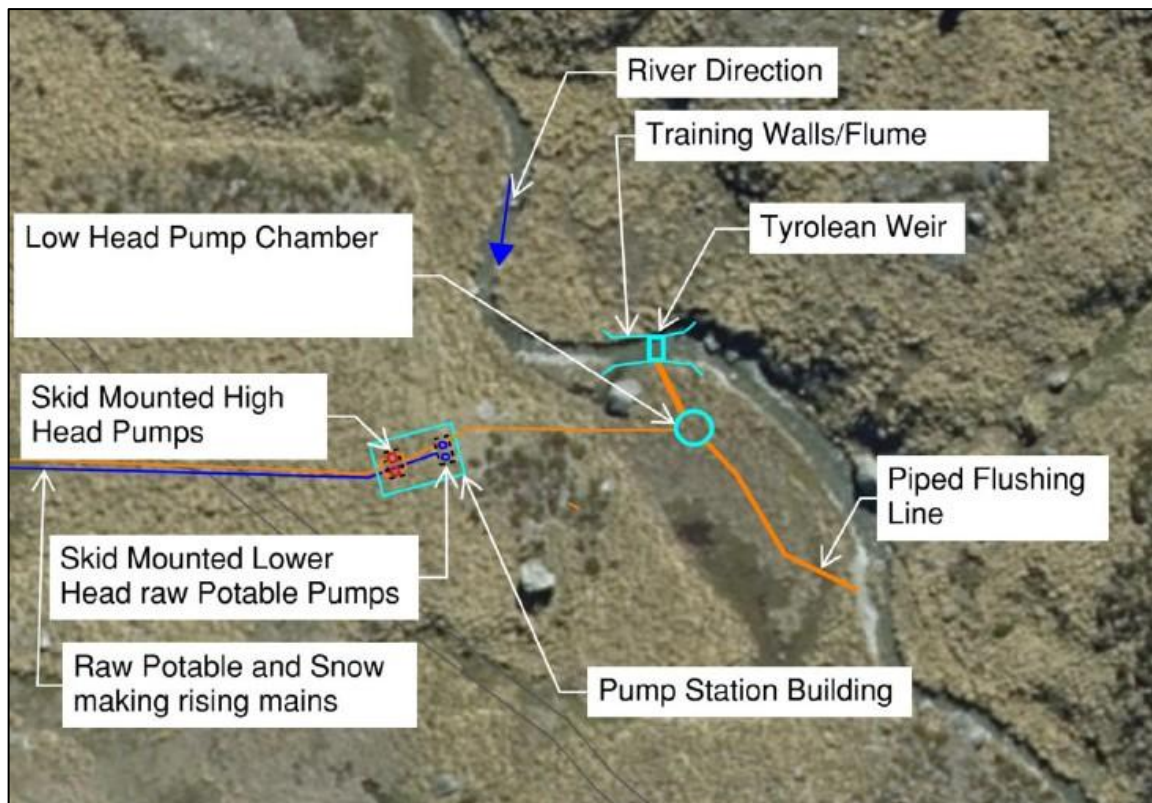
**Figure 4: Weir location and design (Source: Stantec, 2025).**

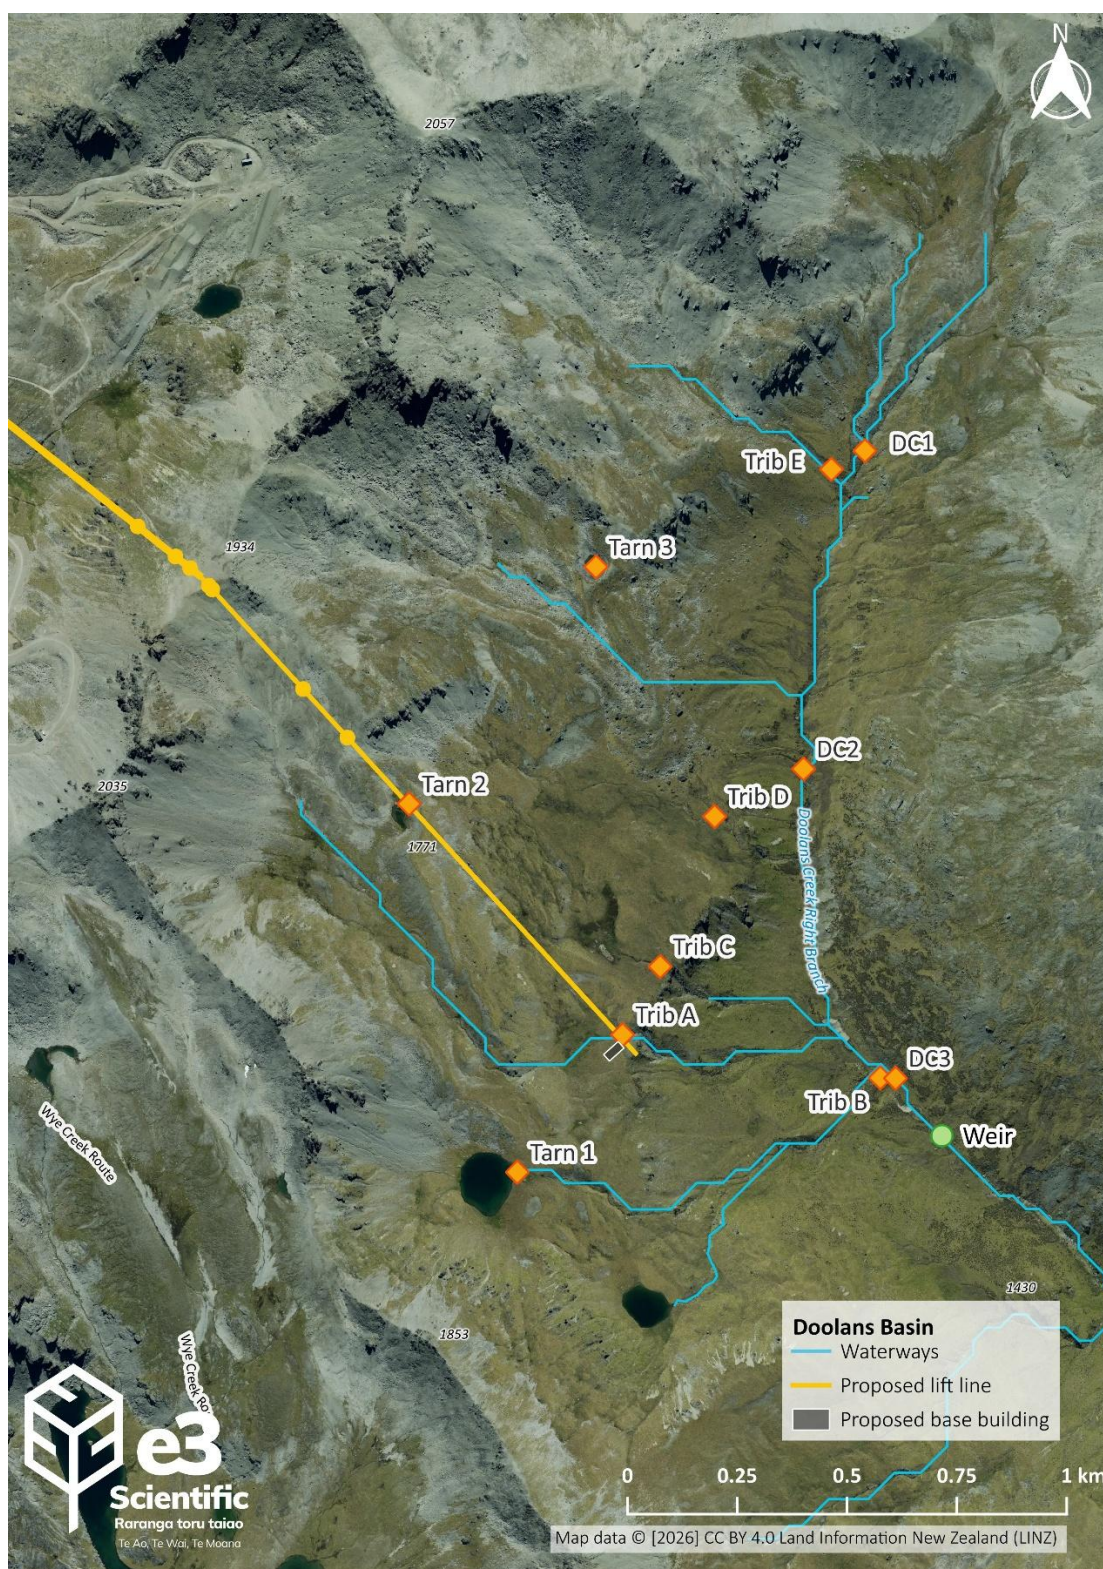
Figure 5: Tarn, Doolans Creek and tributary sampling locations (green diamonds).

location (Figure 5; Table 1). The main tributary inputs to the Doolan Creek Right Branch were also assessed to allow for a robust characterisation of the freshwater habitats and ecological context present.

Three of the four tarns present in the valley were also surveyed to assess the ecological values present. The fourth, most southern tarn, was considered far enough from activities to likely remain unaffected (Figure 5). Tarn 1 was large and deep and surrounded by tussockland. Tarns 2 and 3 were much smaller and shallower with tarn 2 surrounded by a herbfield and tarn 3 surrounded by bare rocks at low water levels and tussocks at higher water levels (Appendix A). Riparian plant communities have been assessed in a separate terrestrial ecology report (e3Scientific, 2026c). A return visit was made to sample zooplankton from the tarns in January 2026 to further assess the ecological values present. It was noted that the water level at Tarn 3 was considerably lower on the April 2025 visit than on the January 2026 survey date (Appendix A). Zooplankton are assessed in alpine tarns as they help indicate if there is nutrient enrichment, warming or algal blooms and respond rapidly to changes in conditions. With less water in a tarn the shallower water may become warmer and may result in a community shift to smaller taxa.

The physico-chemical properties of the waterways (Doolans Creek, tributaries and tarns) were assessed along with the stream macroinvertebrate community and habitat quality at each sampling site. eDNA samples were also collected at a number of sites to evaluate the presence of fish or rare taxa (Figure 5; Table 1). Methods utilised for these assessments are detailed in the following sections.

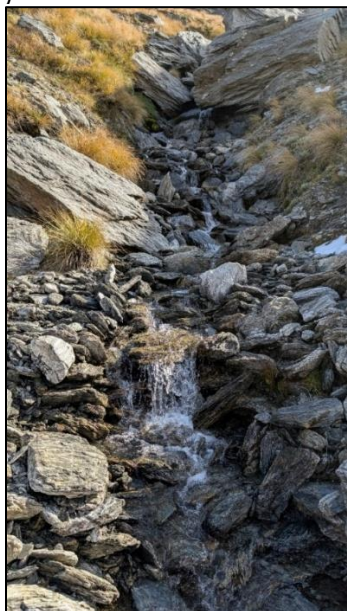
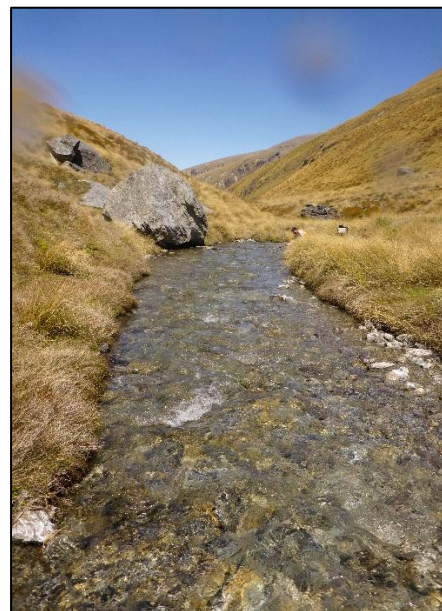
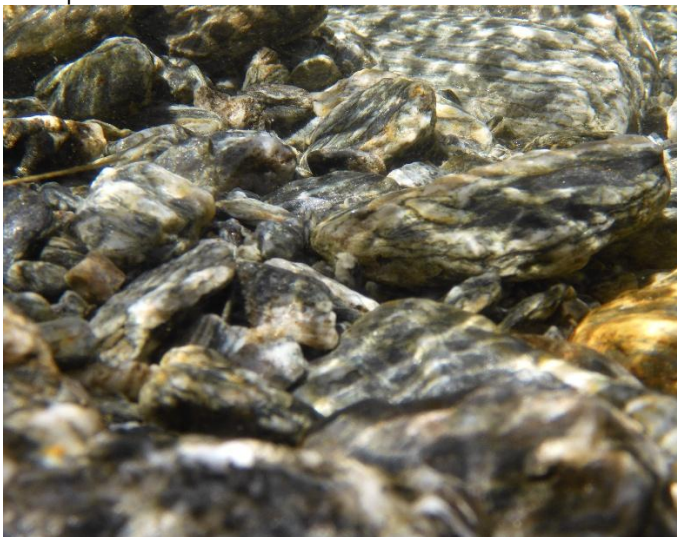
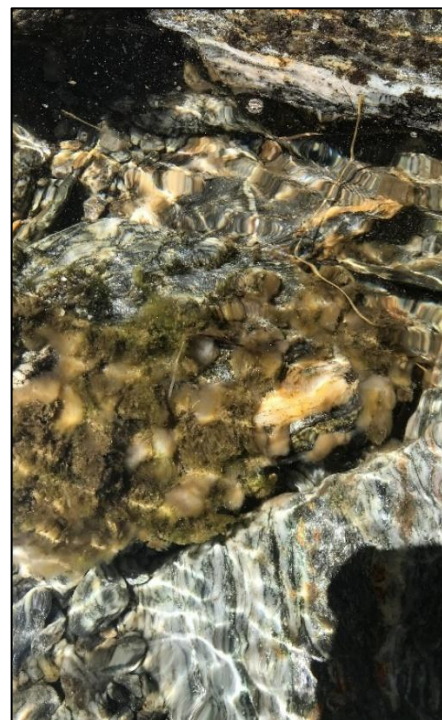
Steep headwaters

Weir site

Weir site bed substrate

Submerged moss and didymo

**Figure 6: Representative images of habitat.**

The streambed characteristics were consistent with an undeveloped alpine catchment with predominantly large substrates present and exposed bedrock in steeper sections (Figure 6; Appendix A). Although the environment was open with no tree cover to shade the watercourses, algal cover was limited, most likely due to the cold, low nutrient water present. Submerged bryophytes (moss) were present at a number of locations; however, submerged moss habitat was only included within the area sampled at DC3, Trib A and Trib C (Figure 6; Appendix A). Didymo was observed to be present at the DC Weir site in January 2026 which

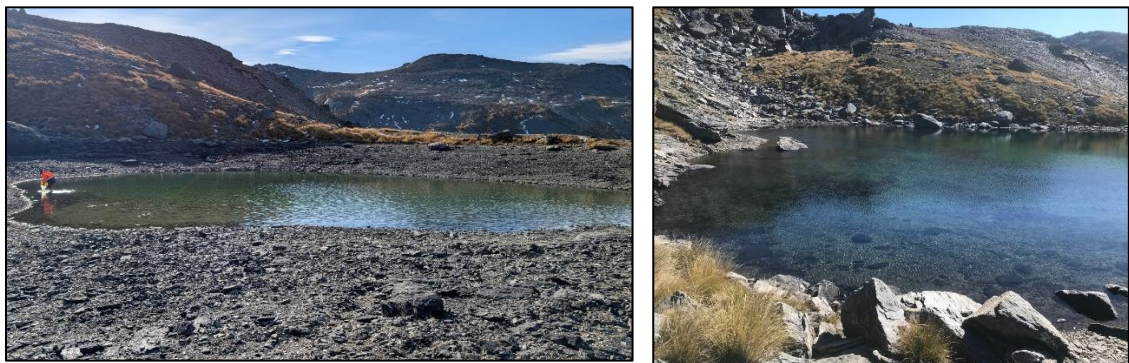
**Figure 7: Images of Tarn 3 in April 2025 (left) and January 2026 (right).**

Within the Doolans Basin the total mapped wetland area is 58.8 hectares (ha) and the total tarn area of the four tarns in the basin cover 3.3 ha. The tarn habitat varied between the three tarns assessed. Tarn 1 has an elevation of 1650 m a.s.l., was large and deep with gravels around the littoral edge and outlet. Sandy silt covered deeper areas and small tufts of brown algae were present on some boulders. Tarn 2 has an elevation of 1750 m a.s.l., had a turf bed of short macrophytes (potentially *Lilaeopsis ruthiana*) with areas of filamentous algae cover and a sandy/silty bed in deeper areas. Tarn 3 has an elevation of 1700 m a.s.l., had low water levels at the time of the April 2025 assessment and the bed comprised mainly of sand with some areas of stunted macrophyte present and areas of brown algae. In January 2026 Tarn 3 had much more water present, this appears to have caused the inundation of early succession terrestrial plants leading to them dying off and algae growing on top of them presumably utilising nutrients being released from the decaying plants (Figure 7).

Of the three Tarns, Tarn 3 was considered to have the lowest habitat diversity due to a lack of macrophytes and deep water.

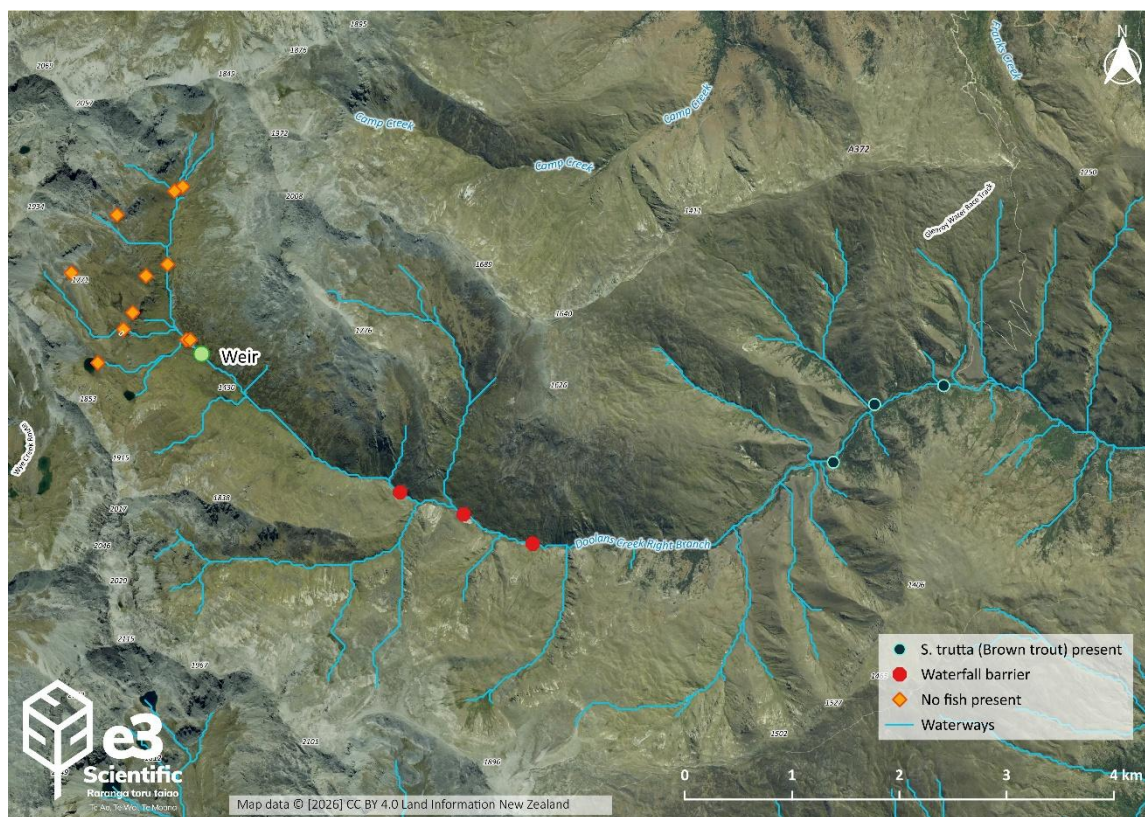
**Figure 8: Fish presence/absence in relation to proposed weir location and natural barriers.**

the Doolans Basin. Records from the ORC monitoring site on the Nevis River at Wentworth Station were present and showed the presence of brown trout, brook char, rainbow trout, kōaro and Nevis galaxias. The threat classifications for the fish known from the wider catchment are outlined in Table 8 below.

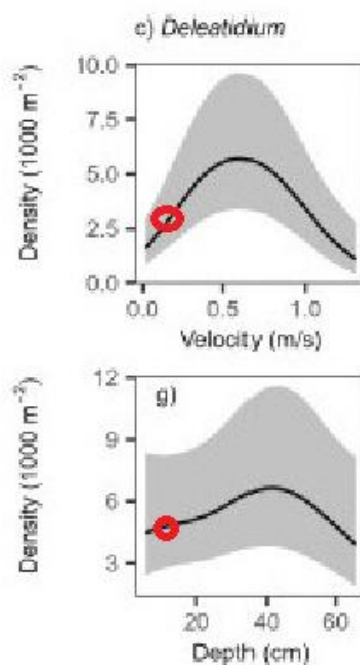
**Figure 9: Predicted macroinvertebrate foodscape (Modified from Stoffels *et al.* 2026).**

Further evidence indicating a minor effect on macroinvertebrates associated with the proposed flow reduction and depth is provided in research by Stoffels *et al.*, (2026). This work examined the effects of flow rate and water depth on the density of macroinvertebrates in the Upper Selwyn River. The study found a minor change in mayfly (*Deleatidium*) densities where flow rates and depth changes were analogous to the proposed changes associated with the Doolans Creek water take (see Figure 9). Furthermore, macroinvertebrate abundance in Doolans Creek is naturally significantly lower than the Selwyn River. It therefore follows that a reduction in flow rate and water level in this location is likely to have a minor effect on macroinvertebrate density within the foodscape.

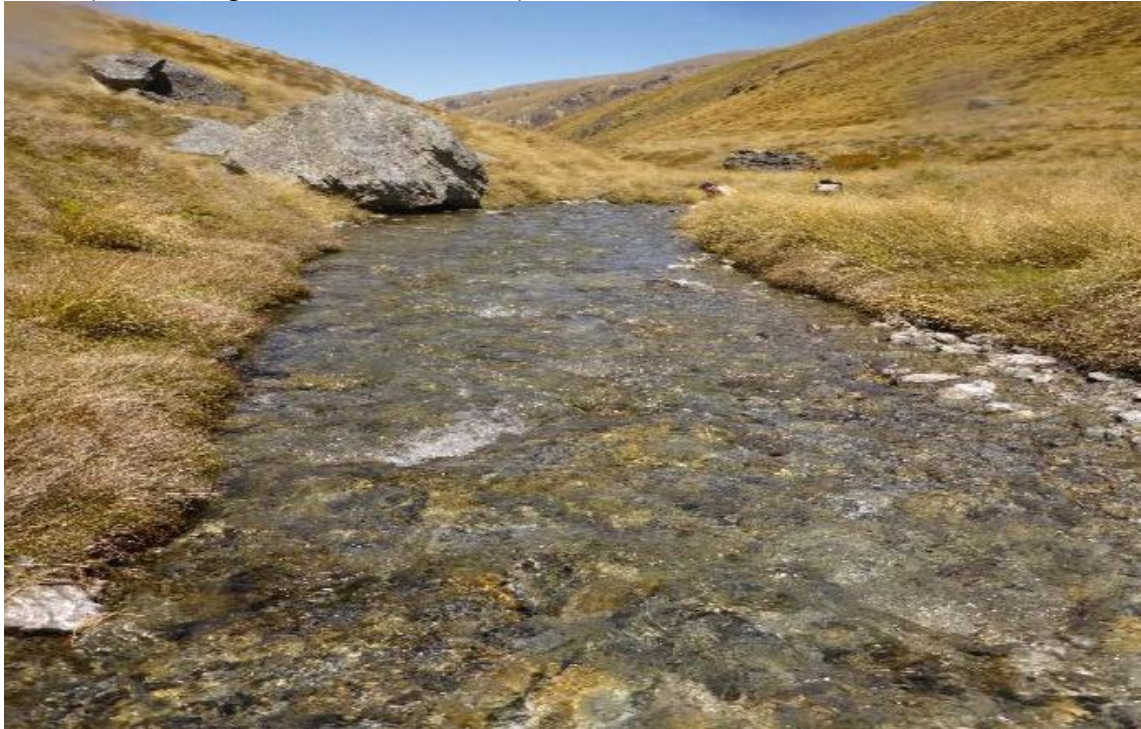
**Figure 1: Downstream view at Doolans Creek at DC3 gauging site.**

For the SEFA model water depth, water velocity, stream cross section and measurement locations and streambed substrate at the cross sections are required. The water depth, water velocity measurements and stream cross-section measured on the 19 Nov 2025 by e3 Scientific staff are used as the model cross section. The cross section measured on this day is well above the low flow range of concern. Therefore, the SEFA model does not have to extrapolate the bank profiles for flows higher than the data available has measured. Substrate data for the model was taken from the habitat assessment in the stream habitat assessment (E3 Scientific 2026). This substrate assessment was done as percentages for whole site (boulder 5%, cobble 80%, gravel 10% sand 5%) and these percentages were used at all points on the cross-section in the model.

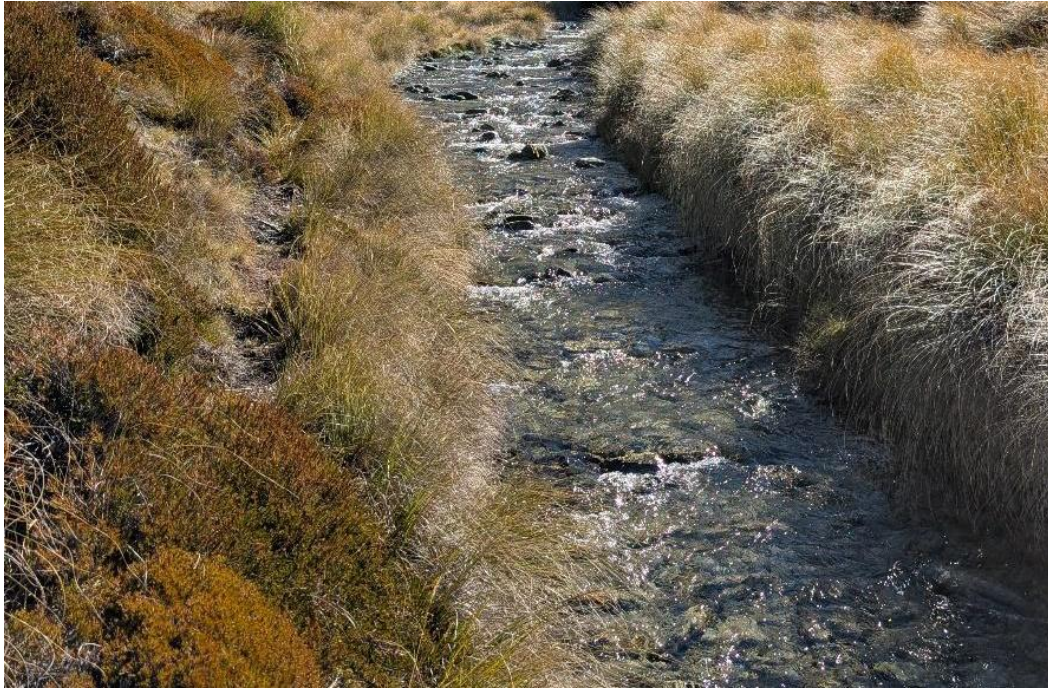
**Figure 2: Upstream view at Doolans Creek site D3.**

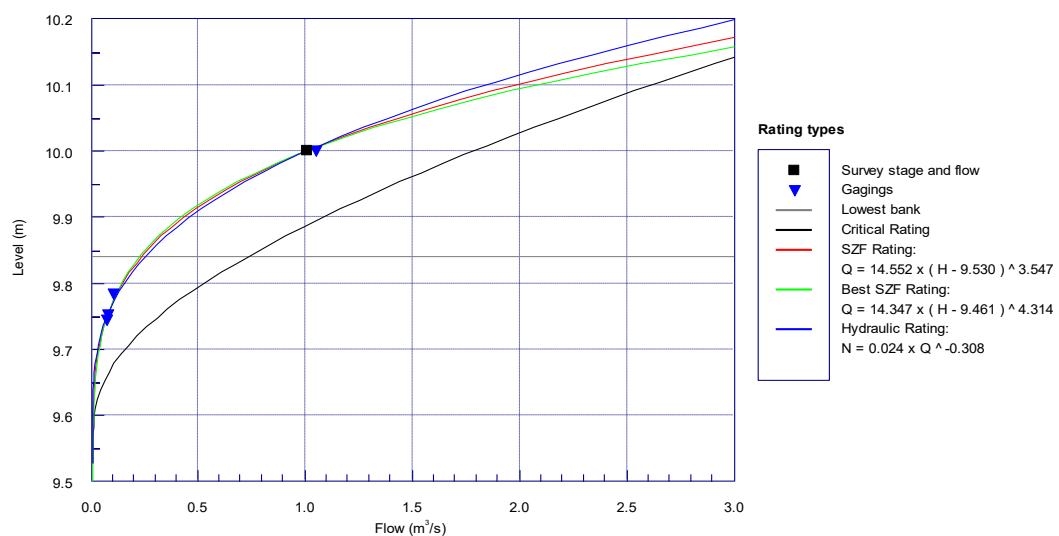
**Figure 2: Rating curve for the DC3 site on Doolans Creek.**

The SEFA model shows the gauging data is well fitted to a rating curve (Figure 2).

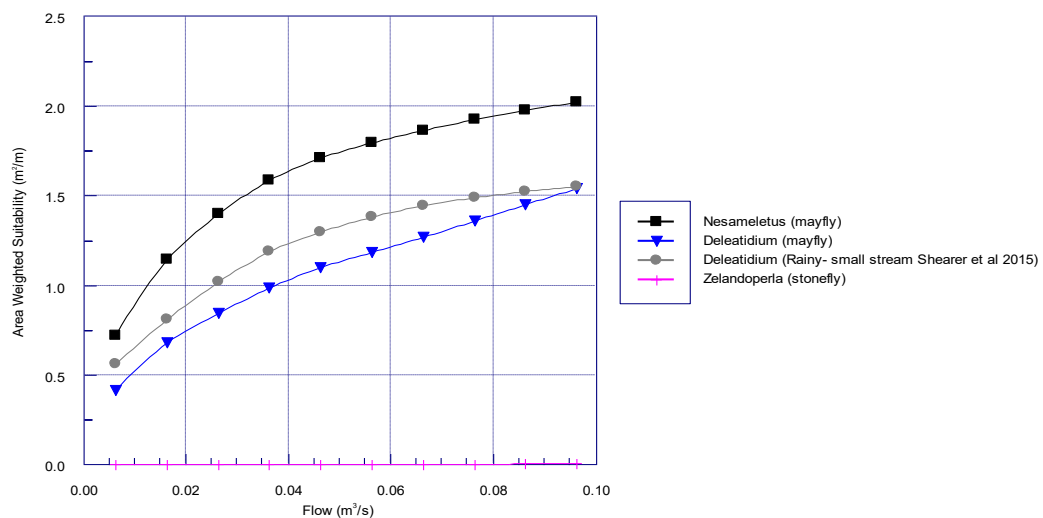
**Figure 3: Predicted habitat for *Deleatidium*, *Nesameletus*, and *Zealandoperla* at Site DC3 with changing flow.**

The DC3 cross section model shows there is no habitat for *Zealandoperla*, and this stonefly was not collected in the Surber samples at DC3 (Figure 3). For the two mayflies and the three HSCs selected there are very similar habitat change trends. Habitat declines throughout the range modelled as flow declines, and this decline becomes very steep decline in below 10 L/s.

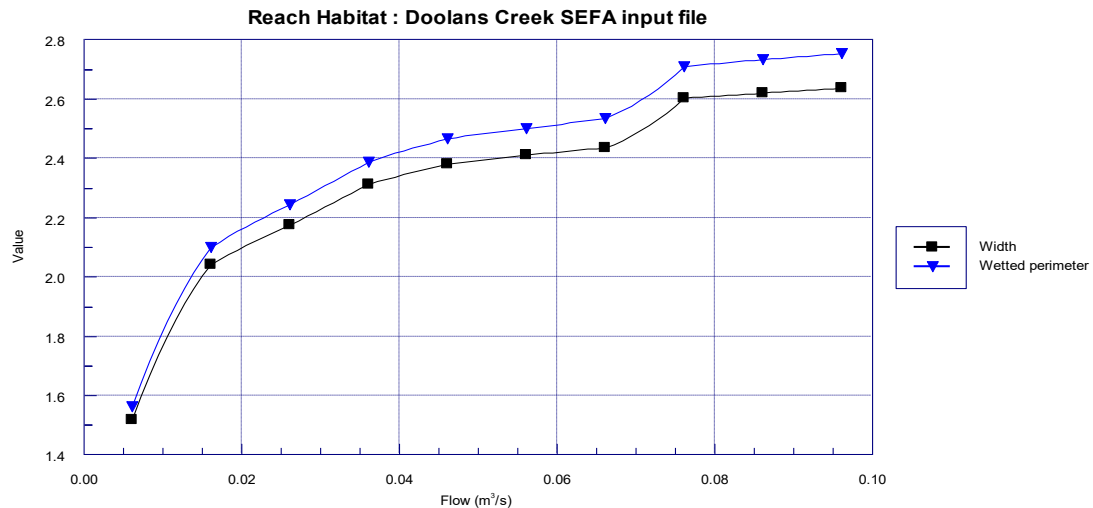
**Figure 4: Predicted width and wetted perimeter for at Site DC3 with changing flow.**

The model also provides two width outputs, wetted perimeter and width. Both show the same trend and steep decline in the width occurs below 30 L/s (Figure 4, Table 2). The slow change in stream width above 30 L/s is due to the stream channel that has steep banks and requires a substantial drop in flow and water level before the streambed is exposed. The site photo shows this channel form appears to continue downstream of the site for approximately 250-300 m (Google Earth images). The next 300-350 m downstream to the first tributary confluence appears to be a cascade section where this physical habitat model output is not appropriate.
