# **Pre-Feasibility Study:**

## **Escarpment Extension Geotechnical Assessment**

3 July 2025

Version 1.1

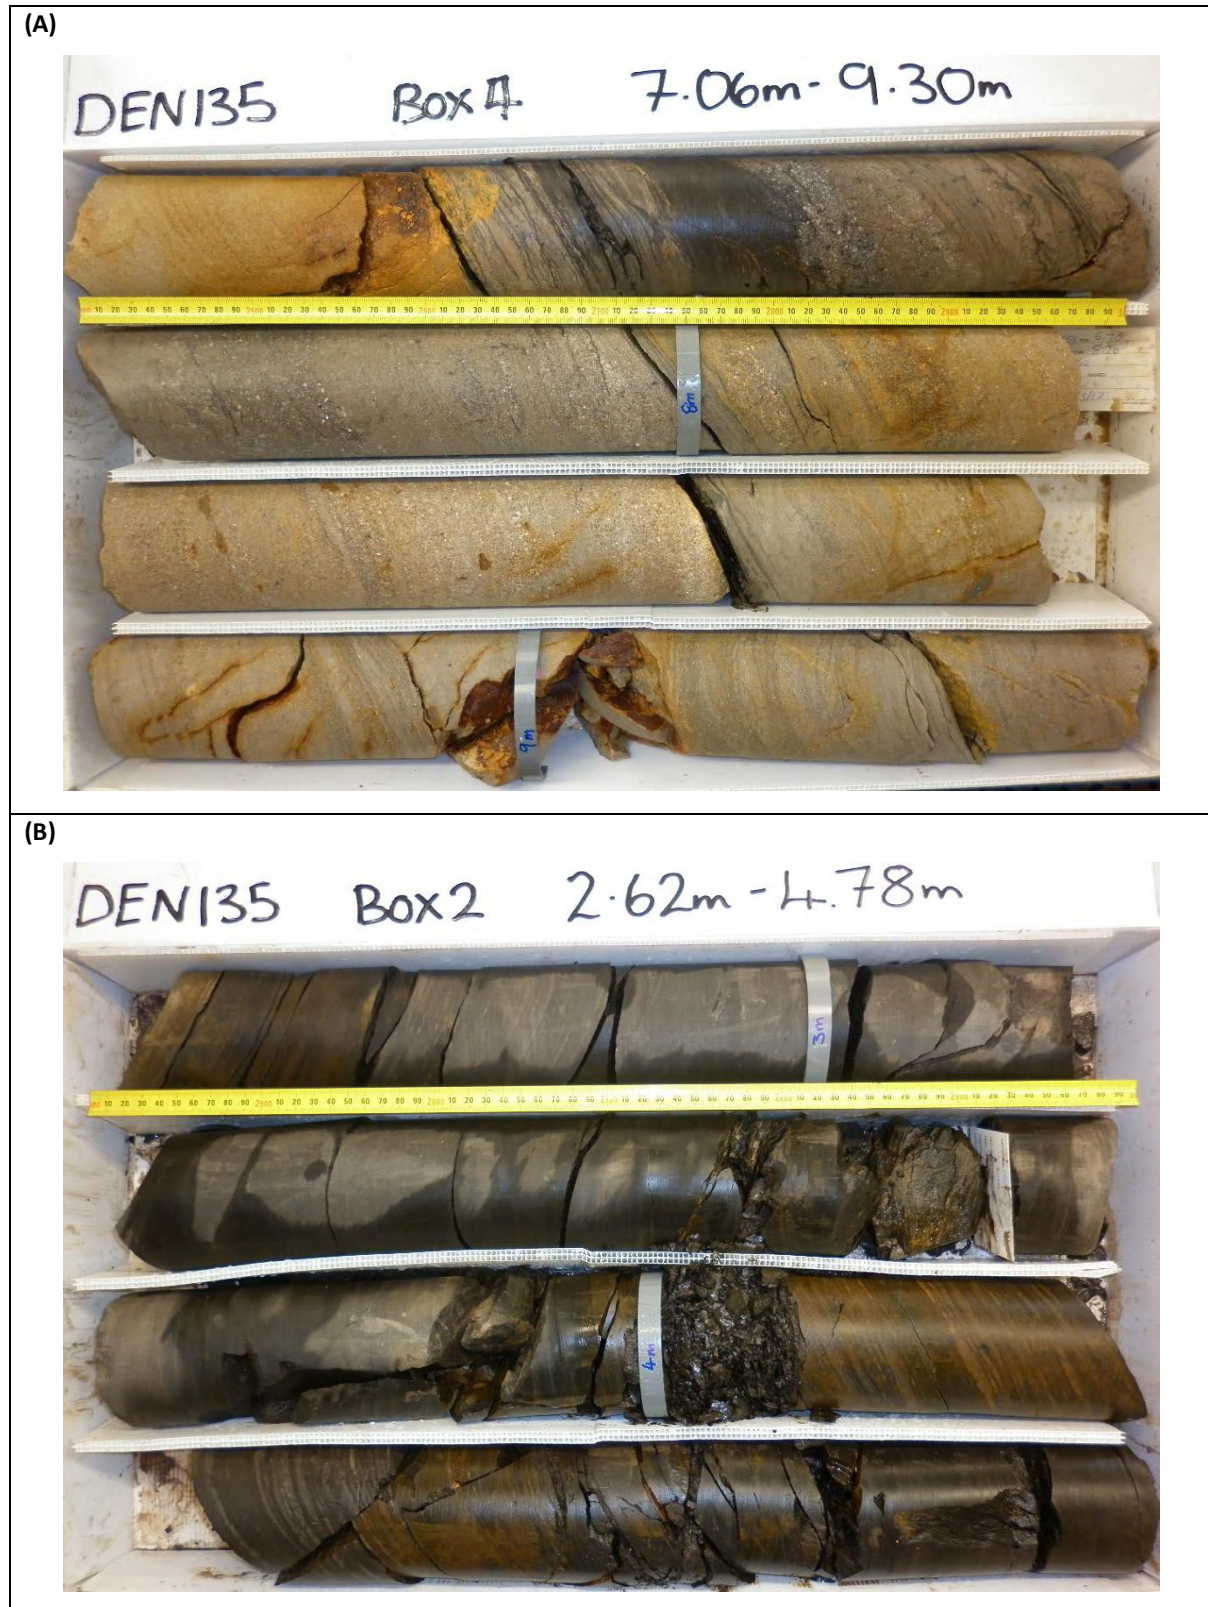
**Figure 5. Drill core examples through Brunner Coal Measures sediments from bore hole DEN135. A) Fine – coarse grained sandstone, representative of the typical overburden found at the site. B) Fine sandstone and mudstone with minor carbonations bands, less frequent at the site.**
