Earthworks Specification and Practical Completion
Certificate

Section 7 Drury Centre Bulk Earthworks: Earthworks **Specifications** Leading. Vibrant. Global.

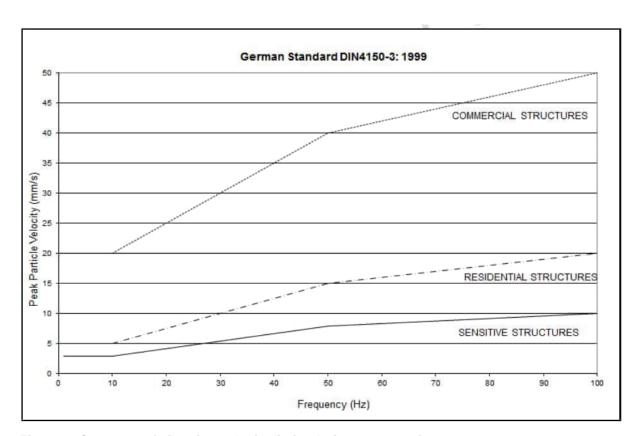
Figure 1: Summary of vibration velocity limits during construction

Construction vibration monitoring shall be undertaken to demonstrate that all vibrations to third party buildings or structures generated from construction activities are less than the maximum limits recommended in the German Standard DIN 4150-3:1999 "Structural Vibration – Effects of Vibration on Structures". In the first instance the Contractor shall undertake vibration monitoring at the property boundary. Additional monitoring inside the neighbouring property shall be undertaken where the vibration limits at the boundary exceed the above standard, or where complaints are received. Where access is granted such additional monitoring shall be undertaken either outside the building but connected to the building foundation, or inside the building. The peak particle velocity (ppv) limits which are to be applied are summarised in Table 1 and Figure 1 or as otherwise required by the Resource Consent.

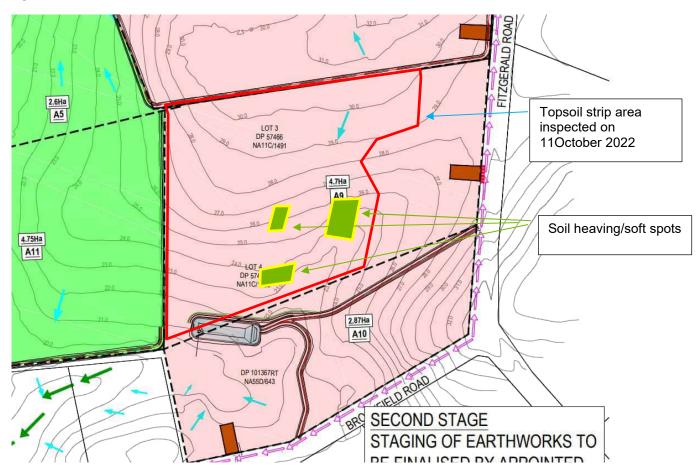
Figure 1: Extent of works observed.

- The ground conditions being exposed during the earthworks are as anticipated.
- The soft spots located in the fill area should be undercut to a depth of 0.5m or at level where shear vane values of 100kPa or greater are encountered.
- The undercut to be backfilled using a well graded, clean imported fill approved by the Engineer. A
 layer of geotextile (A19 or similar) should be placed on the subgrade prior to filling.
- The backfilling of the undercut should be undertaken immediately so excavations are not left open overnight.
- Material from the undercut is to be stockpiled and conditioned for use as bulk filling elsewhere onsite. This may require mixing with other site won material.

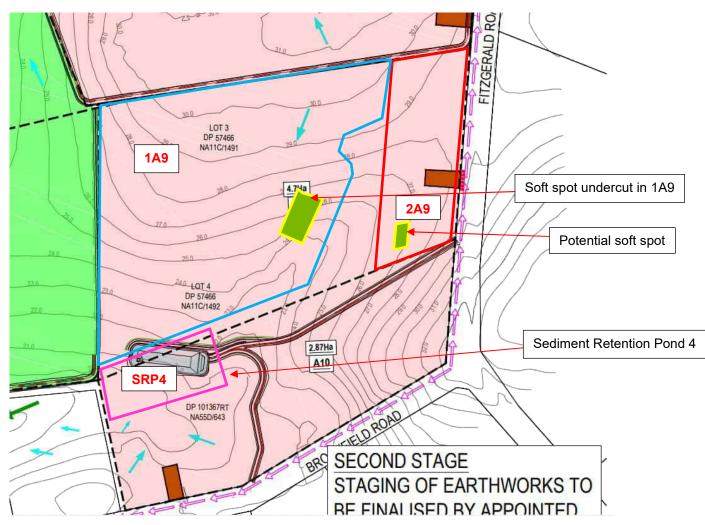
Figure 1: Extent of works observed.

- If the soft spot in Area 2A9 deteriorates then this area may require undercutting.
- NDM and shear vane test results of the subgrade to be supplied to Aurecon.

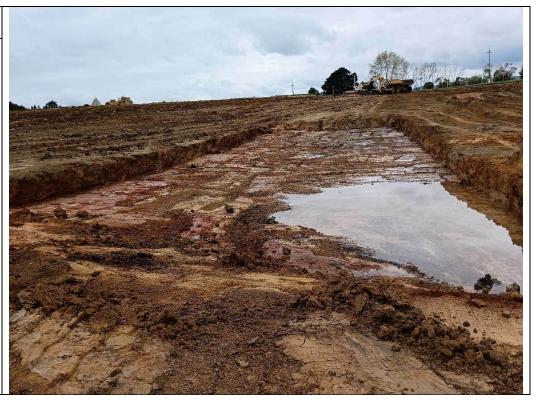
The perch water can be observed in the pit.

Shearvane readings ranged from 25 to 140+ kPa.

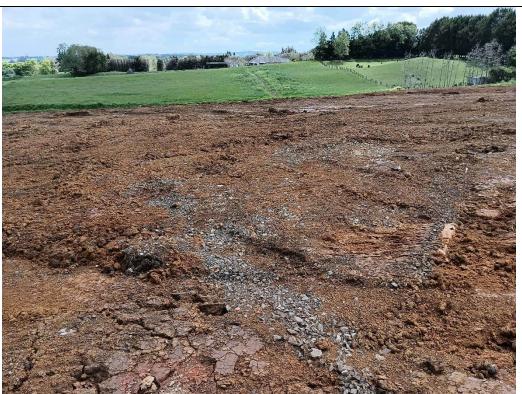
View of the gravel scattered below the topsoil was observed across the strip site.

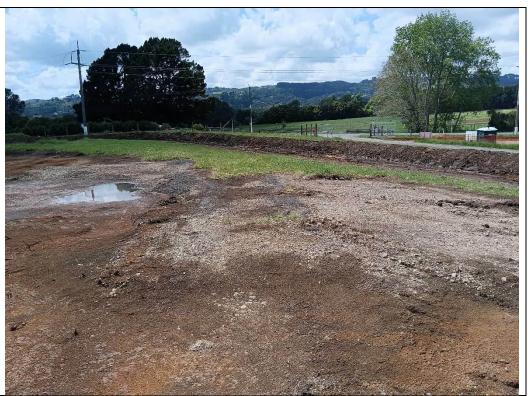
Gravel can be observed underneath the topsoil.

As per Reid contractors, the gravel layer to be excavated and placed on a stockpile deemed as unsuitable.

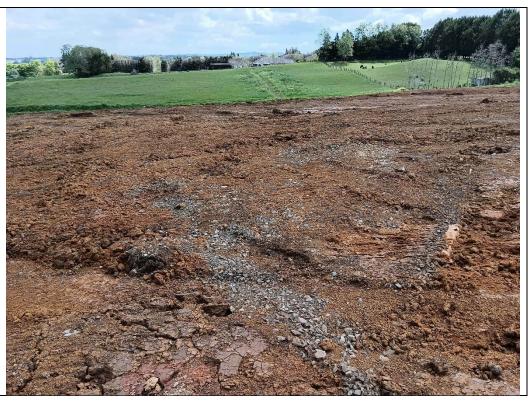
View of the gravel scattered below the topsoil was observed across the strip site.

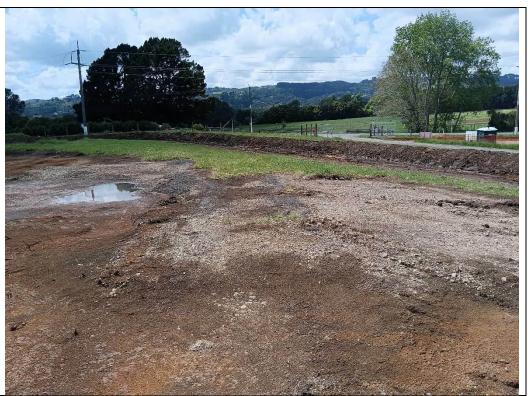
As per Reid contractors, the gravel layer to be excavated and placed on a stockpile deemed as unsuitable.

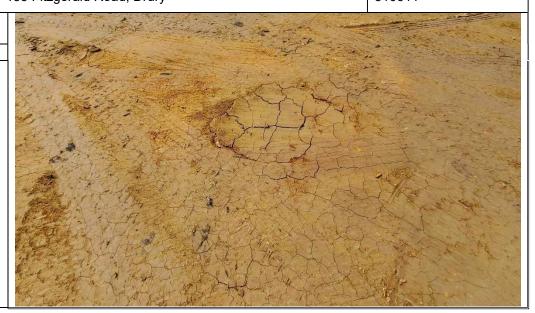
Cracking of subgrade, evidence of clayey soil.

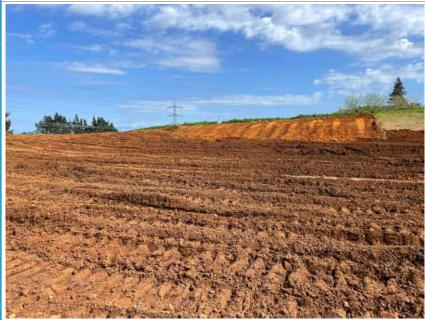
Looking south – Cutting of A4 comprising clayey silt material with basalt clast inclusions.

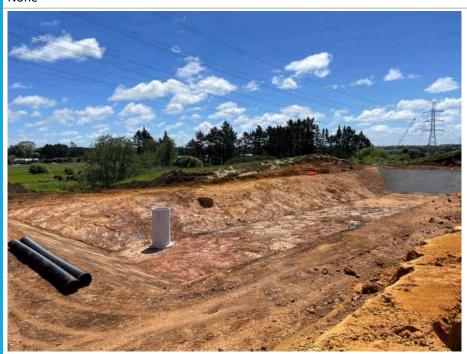
Looking south east - Pond 3

Completion to final design levels. No stability issues identified. Basalt boulders noted on the south east and south western slopes. Contractor to construct outflow on the north eastern corner.

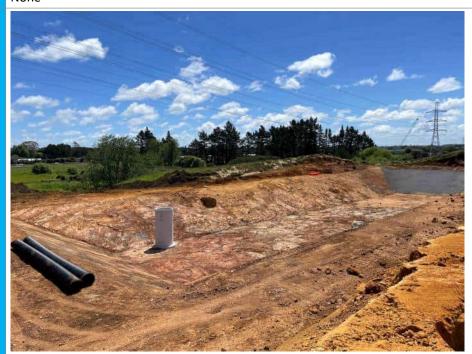
Looking south east - Pond 3

Completion to final design levels. No stability issues identified. Basalt boulders noted on the south east and south western slopes. Contractor to construct outflow on the north eastern corner.
