TRAFFIC ASSESSMENT REPORT – 362 JONES ROAD, DRURY

Further to your instruction, we are pleased to provide this traffic assessment in respect to the proposal to use the plot at 362 Jones Road, Drury, as a fill site. This transport assessment addresses the following aspects with respect to the proposal:

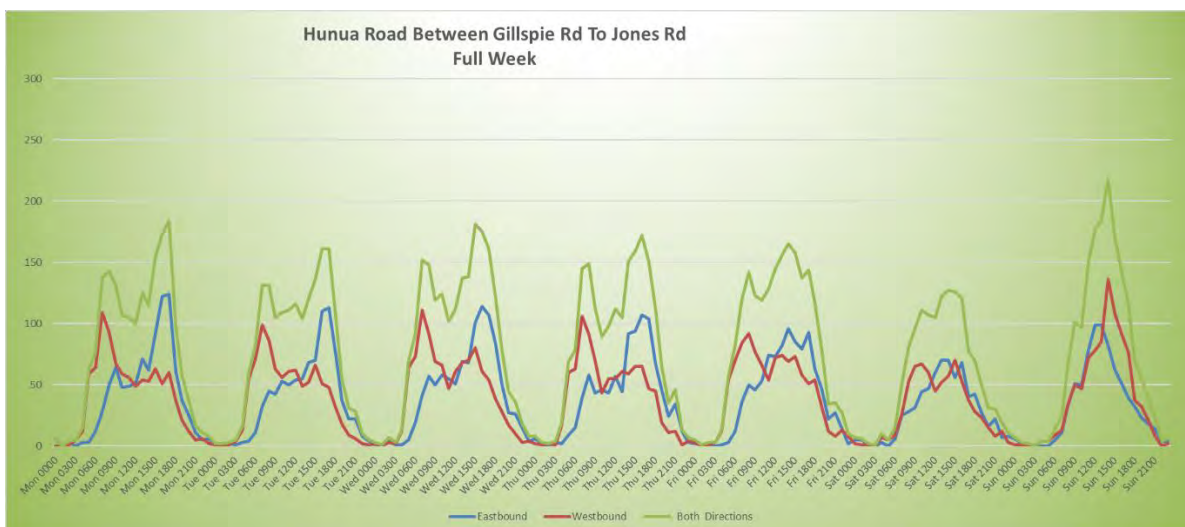
Figure 2-1: Traffic Volumes

A tube count was placed on Hunua Road, adjacent to the existing farm gate access to the site, to collect traffic volume and speed data. Data was recorded between Monday 18 March and Sunday 24 March, 2024.

The 5-day ADT for the corridor was found to be 1,921 vehicles. The 5-day AM peak hour was found to occur between 7:15 - 8:15 AM with 145 vehicles recorded, 41 eastbound and 103 westbound, and the 5-day PM peak hour was found to occur between 4:30 - 5:30 PM with 169 vehicles recorded, 116 eastbound and 53 westbound.

The 85th percentile speed for eastbound vehicles was found to be 88km/hr, while the 85th percentile speed for westbound vehicles was found to be 96km/hr. Given the corridor is signposted at 80km/hr, the speeds recorded are higher than expected and it is therefore recommended that Auckland Transport together with NZ Police undertake actions to manage vehicle speeds on this corridor.

Of particular note the survey also recorded that Heavy Commercial Vehicles (HCV) represented 25% of total traffic over the week.

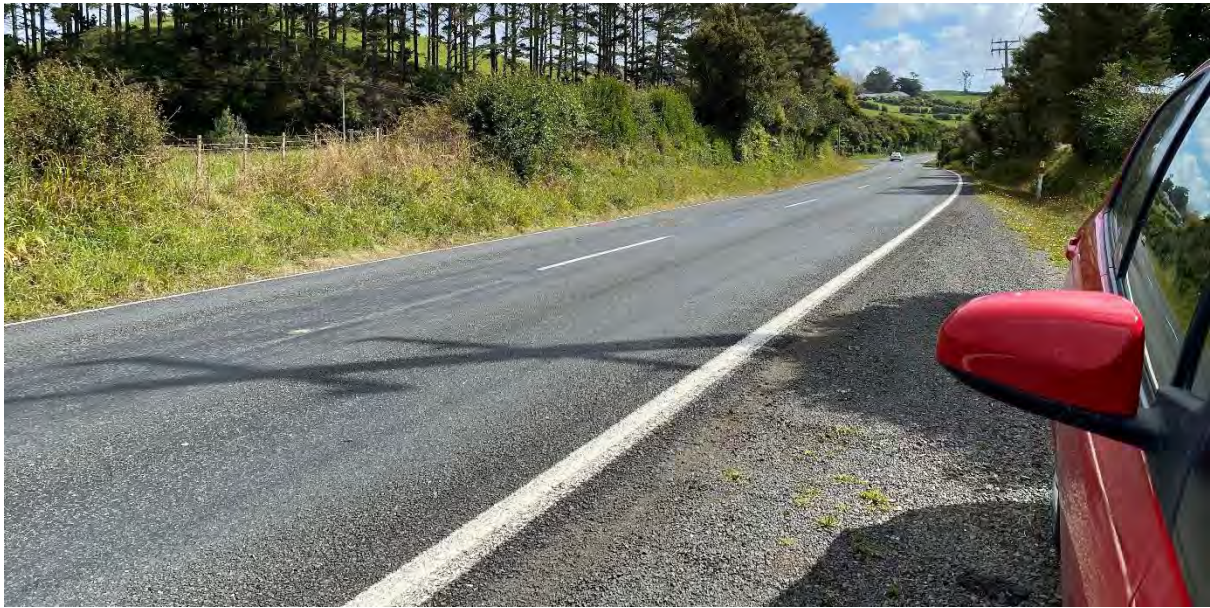
Photograph 1: Sight Distance to the West of the Site Access on Hunua Road

Photographs 1 and 2 show the sight distance available to the east and west of the proposed access on Hunua Road.

The available sight distance to the west is currently 198m and therefore meets the required 182m sight distance. The available sight distance to the east is currently 180m and therefore short of the 207m Austroads design standard. This sightline is restricted due to vegetation that is located within the road reserve, and therefore it is recommended that the trees along the corridor are cut back to improve the visibility from the site access.

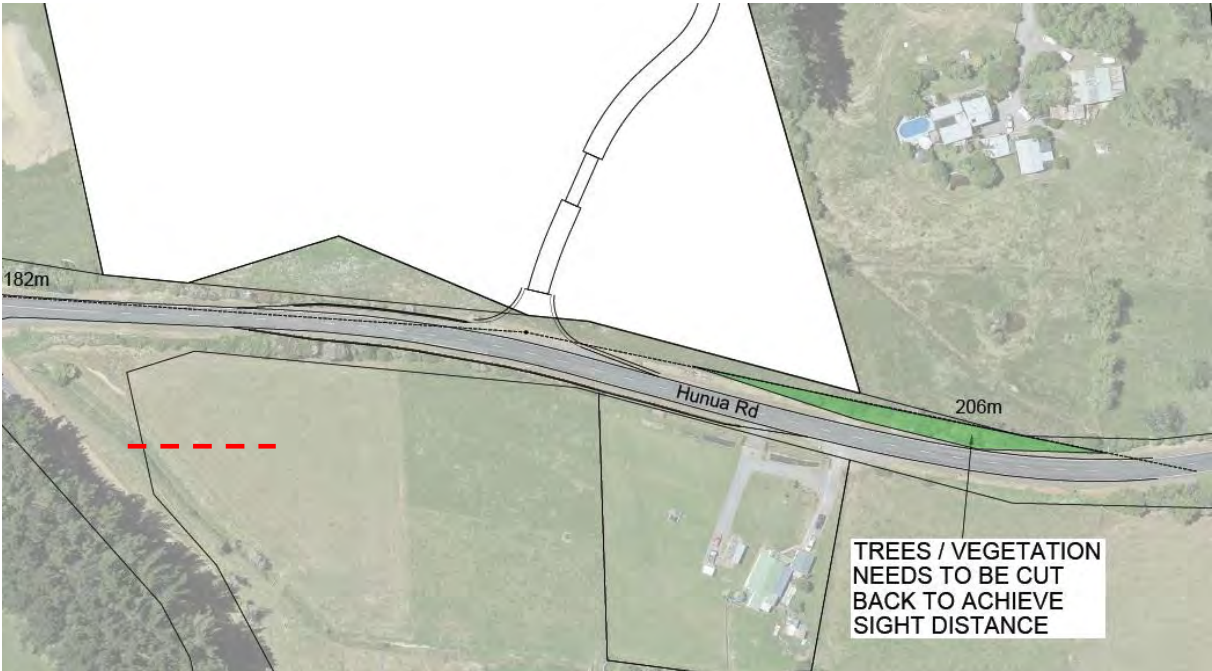
Figure 5-2: Recommended Vegetation removal

Upon trimming the vegetation within the road reserve, the Austroads sight distances can be met as shown in **Attachment B**.

Furthermore, it is reiterated that the speeds on the corridor are higher than expected when compared to the posted speed limit. While beyond this application, it is noted that enforcing the posted speed limit on Hunua Road, notably the westbound speed, would improve safety and reduce the sight distance requirements (and therefore vegetation removal) at this access.

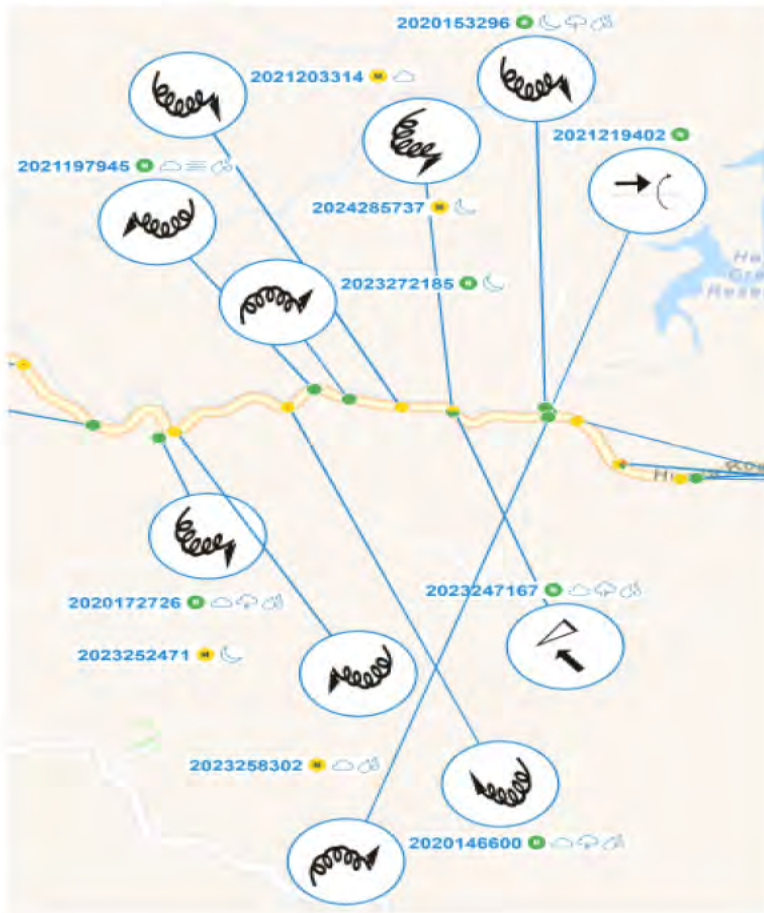
Figure 6-3: Crash Diagram for Winstone Quarry to Ardmore Quarry Rd

Figure 6-2 shows the collision diagram for the search area and time period. No serious crashes, crashes involving trucks, or crashes relating to vehicles passing each other head on, occurred in this part of the corridor within the search timeframe.

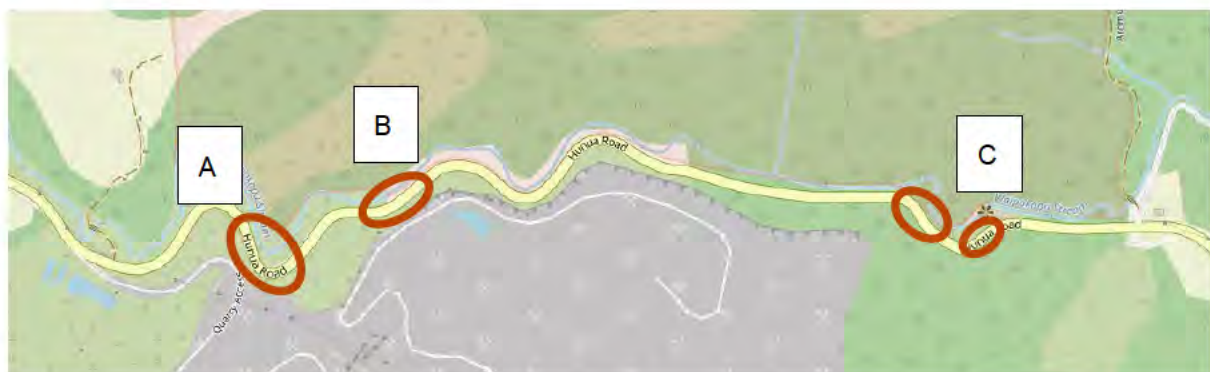
Figure 6-4: Segments of Hunua Road which require widening

Vehicle tracking shows to fully accommodate two 19m truck and trailers (as used by the applicant), widening is required in three general locations between Winstone Aggregates Quarry access and Ardmore Quarry Road. The full vehicle tracking is included in **Attachment A**, with the sections which require widening highlighted in Figure 6-4.

On-site observations have shown that the trucks currently using this section of road tend to travel slowly through this section of road and potentially wait for other trucks to pass safely.

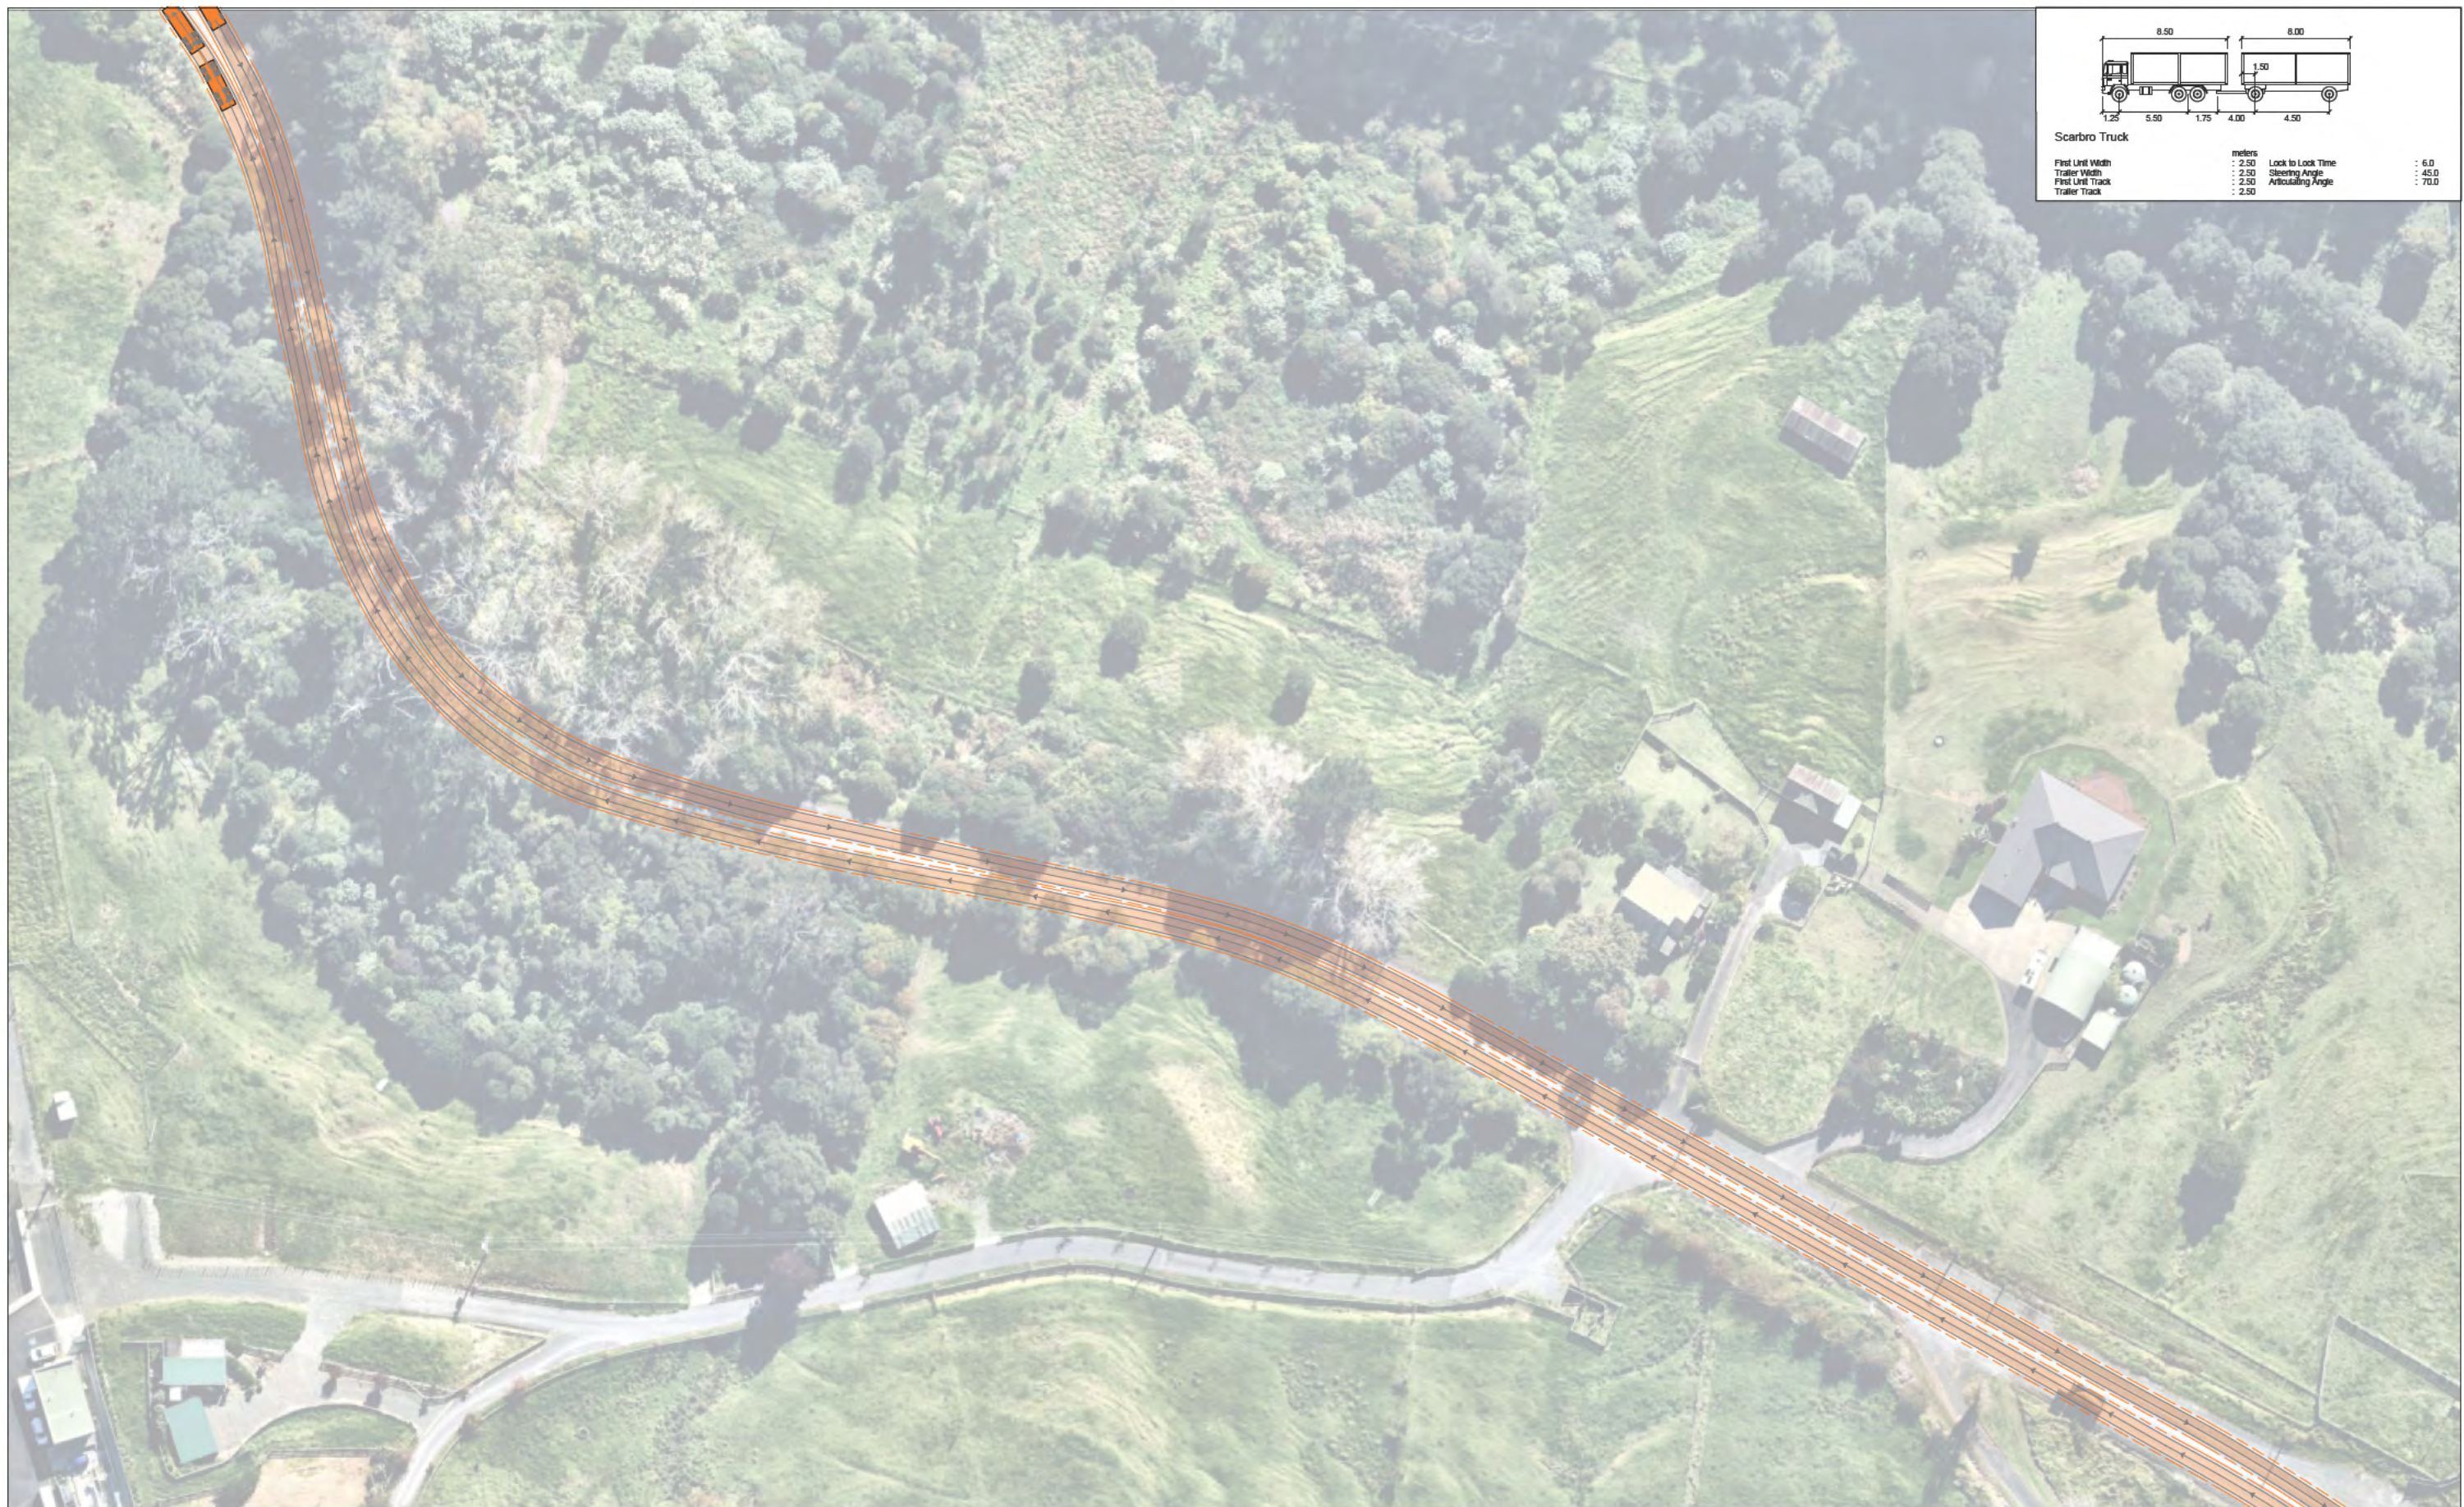
Scarbro Truck

meters		
First Unit Width	: 1.25	Lock to Lock Time	: 6.0
Trailer Width	: 8.50	Steering Angle	: 45.0
First Unit Track	: 1.75	Articulating Angle	: 70.0
Trailer Track	: 4.00

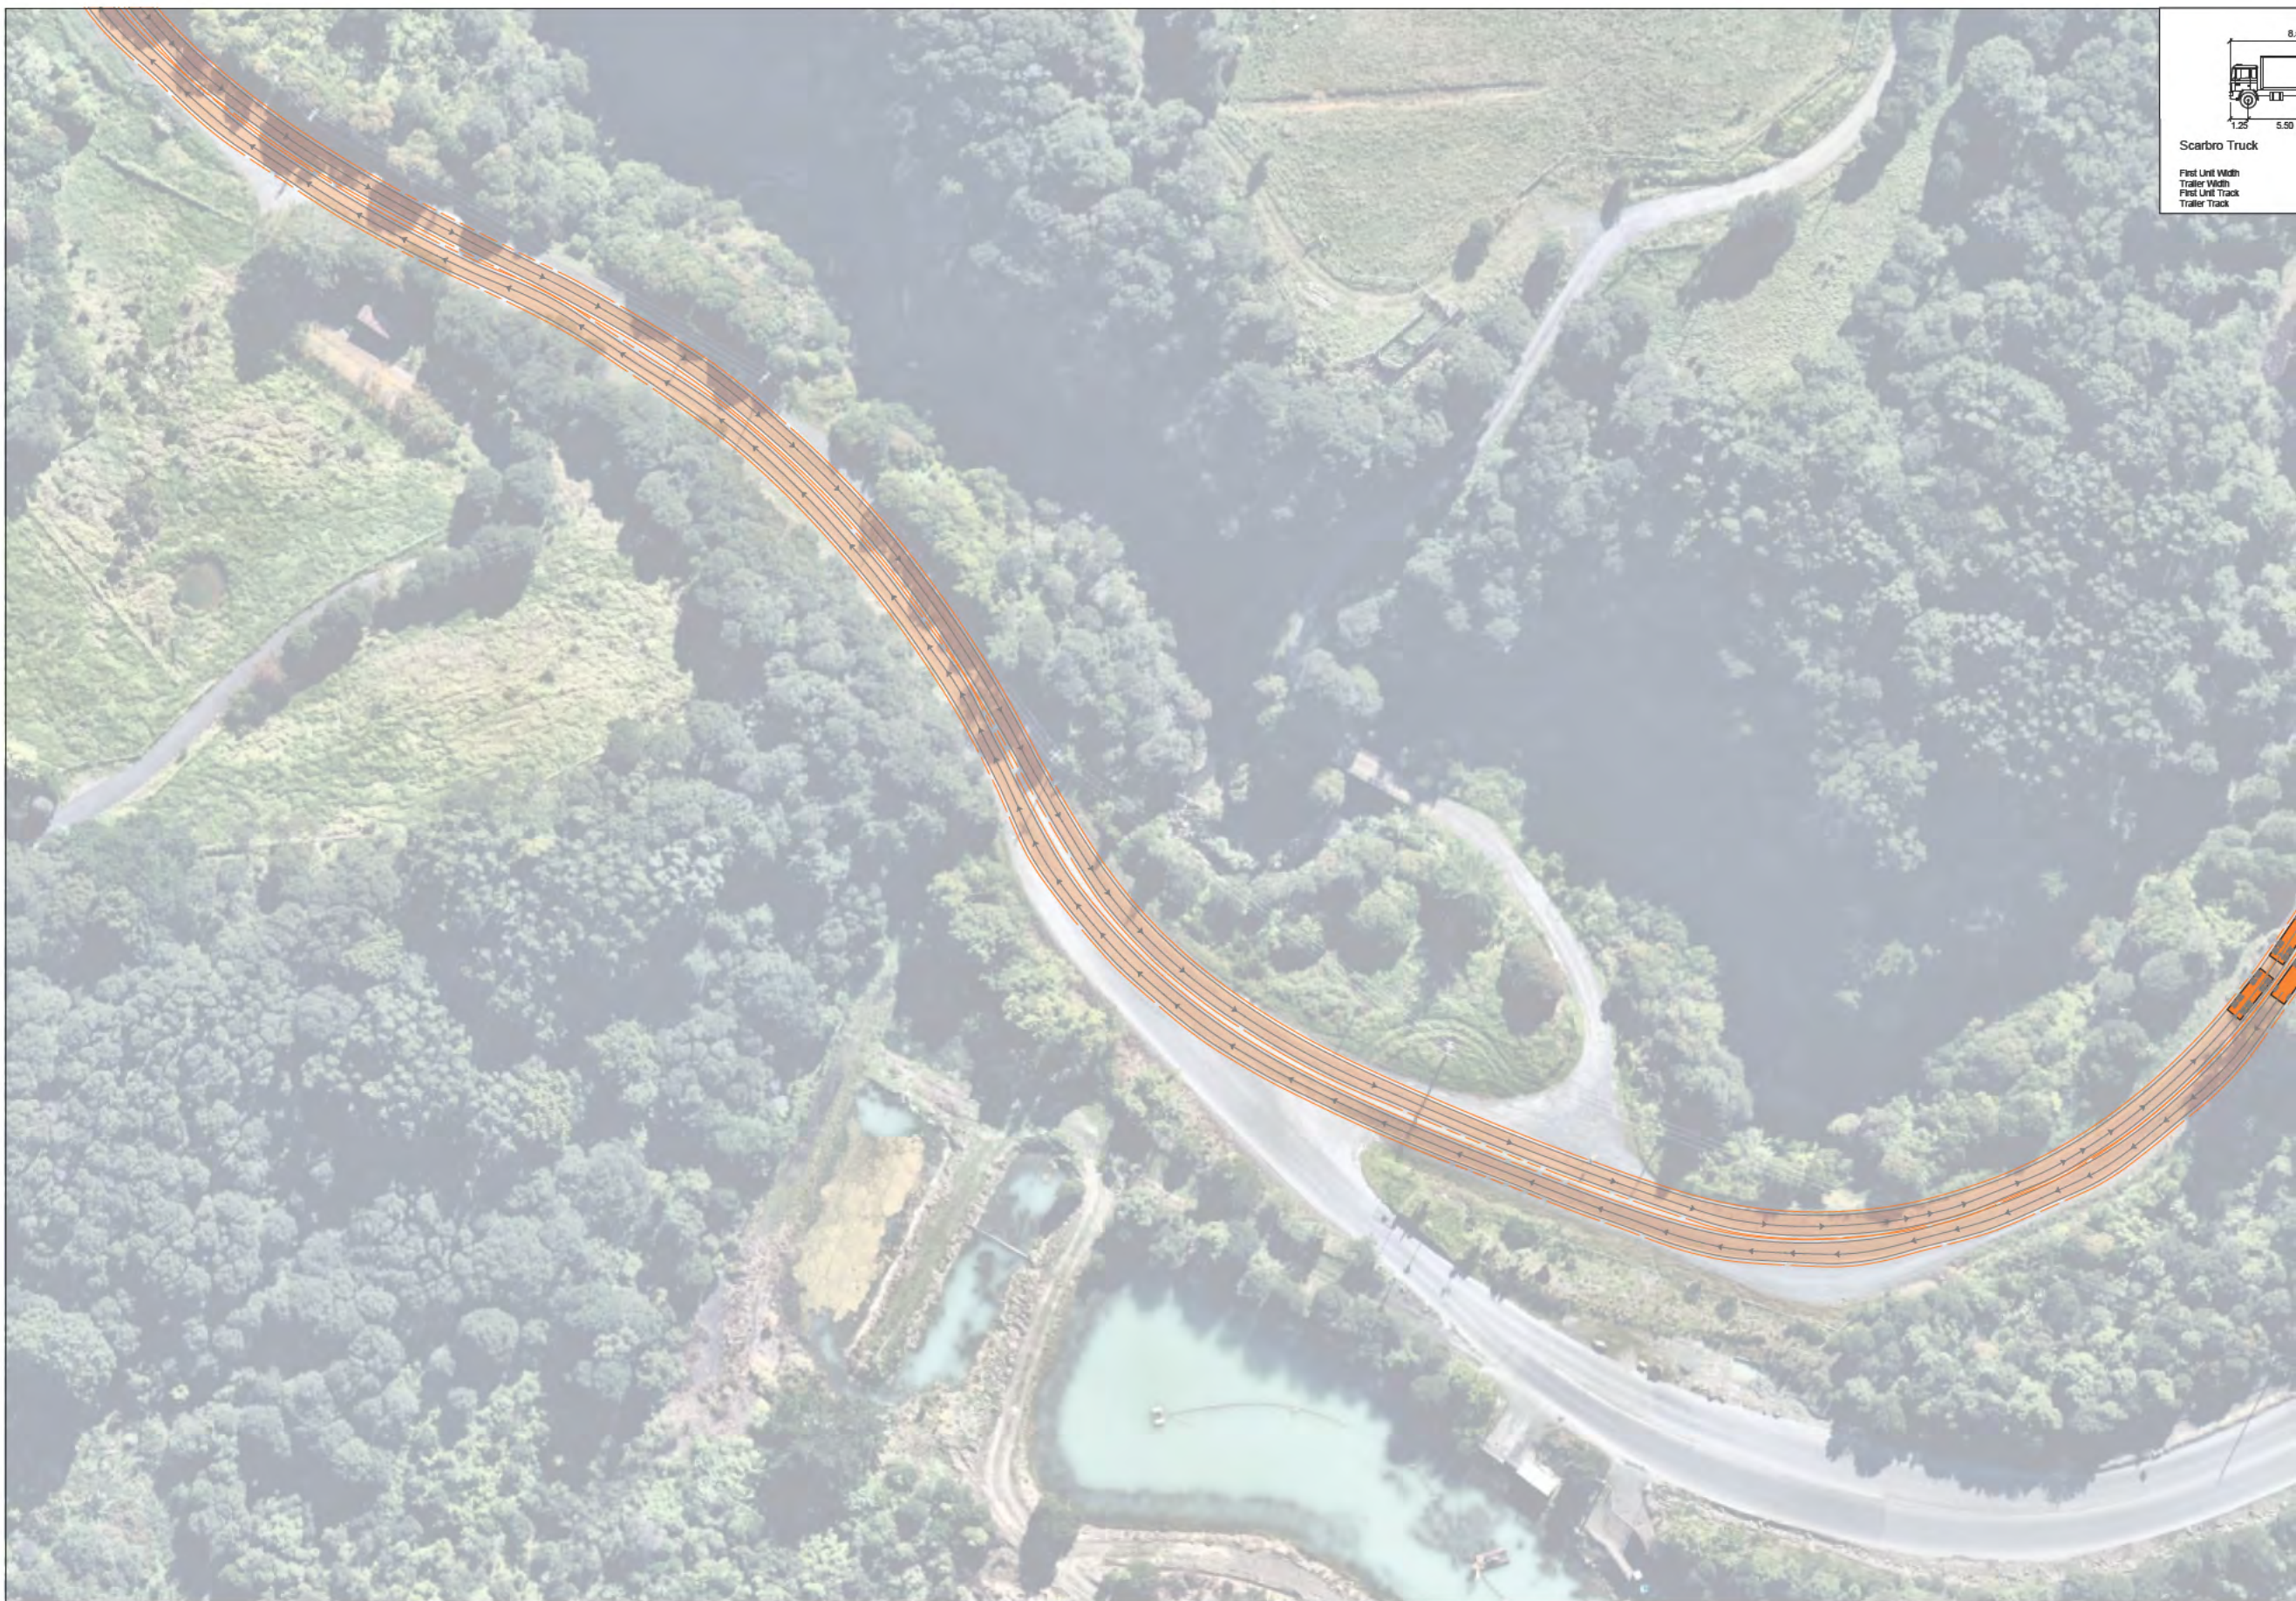
Figure: **2-2**

Scarbro Truck

meters		
First Unit Width	: 2.50	Lock to Lock Time	: 6.0
Trailer Width	: 2.50	Slewing Angle	: 45.0
First Unit Track	: 2.50	Articulating Angle	: 70.0
Trailer Track	: 2.50

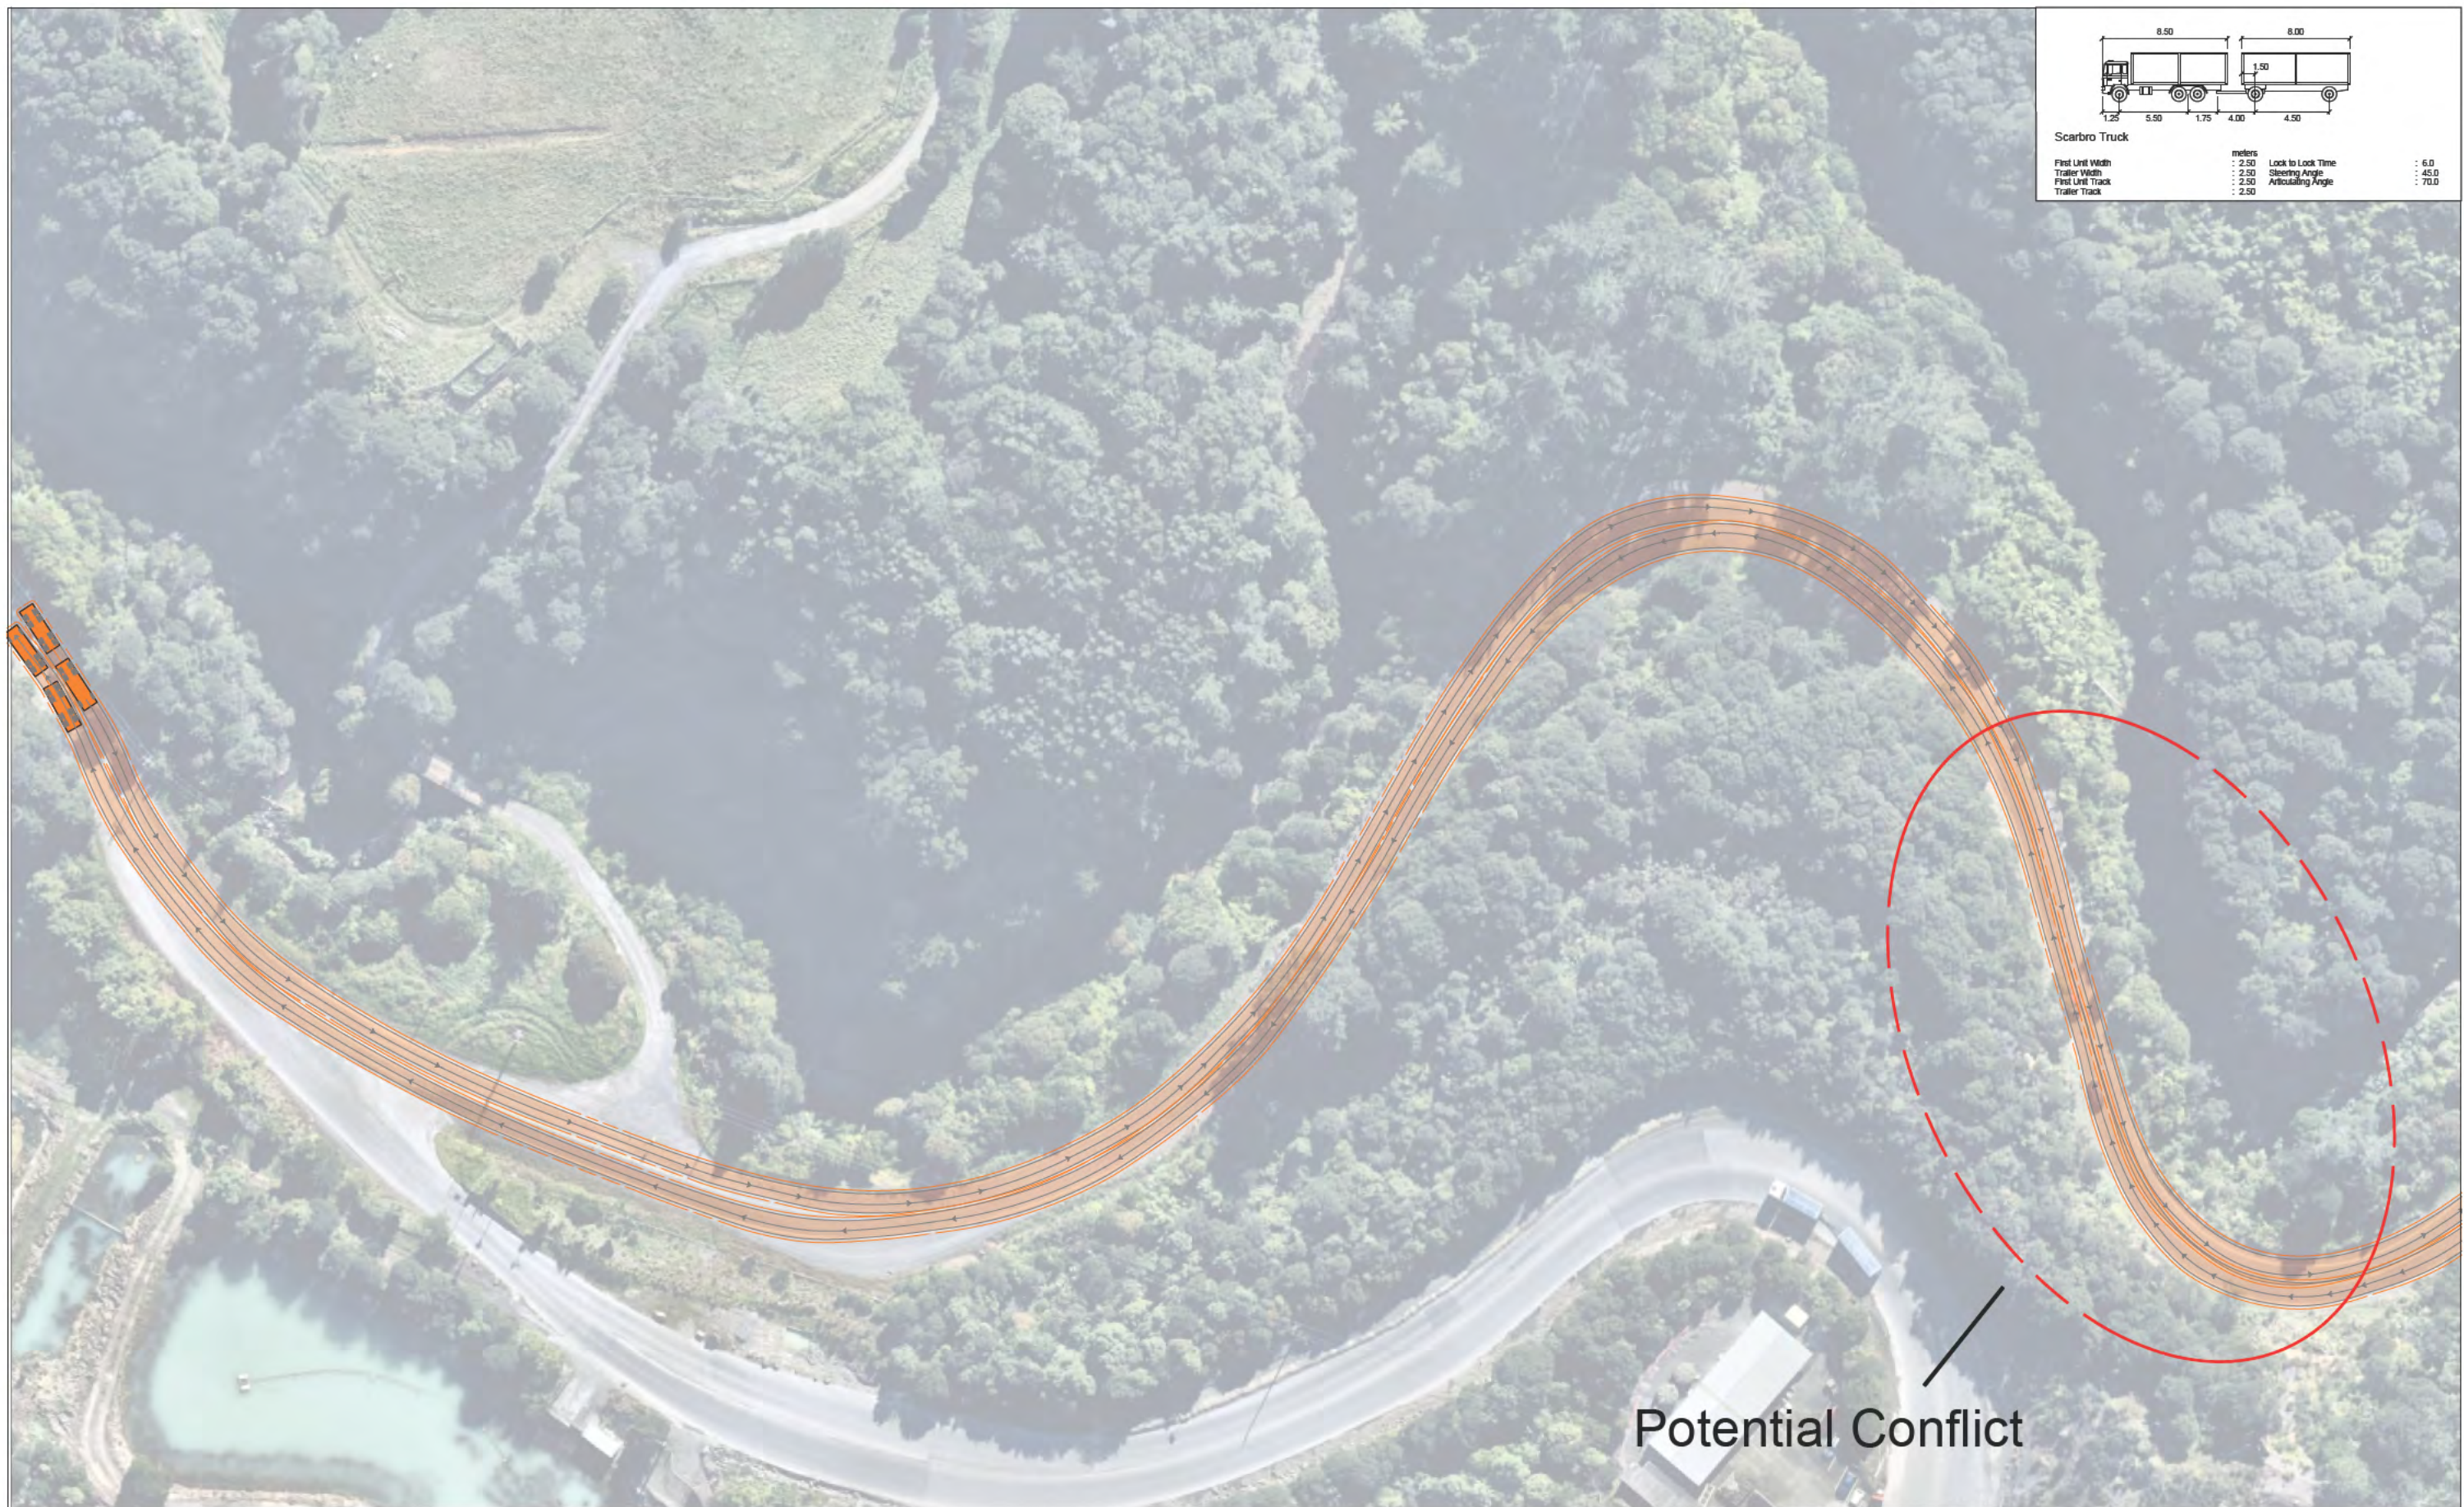
Figure:
2-3

Potential Conflict

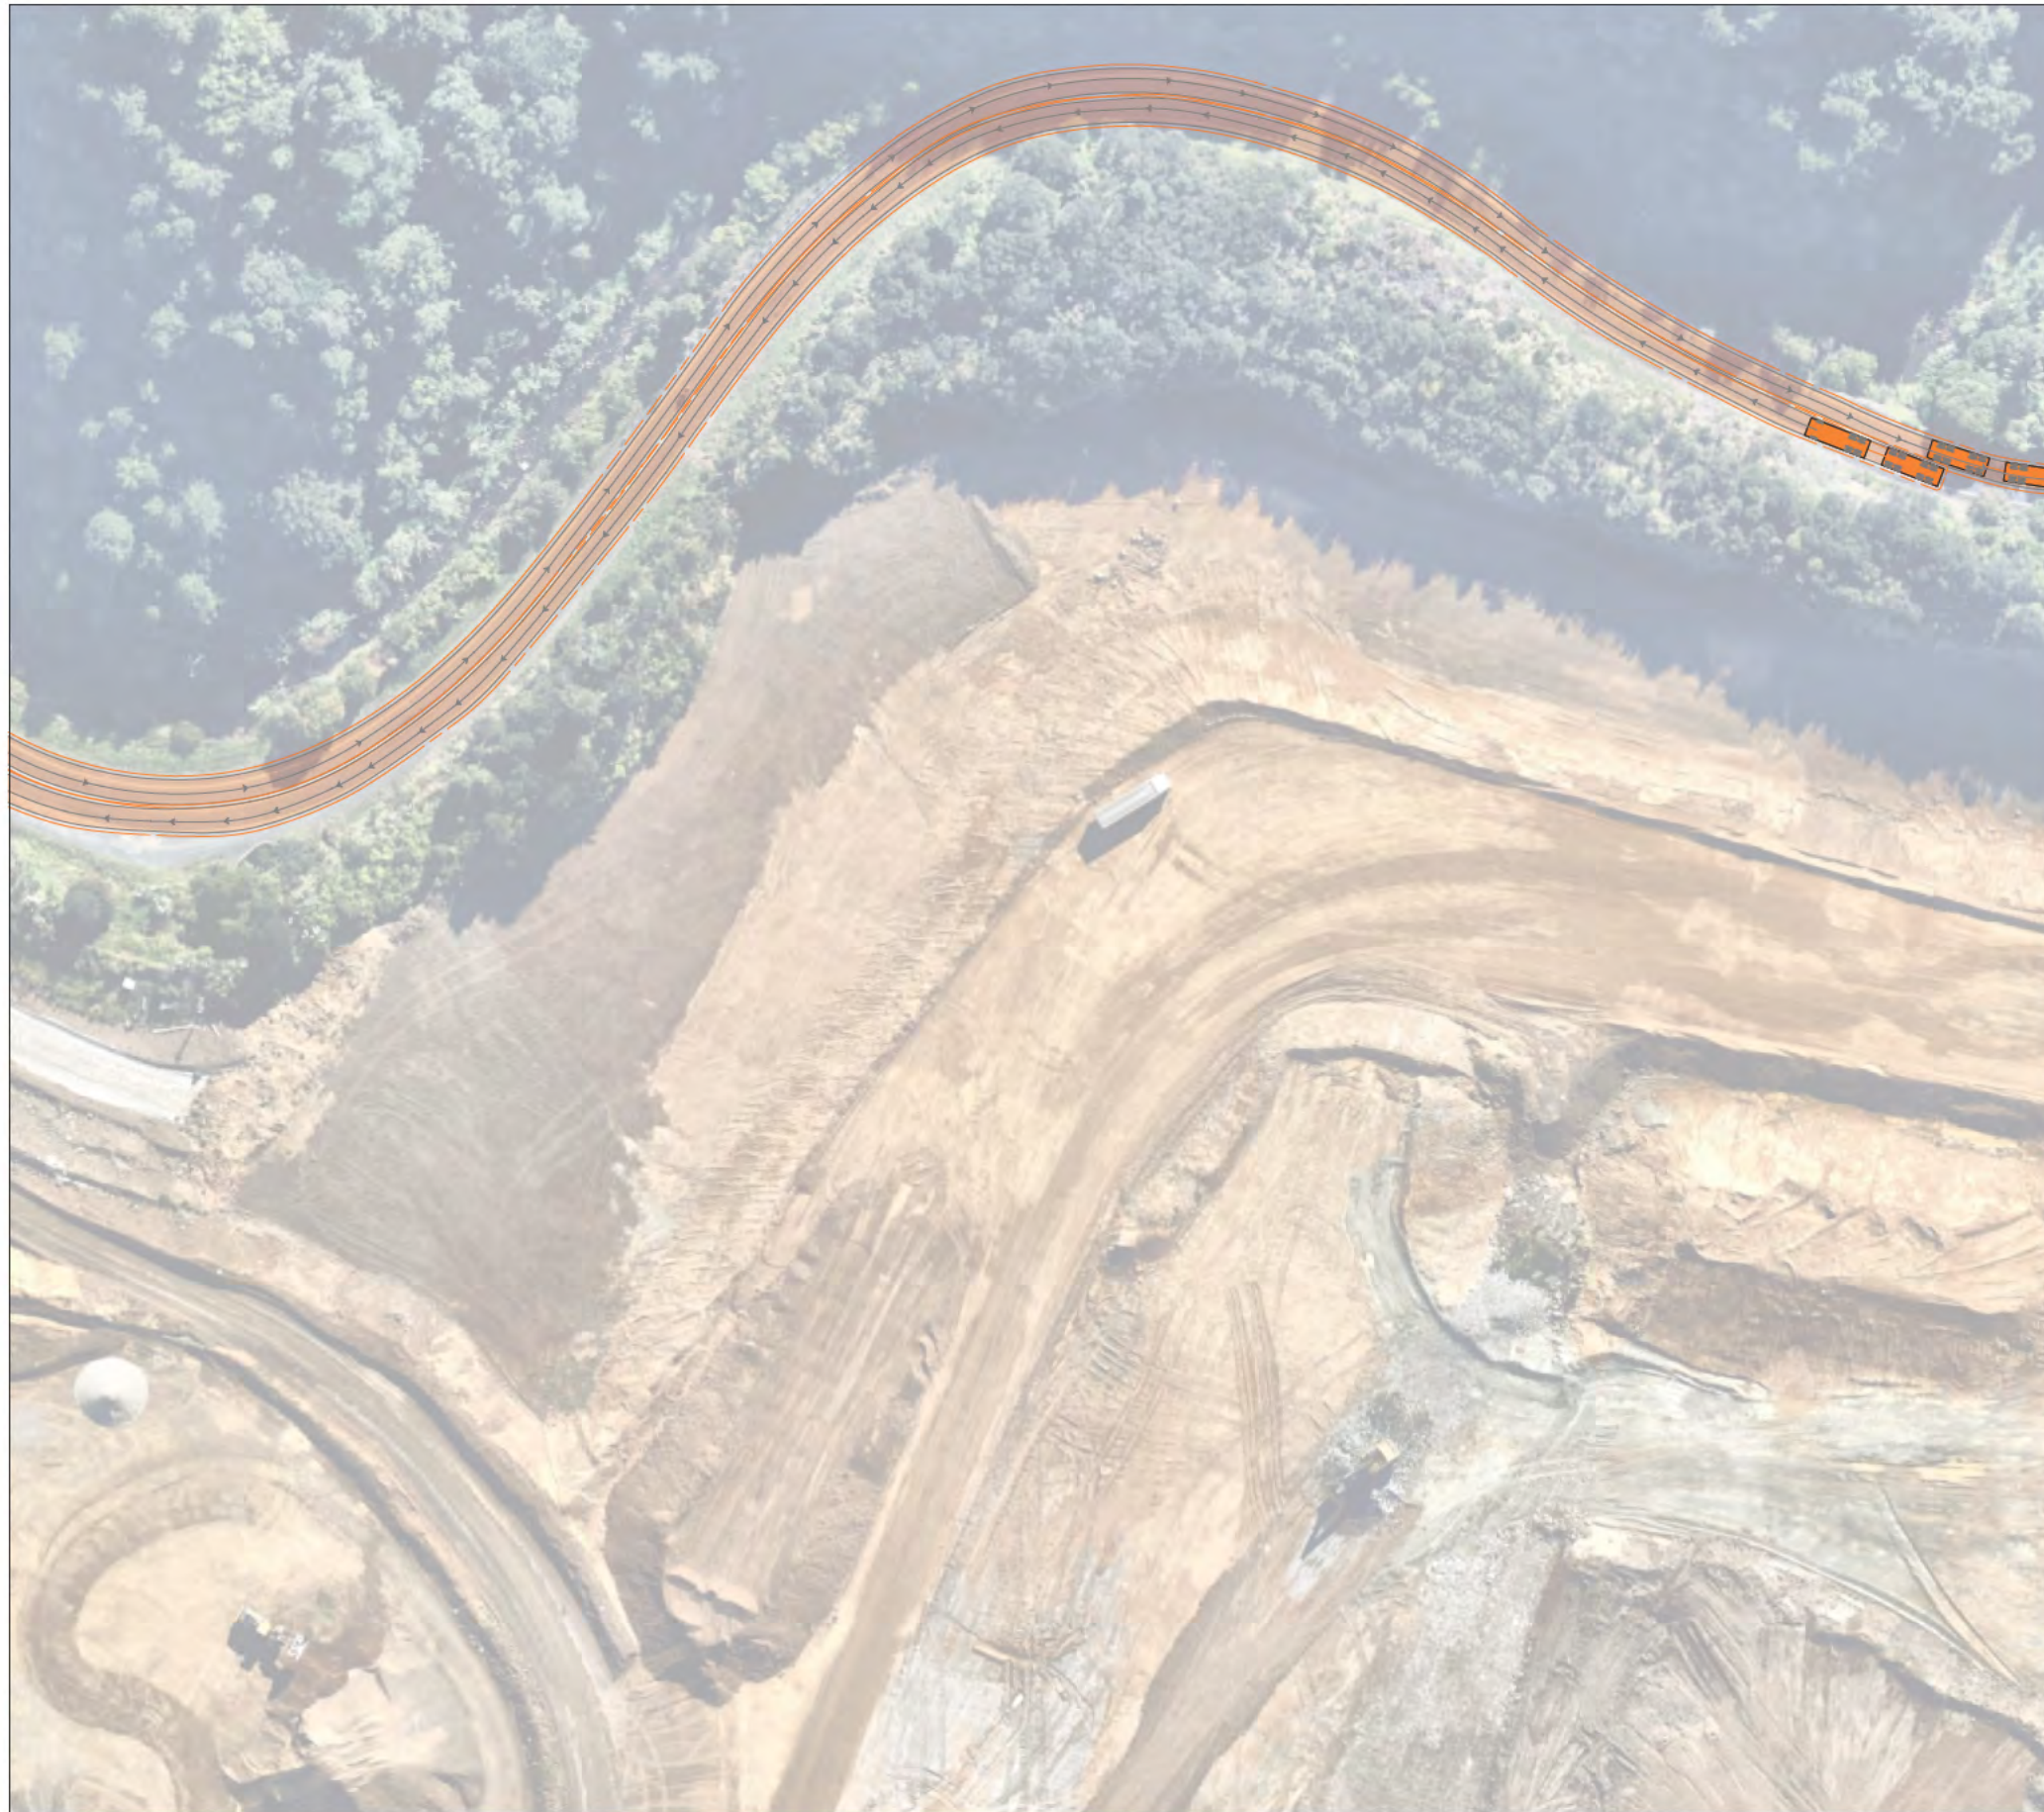
Figure:
3-2

Scarbro Truck

meters		
First Unit Width	: 2.50	Lock to Lock Time	: 6.0
Trailer Width	: 2.50	Steering Angle	: 45.0
First Unit Track	: 2.50	Articulating Angle	: 70.0
Trailer Track	: 2.50

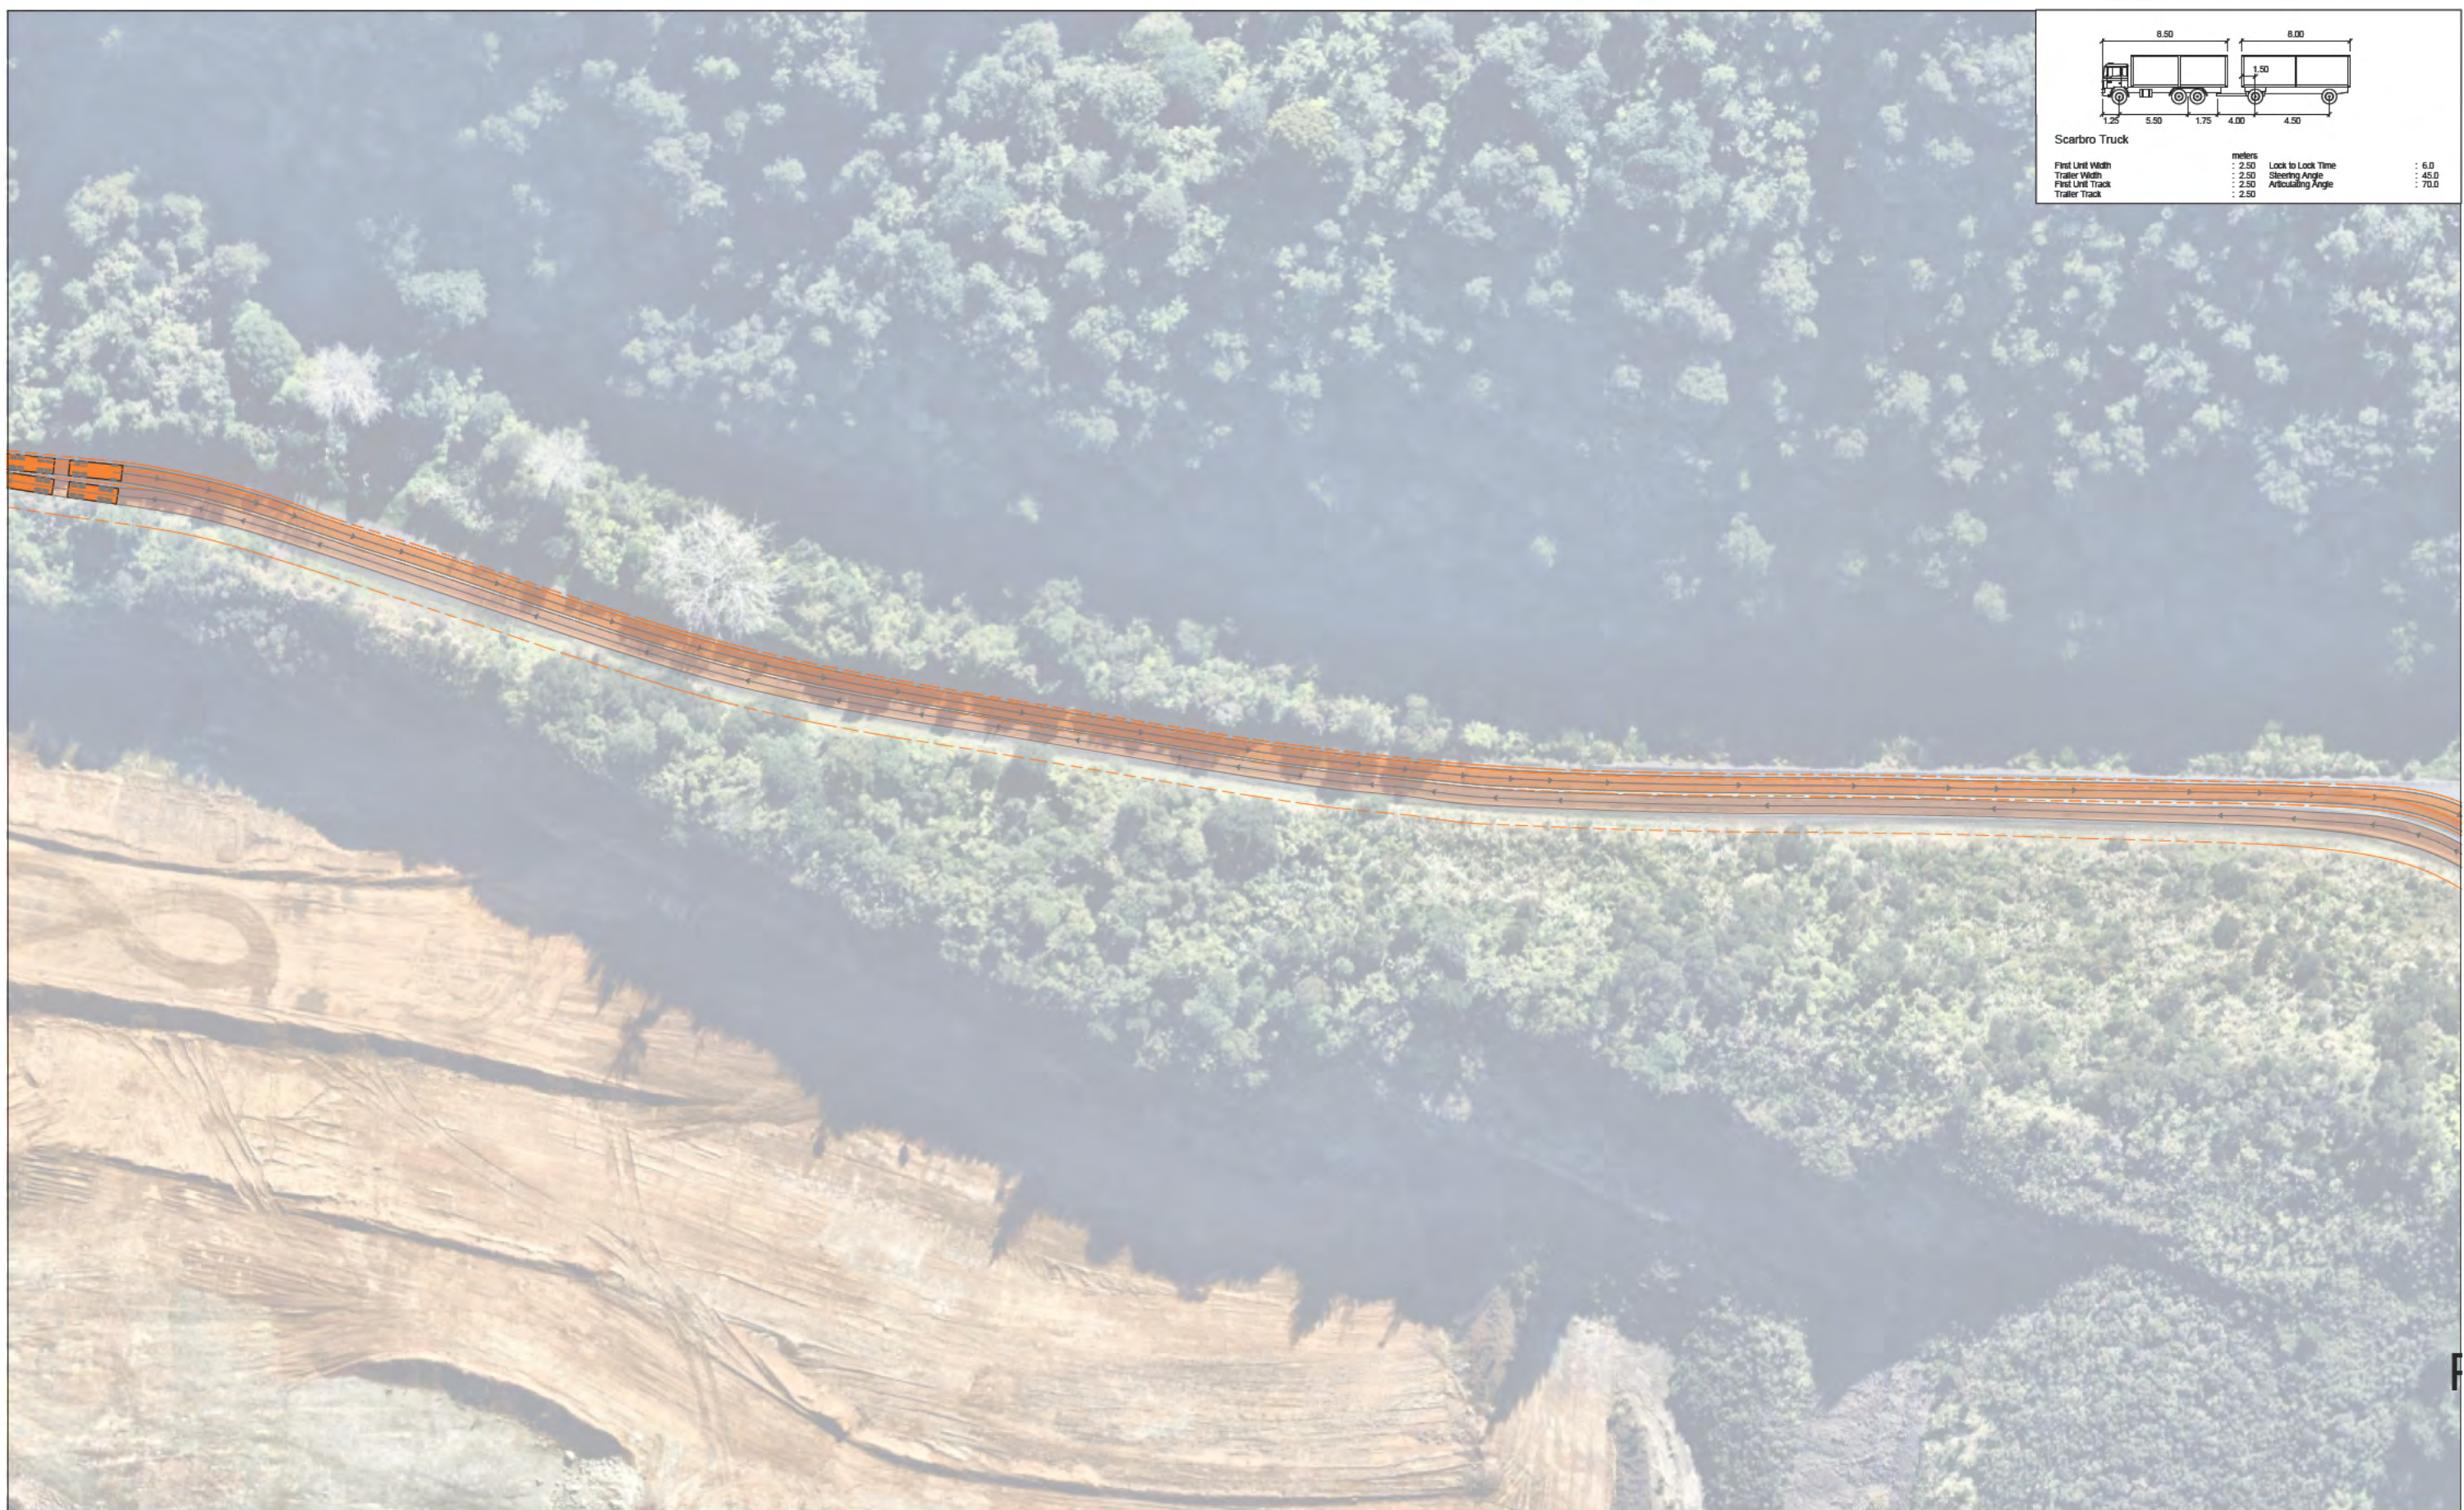
Figure:
3-3

Scarbro Truck

meters		
First Unit Width	: 2.50	Lock to Lock Time	: 6.0
Trailer Width	: 2.50	Steering Angle	: 45.0
First Unit Track	: 2.50	Articulating Angle	: 70.0
Trailer Track	: 2.50
