TRAFFIC ASSESSMENT REPORT – 362 JONES ROAD, DRURY

Further to your instruction, we are pleased to provide this traffic assessment in respect to the proposal to use the plot at 362 Jones Road, Drury, as a fill site. This transport assessment addresses the following aspects with respect to the proposal:

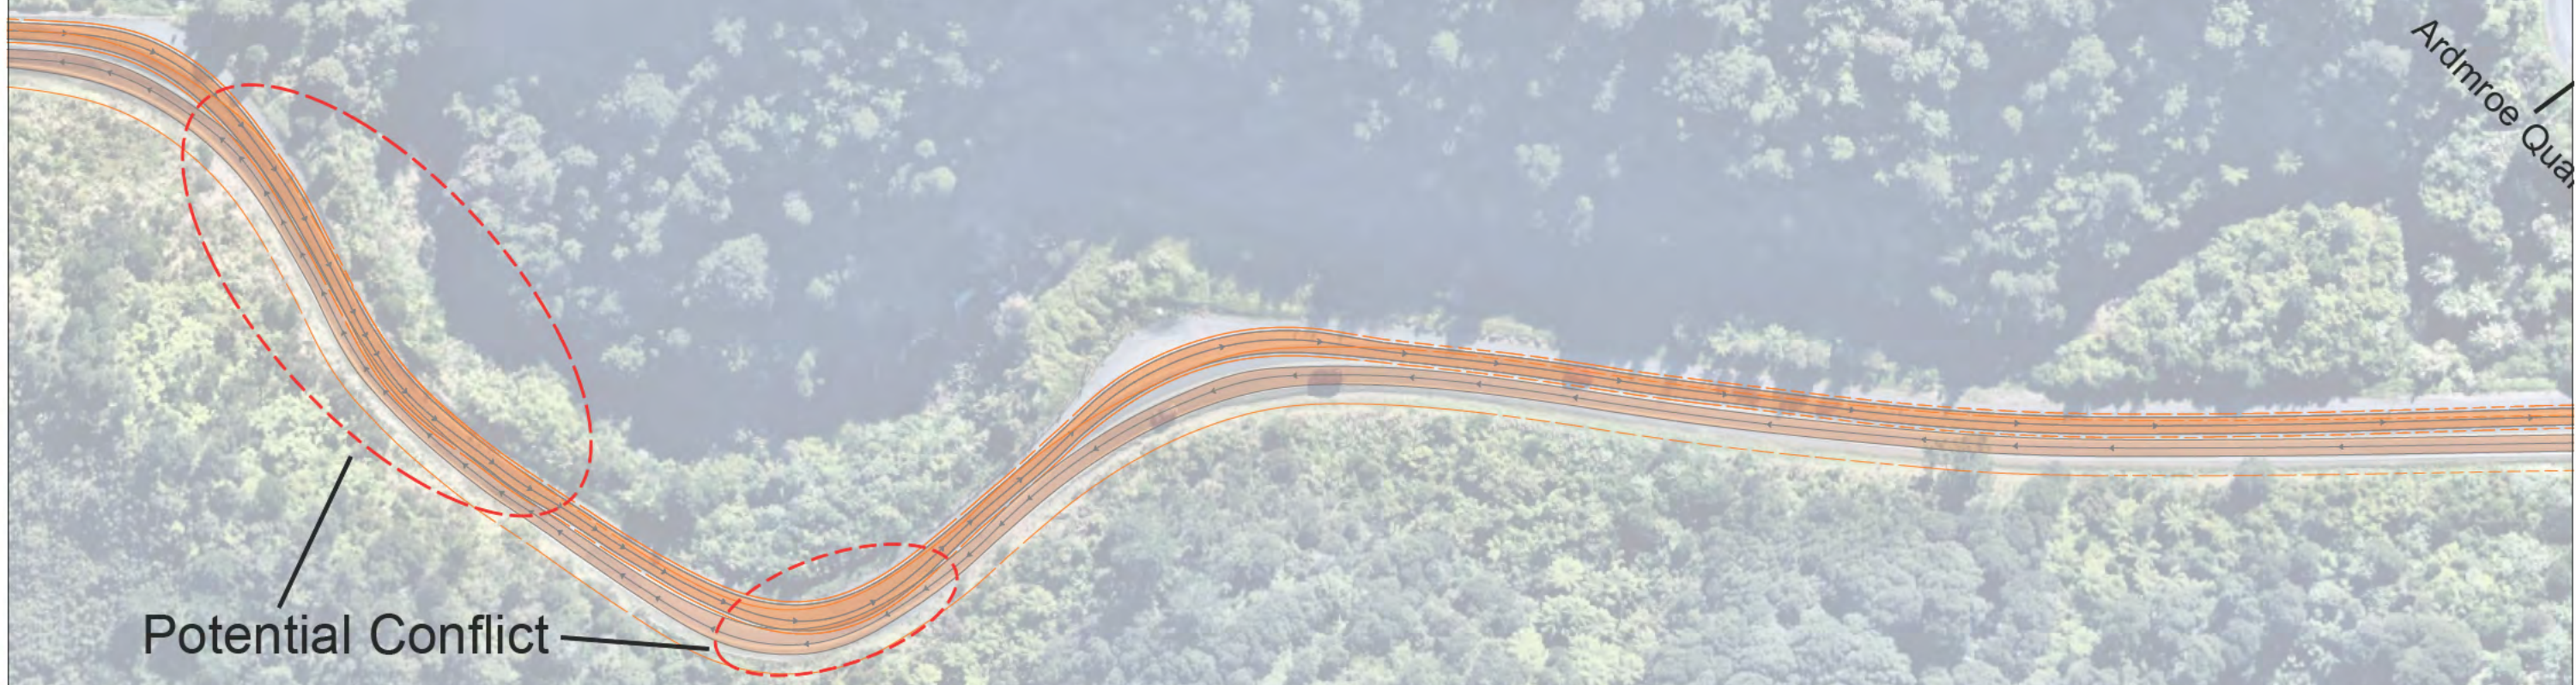
Figure:
3-4

Scarbro Truck

metres		
First Unit Width	: 2.50	Lock to Lock Time	: 6.0
Trailer Width	: 2.50	Steering Angle	: 45.0
First Unit Track	: 2.50	Articulating Angle	: 70.0
Trailer Track	: 2.50

Potential Conflict

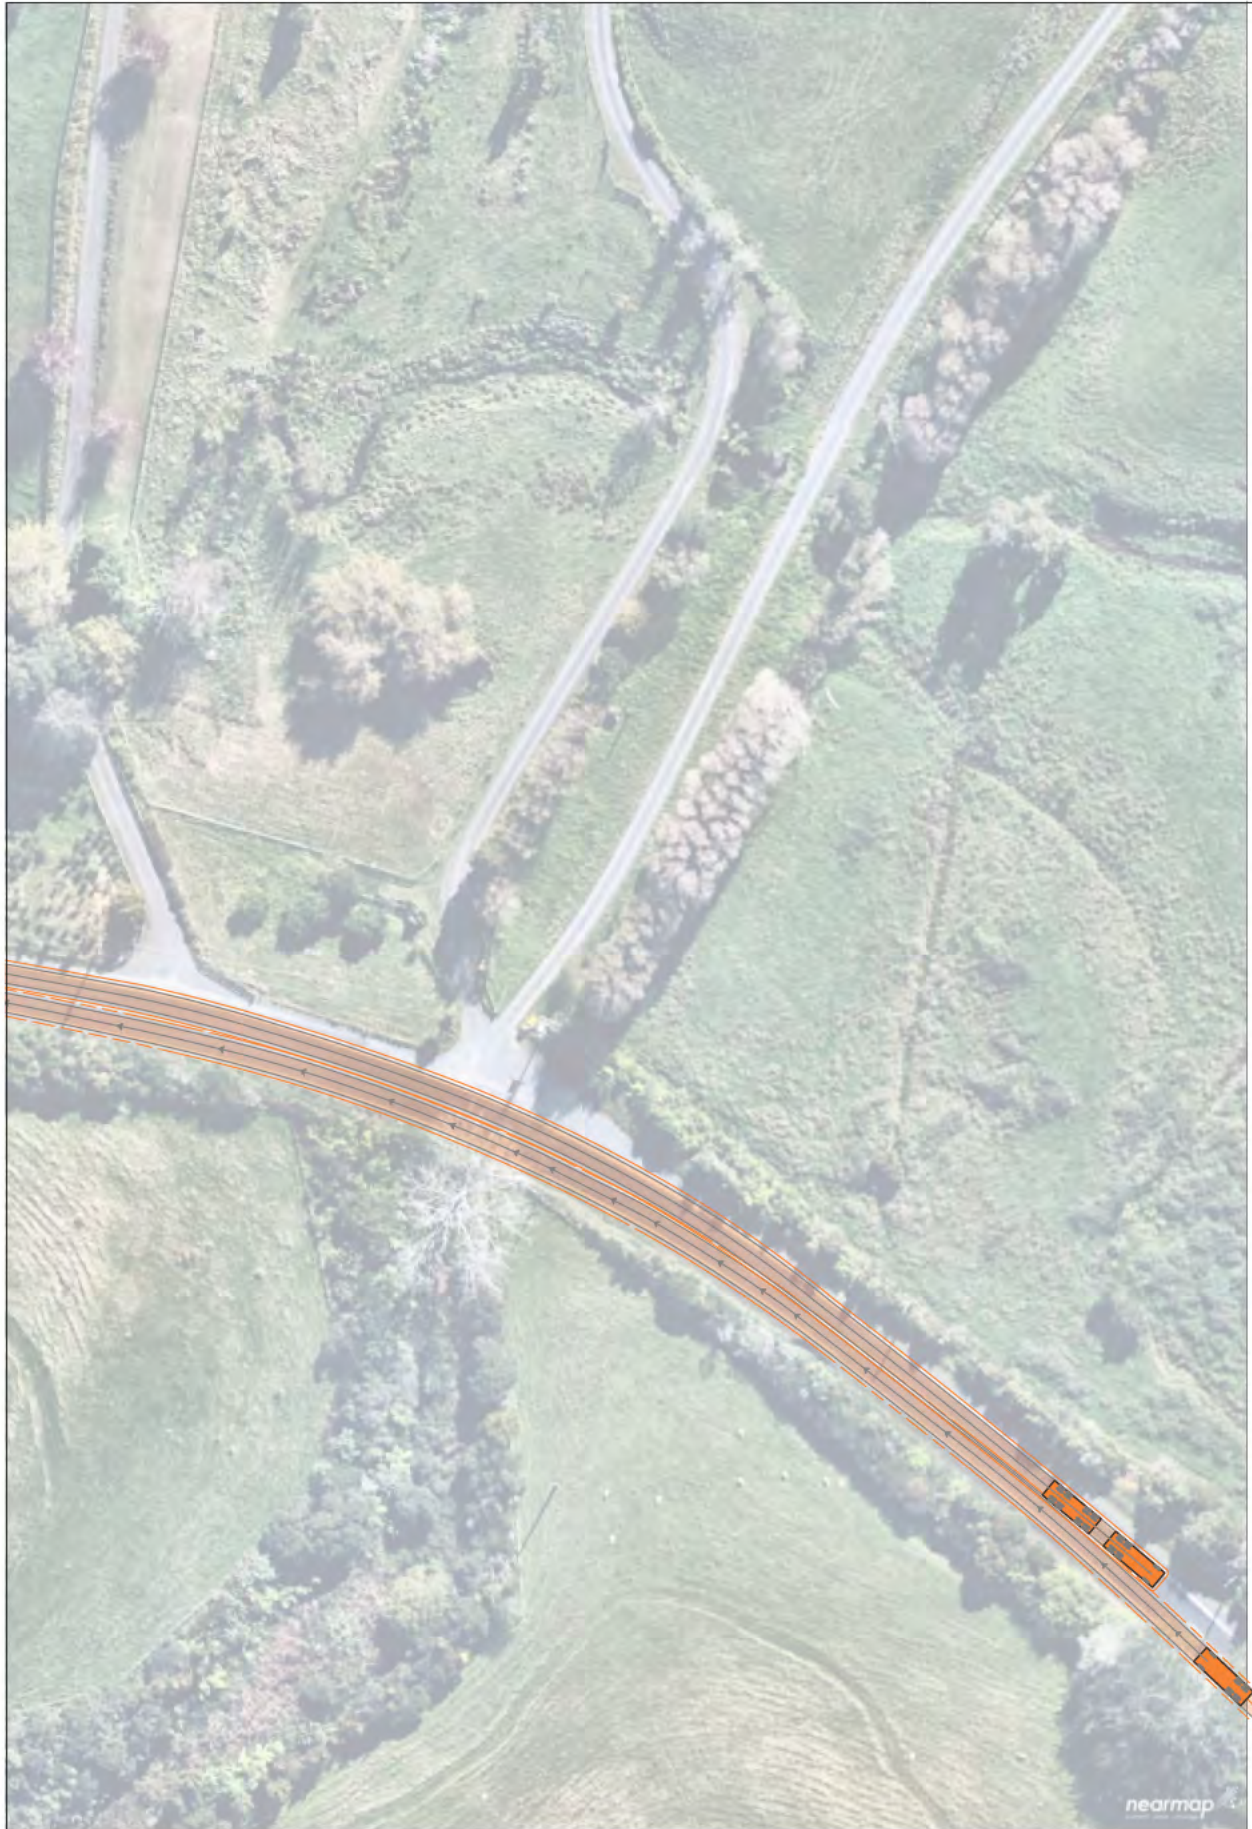
4-2

Scarbro Truck

meters		
First Unit Width	: 2.50	Lock to Lock Time	: 6.0
Trailer Width	: 2.50	Steering Angle	: 45.0
First Unit Track	: 2.50	Articulating Angle	: 70.0
Trailer Track	: 2.50

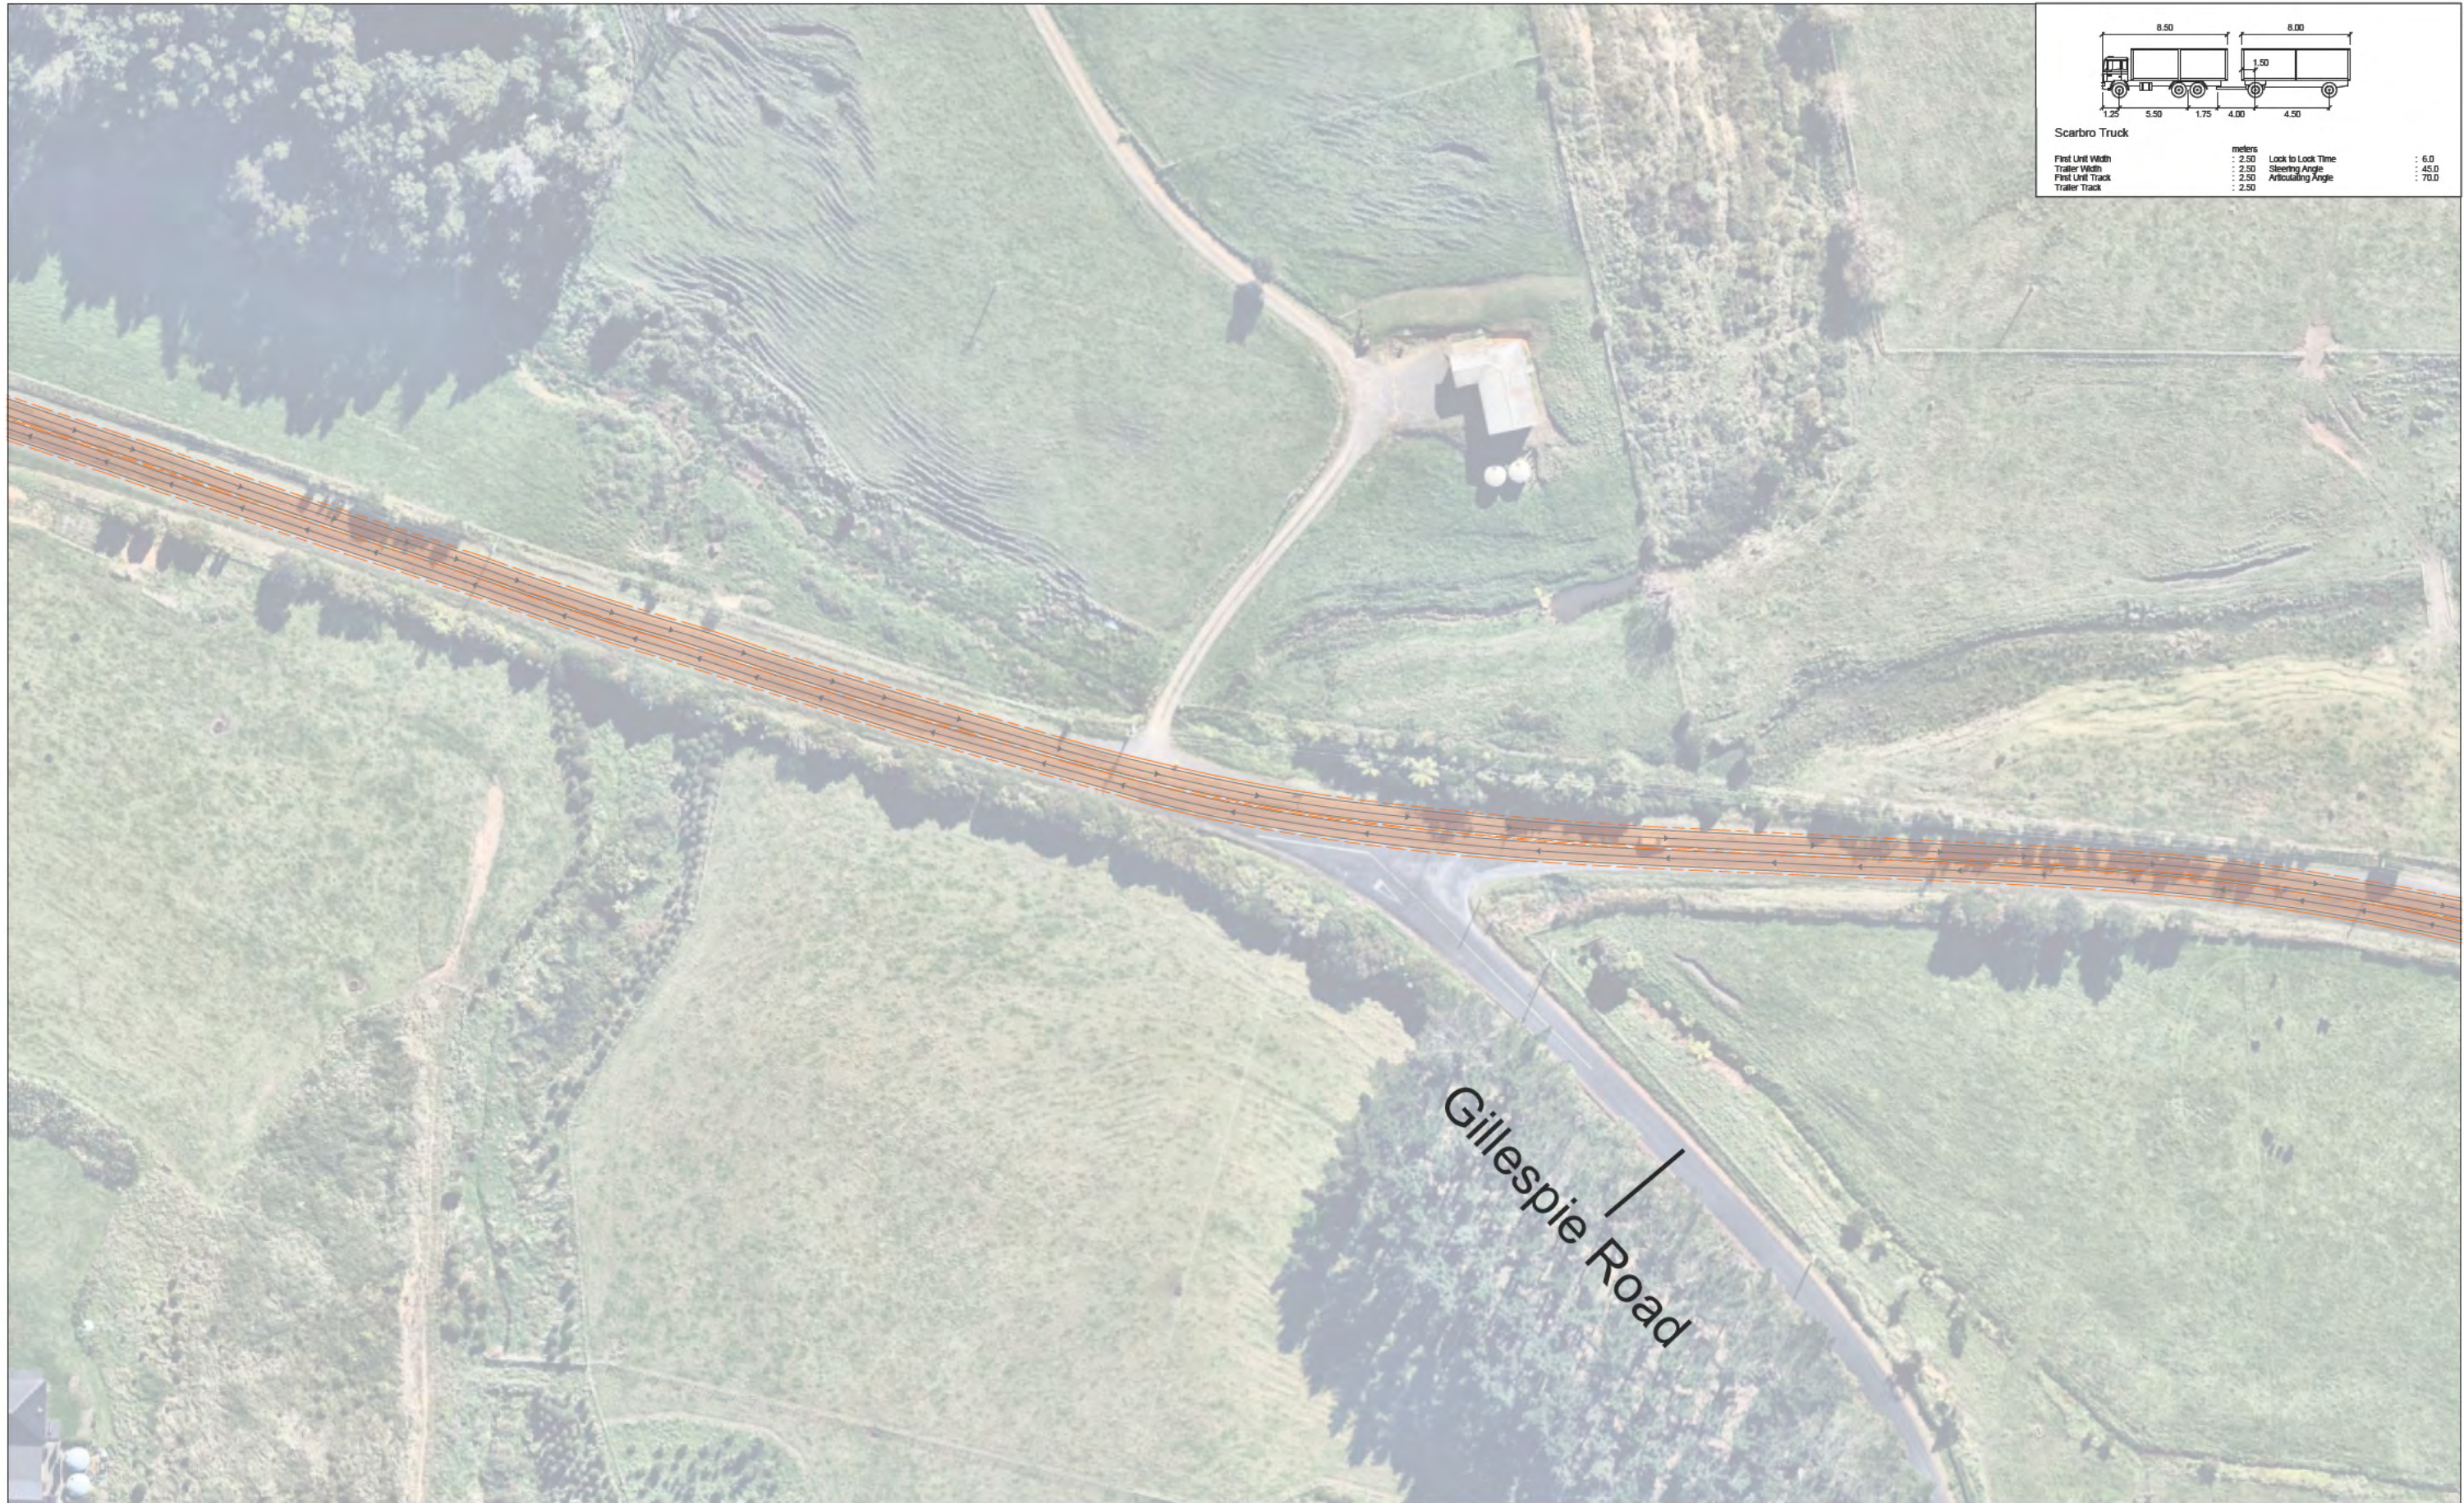
Figure:
5-1

Scarbro Truck

metres		
First Unit Width	: 2.50	Lock to Lock Time	: 6.0
Trailer Width	: 2.50	Steering Angle	: 45.0
First Unit Track	: 2.50	Articulating Angle	: 70.0
Trailer Track	: 2.50
