Title: Downtown Carpark Site Development Contamination Site Management Plan					
Date	Version	Description	Prepared by:	Reviewed by:	Authorised by:
September 2025	1	Draft CSMP for 80% FTAA	C. Di Vitto	L. Phuah	P. Millar
November 2025	2	Final CSMP	C. Di Vitto	L. Phuah	P. Millar

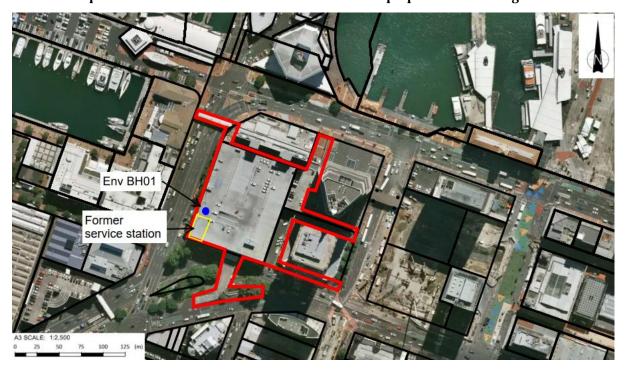
Figure 1.1: Site location shown in red outline (Basemap Source: LINZ Creative Commons Atribution 3.0 New Zealand)

Tonkin & Taylor Ltd. (T+T) has been engaged by Precinct Properties NZ Limited (Precinct) to prepare this preliminary contamination site management plan (CSMP) to outline procedures for Precinct's appointed contractor to follow during the proposed development, located at 2 Lower Hobson Street, Auckland (herein referred to as "the site"). The site location is presented in Figure 1.1.

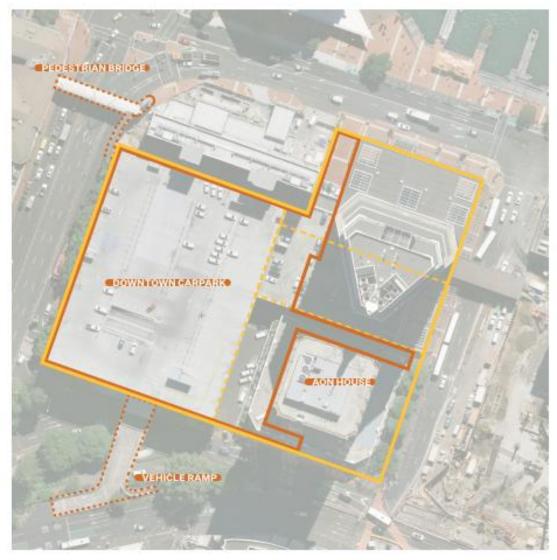
Figure 1.2: Site location and extent of physical works shown in solid orange outline (Source: WAM – Downtown Carpark Site Development Architecture & Landscape Report)

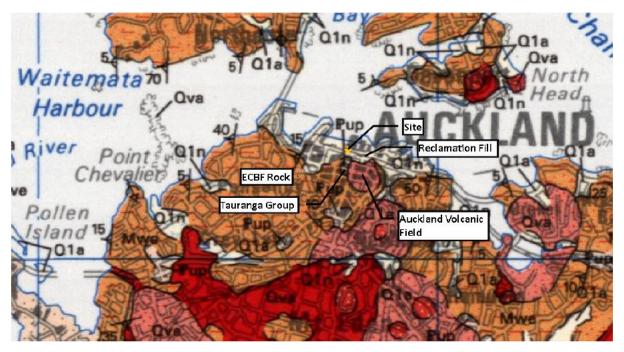
Figure 3.1: Published Geological Map (Source: Edbrooke, 2001)

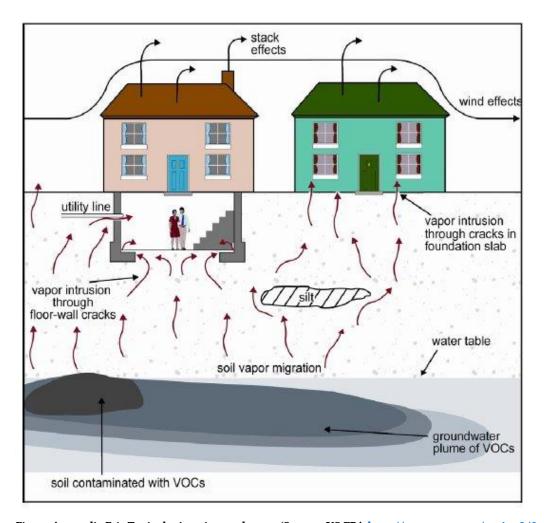
Figure Appendix F.1: Typical migration pathways (Source: US EPA http://www.epa.gov/region6/6pd/rcra_c/ca/)

- Sources of vapour.
- Potential receptors associated with any development works.
- Possible pathways for vapour.

As outlined in Section F2, the potential for vapour is associated with contaminants present in soil at the site.
