Drill hole ID: BH2B\_1116  
Client: Drill Force Ltd  
Run Number(s): 02, 03, 04, 05, 06, 07  
Tool Type(s): ABI40-2G Acoustic Televiwer  
OBI40-2G Optical Televiwer  
QL40-CAL Mechanical Calliper

Service Company: RDCL  
Operator: K Seth  
Date Logged: 11/09/2025  
Field: Brynderwyn Hills  
State / Province: Auckland  
Country: New Zealand

Drill hole ID: BH2B\_1124  
Client: Drill Force Ltd  
Run Number(s): 01, 02, 04  
Tool Type(s): ABI40-2G Acoustic Televiwer  
OBI40-2G Optical Televiwer  
QL40-CAL Mechanical Calliper

Drill hole ID: BH2B\_1127  
Client: Drill Force NZ Ltd  
Run Number(s): 02, 04, 05, 06, 08  
Tool Type(s): ABI40-2G-VLB Acoustic Televiwer  
OBI40-2G Optical Televiwer  
QL40-CAL Mechanical Calliper

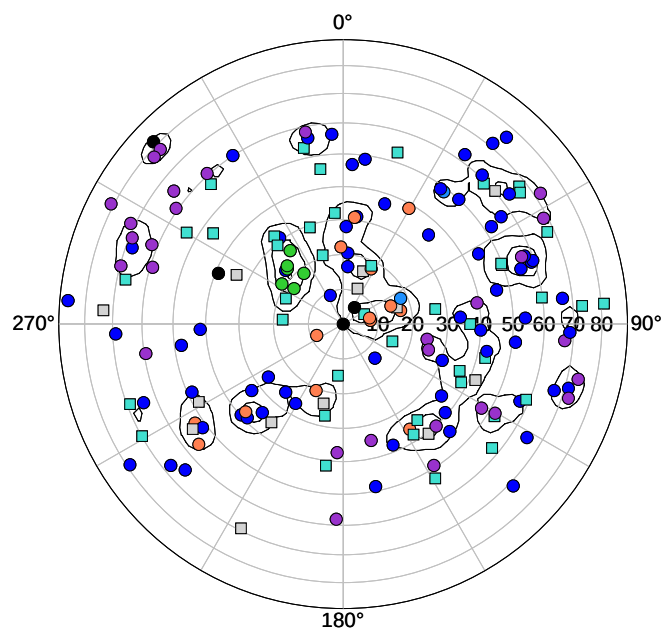
### Stereoplot - Polar Projection Dip

Schmidt Plot - Upper (Northern) Hemisphere - Structures - True  
Depth: 1.17 m to 49.81 m

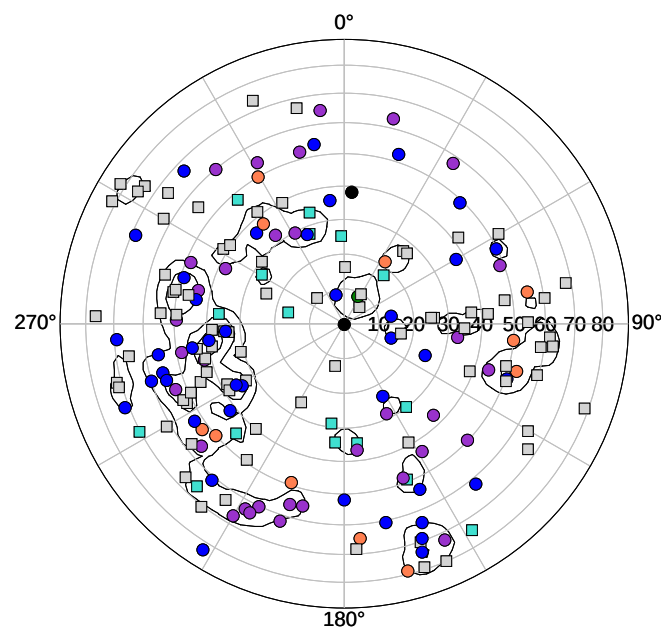
### Stereoplot - Polar Projection Dip

Schmidt Plot - Upper (Northern) Hemisphere - Structures - True  
Depth: 0.83 m to 40.60 m

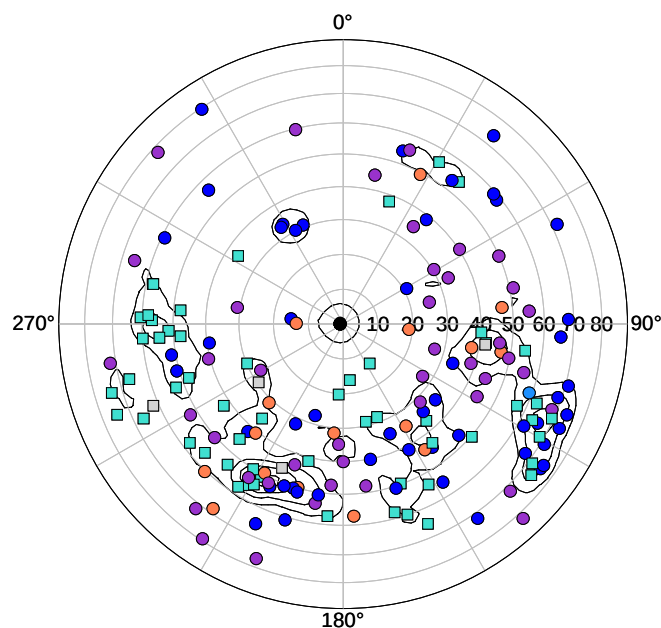
### Stereoplot - Polar Projection Dip

Schmidt Plot - Upper (Northern) Hemisphere - Structures - True  
Depth: 2.00 m to 40.20 m
