# Belmont Quarry Development – Part F

Substantive Application  
Appendix F.1.B.5 – Land Exchange Application  
- Archaeological Assessment  
Winstone Aggregates

# **PROPOSED LAND EXCHANGE FOR WELLINGTON BELMONT QUARRY, OBDA: ARCHAEOLOGICAL ASSESSMENT**

Prepared for Winstone Aggregates  
A Division of Fletcher Concrete and Infrastructure Ltd  
November 2025

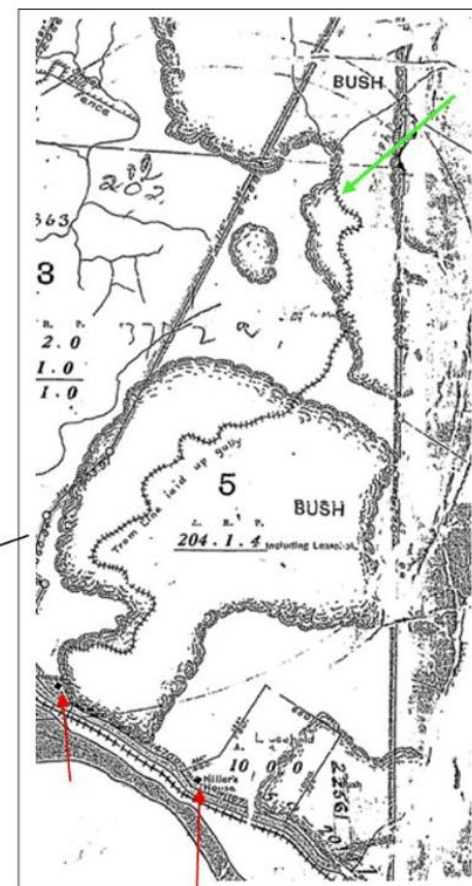
Figure 8. WN Deed 257 surveyed in 1900 and titled 'Plan of the Liverton Estate Hutt District' with area in Lot 5 showing a tram line (indicated by green arrow) which may run through the Southern and Northern Gully land exchange areas and buildings along the southern boundary (red arrows) shown in detail in right inset (source: Quickmap)

45. If any unrecorded sites are located in the Northern and Southern Gullies, they are most likely associated with early European settlement activities. It is noted that a 19<sup>th</sup> century tramway associated with timber extraction is described as being located in the area containing the current Belmont Quarry on a 1900 plan and also in an accompanying written newspaper description. The exact

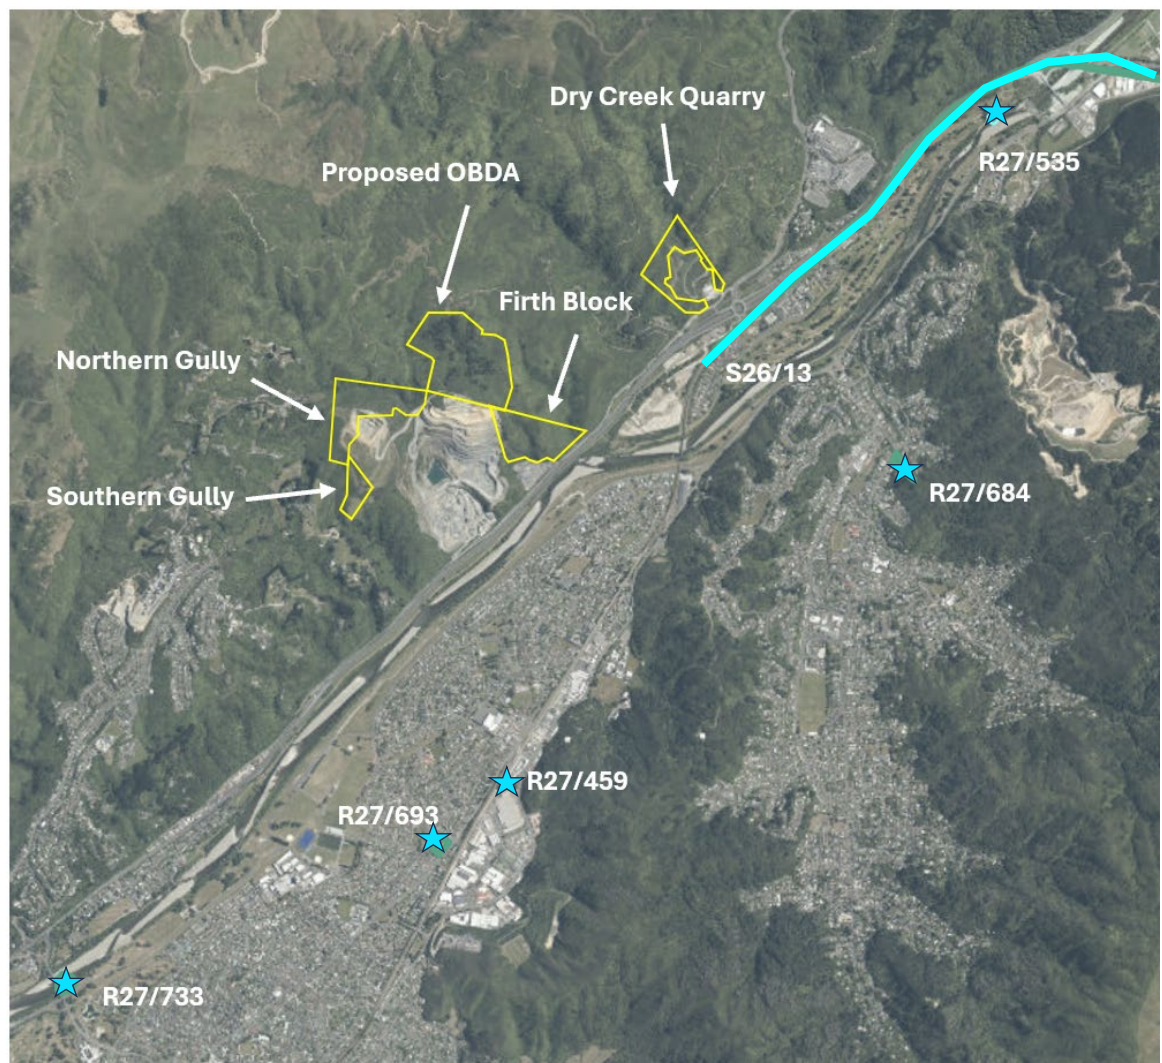
**Figure 10. Map showing the locations of recorded archaeological sites (blue stars and blue line) in the general area (between c.200m and c. 3500m) from the proposed land exchange areas outside of Belmont Regional Park with proposed land exchange areas indicated by yellow outlines (source: NZAA Archsite Website)**

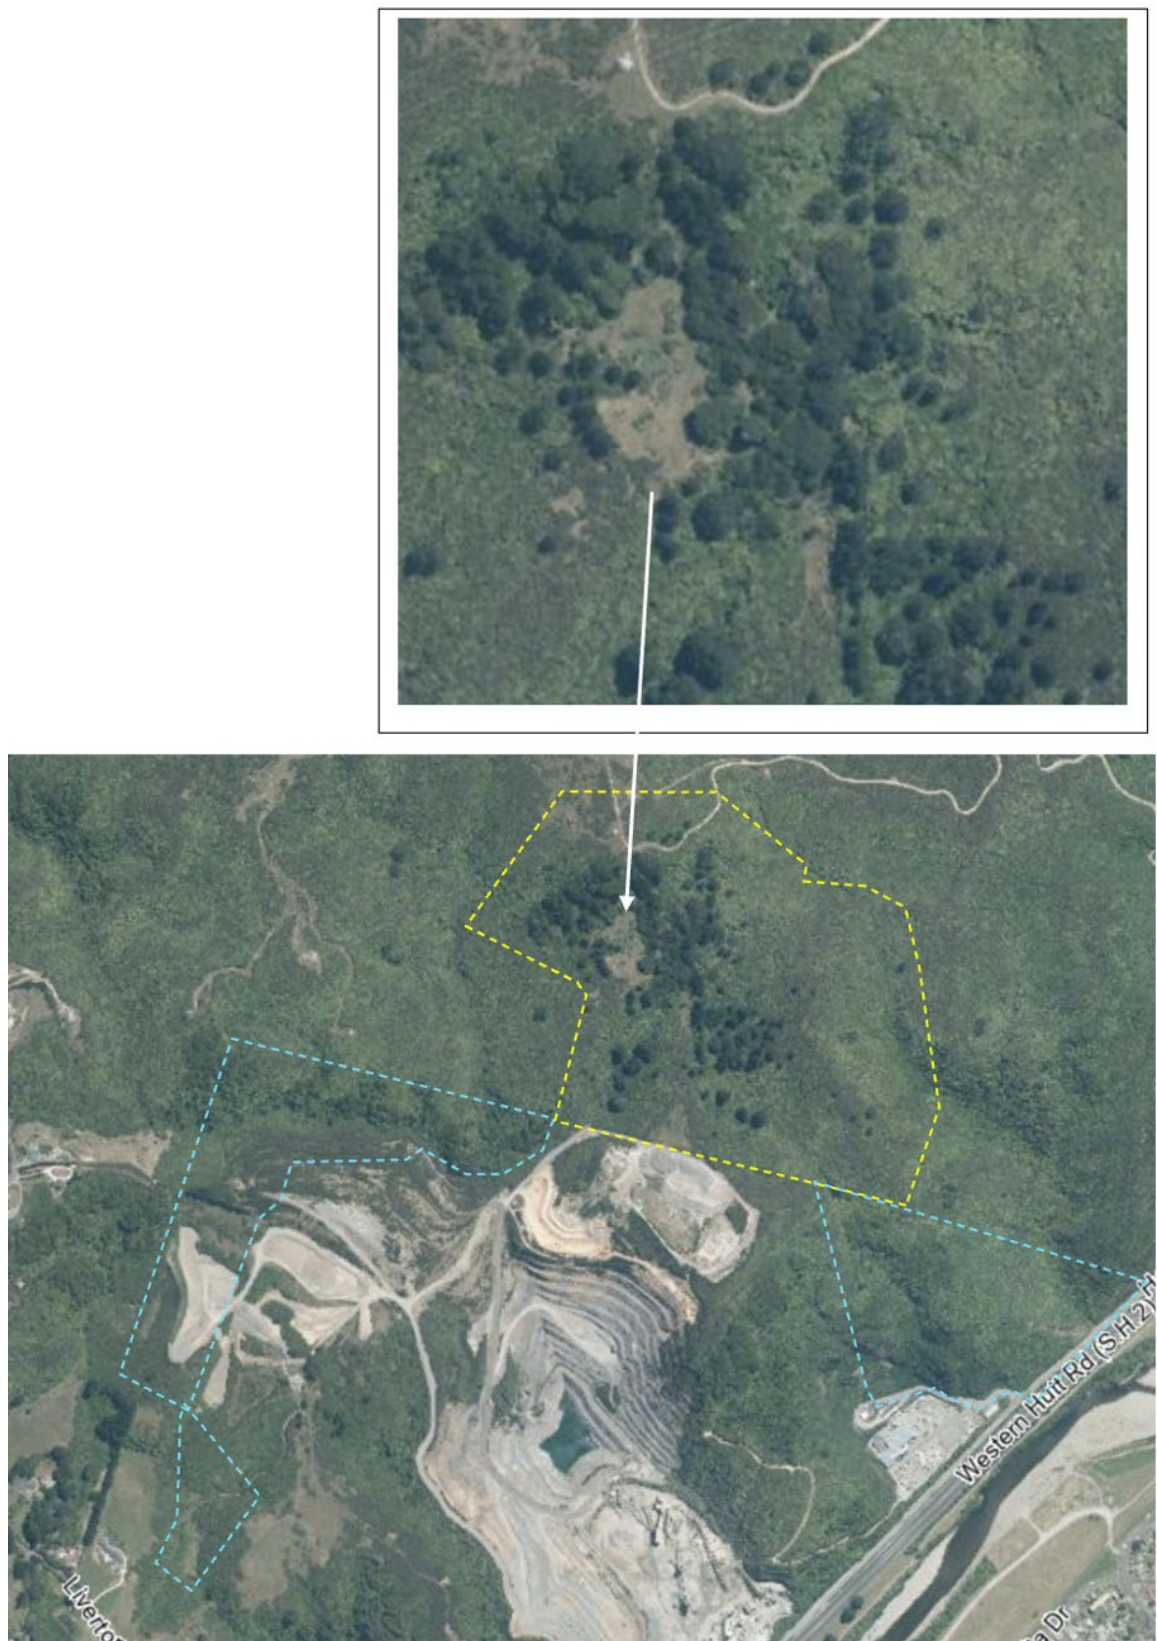
**Figure 16. Aerial photograph dated 2005 showing the proposed OBDA (outlined by yellow dashed line) and three land exchange areas at the Belmont Quarry (outlined by blue dashed lines,) with detail of the area that previously contained structures shown in upper inset (source from: Google Earth)**

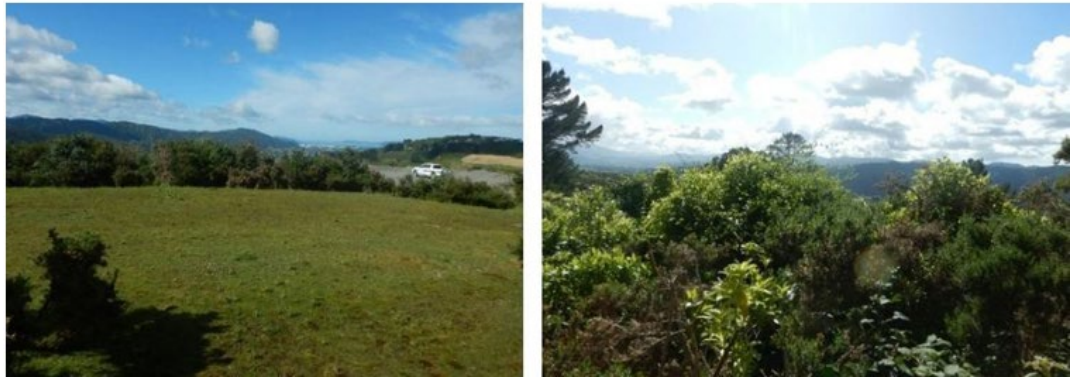
Figure 18. Left photograph showing the modified area where entry to the proposed OBDA was accessed, looking southwest; and right photograph taken during the survey showing the thick vegetation cover, looking east

52. Entry to the OBDA was attempted from the northern point of the quarry through an area of grassed land that had been previously modified (Figure 18, left). The surrounding area was found to be covered by very thick scrub and also with very steep hillsides, also shown in Figure 18 (right), and it was decided that a full walkover survey could not be safely undertaken.

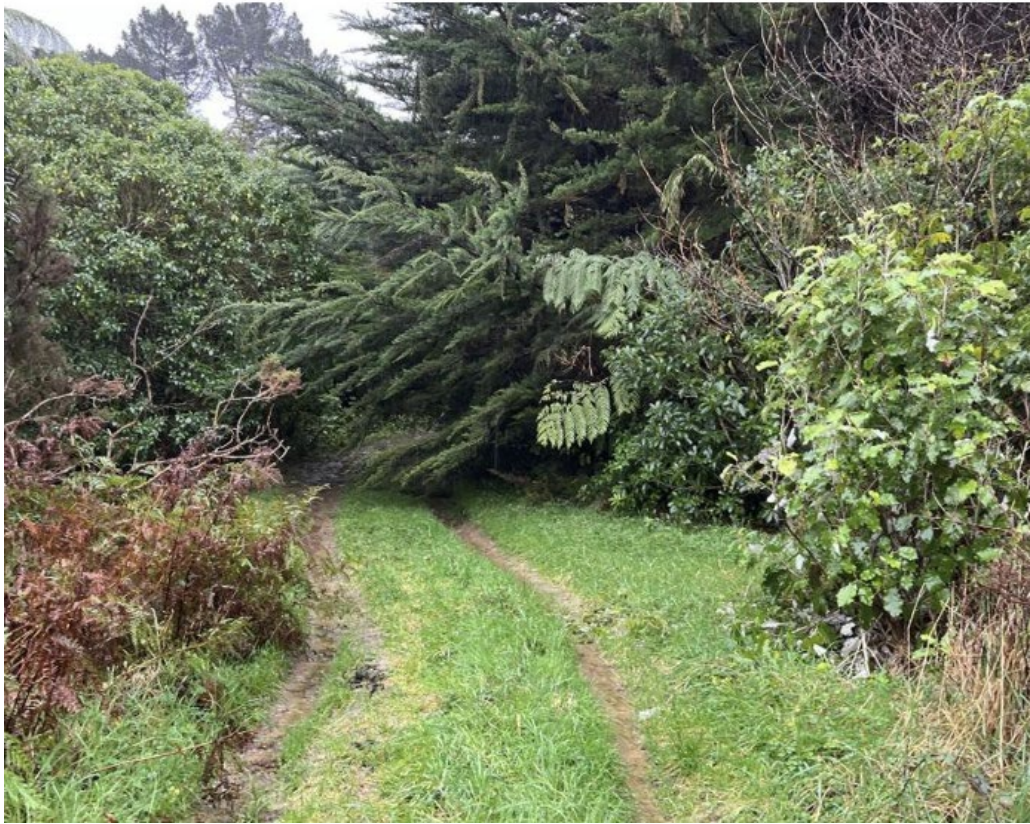
**Figure 19. View of the grassed access track in the proposed OBDA looking north**

54. The OBDA was entered from the north along the ridge and the area where structures were observed in early aerial photographs was visited. The area was accessed by a grassed vehicle track with large trees on either side. This opened onto some cleared areas containing tall grass and areas of scrubby vegetation. The area was walked over but no evidence of the former structures was observed. As well, no evidence of features or deposits on the ground surface were visible. However, it is noted that the thick vegetation cover hindered visibility over much of the survey area. Finally, it was noted that one of the open grassed areas contained beehive boxes, and this area was only observed from a distance. Photographs taken during the survey are shown in Figure 19 - Figure 22.

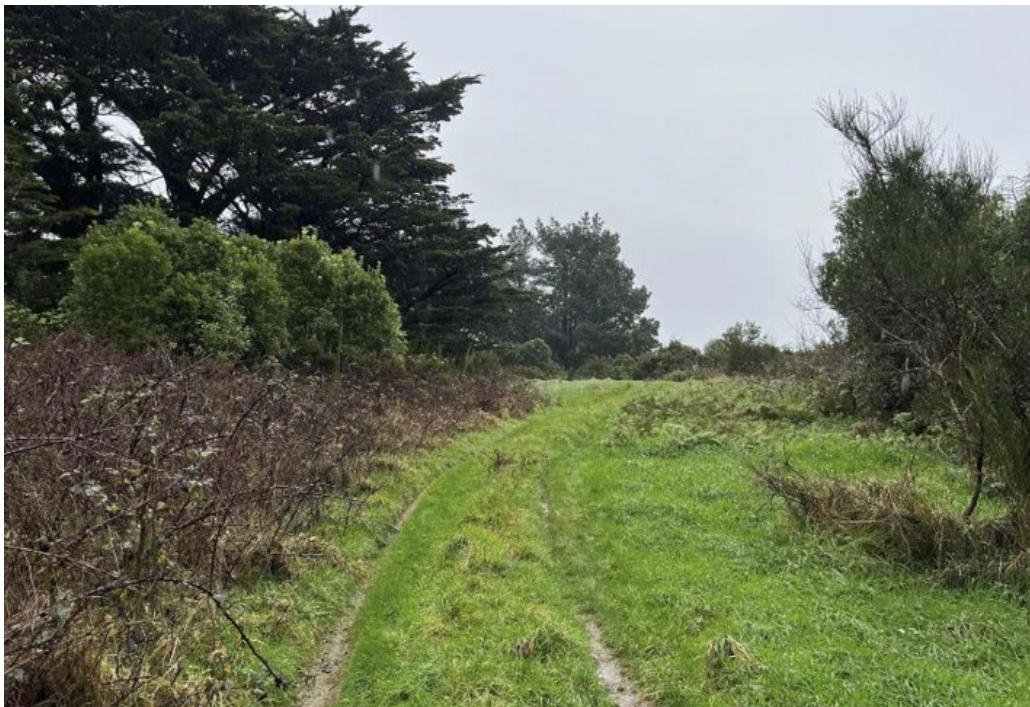
**Figure 20. View of the southern end of the access track leading to the open area in the proposed OBDA, looking south**

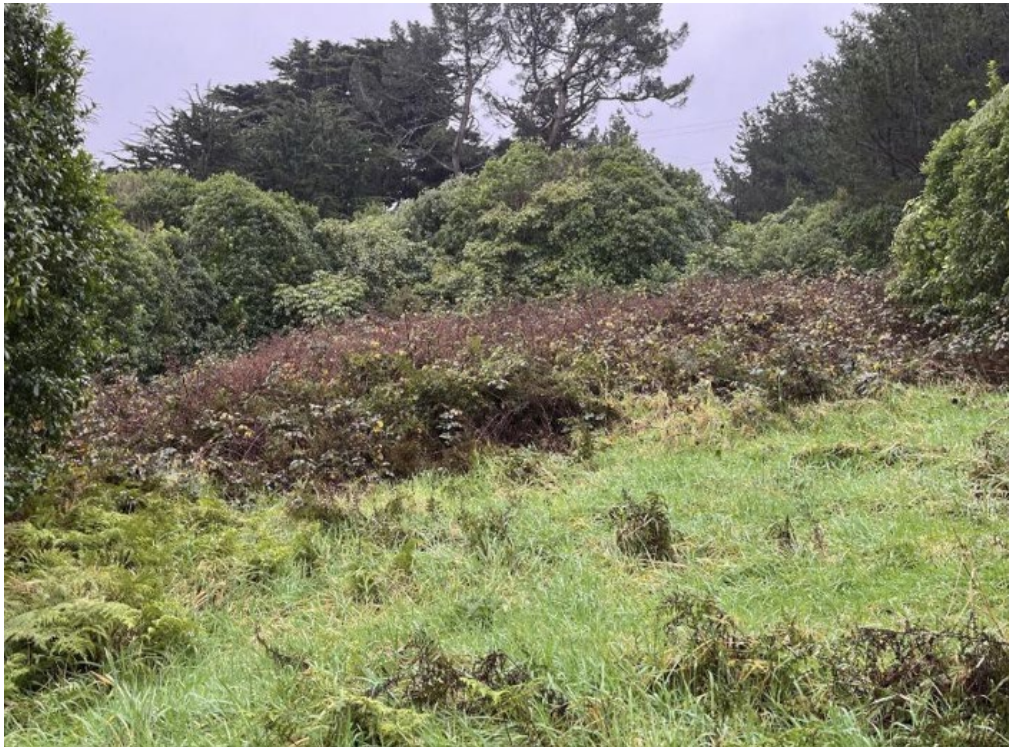
**Figure 21. View of an area covered by thick grass and surrounding vegetation in the proposed OBDA, looking south**

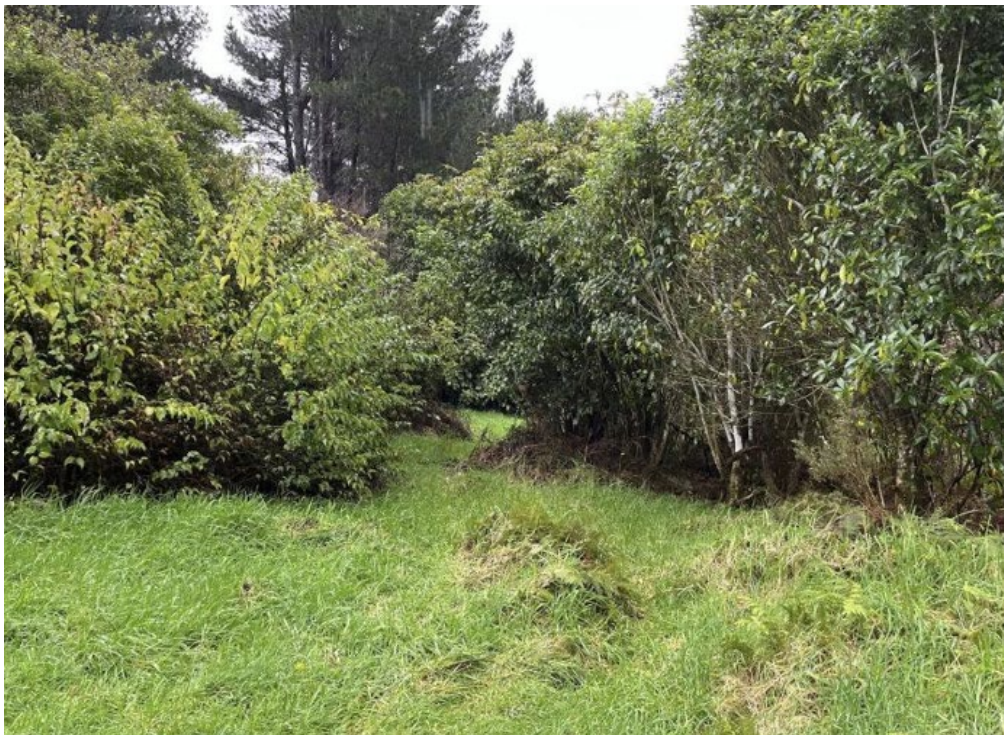
**Figure 22. View of an open area with thick grass and surrounding thick vegetation in the proposed OBDA, looking west**
