# **WAIHI NORTH PROJECT – FAST TRACK APPROVAL: ASSESSMENT OF HISTORIC HERITAGE AND ARCHAEOLOGICAL EFFECTS**

## **APPENDICES**

Prepared for Oceana Gold (New Zealand) Ltd  
Document Number:

January 2025

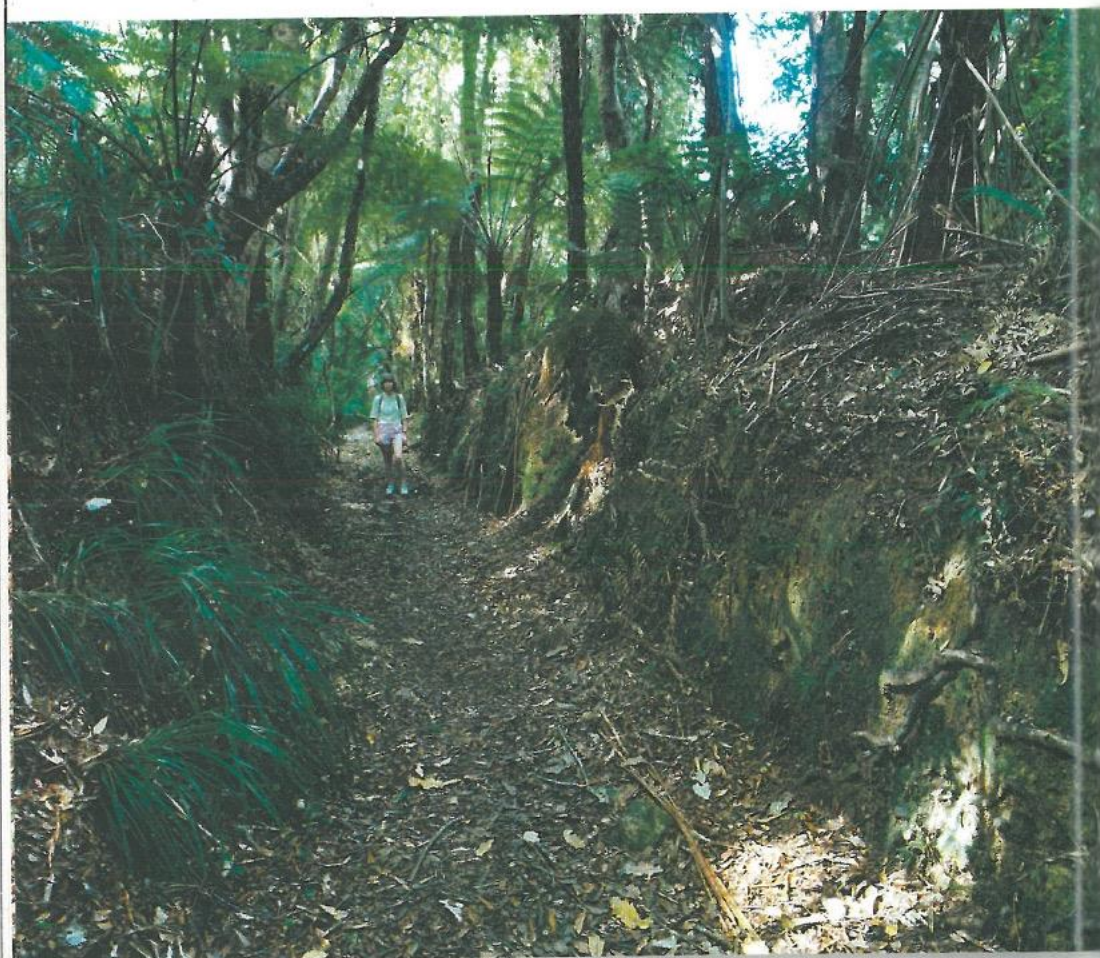
FIGURE 11.10 The Royal Standard tramway route now provides easy access up the Wharekirauponga Valley. Wooden sleepers are still visible in places along the track.

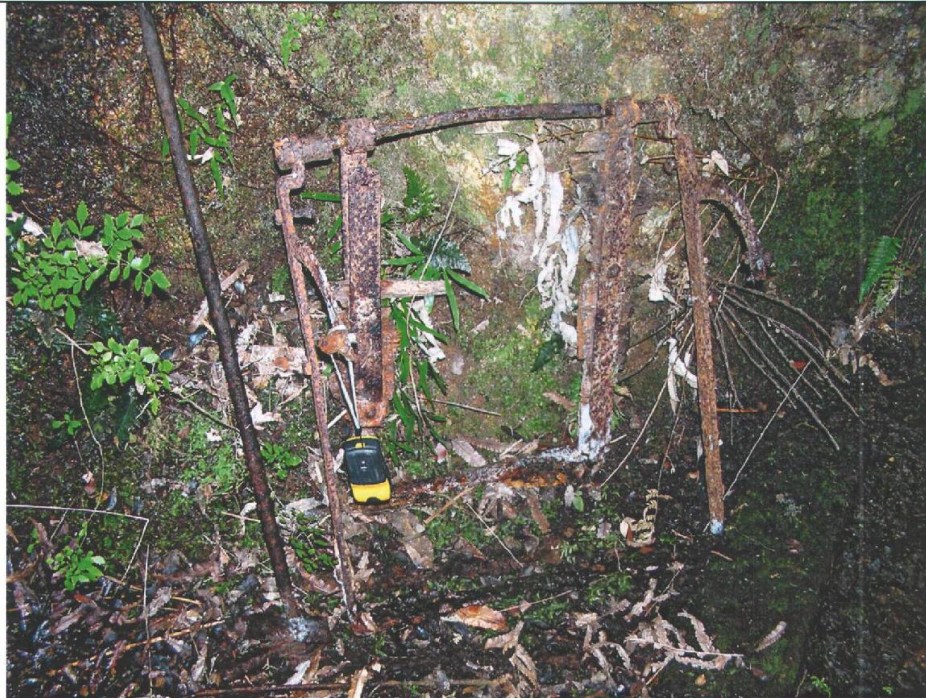
Figure 19 Metal remnants in adit entrance WP 314 (probably the tipping mechanism for a cart)

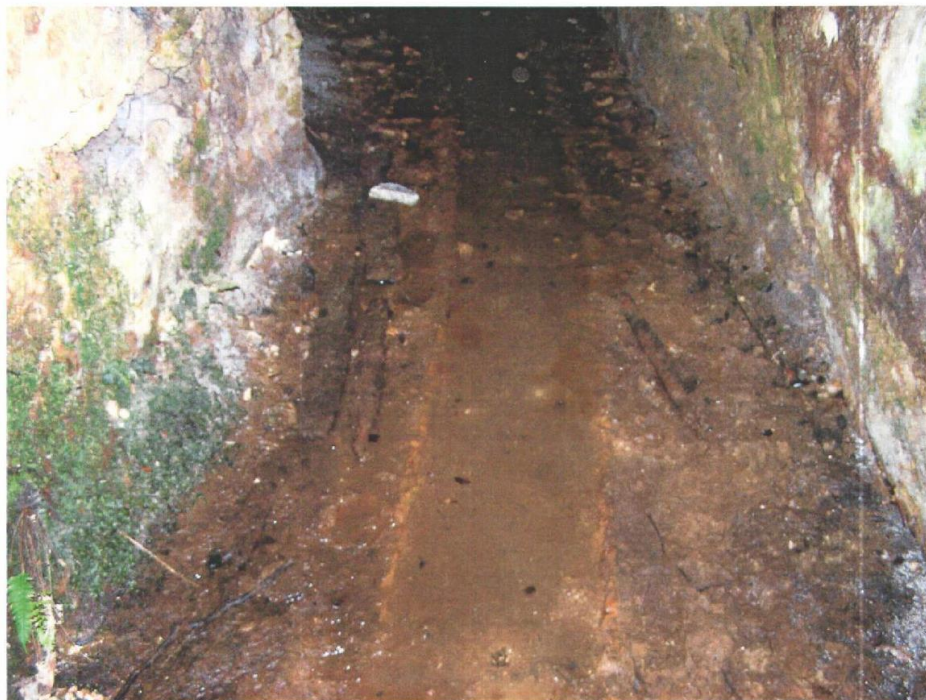
Figure 20 Metal rails in adit, WP 314

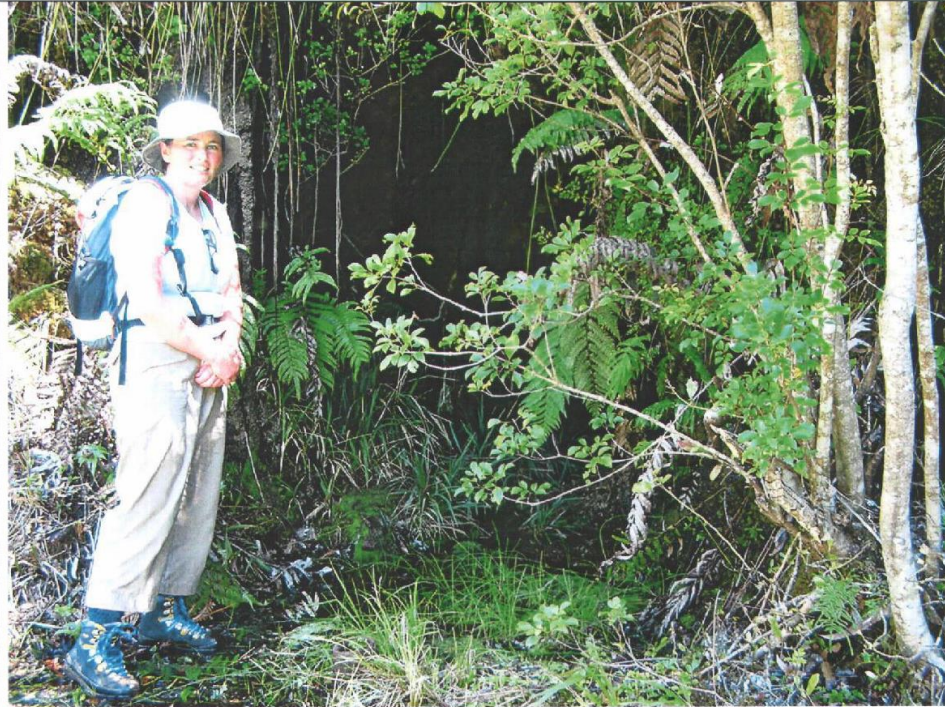
Figure 17 Adit entrance WP 296

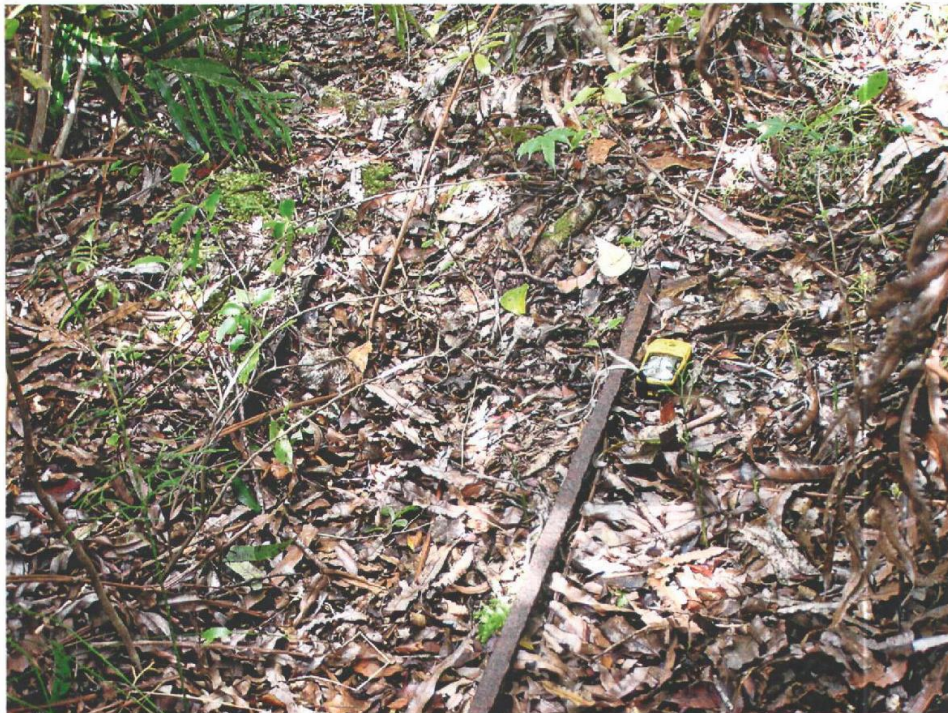
Figure 18 Rails on upper tramway (WP 312)

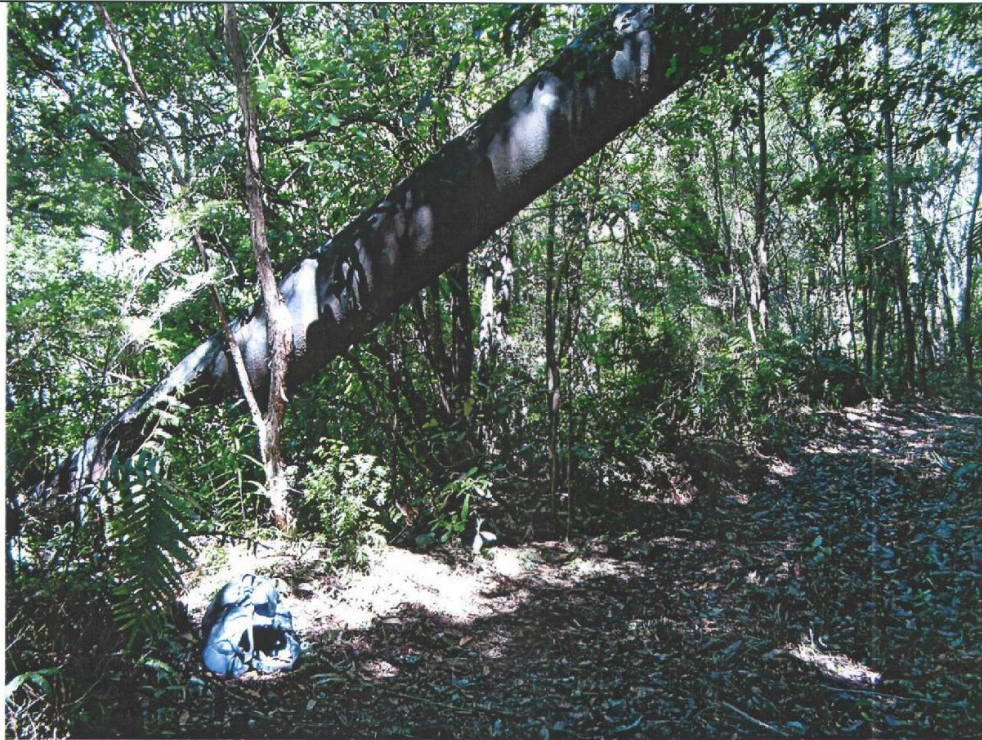
Figure 15 Water race pipeline crossing track at WP 294

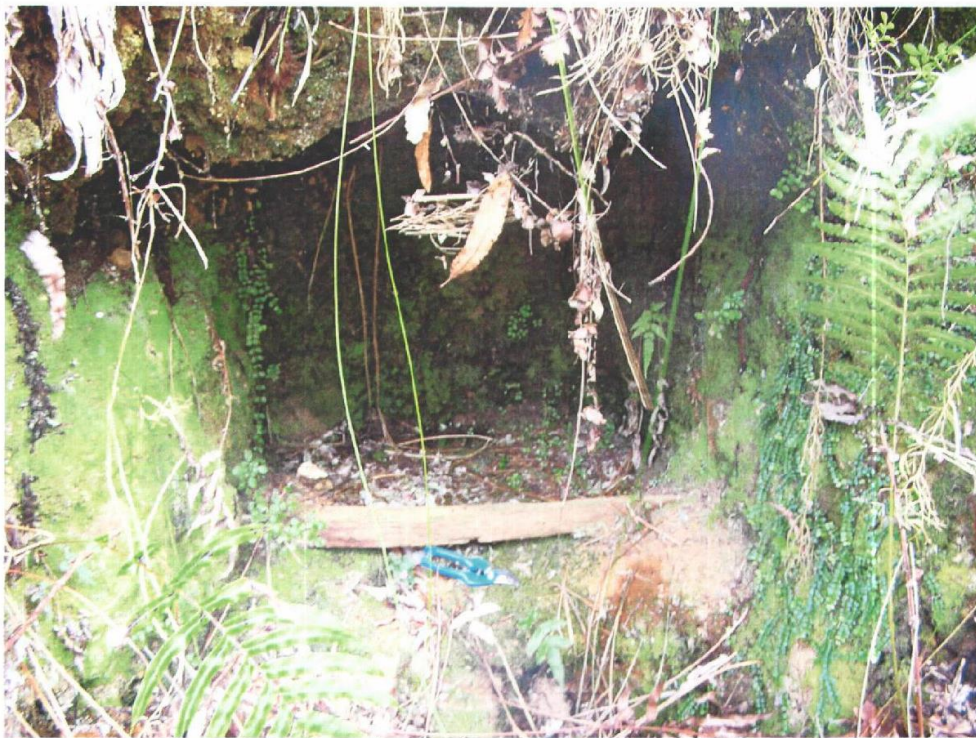
Figure 16 Cave dug into bank (WP 313) with remains of door sill (probably an explosives store)

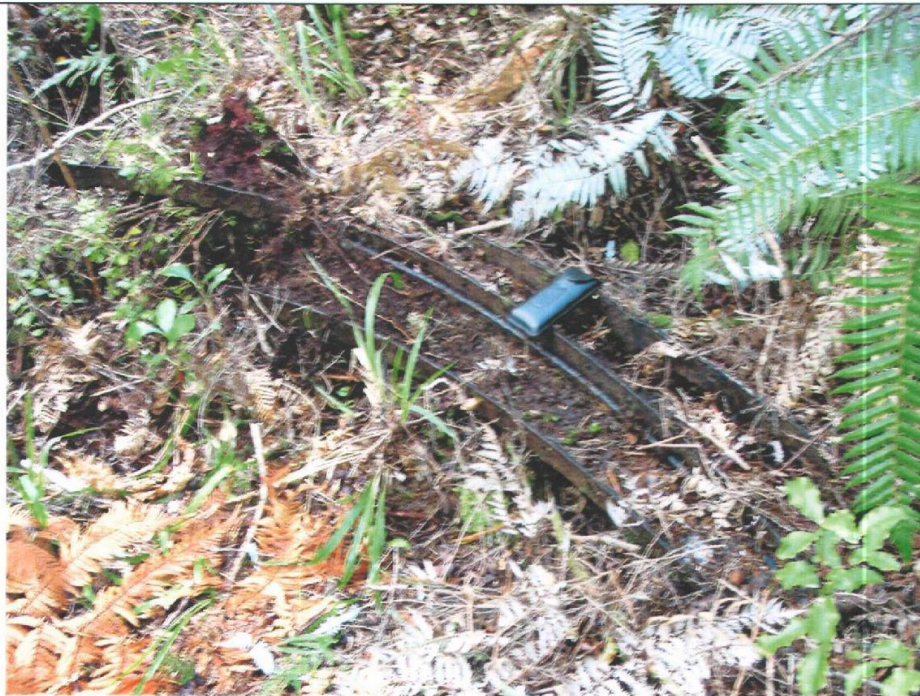
Figure 13 Sections of cyanide tank frame at battery site WP 299

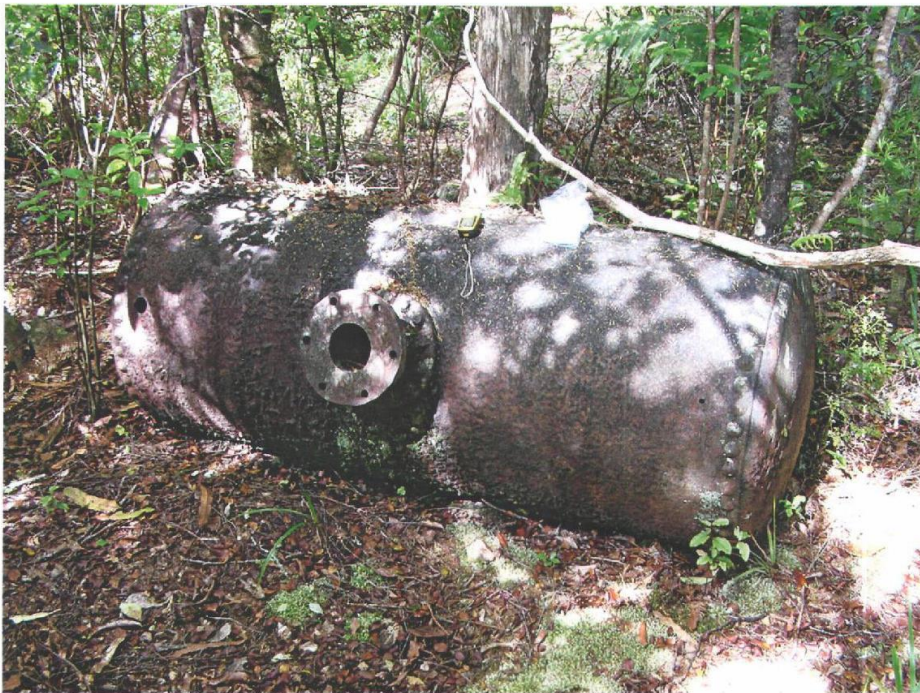
Figure 14 Pressure vessel WP 219

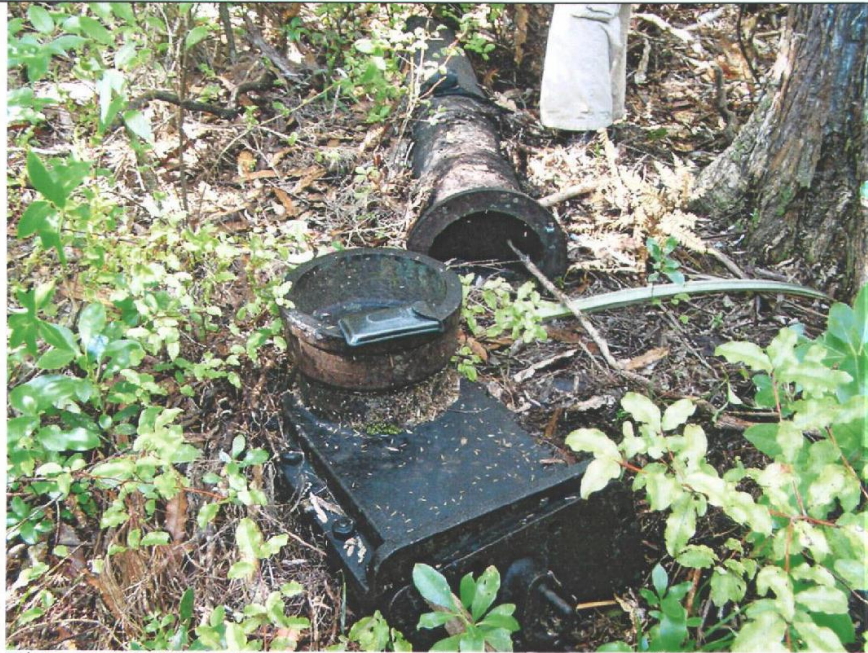
Figure 11 Miscellaneous metal remnants at battery site WP 299

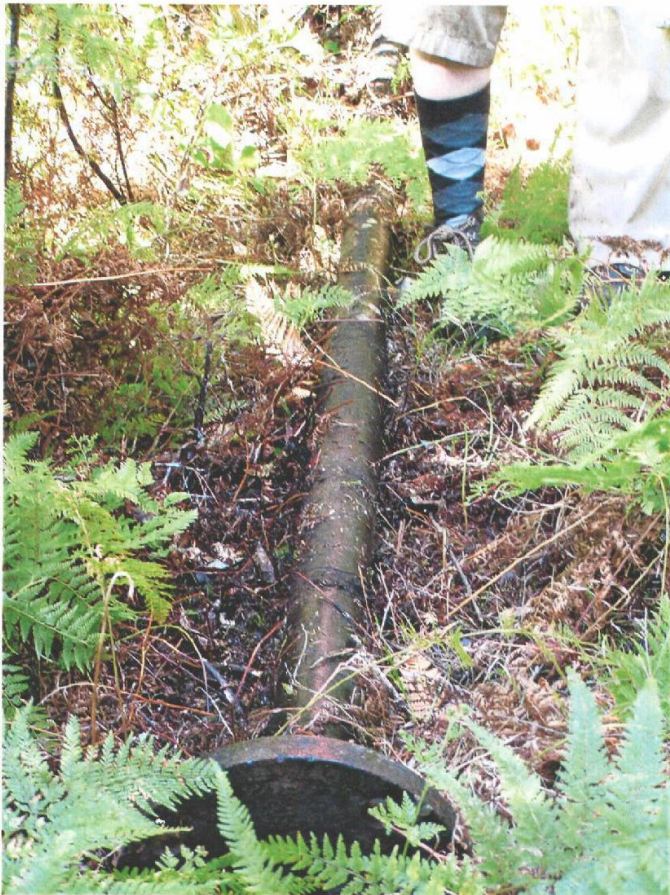
Figure 12 Cylindrical shaft at battery site WP 299

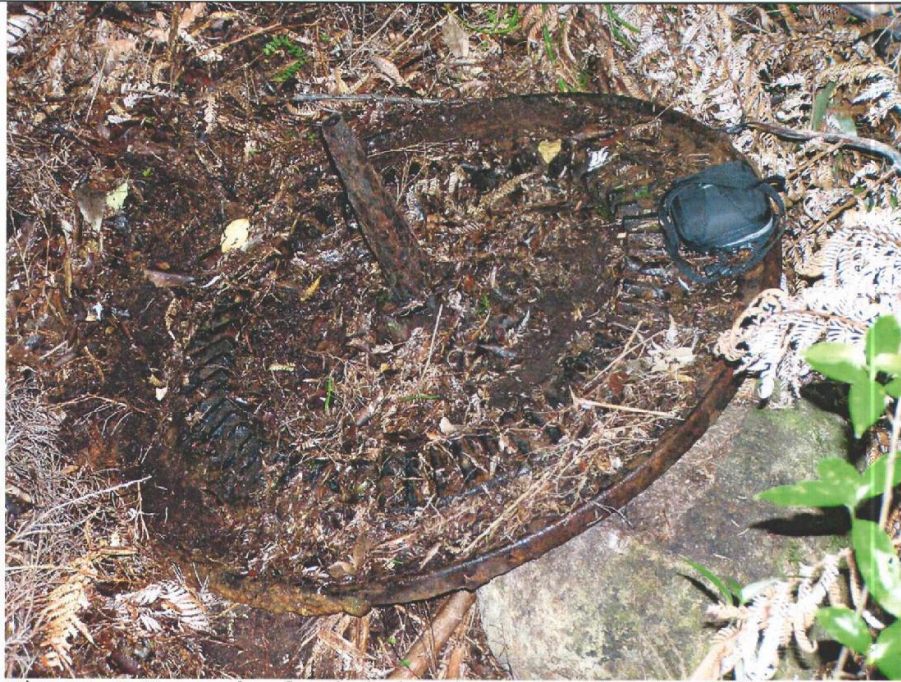
Figure 9 Gear wheel vicinity battery site WP 299

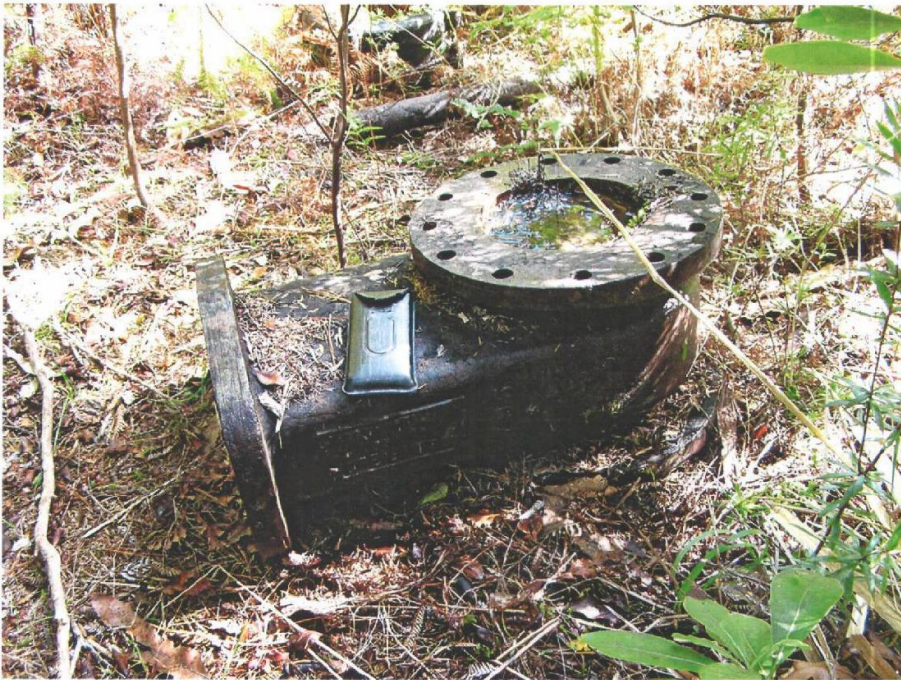
Figure 10 Hydraulic joint, battery site WP 299. Inscription on side reads: "Glenfield and Kennedy Ltd Kilmarnock".

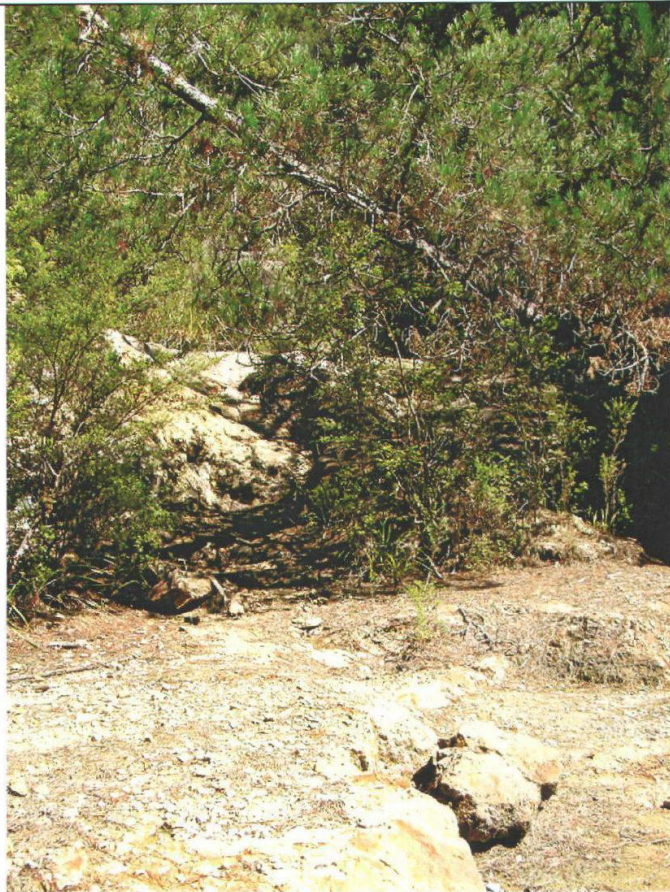
Figure 7 Battery site (WP 299) showing terraces

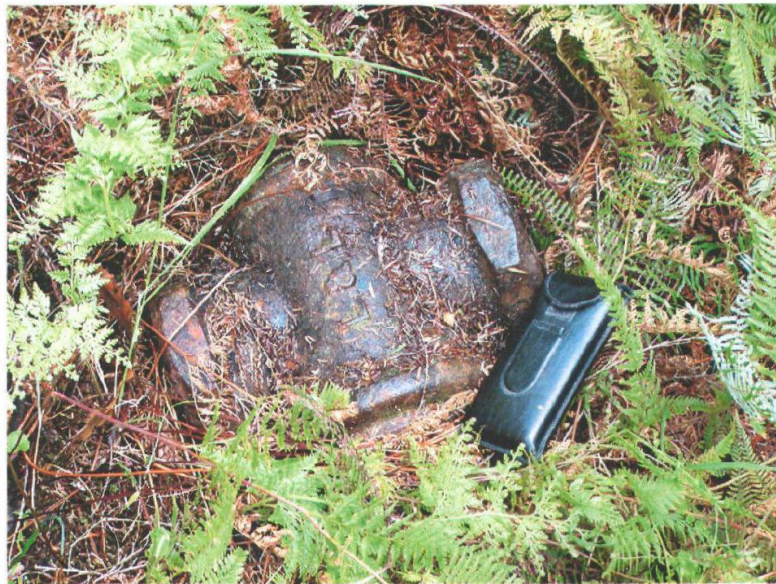
Figure 8 Hydraulic valve at battery site WP 299

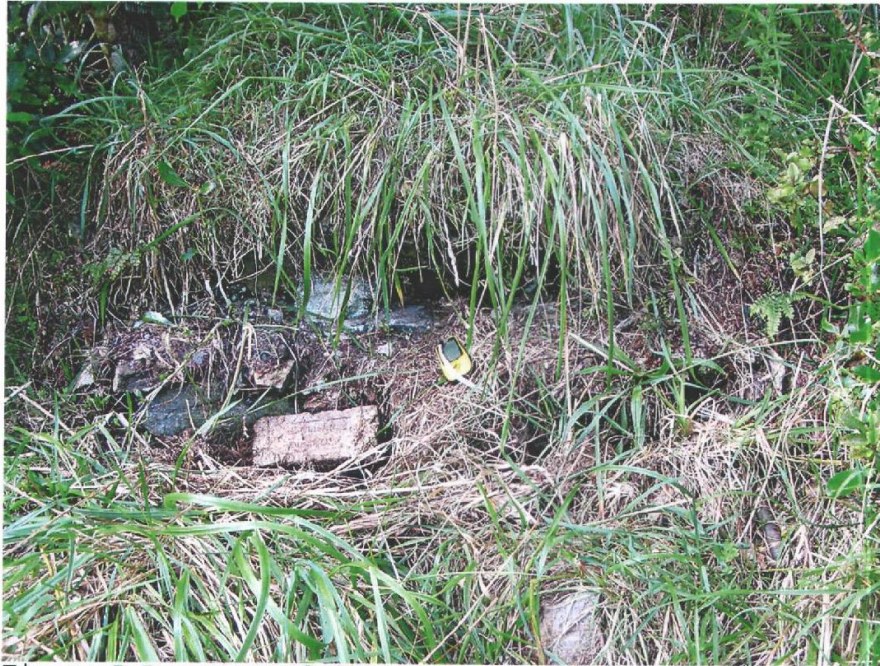
Figure 5 Remnants of fireplace or furnace, vicinity of WP 215

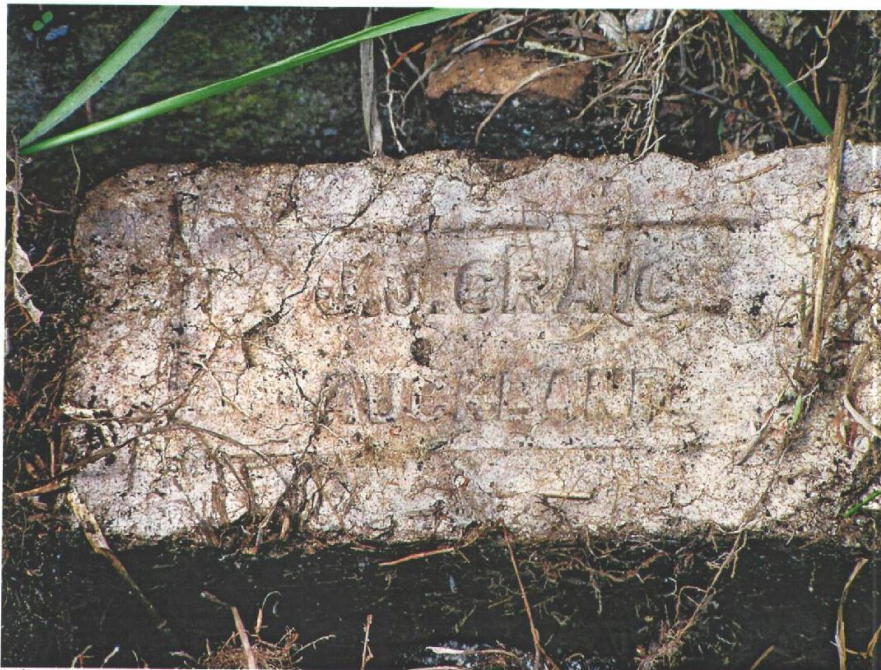
Figure 6 Brick bearing inscription "JJ Craig Auckland". Several of these were found in the vicinity of the clearing at WP 215 and the battery site at WP 299.

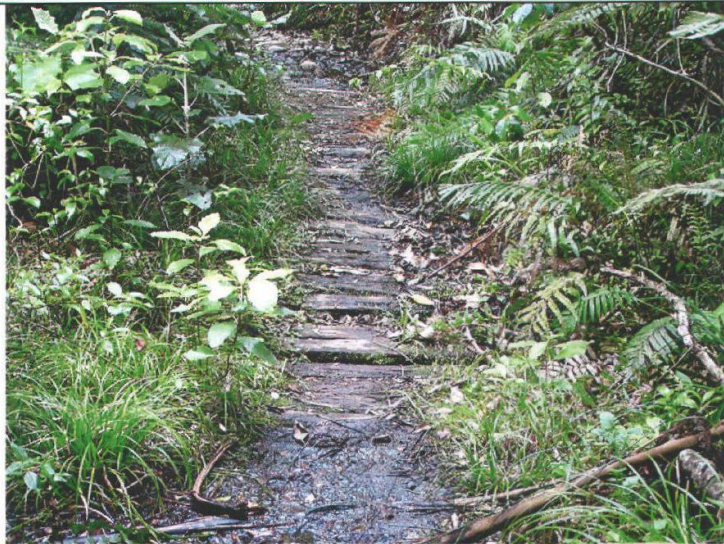
Figure 3 Tramway sleepers at WP 222

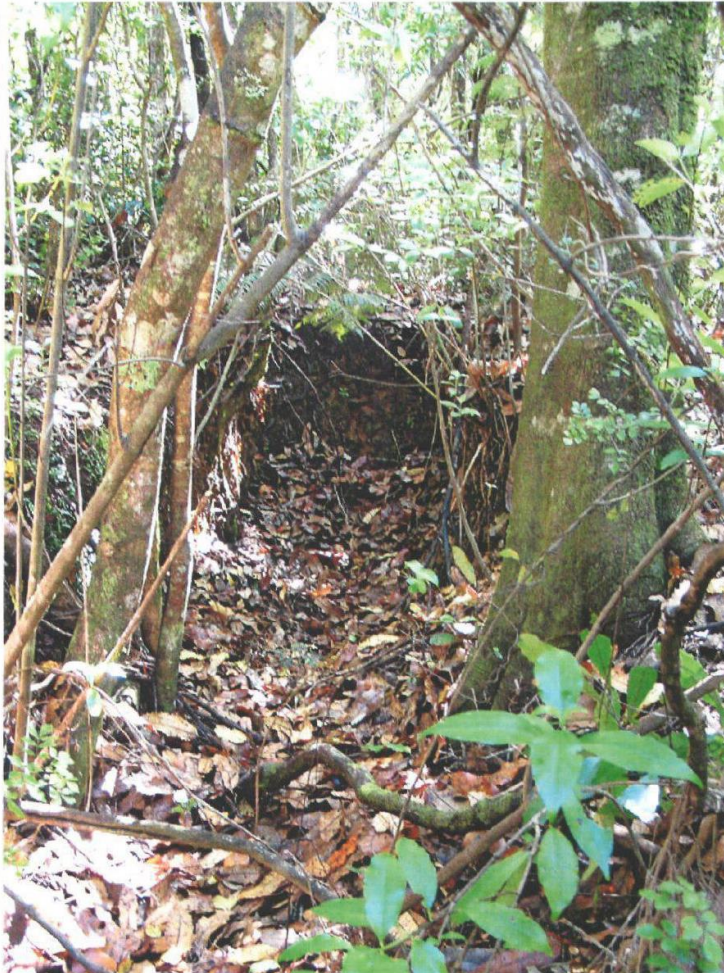
Figure 4 Possible loading bay - one of two at WP 292. This is at the junction of Thompsons Stream, and possibly associated with the removal of battery components from the site c.1970s

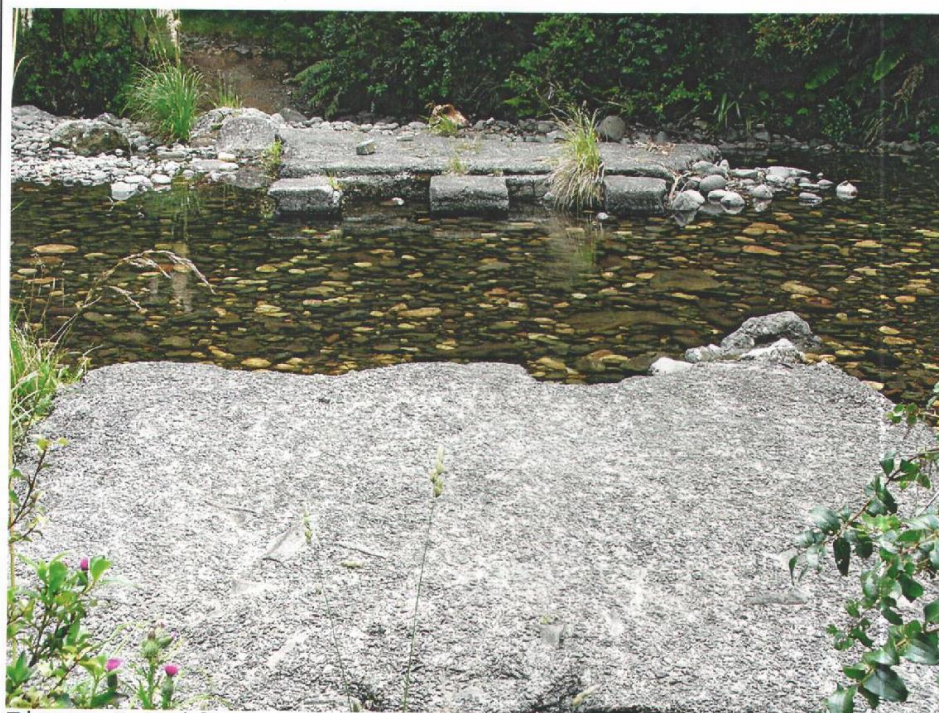
Figure 1 Bridge remnants at WP 214

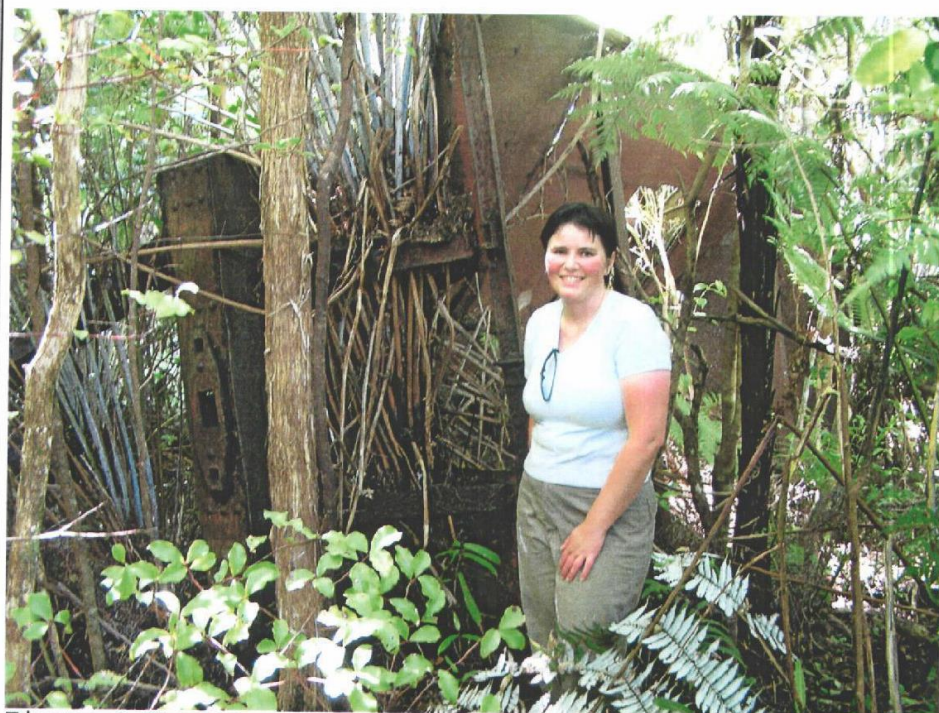
Figure 2 Hopper at WP 301 (this is thought to be associated with quarrying, rather than gold mining)

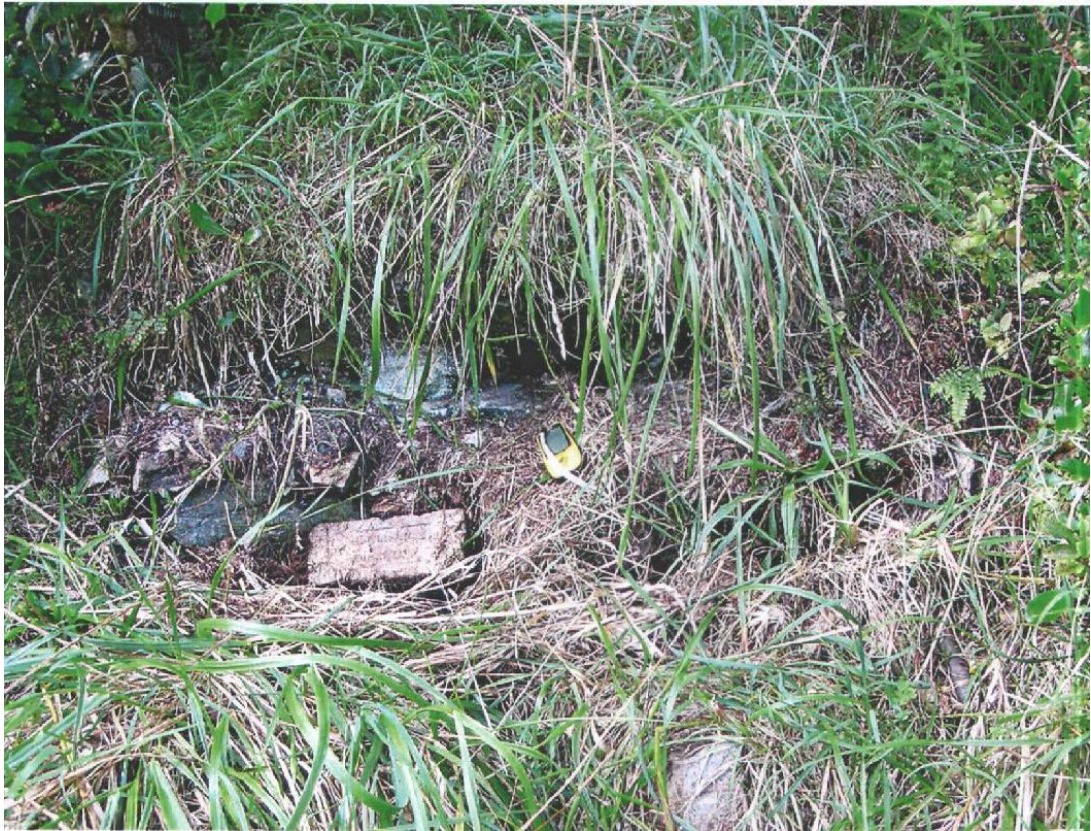
**WP 215. Remnants of fireplace or furnace (2008)**

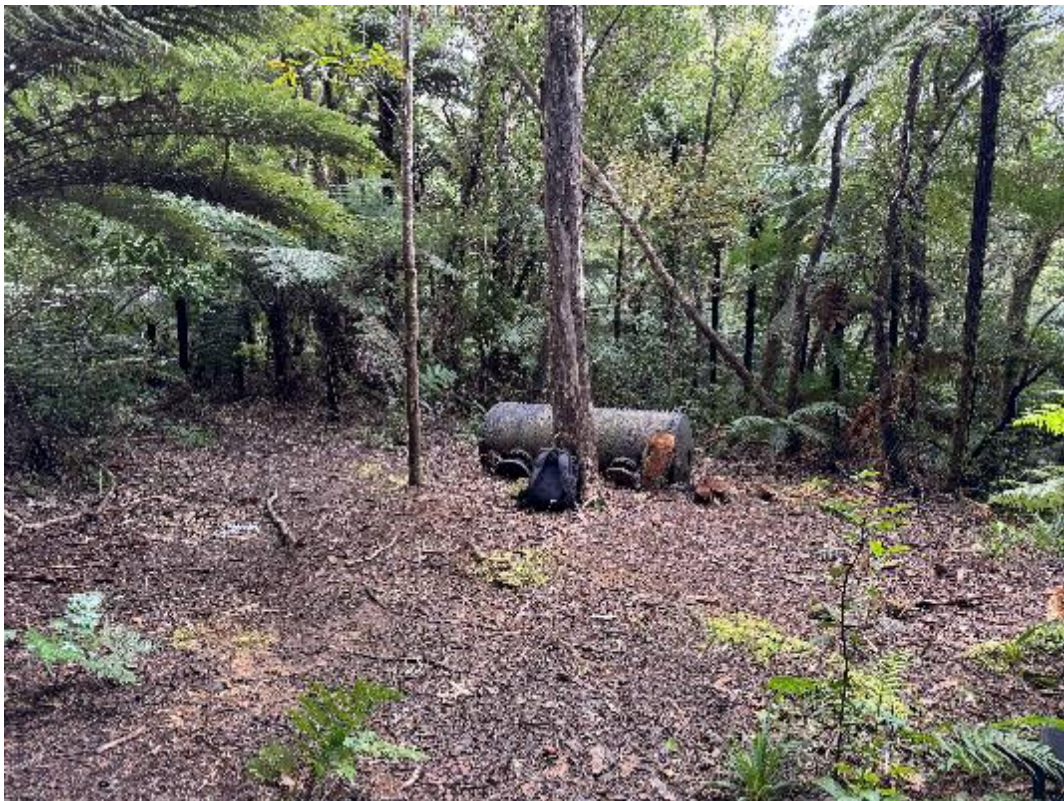
**WP 219 Pressure vessel on the large terrace on the Lower Tramline Track above the battery site (2024)**

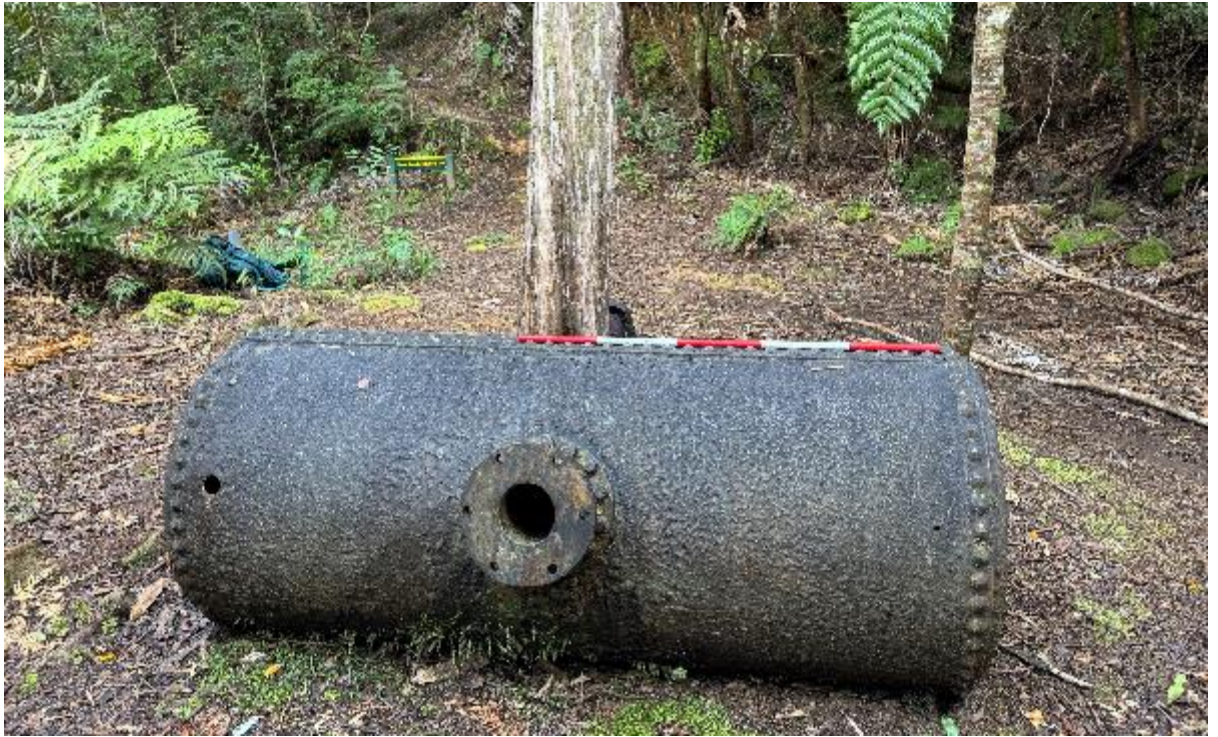
**WP 219. Pressure vessel (2024)**

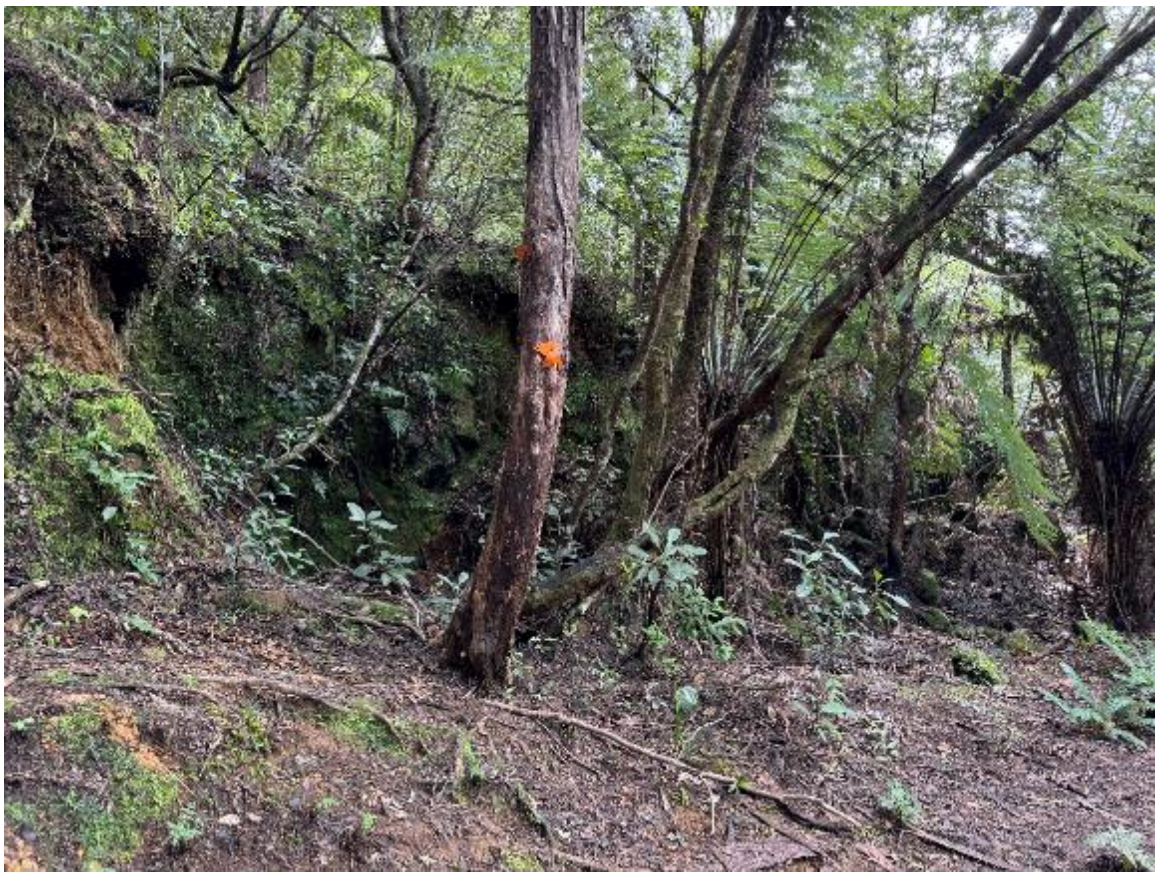
**WP 219 The back of the large terrace on the Lower Tramline Track has been excavated to form two large square cuttings, possibly for previous buildings (2024)**

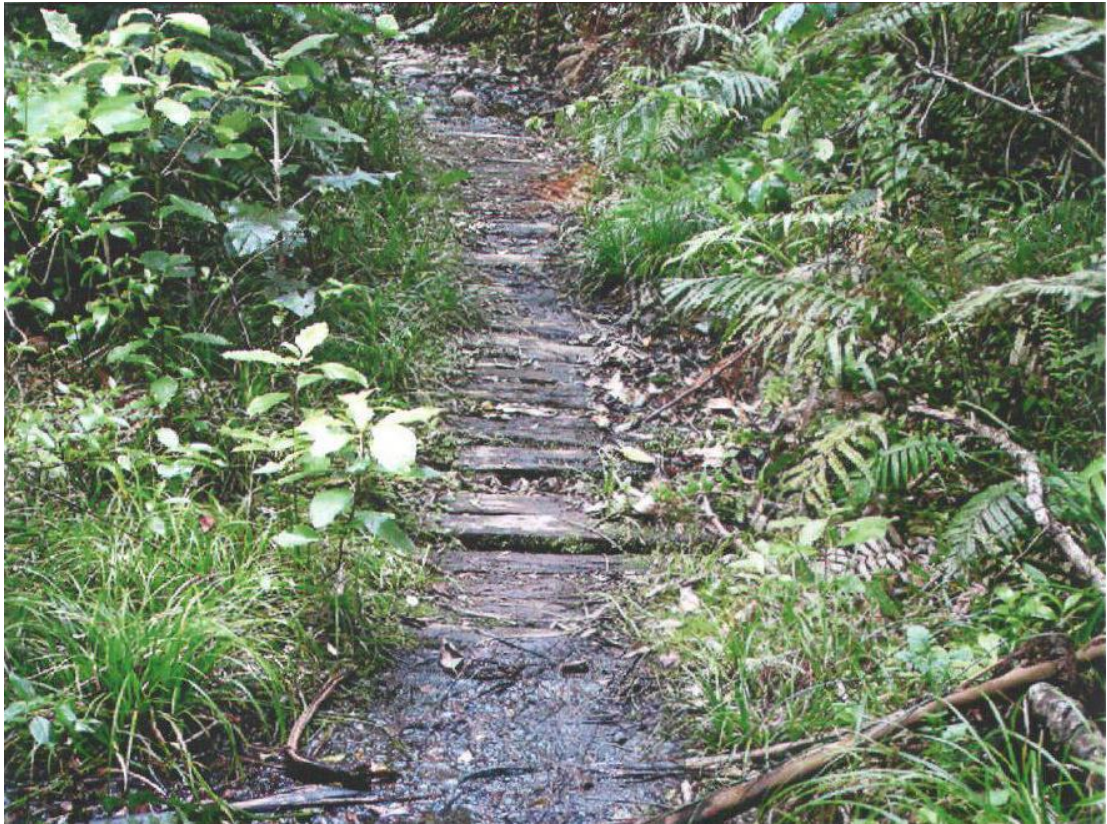
**WP 222. Tramway sleepers (2008)**

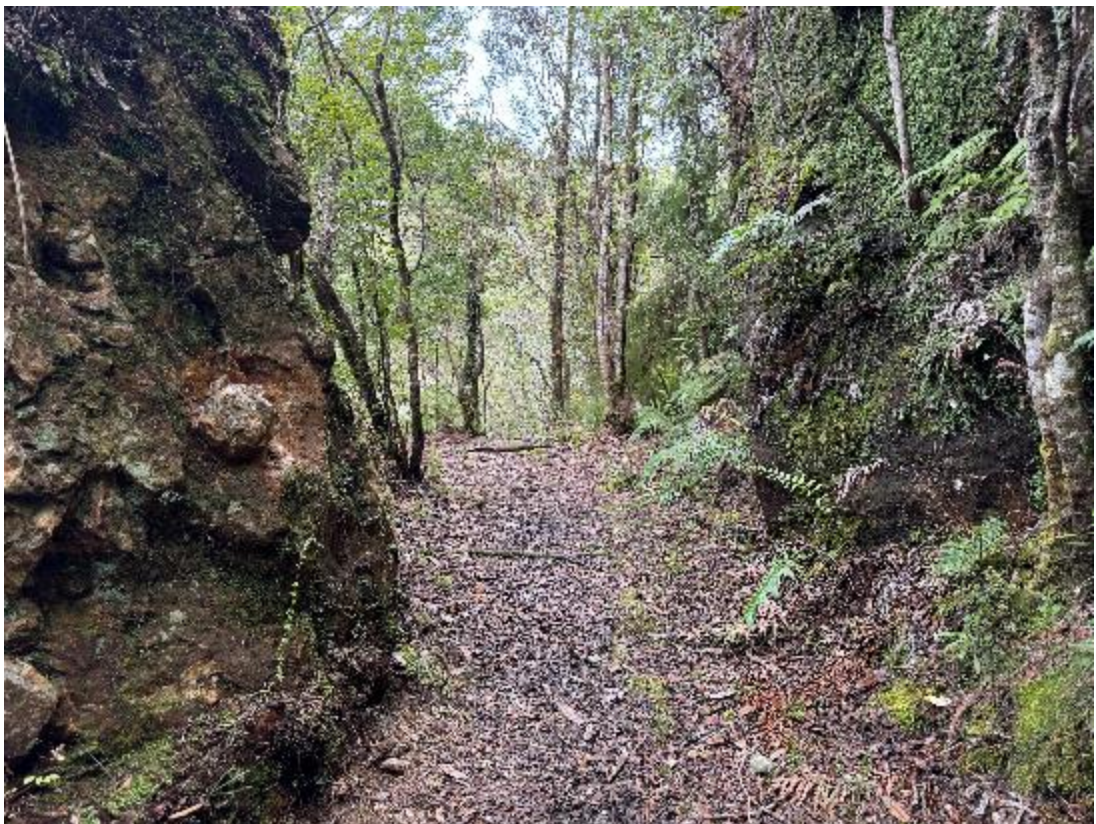
**Deep cutting on the Lower Tramway Track north of the swing bridge**

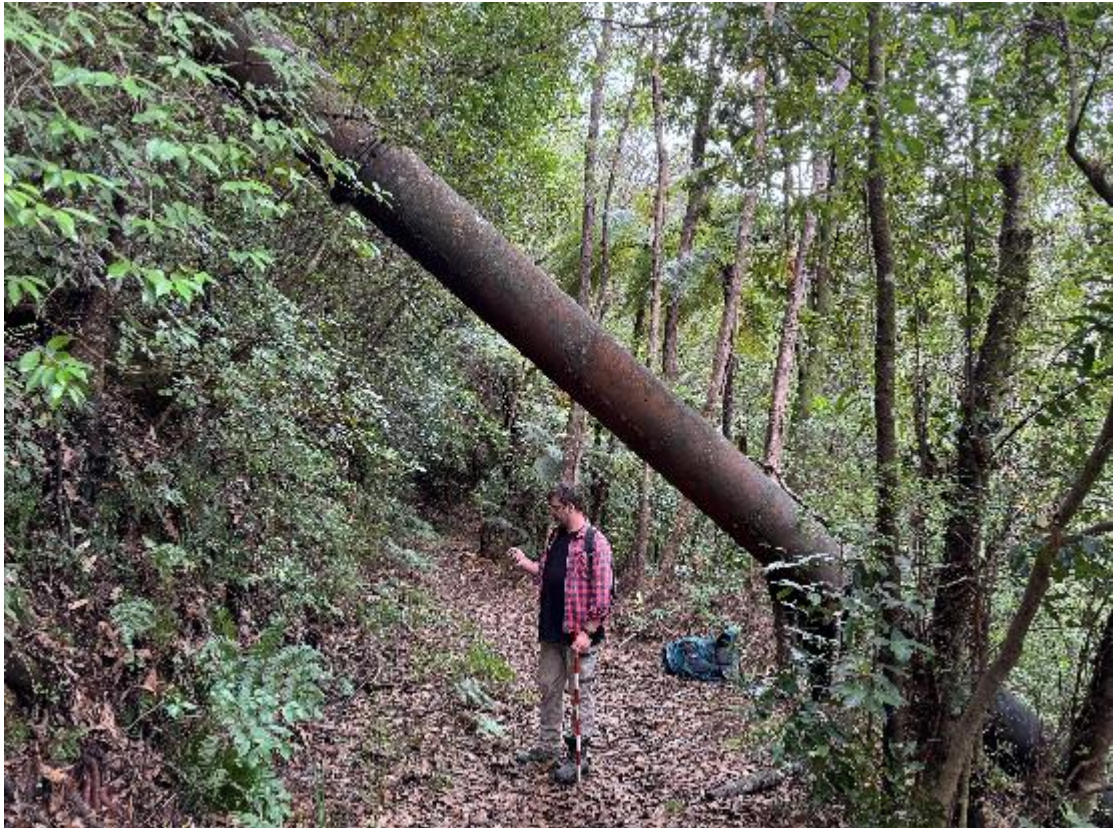
**WP 294. Water pipe crossing the Lower Tramline Track (2024)**

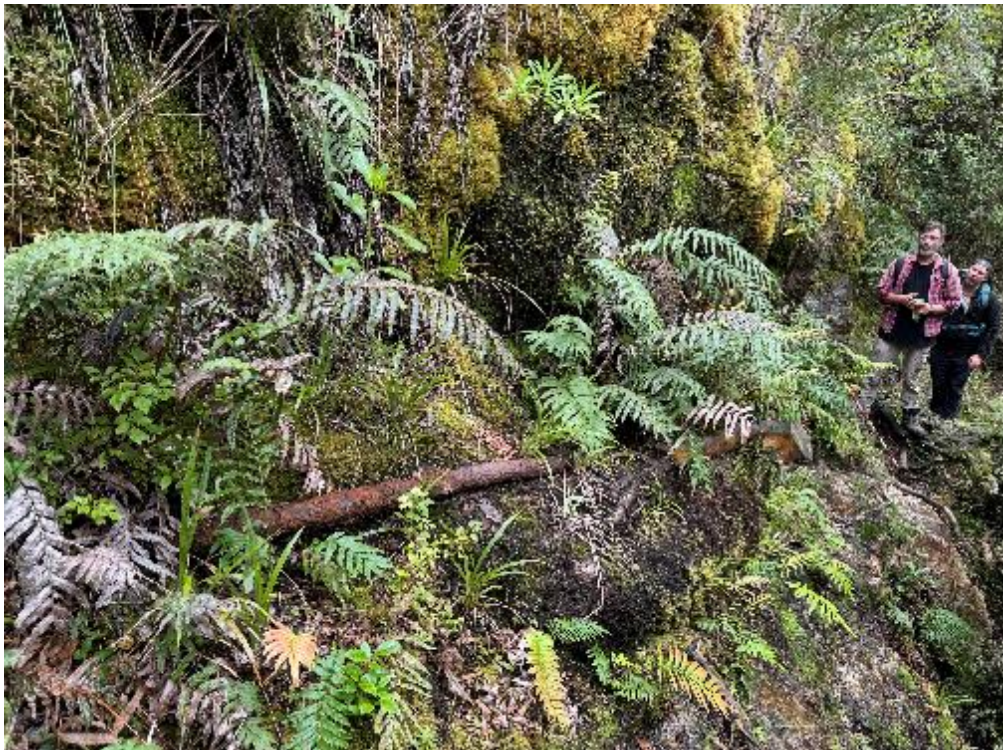
**WP 295. Pipe running along the uphill side of the Lower Tramline track north of Adit 296 (2024)**

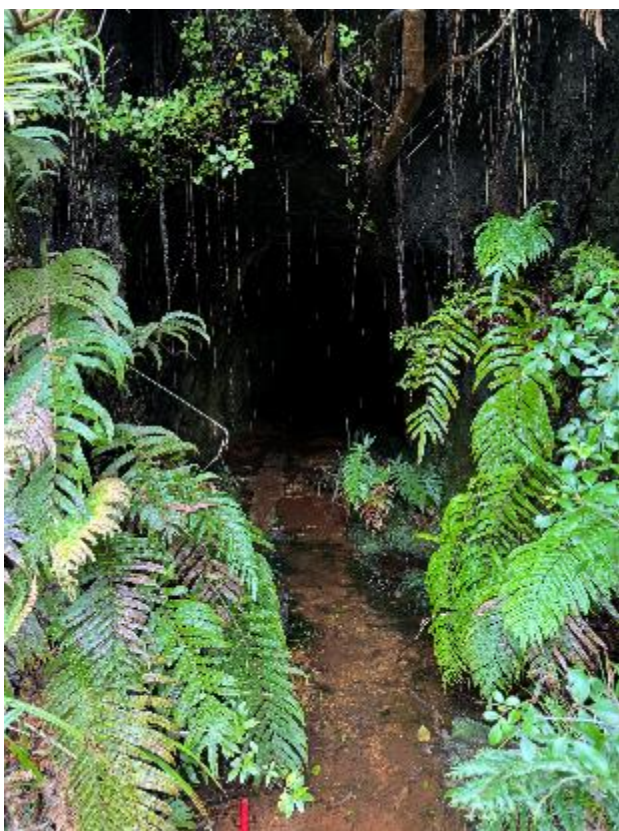
**WP 296. Adit entrance with metal plate on the floor (bottom of photo) (2024)**

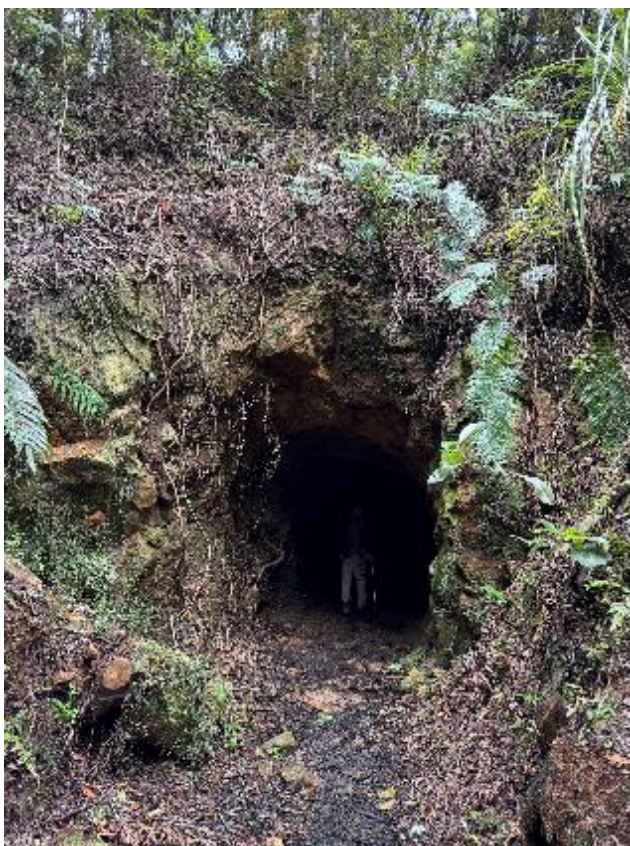
**WP 298 Tunnel on the Lower Tramway Track (2024)**

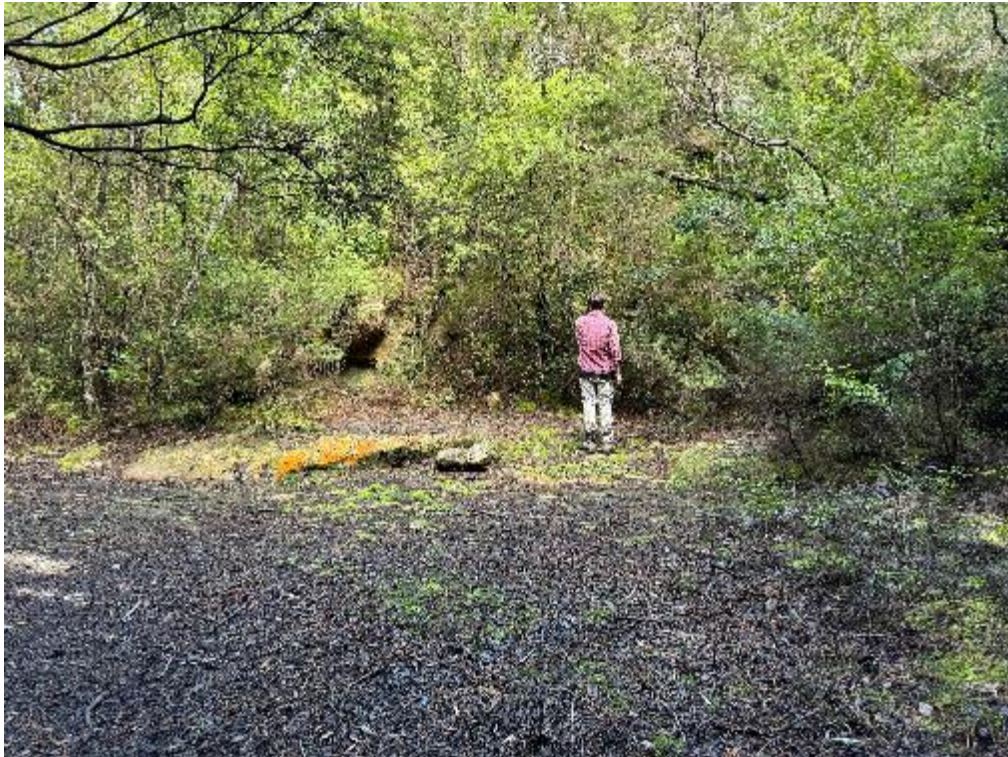
**WP 299. Lower terrace of the Royal Standard Battery site (2024)**
