# **WAIHI NORTH PROJECT – FAST TRACK APPROVAL: ASSESSMENT OF HISTORIC HERITAGE AND ARCHAEOLOGICAL EFFECTS**

## **APPENDICES**

Prepared for Oceana Gold (New Zealand) Ltd  
Document Number:

January 2025

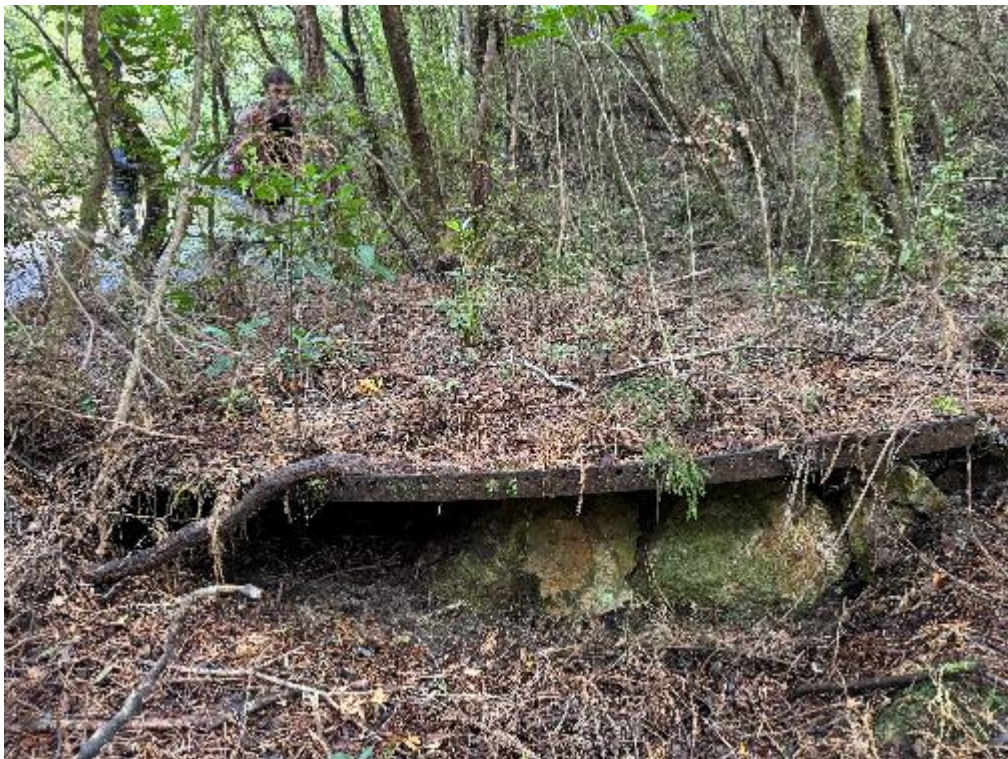
**WP 299. Sections of cyanide tank frame at battery site (2024)**

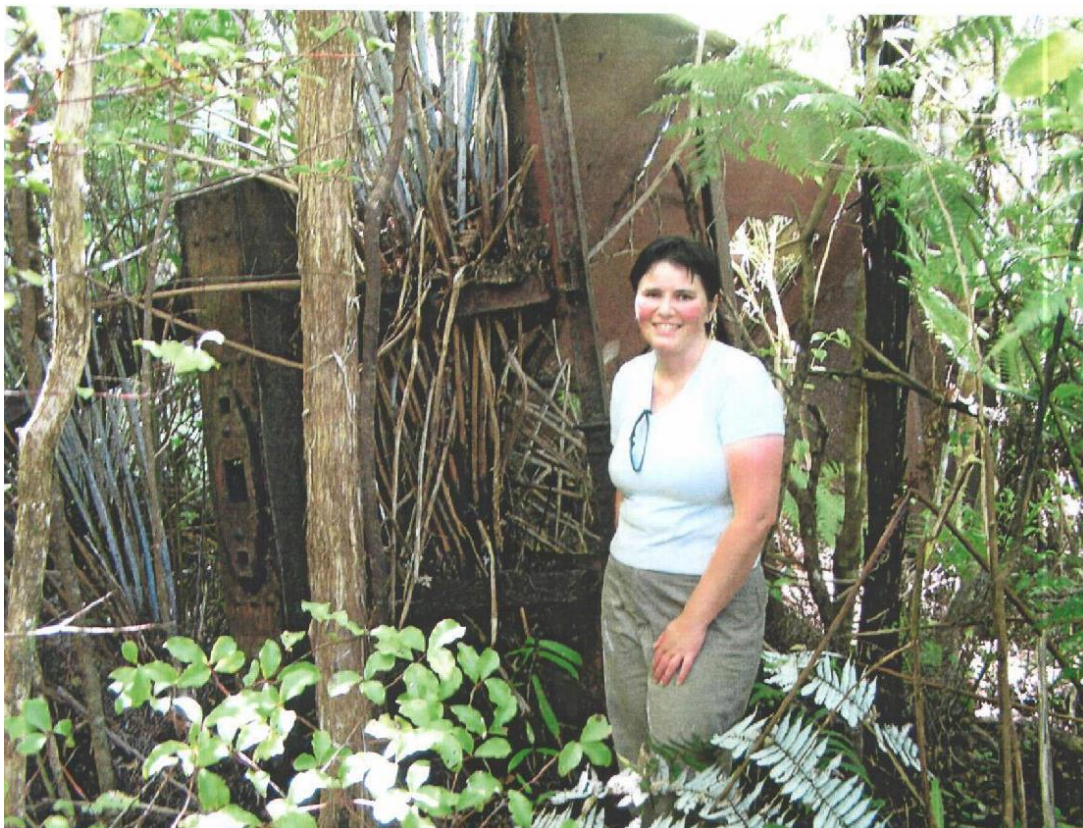
**WP 301. Metal hopper thought to be associated with quarrying, rather than goldmining (2008)**

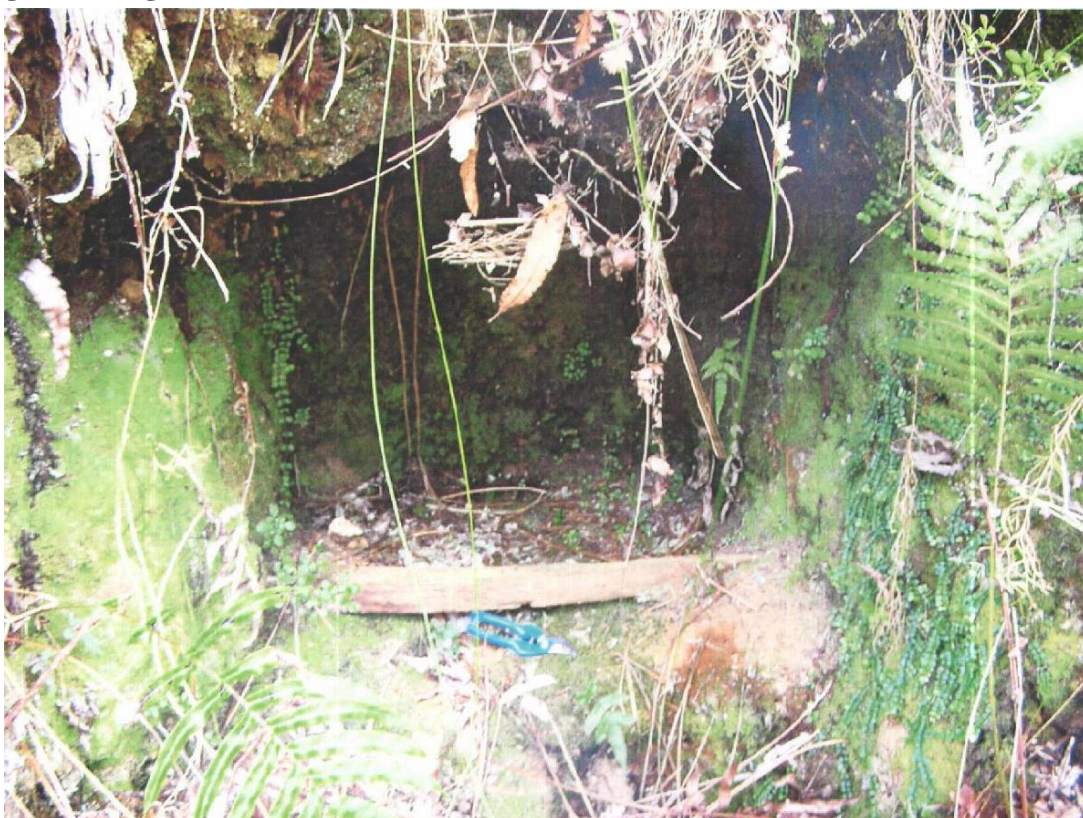
**WP 313. Cave dug into bank with remains of door sill (probably an explosives store) (2008)**

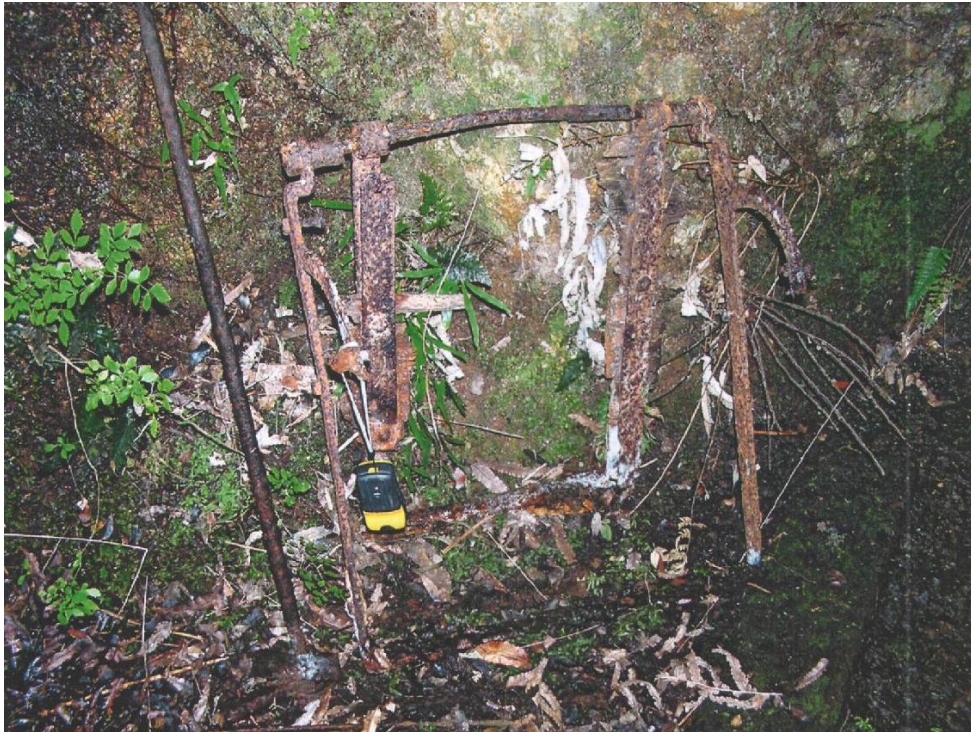
**WP 314. Metal remnants in adit entrance (probably the tipping mechanism for a cart) (2008)**

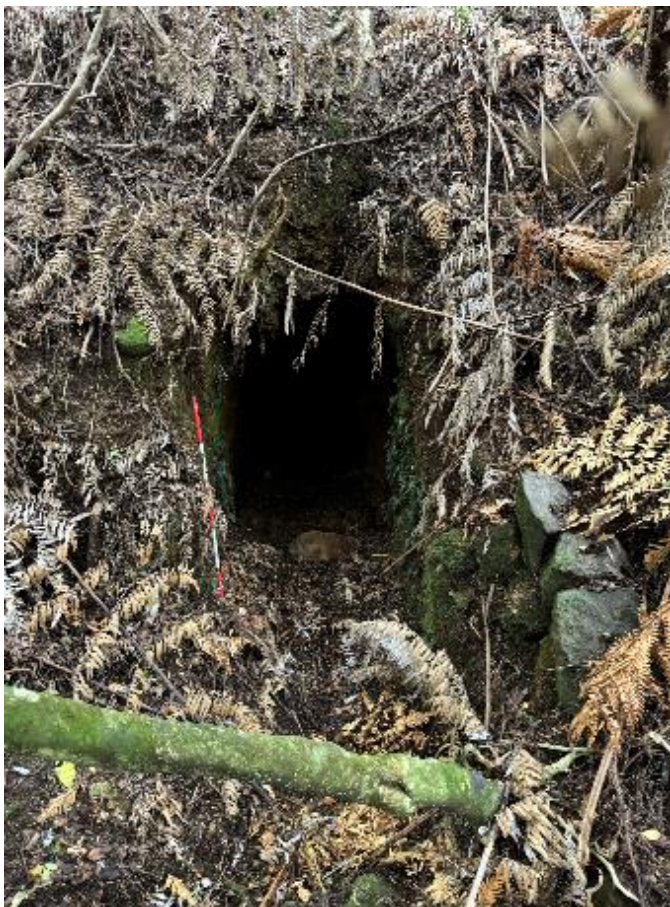
**WP 402. Adit entrance. Stone retaining visible to right of entrance (2024)**

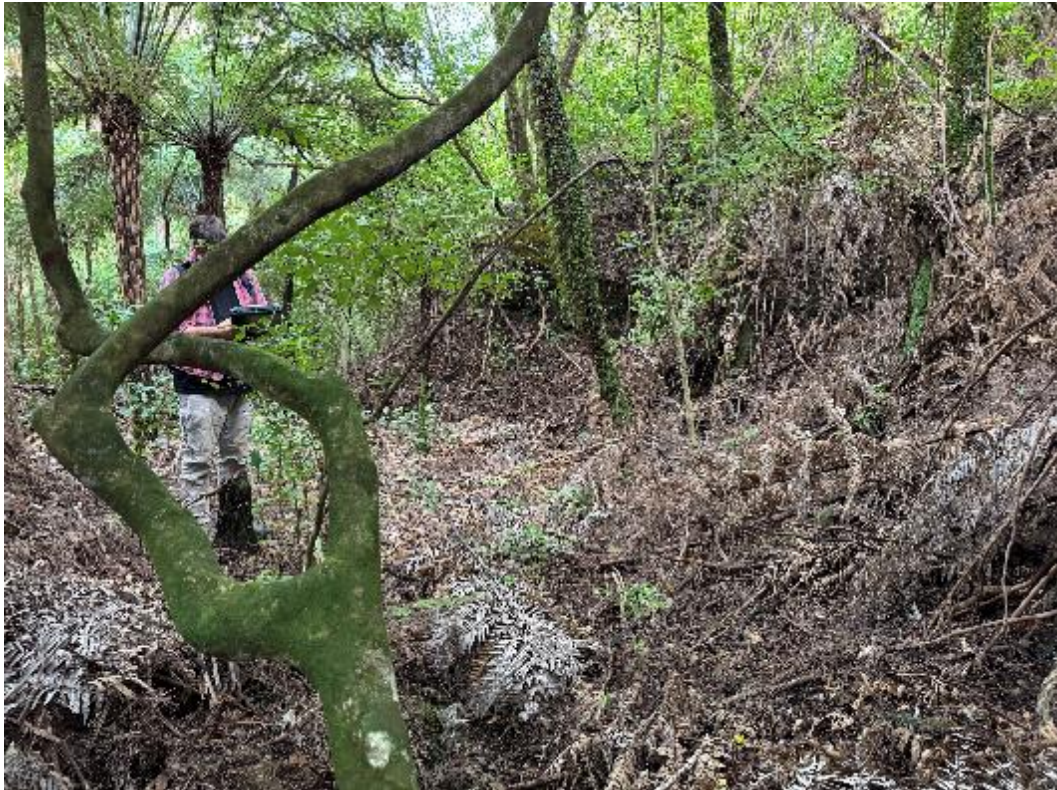
**WP 402. Terrace in front of Adit (2024)**

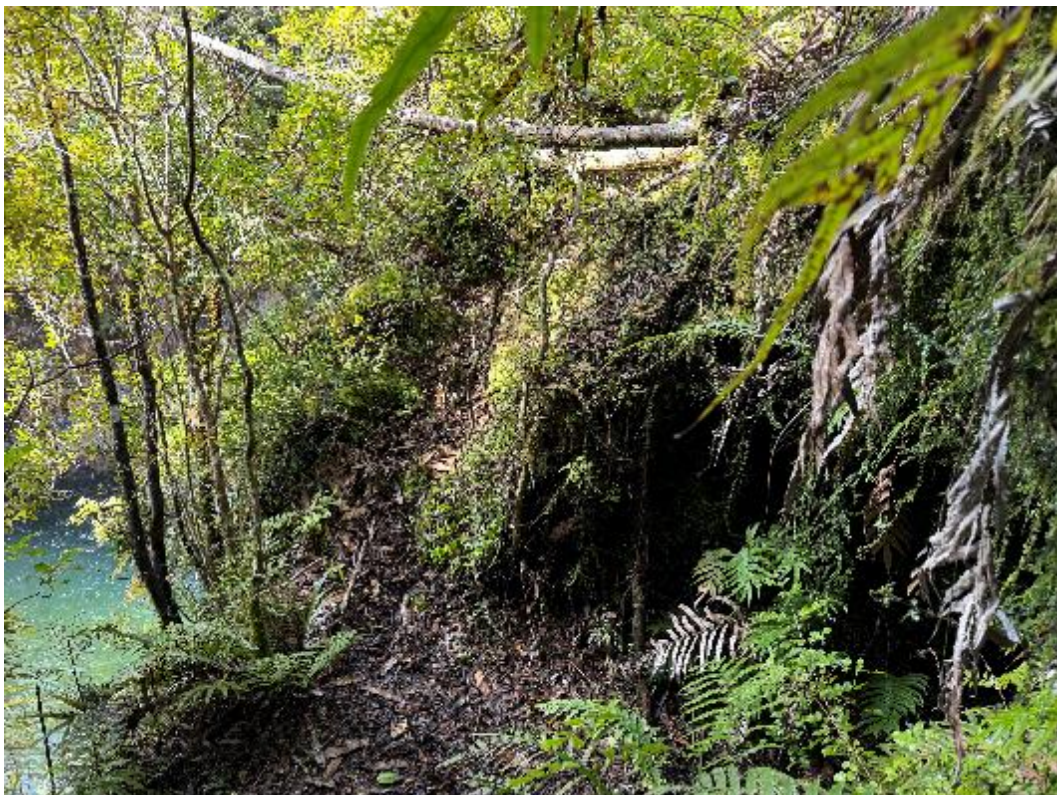
**WP 405a). Adit (one of three). Narrow miners track to the adit visible on the cliff edge to the left (2024)**

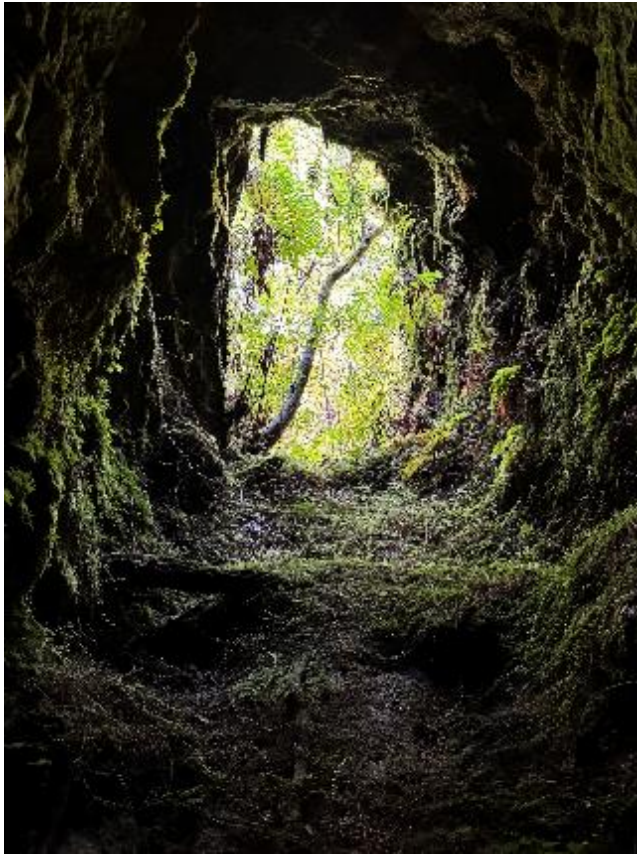
**WP 405b). Adit entrance (2024)**

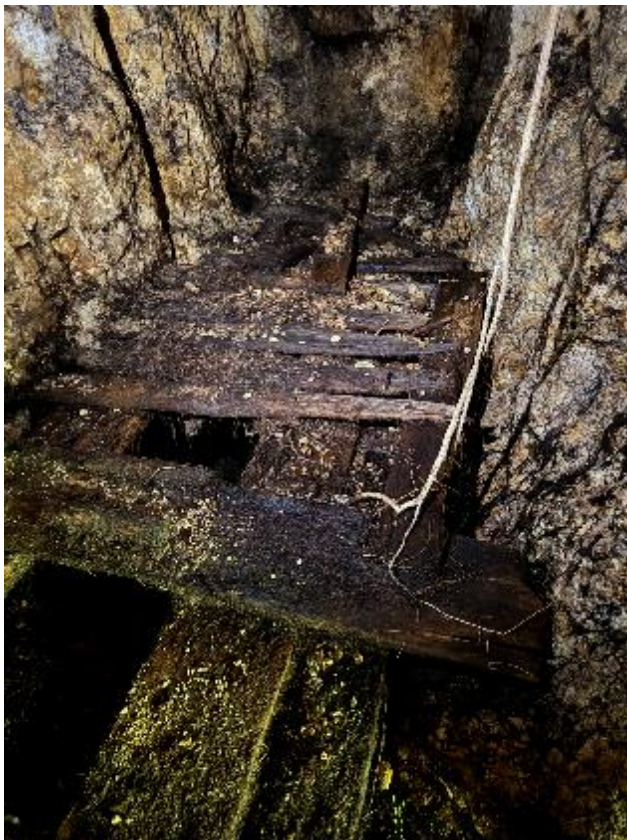
**WP 405b). Adit - floor timbers inside the adit (2024)**

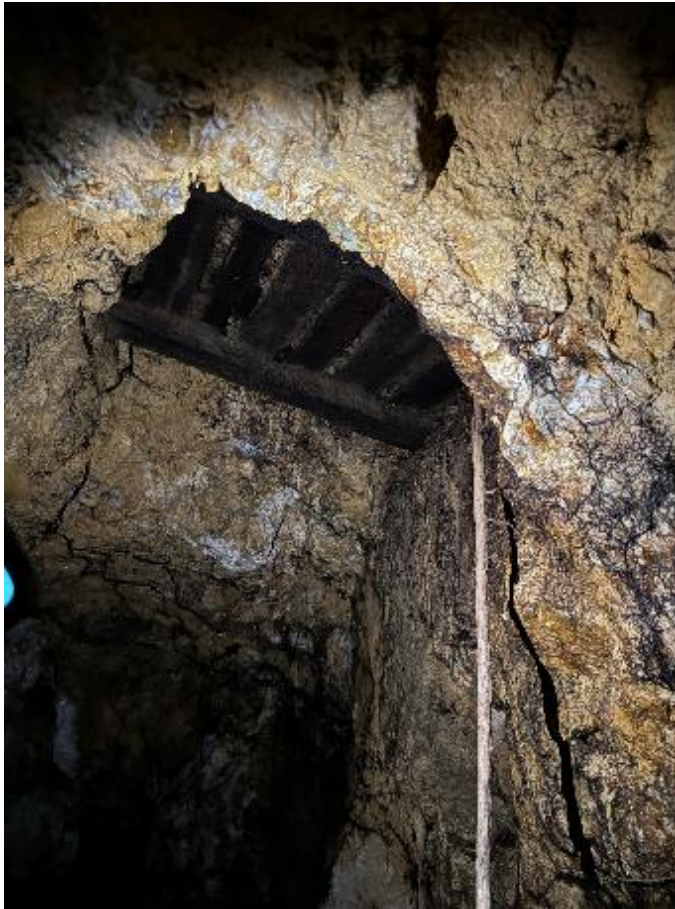
**WP 405b). Adit - roof timbers inside the adit (2024)**

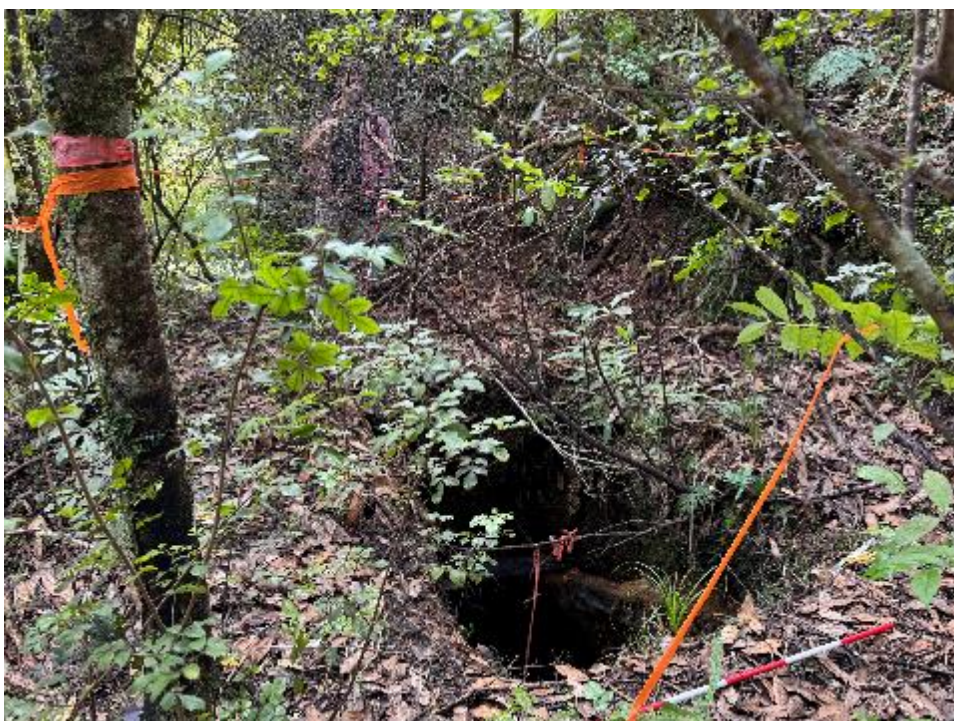
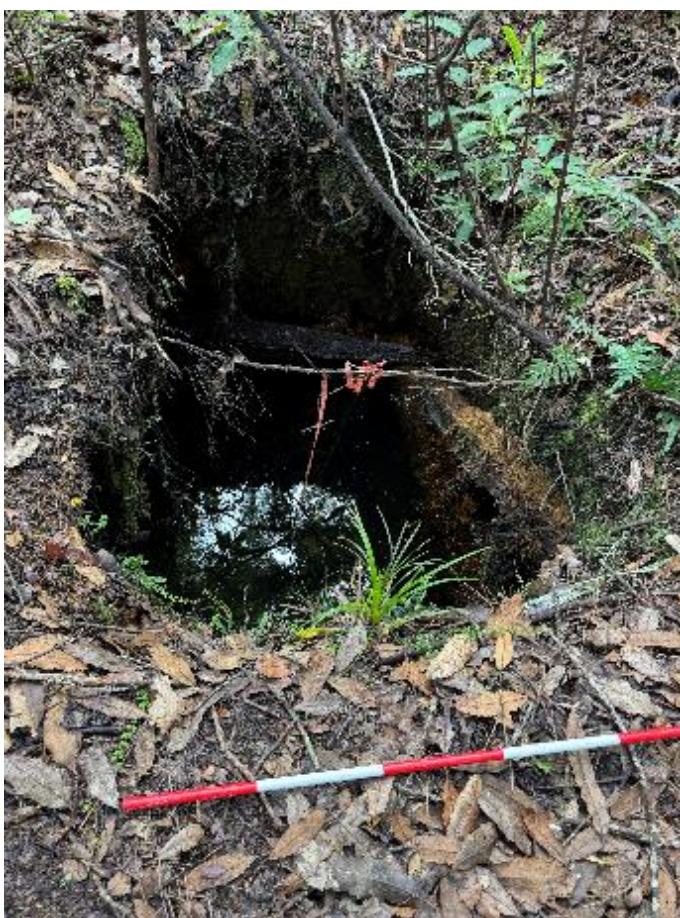
**WP 406. Shaft (2024)**

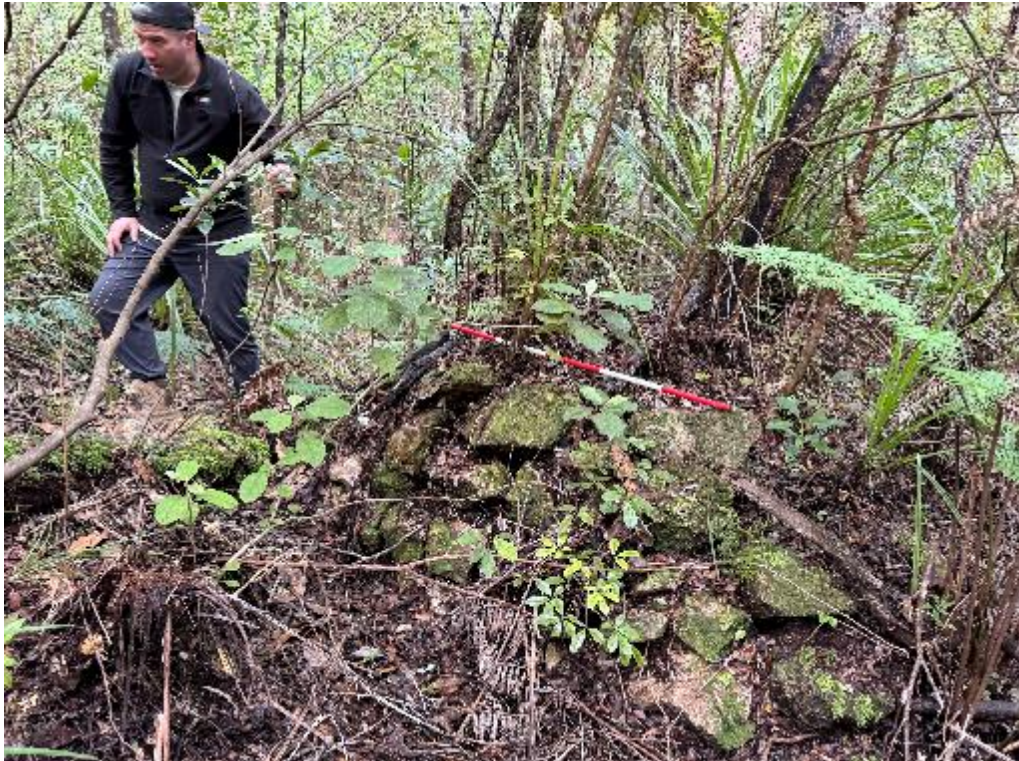
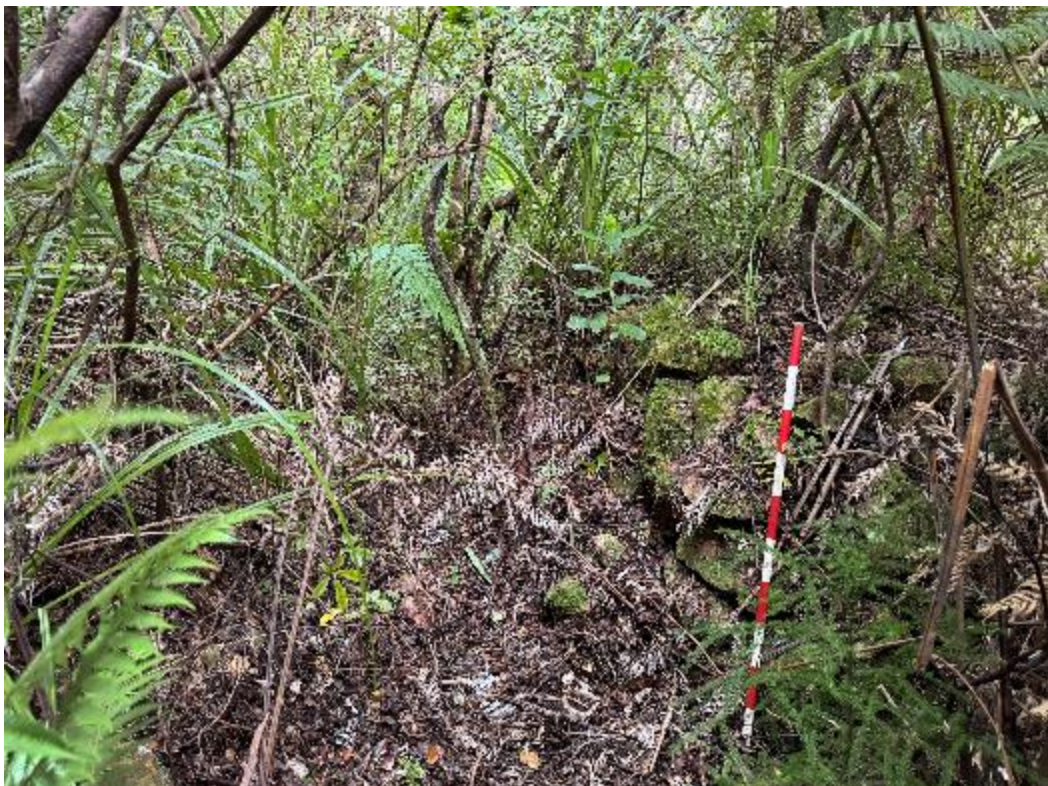
**WP 408. Stone retained 'bunds' at the entrance to the cutting leading to the adit (2024)**

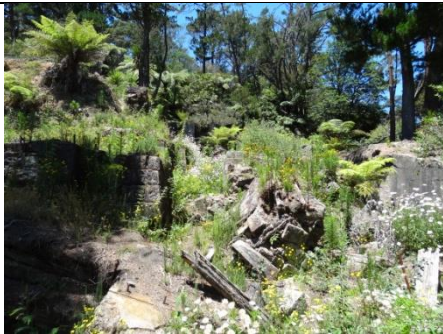
Relatively stable condition, but facing stones missing on much of main wall, crack evident along face of tube mill floor, collapsed tube mill floor at southern end, collapsed masonry/foundations at engine house end. Encroaching exotic (pine, wattles) and native vegetation on the structures. In situ and displaced metal elements. Timber elements deteriorating. Boiler room floor covered by tailings and bulldozed material. Visible and semi-accessible, with dangerous areas (concrete tanks) fenced off. Stability of masonry wall being monitored during Trio mine operations (2004 photo at top; 2012 photos below)

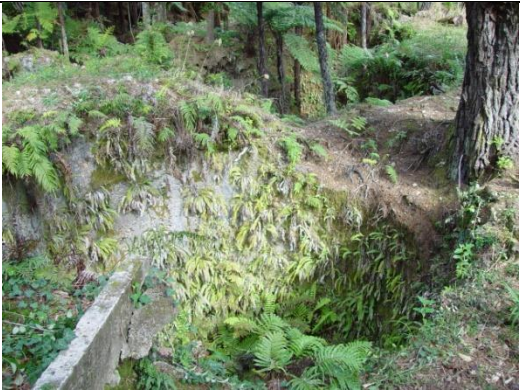
WGCL	Kilns	10 ore roasting kilns in two rows, with associated access tunnels; c. 6.7m to 8m in diameter, c.8m to 8.8m in depth; 4 of the kilns are brick lined. A probable remnant of the 1886 Union Level drive consisting of a 2m section of tunnel is apparent in the wall between kilns 3 and 9. A buried tramway section is present at the southern end, subsurface but visible in a collapsed hole. (See Appendix A, Figure D)

Vegetation on kiln walls and some large pines – notably in kiln 7, where tree roots now an integral part of the kiln wall. Stable apart from rock falls within access tunnels and around one of the tunnel portals. Tunnel portal entrances cordoned off with safety signs. Kilns not clearly visible from access point at N end. Stability is being monitored during Trio mine operations (2004 photo)
WGCL	Cyanide tanks	6 ferro-concrete cylindrical air agitation cyanide tanks supported on bases with 6 radiating legs 2-2.6m long; c.16.5m high and 3.7m in diameter. (See Appendix, Figure E)

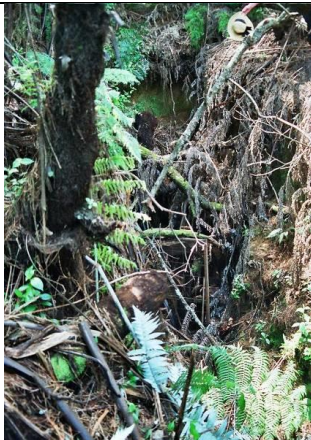
Portal trench and mullock dump well preserved but some collapse around portal; portal timbering and wire mesh collapsing (2004 photo, not reinspected in 2012)

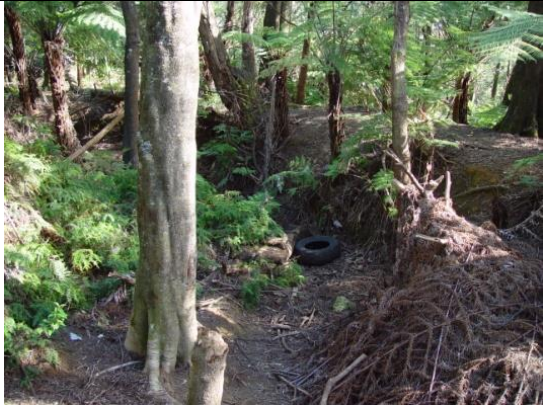
Generally well preserved, but parts infilled by slumping and erosion, especially in northern section and former Keatley block. (2004 photo)

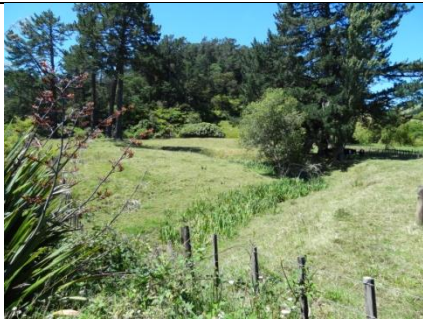
Portals not accessible for inspection (2012 photo)
WGCL	Concrete tank	Located in former Keatley property, built beside infilled low level water race, related to an early house. 6m x 2.4m x 600mm high, 400mm thick walls; internal compartments, 1.2m x 1.8m and 1.8m x 3.94m with 320mm dividing wall. (GPS 1852711 5857792)

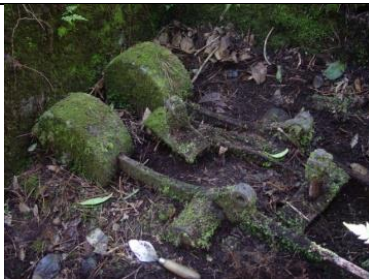
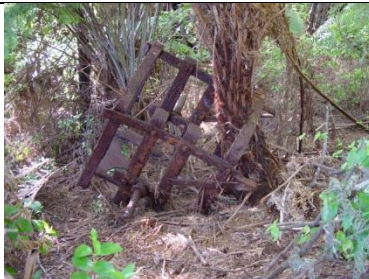
potential for subsurface remains, two on W side of Mill Stream, one SW of New No. 1 shaft (general locations in CP, Figure 75)		
WGCL /DOC	Machinery	<p><u>In situ machinery</u>: (1) at New No. 1 Shaft (see right, above); (2) on Battery foundations; (3) cast iron tub on E bank of Mill Stream to S of Cascades, 1.4m x 0.64m x 0.25m deep, bolted to concrete foundation (CP, Figures 75, 78)</p> <p><u>Displaced machinery</u> including: (1) ore lift cage immediately SE of battery foundations below middle vehicle track (see right, below); (2) two sections of cast iron pump pipes c.40+m N of New No. 1 shaft, 3.15m x 0.4m int. diam and 2.75m x 0.33 int. diam. (CP, Figures 75, 77).</p>

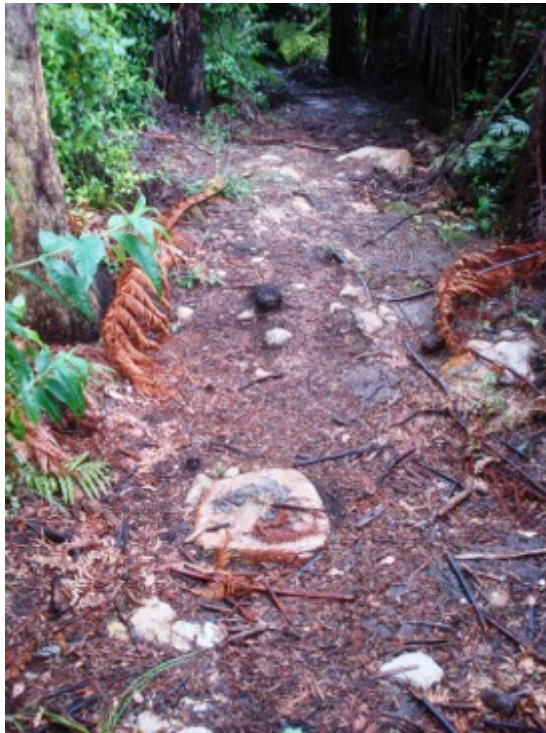
**Short but steep and when wet slippery slope.**

At the far end of the old Battery foundation as previously mentioned is a short steep section of the track. This should have either a set of steps or if possible an easier section of track should be cut..

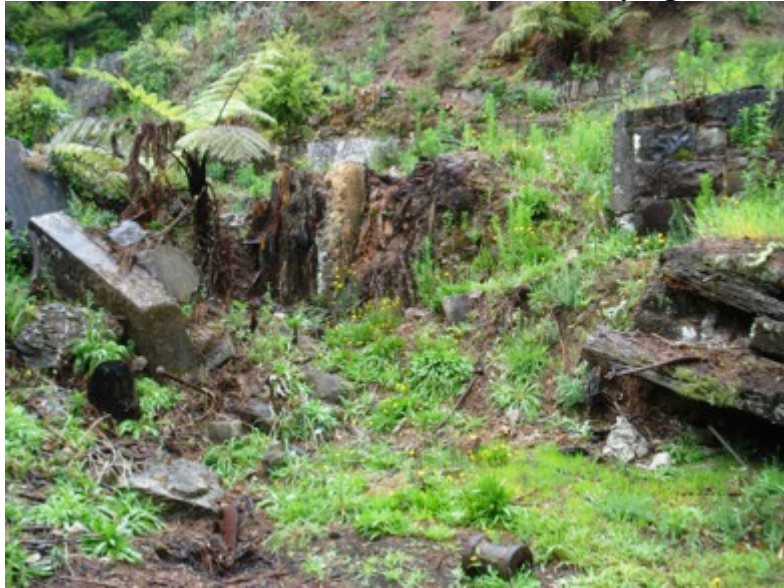
### **Broken foundations due to site modifying.**

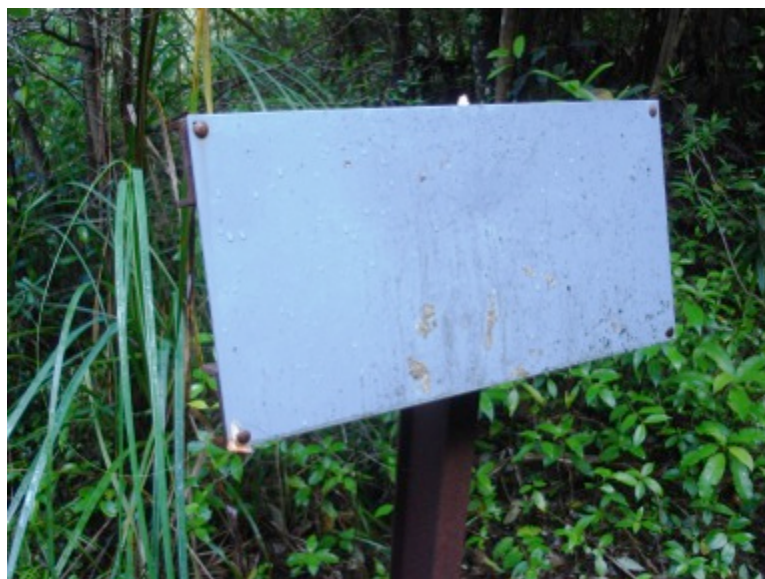
This will require regular inspections as to their condition. It is noted that even on the Old Mill Stream walk one of their signs has been damaged already. The Department of Conservation signs at the Victoria Battery from time to time become either defaced or completely removed and at Karangahake the same destructive forces are at work.

### **An example of a D.o.C. sign at Karangahake showing complete removal of information**

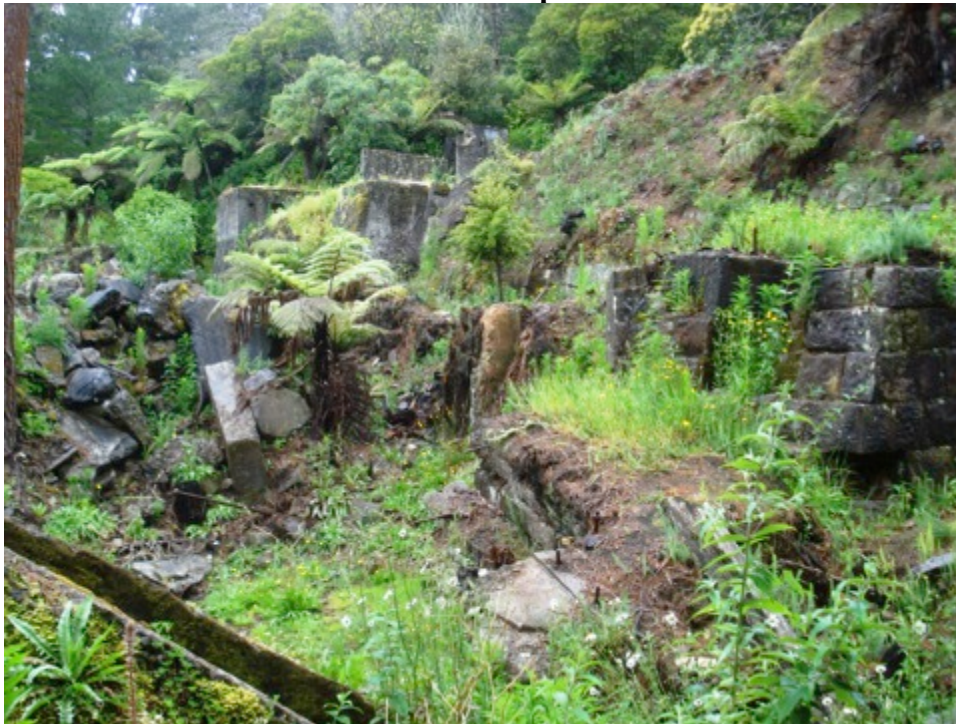
**The old Battery site showing broken foundations and areas from which people can fall from at present.**

For the protection of the public as well as the protection from vandalism or removal of artefacts, fencing should be placed around several locations. For example, the Battery site due to the height of the concrete structures and the heaps of broken rock/concrete piled up which people/children would just love to climb over. Also the top of the kilns even though the public would not have (?) access to at present.

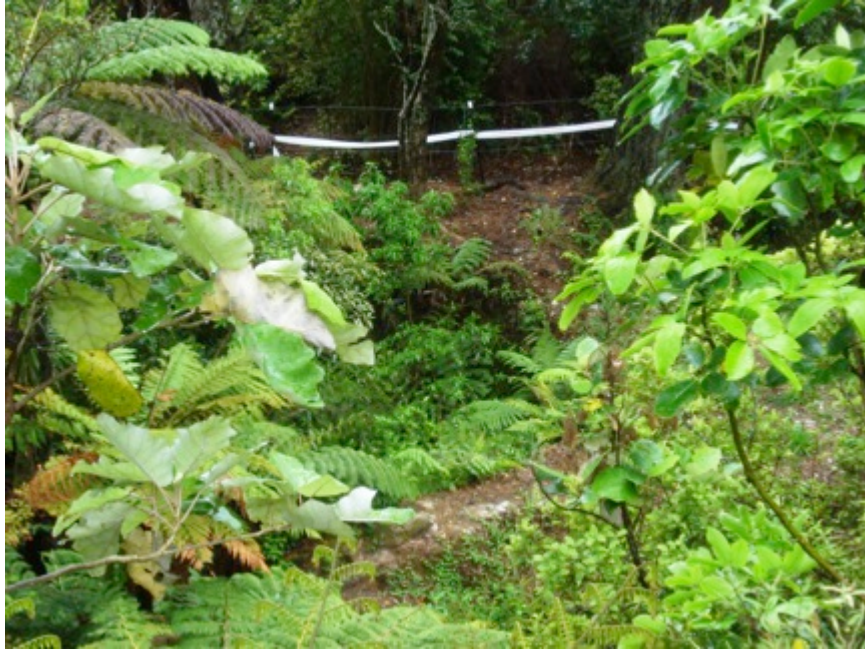
**Looking down on one of the Kilns from roadway from vent shaft.**

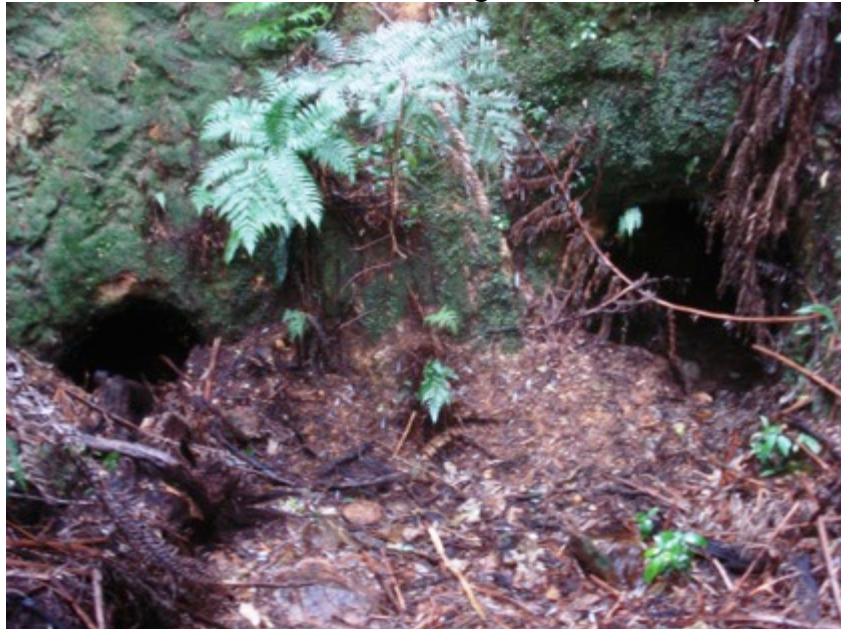
Portals of the Old Trio workings next to the walkway.

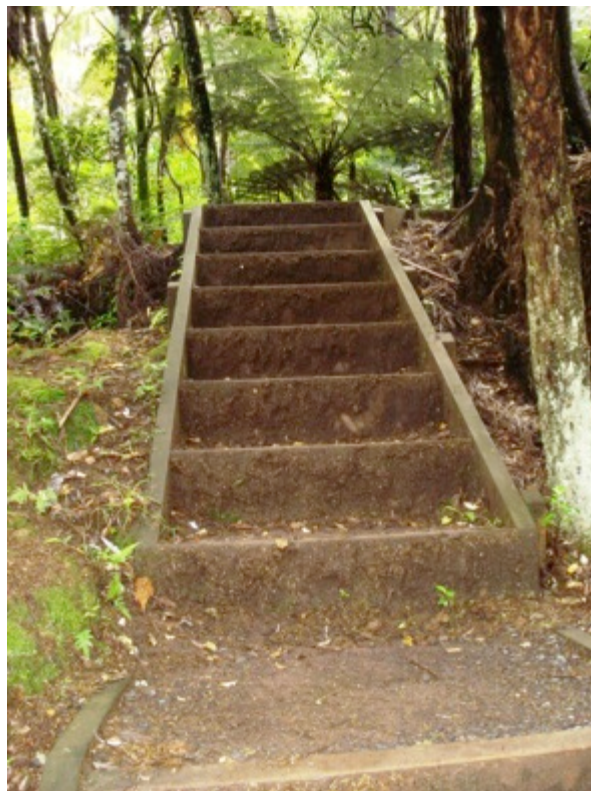
**Example of steps. Battery site, Karangahake.  
The Walking Track. 2**

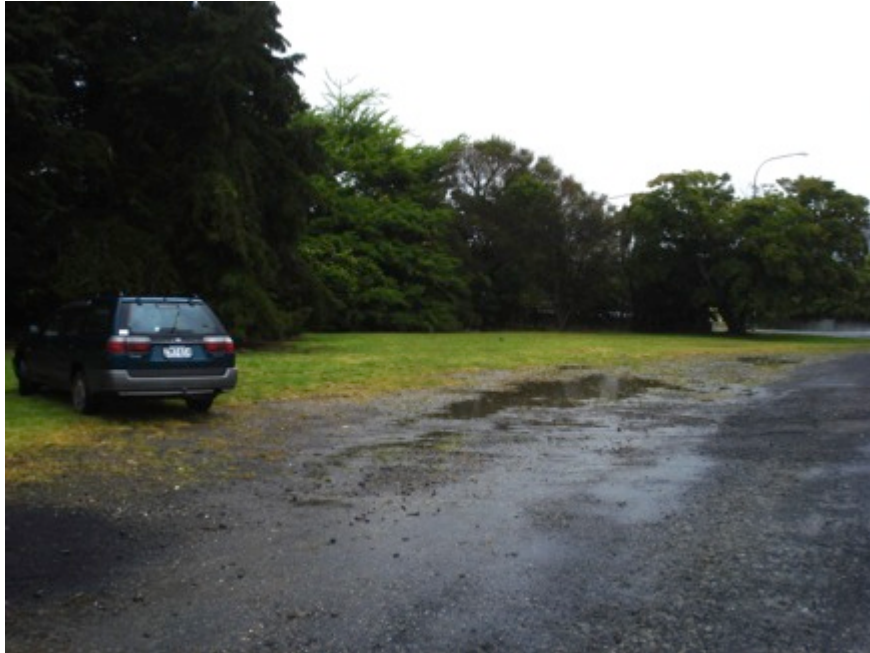
**A suggested parking site off Barry Road.**

On entering the site from the car park, as suggested at Barry Road the visitor will walk parallel to the conveyor belt. (Park Here signage, Warning sign as to the danger of old mines and shafts on the property as well as Please keep to the marked tracks and do not wander off them.)

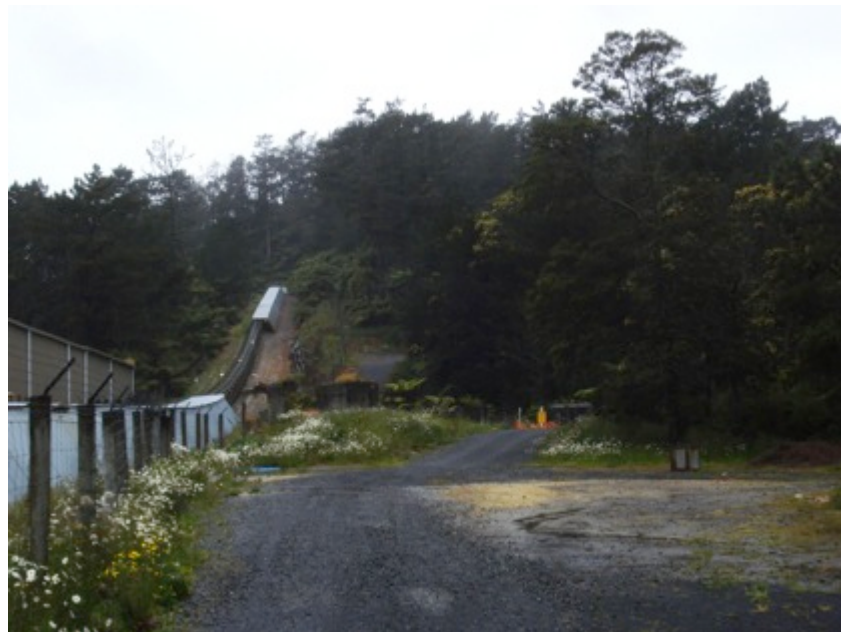
**Looking along the conveyor belt and the site of Mineral Resources Plant.**

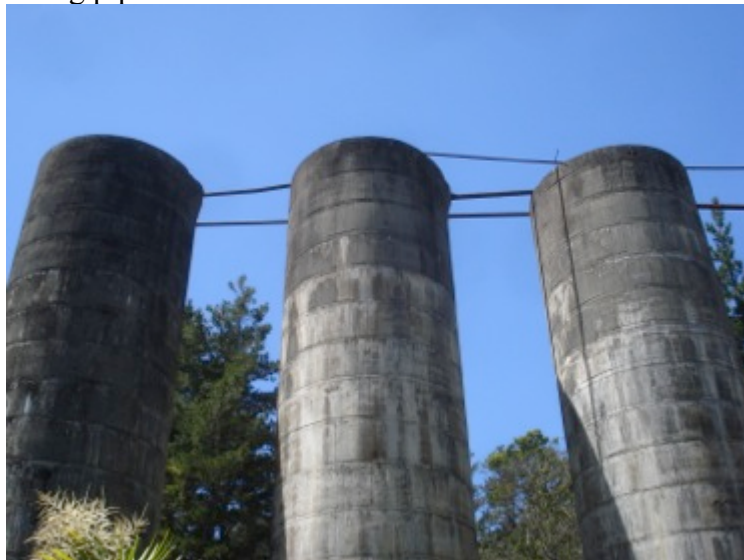
**Ferro-concrete tanks.**

At the Ferro-concrete tanks the walker will leave this road and turning left head towards the tanks. Here there the walker will see a sign telling/explaining what the tanks were used for. Also there will be a sign warning them to keep back due to the possibility of falling pipes.

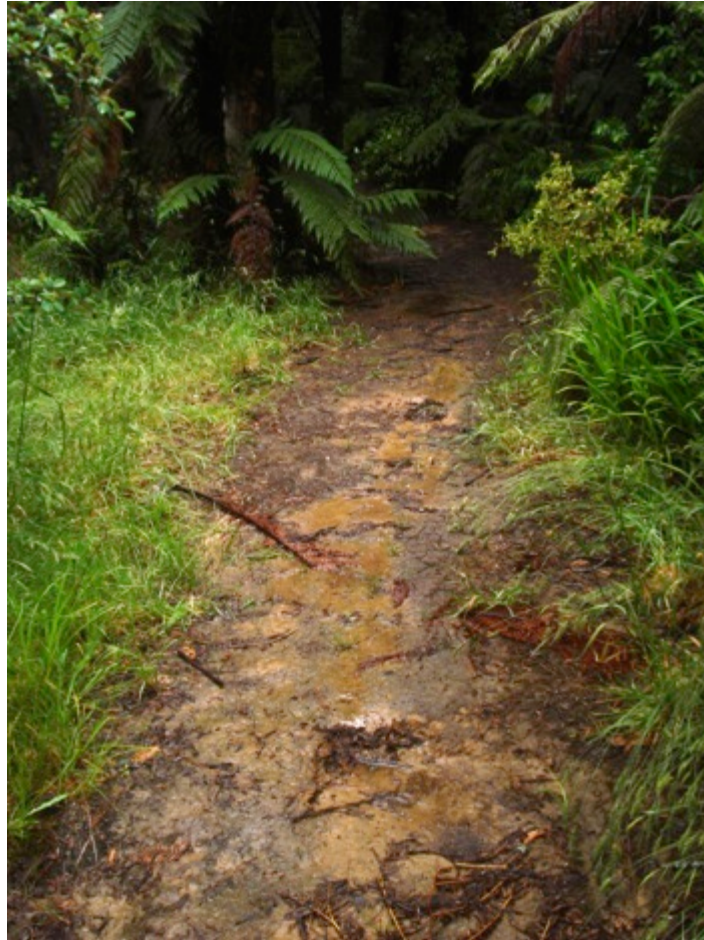
**The present walkway track after leaving the Tanks.**

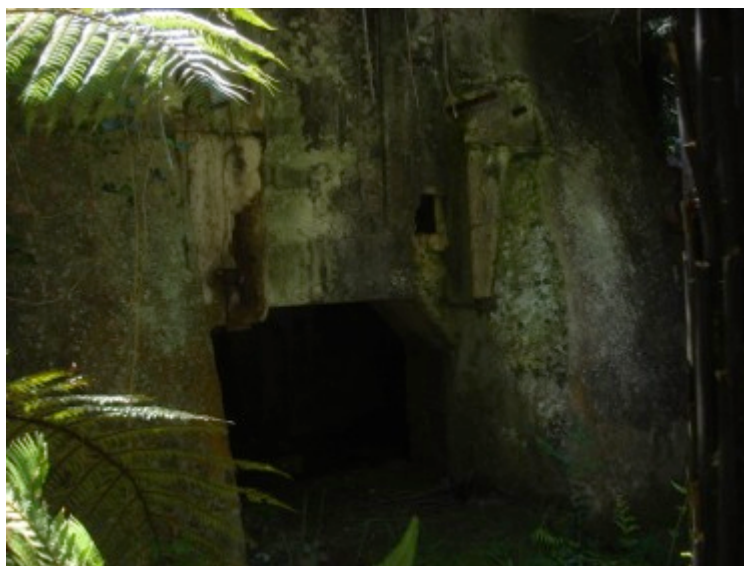
**Interesting but what is it?**

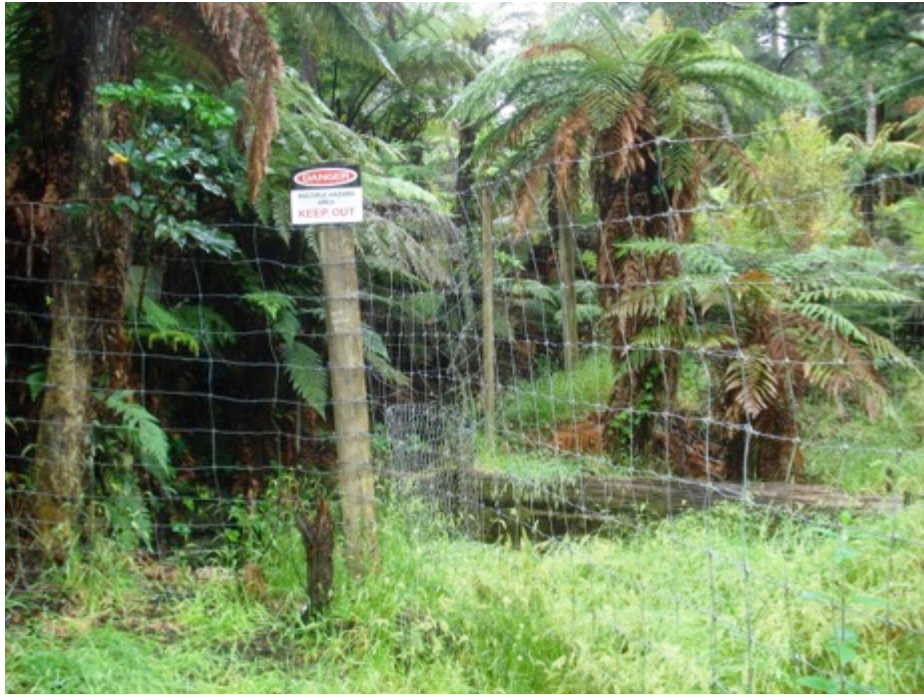
There are two main reefs on Union Hill, i. e., the Union Reef and the Amaranth Reef. The Union Reef had two shafts sunk to access the ore body which was extensively worked; in an area fenced off in the Battery foundations is what appears to be the remains of the original No 1 Union shaft.

**Site of No.1 Union Shaft?**

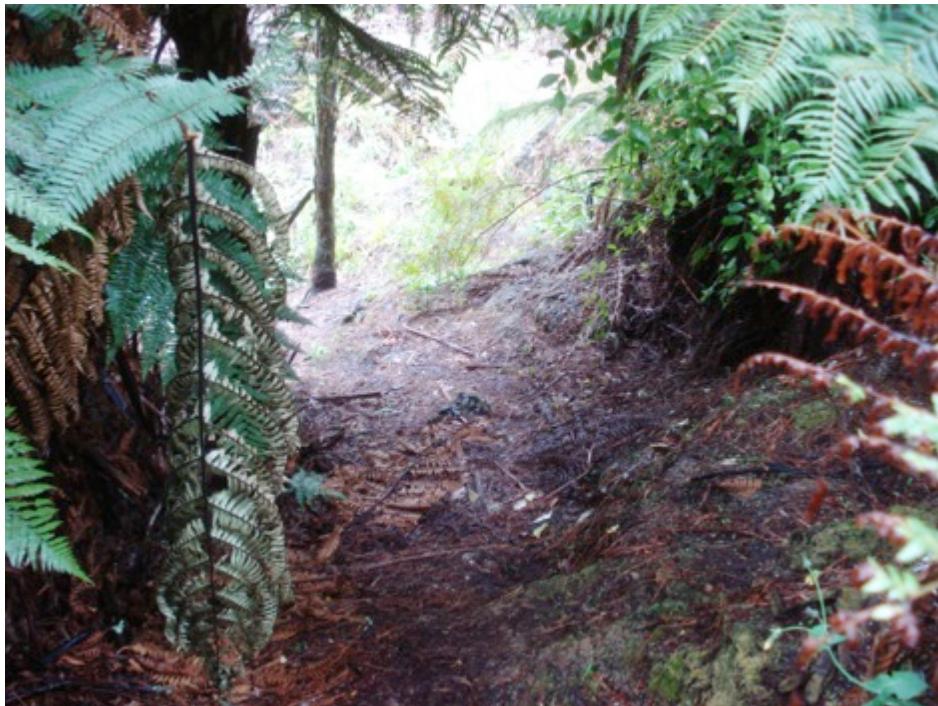
**Site of possible steps or re routed track.**

At the far end of where the stampers were they will climb either a set of steps or a re routed section of track taking them up to a higher vantage point which will be fenced due to a vertical drop.

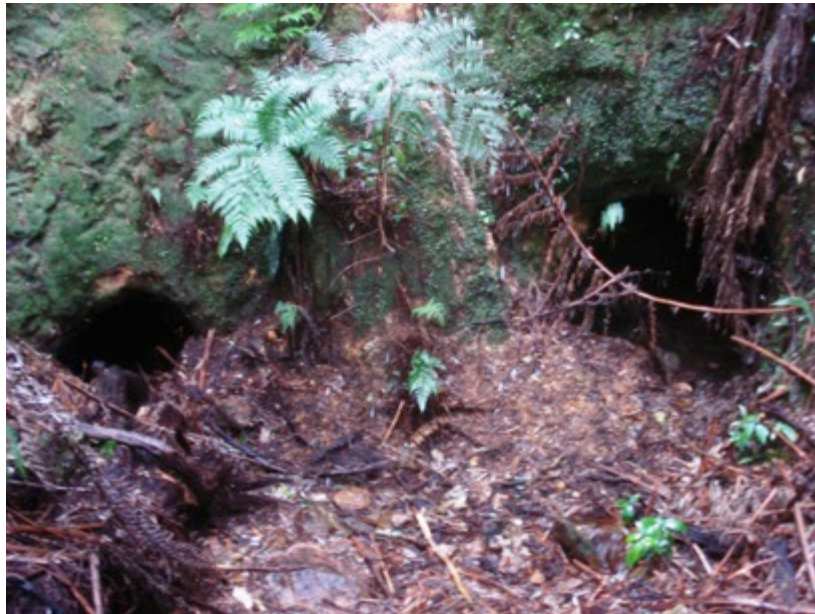
**Twin Portals of the Old Trio Mine.**

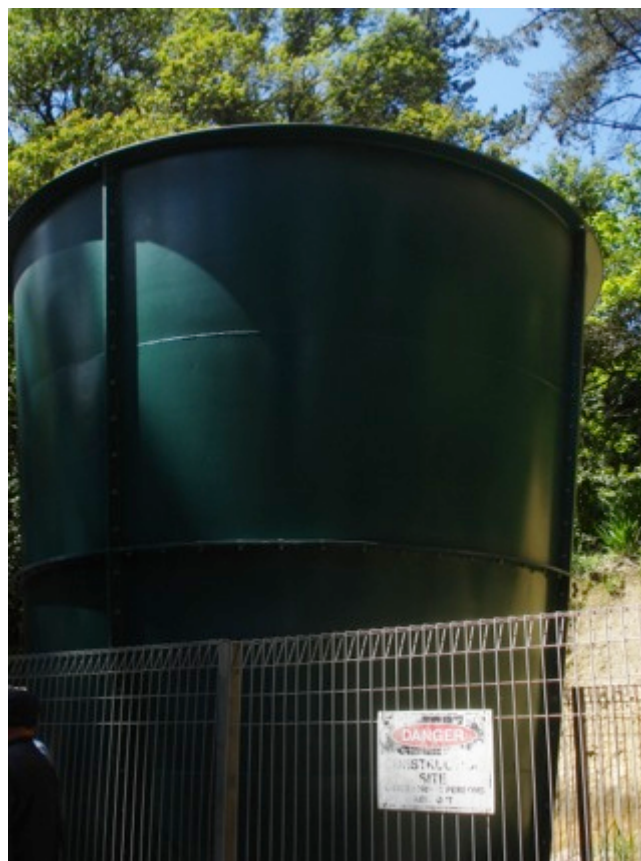
**Vent fan for the present mining activities.**

Continuing along this road they will come up to the vent fan/shaft for the trio underground mine. Here will be placed suitable warning/explanation signs.

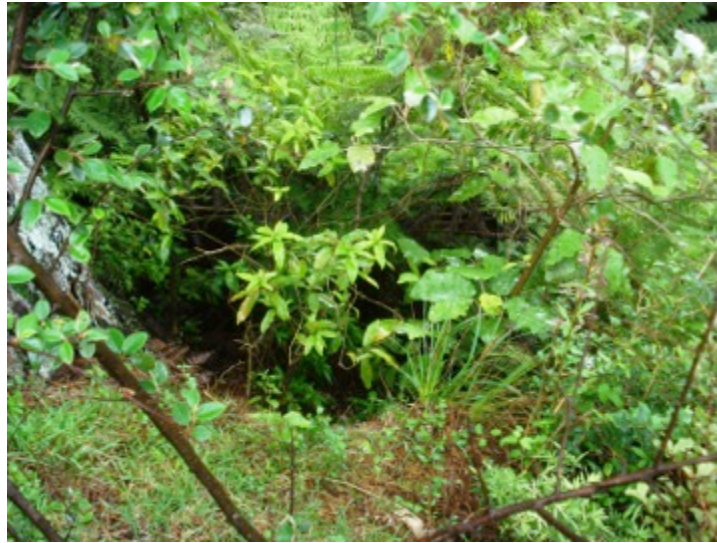
**Air vent from one of the Kilns.**

Following the road up towards the conveyor belt they will find on their left hand side a sign warning of the kilns and open air vent shafts.

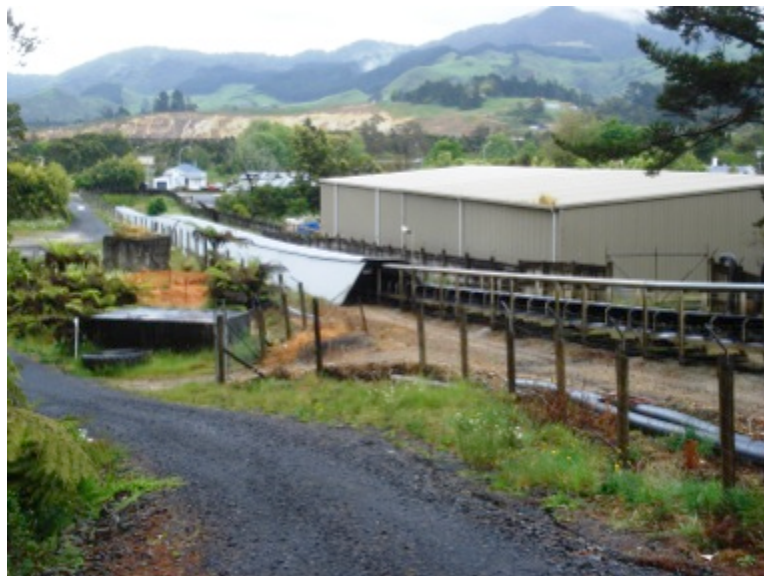
**Site of the Waihi Company's Refinery.**

Exiting at the conveyor belt the walker will walk down towards the car park passing the site of the Waihi Company's refinery site. Here on the right will be a sign locating the site as well as the  $\frac{3}{4}$  buried vault to explain what they are looking at.
