# **WAIHI NORTH PROJECT – FAST TRACK APPROVAL: ASSESSMENT OF HISTORIC HERITAGE AND ARCHAEOLOGICAL EFFECTS**

## **APPENDICES**

Prepared for Oceana Gold (New Zealand) Ltd  
Document Number:

January 2025

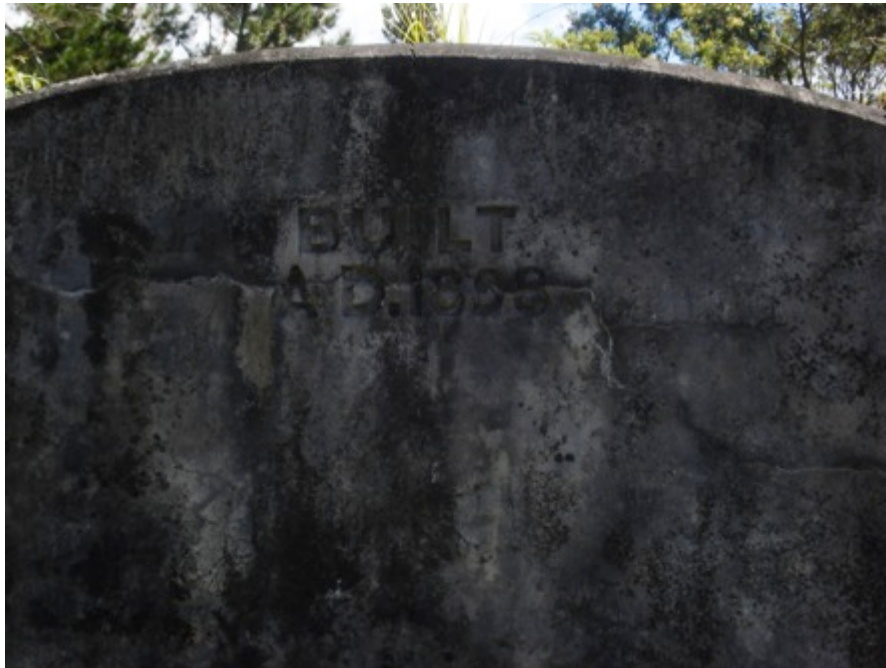
A little further down on the left there they will see a vault with Made in 1898 stamped into it. This is also the site of Mineral Resources Smelt house.

**The 1898 vault. Also the site of Mineral Resources Smelt house.**

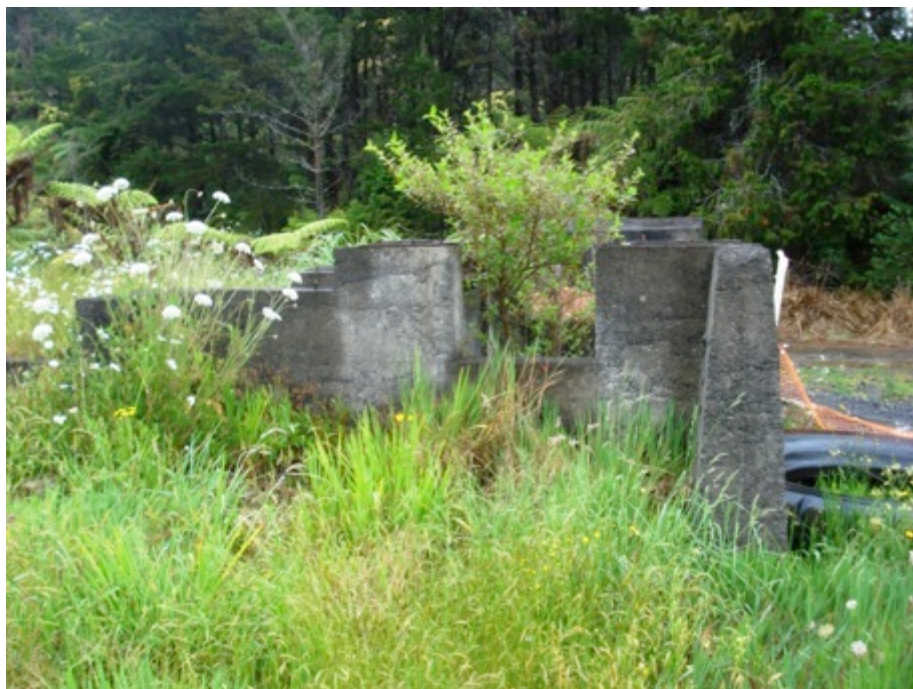
**Mineral Resources crusher foundations.**

On the right hand side almost opposite is another lot of foundations which as will be explained are the foundations of Mineral Resources Crushing plant.
