**Project Number 16998.000.002**

**Cannon Point Stage 3 Geotechnical  
Investigation for Resource Consent**

10 Cannon Point Road, Craigs Flat, Upper  
Hutt, Wellington 5018

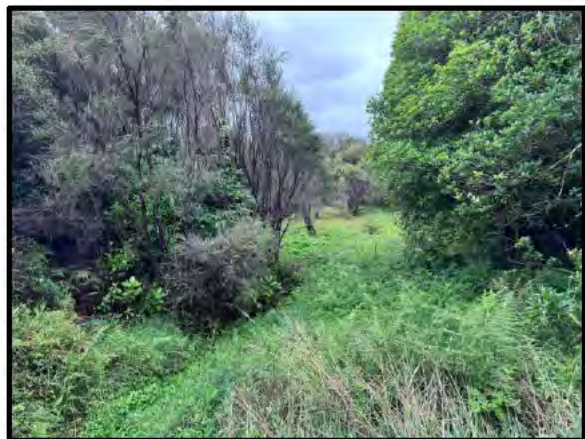
Photo 2: Catchment two feeding wetland area, central site.

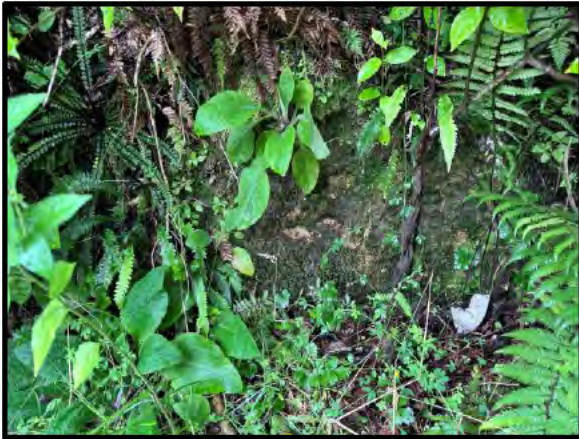
Photo 3: Colluvium identified in farm track cut, west of site.

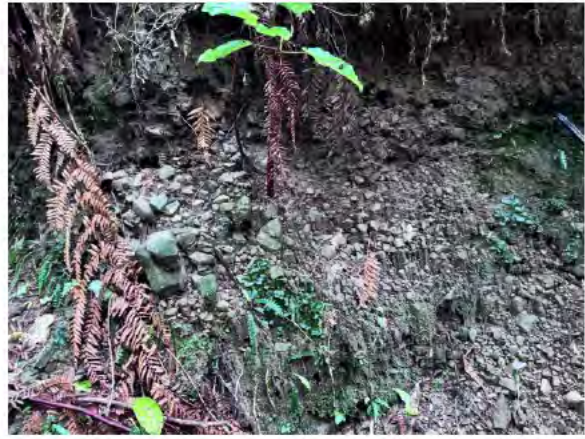
Photo 4: Small-scale debris flows in streams above site.

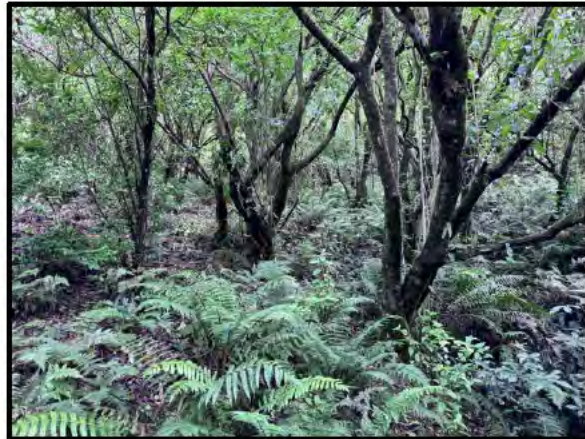
Photo 6: Native vegetation on slopes above the site.
