## 8.4 Archaeological Values

## 9 Golden Bar Haul Road

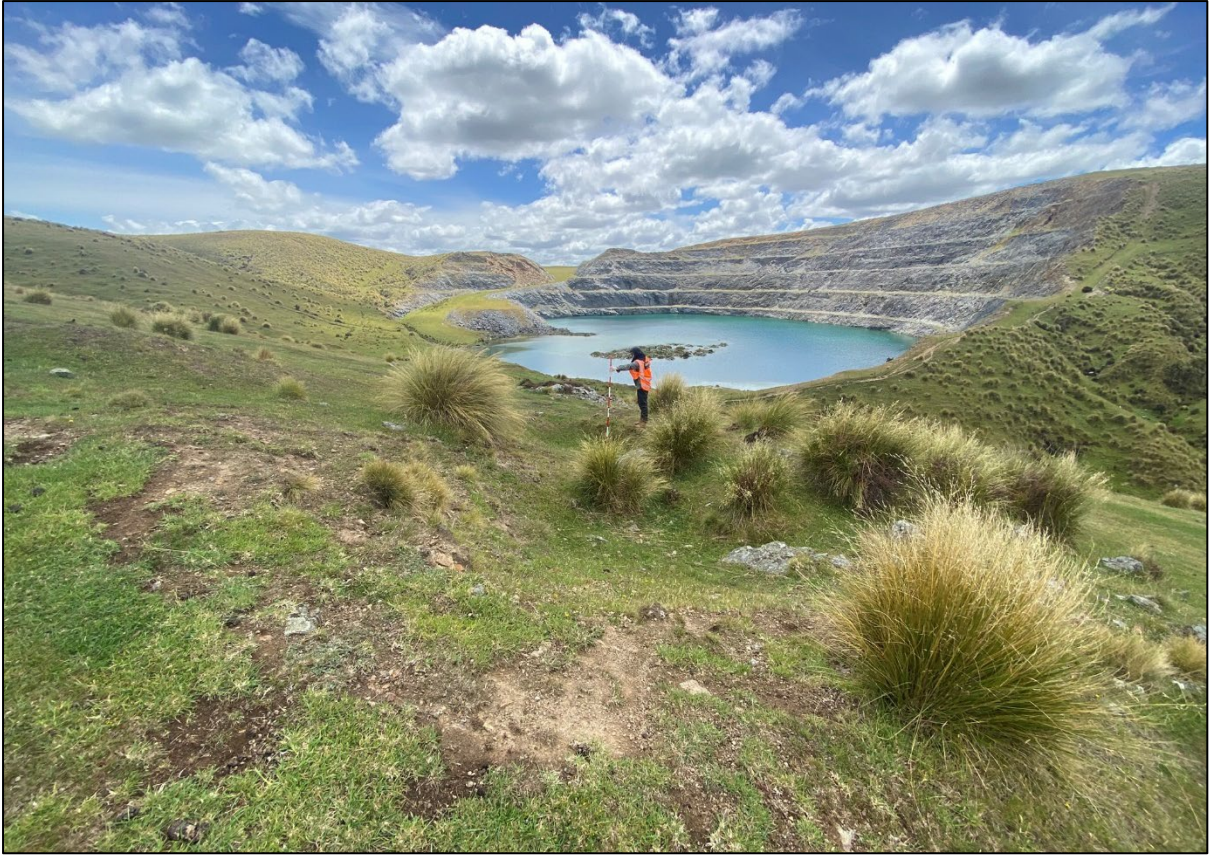
Figure 101. Prospecting pit (P4), looking north-west.

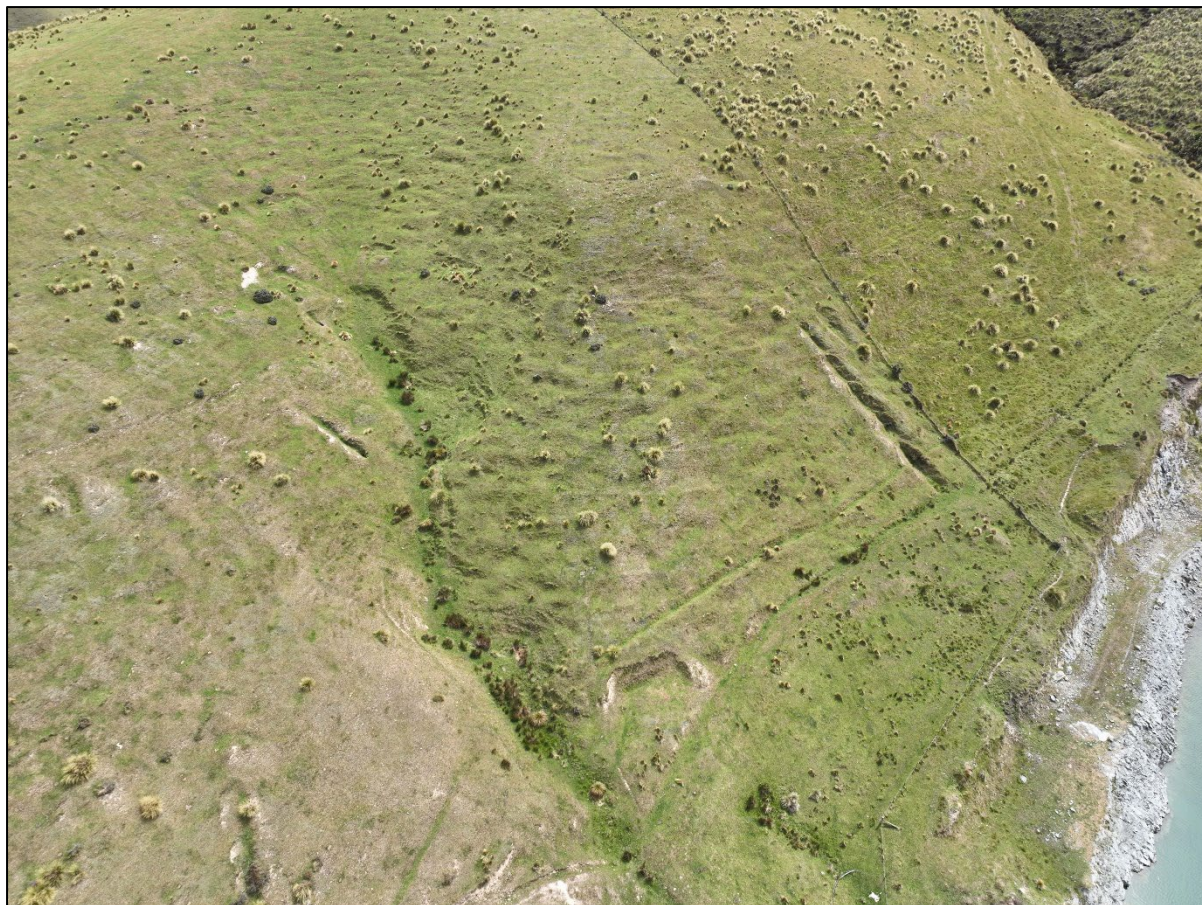
Figure 103. Mine workings to the west of pit lake and hut 6 (H6), looking west.

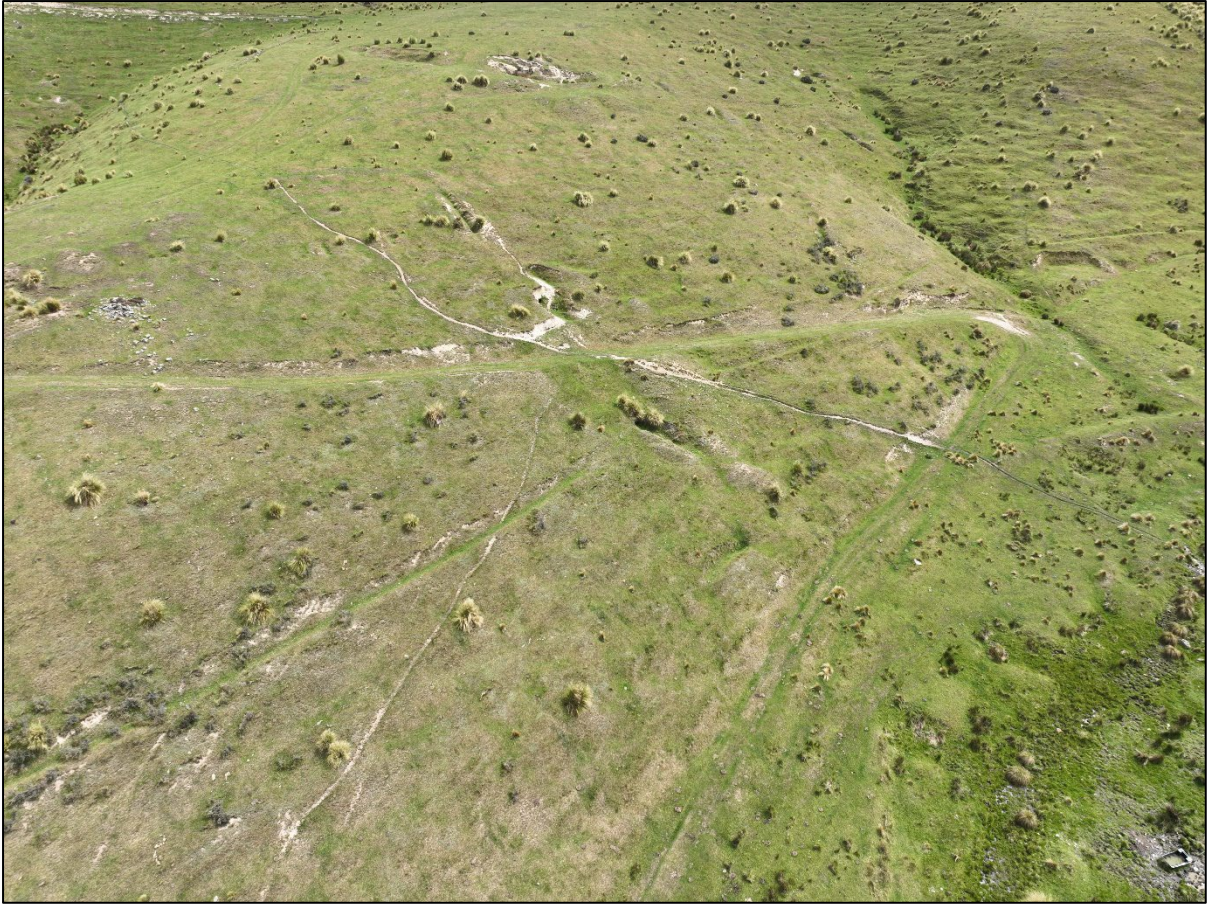
Figure 104. Mine workings to the west of pit lake, looking west.

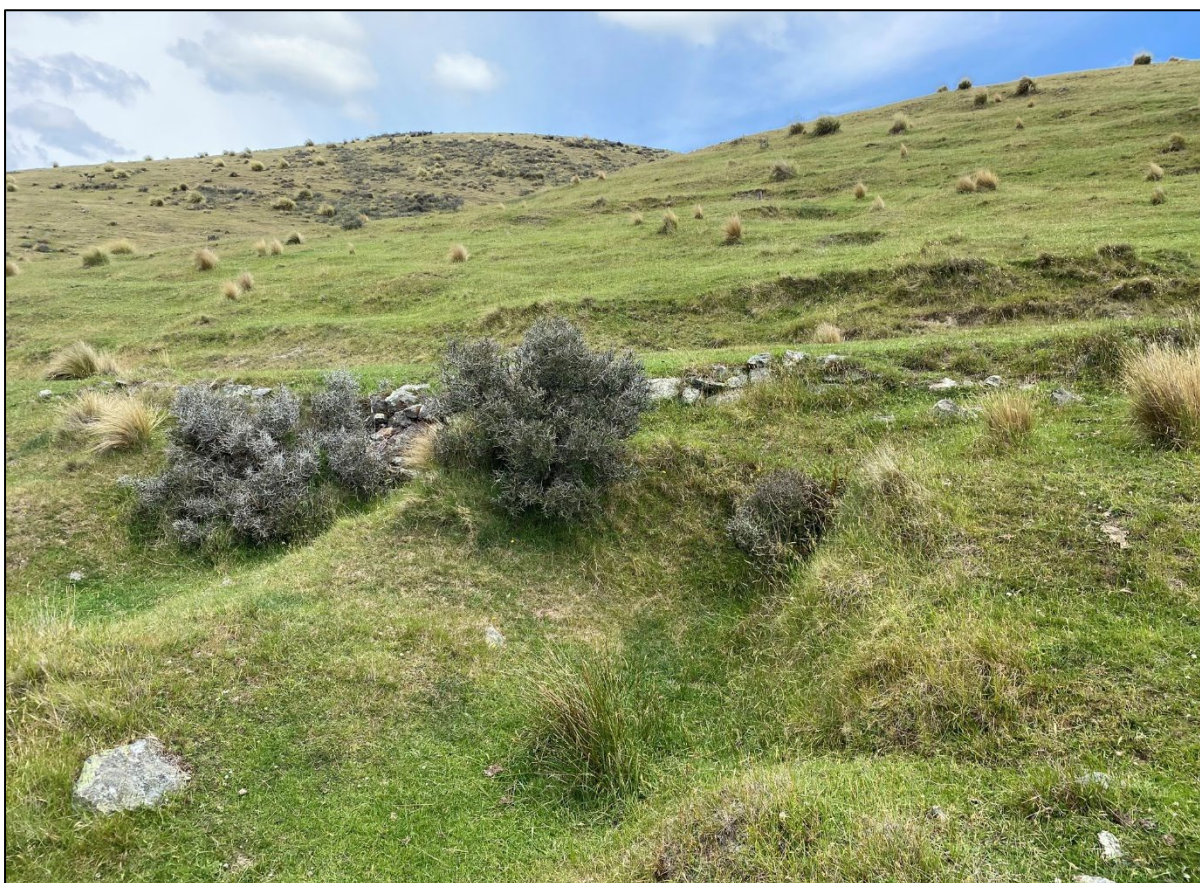
Figure 107. Stone revetting along track (ST), looking south-west.

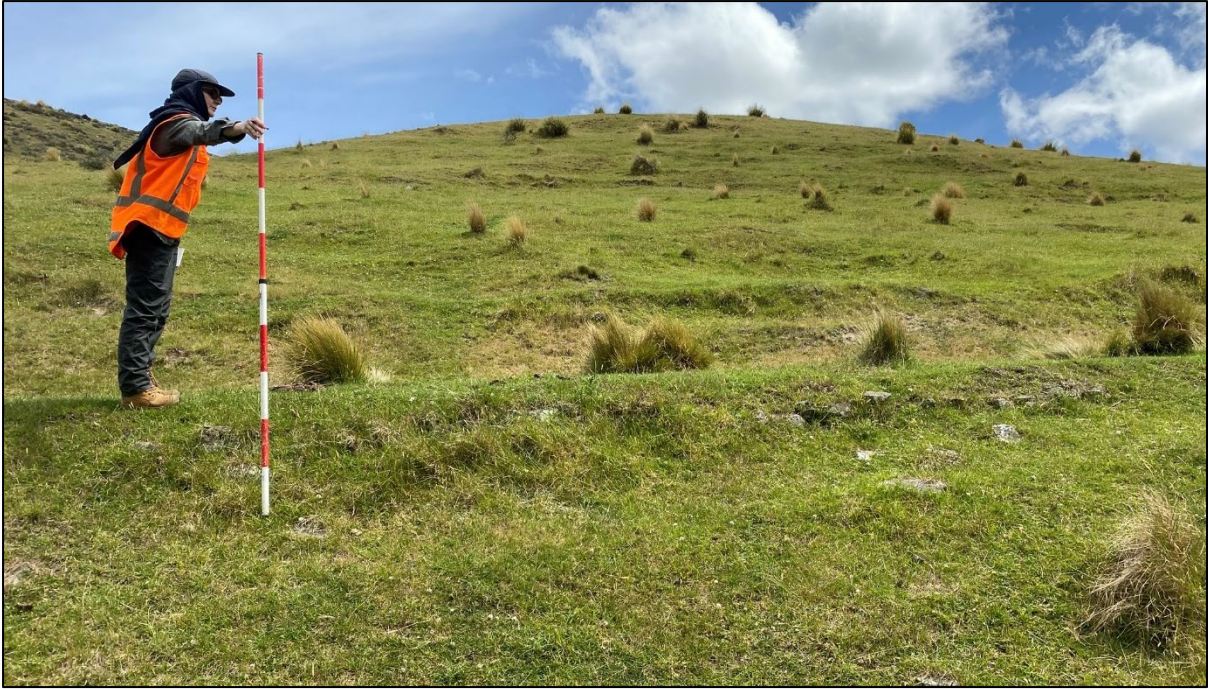
Figure 108. Stone revetting along track (ST), looking south-west.

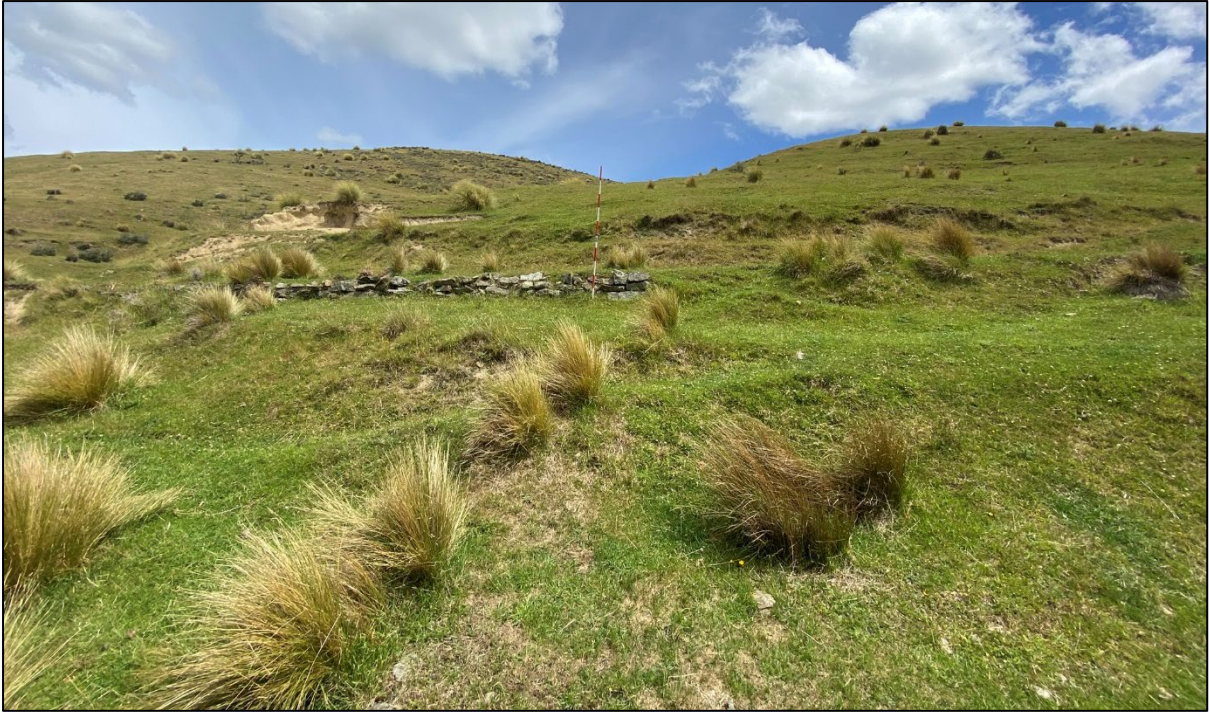
Figure 110. Detail of stone revetted track as shown above, looking south.

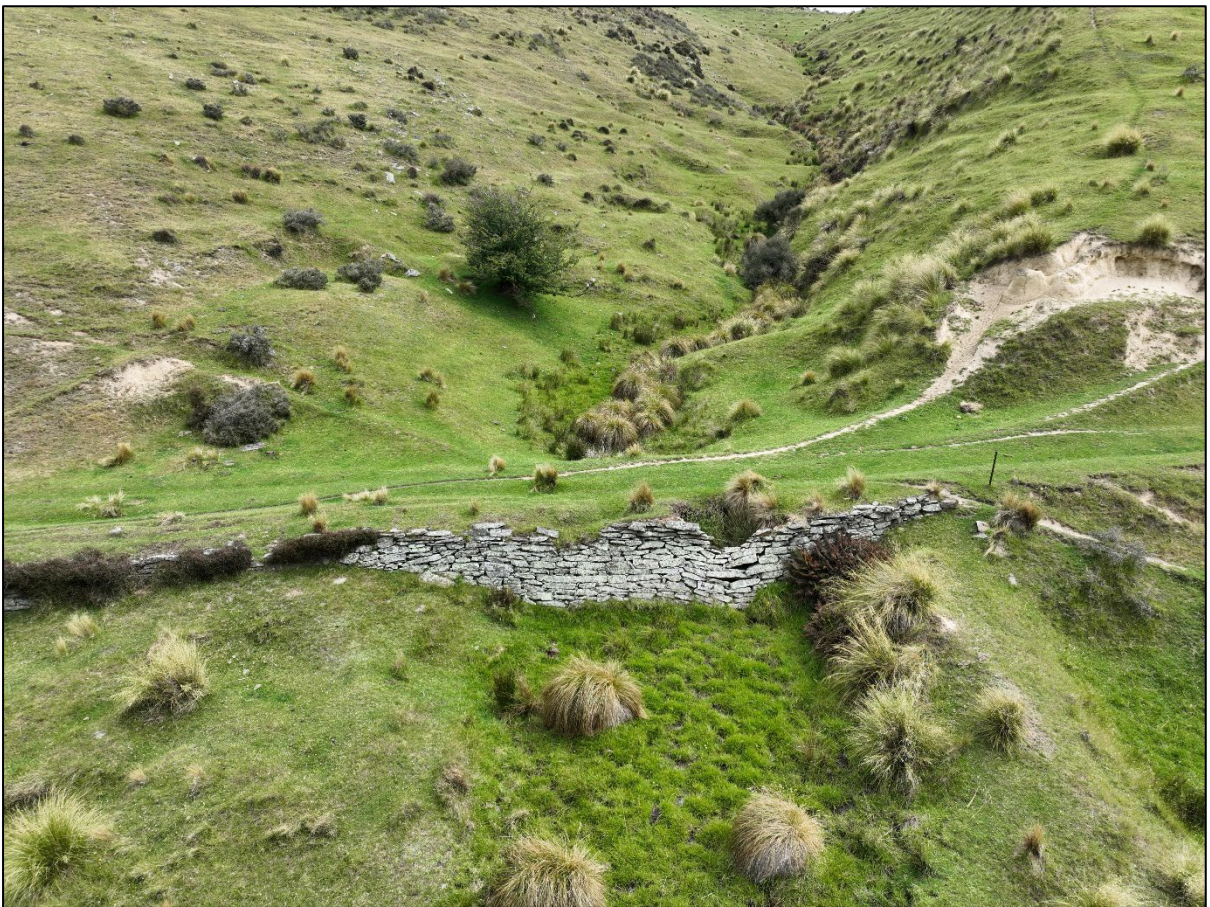
Figure 111. Major revetment, looking south-west.

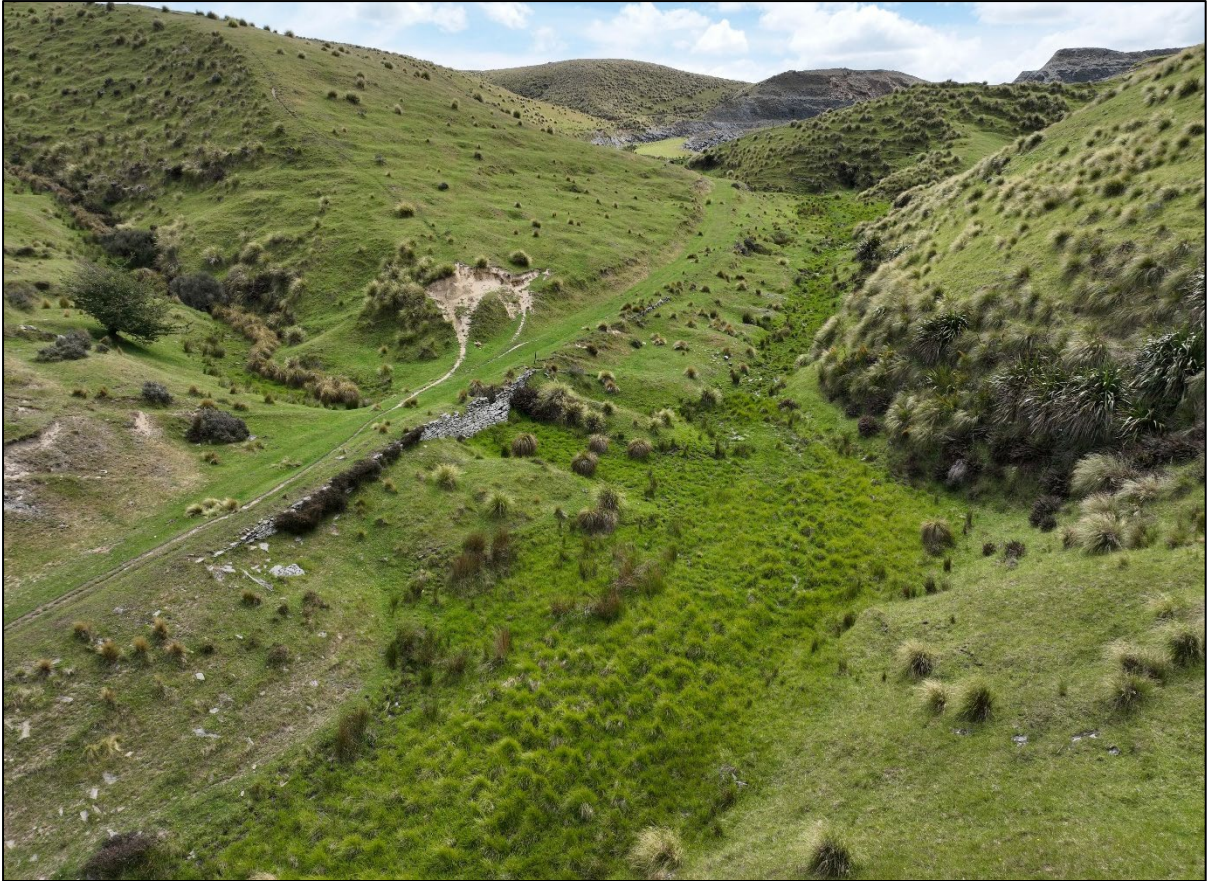
Figure 112. Showing the major revetment along the track in relation to the creek, looking north-west.

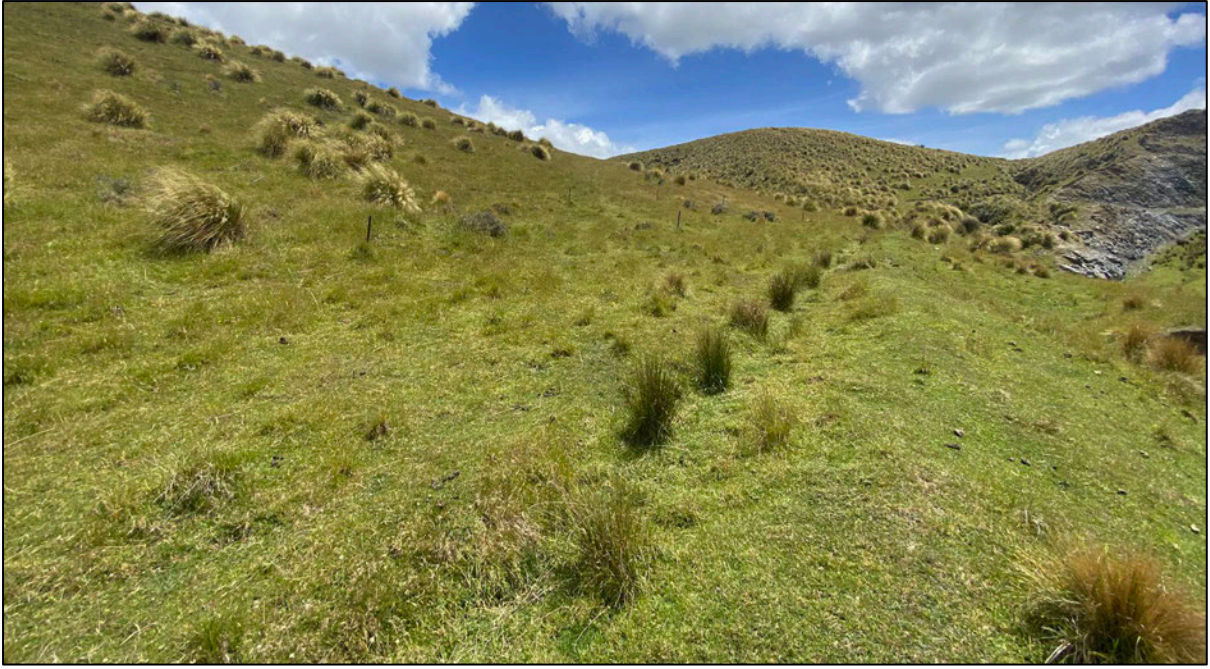
Figure 116. Showing northern most end of the water race (WR). Steel waratahs to the left mark extents of Hut 7 and Hut 8, looking west.

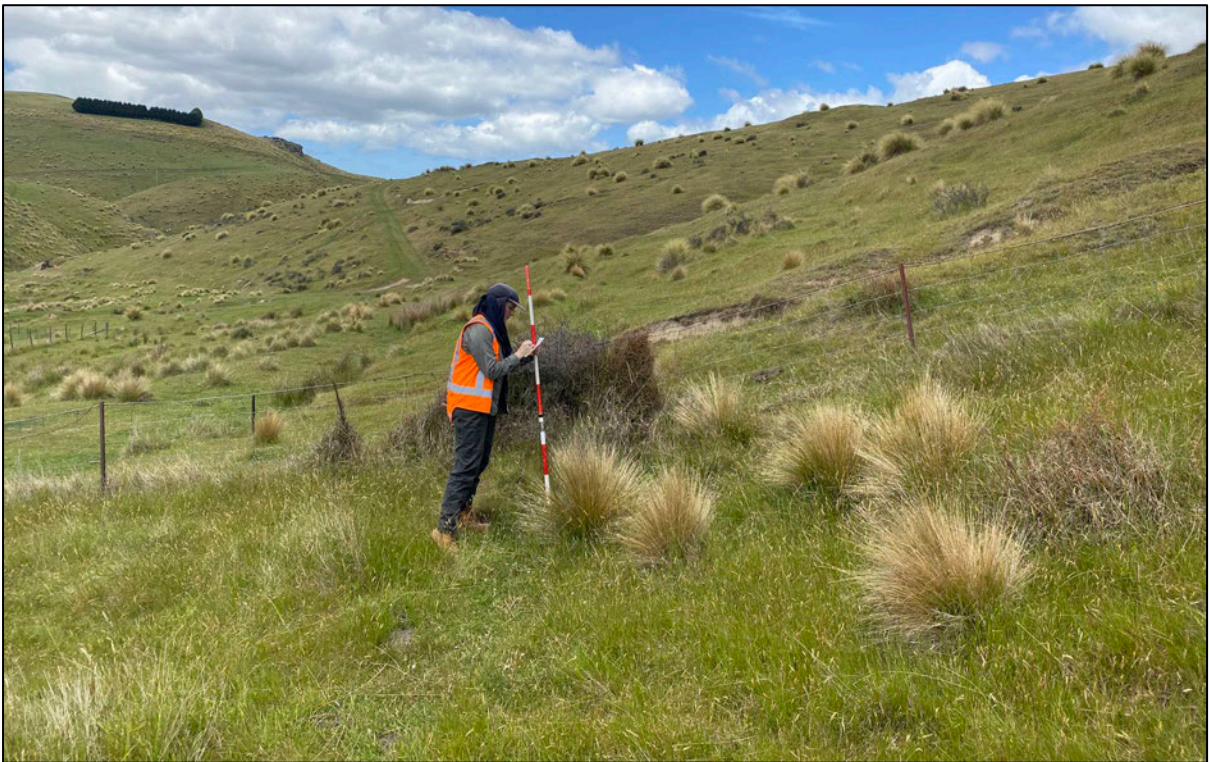
Figure 117. Looking along water race (WR), looking south-east.

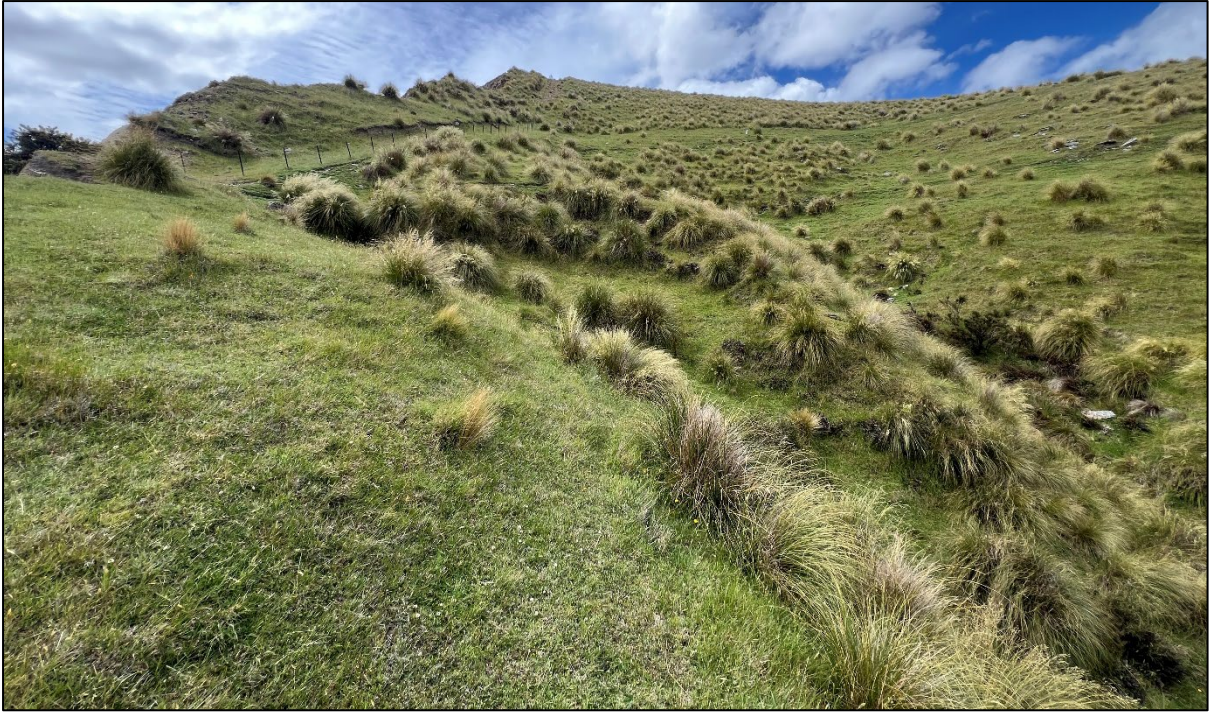
Figure 122. Sluced gully, looking north-west.

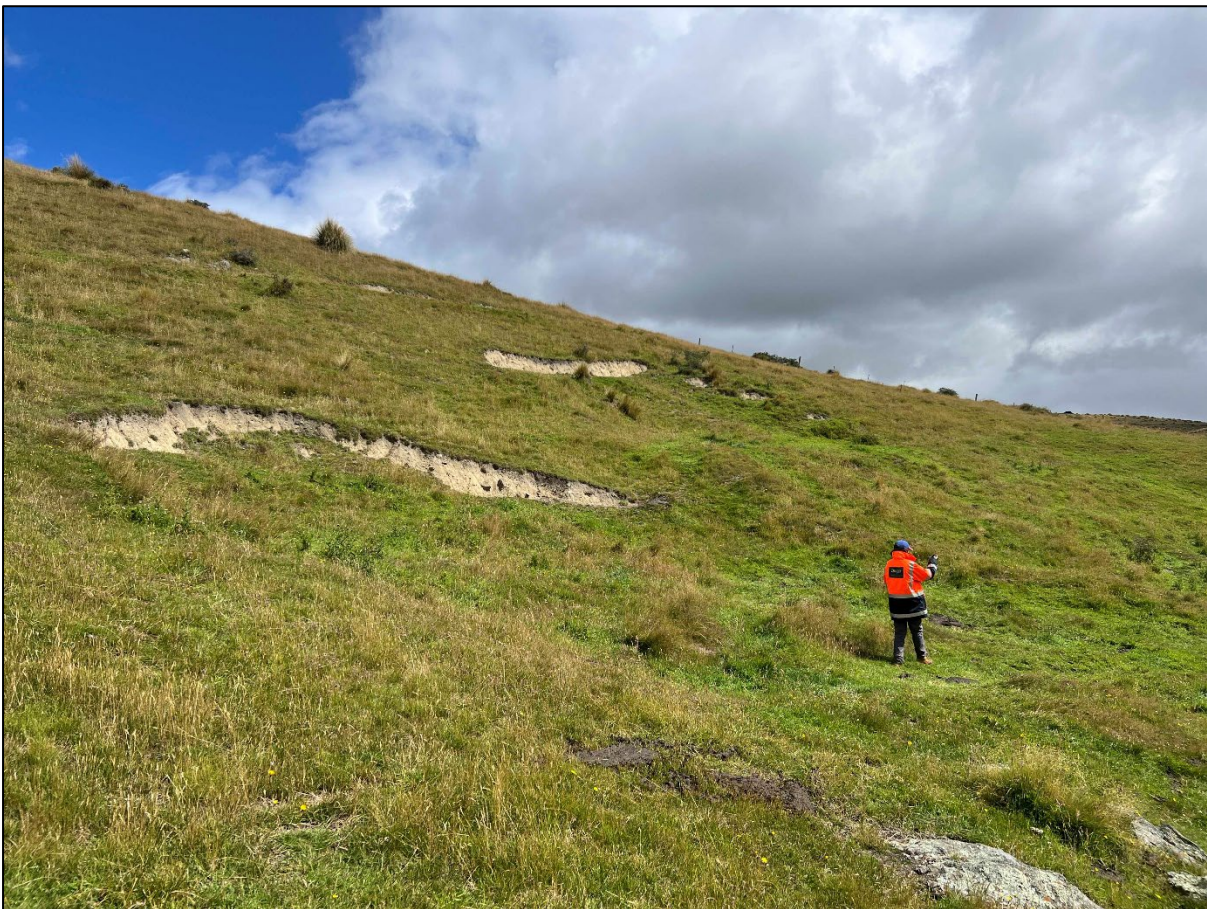
Figure 125. Slumped ground in the proposed waste rock stack area, looking south-west.

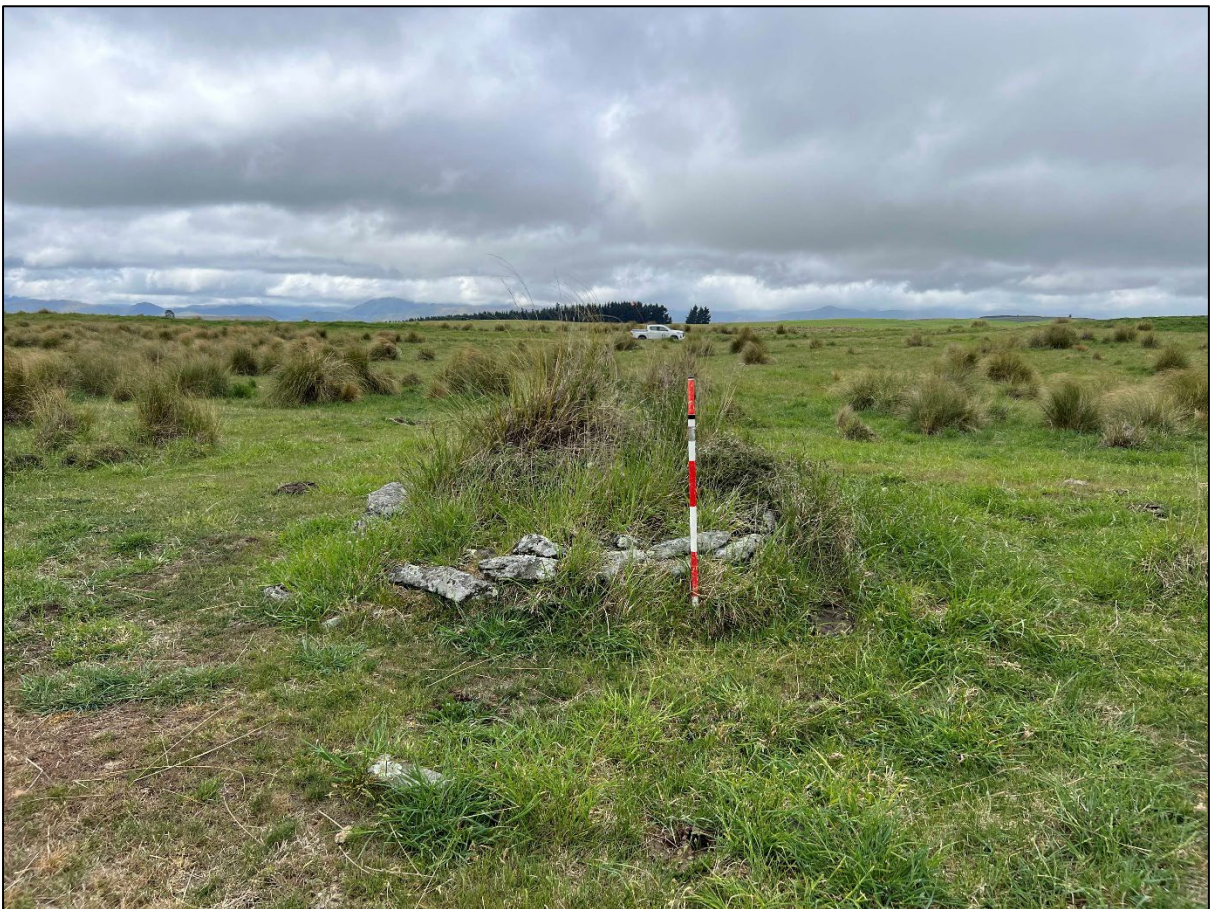
The historic Trig D survey mark consists of an approximately 200mm high circular plinth, walled with schist boulders, surmounted with an iron 'bayonet' type marker (Figure 138-Figure 139).<sup>189</sup> The feature is overgrown with grass. Hamel<sup>190</sup> interpreted this as a 19<sup>th</sup> century feature, and it possibly dates to the establishment of the mark at some point prior to 1867.<sup>191</sup>

Figure 138. I42/41 (Trig D), looking north-east towards a truck on Golden Bar Road in the background.

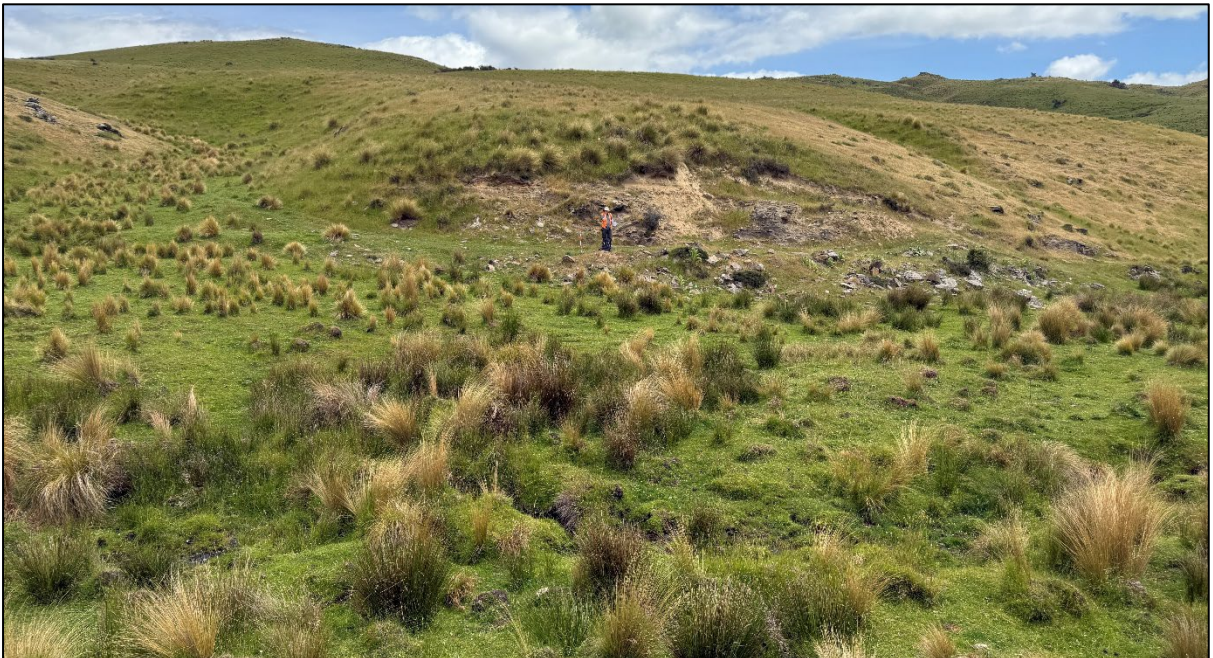
| Ref | Details |
|---|---|
| <b>CC19</b> | Series of subtle mounds possibly representing the remains of paddocking type workings (Figure 190). |

Figure 190. Area marked as mining area on Teele's survey map (CC19), looks west.

| Site | Value | Assessment |
|---|---|---|
| <b>I42/221 (Coal Creek Alluvial Workings)</b> | Condition | The remains of paddocking style gold workings would have never been distinct but have been further impacted by erosion and vegetation. Any other remains would be related subsurface.<br><b>Assessment – Poor and Below Ground</b> |

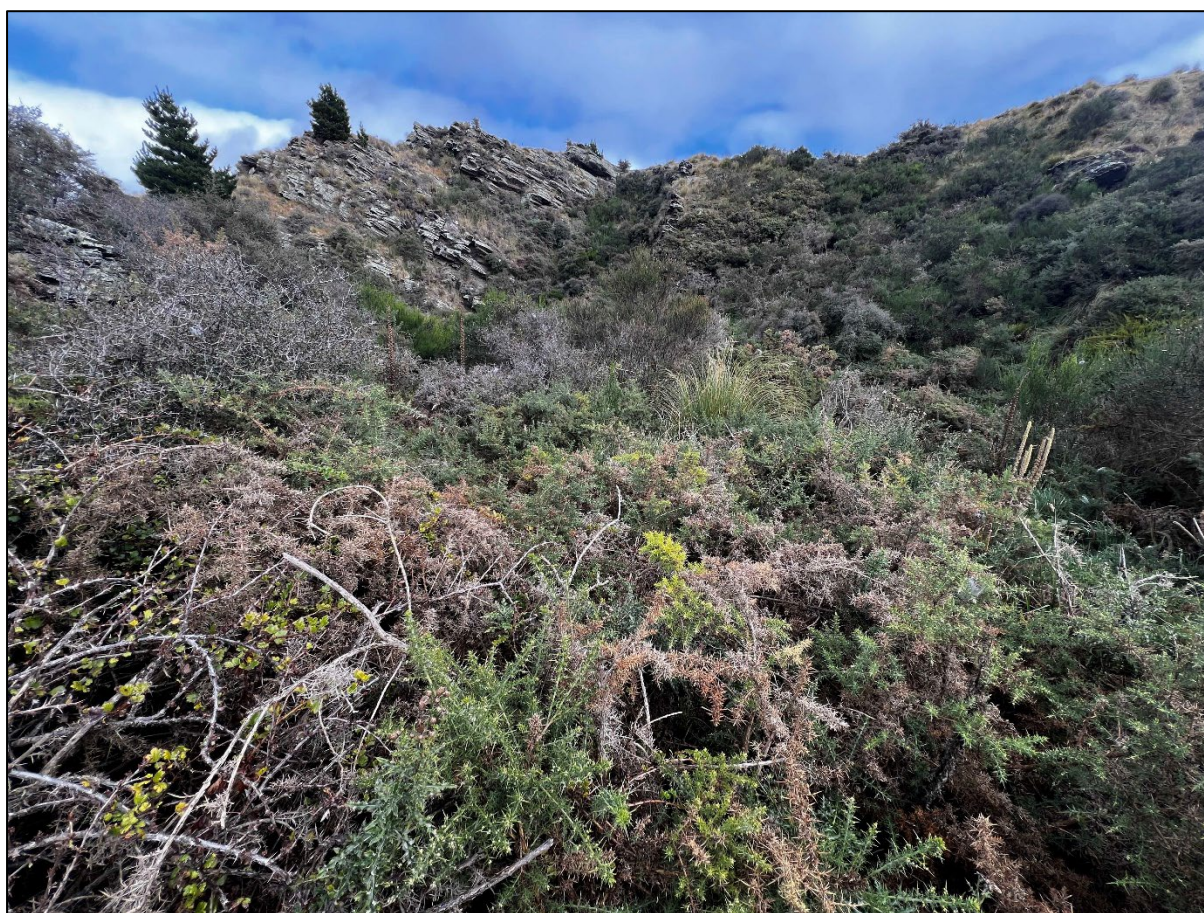
Figure 199. Inaccessible vegetation near the recorded location of I42/151, looking west.

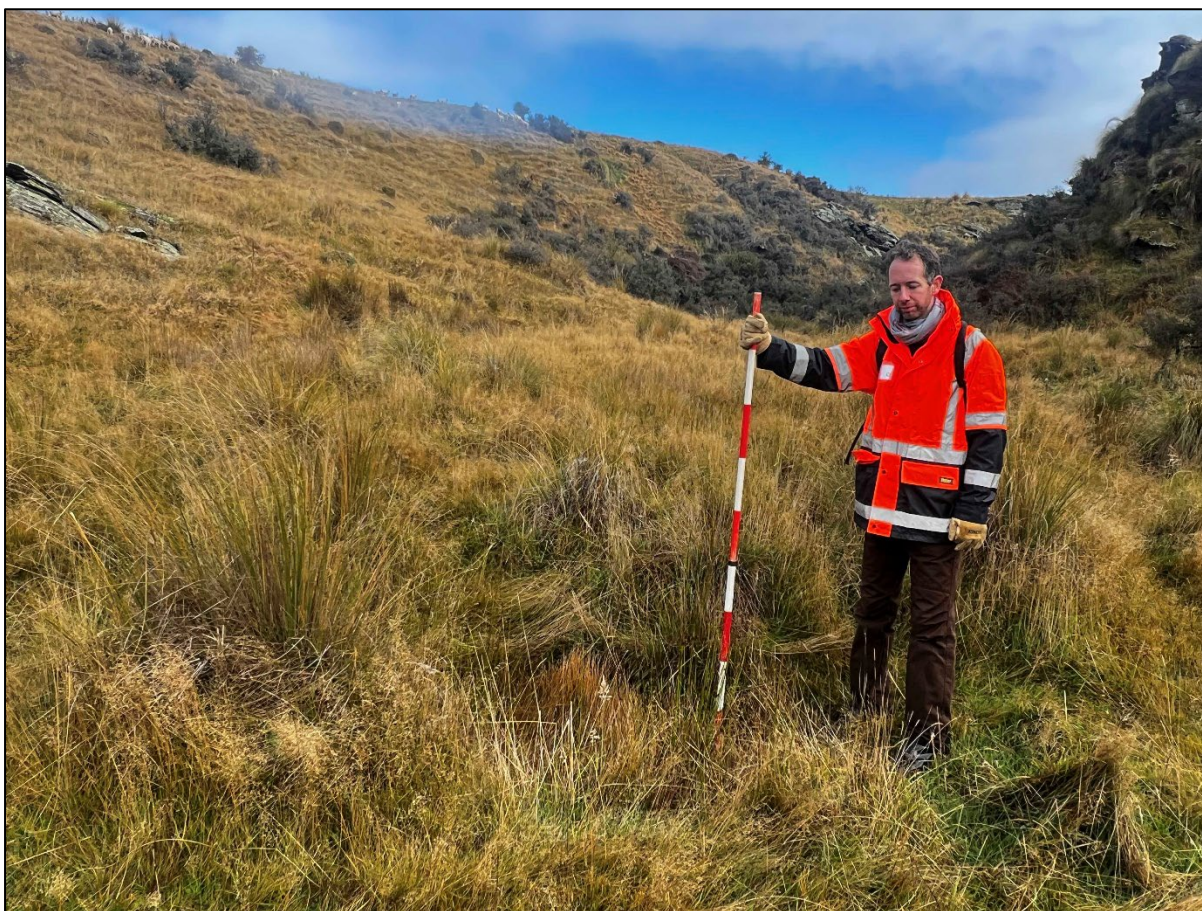
Prospecting pits were inspected at I42/152 (one pit; Figure 201) and I42/148 (two pits). These were all approximately 2m wide and 800mm deep. The pit recorded as I42/150 was not accessible because of vegetation growth.

Figure 201. Prospecting pit at site I42/152, looking north-west.
