# PRELIMINARY GEOTECHNICAL REPORT

## TE KOWHAI DEVELOPMENTS

PROJECT NO: HD1996  
LYSAGHT CONSULTANTS  
REFERENCE: PGR  
25 MAY 2021

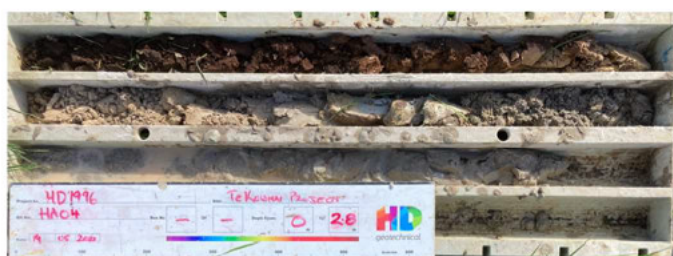
End of log at 2.8 m. Borehole collapse.

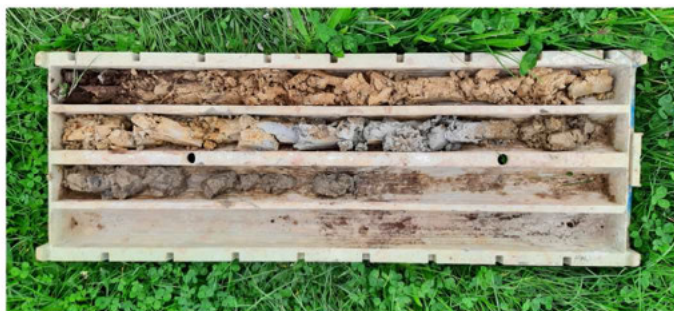
End of log at 2.5 m - material collapse within borehole.

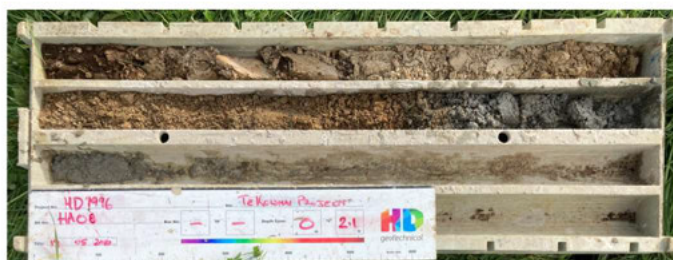
End of log at 2.1 m - material collapse within borehole
