# Geotechnical Assessment A Drive Borrow Pit, Stockton Mine

Bathurst Resources Limited

✦ March 2026

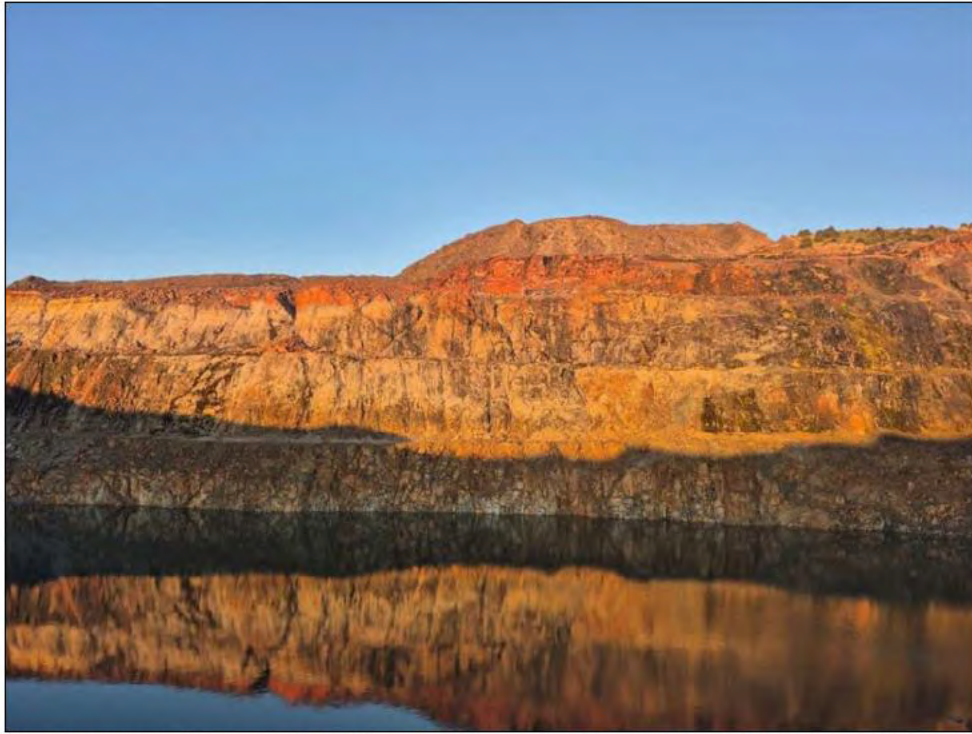
Figure B3: Photograph looking south at face of the southern highwall – 1 July 2025 - Pit Lake visible in foreground.

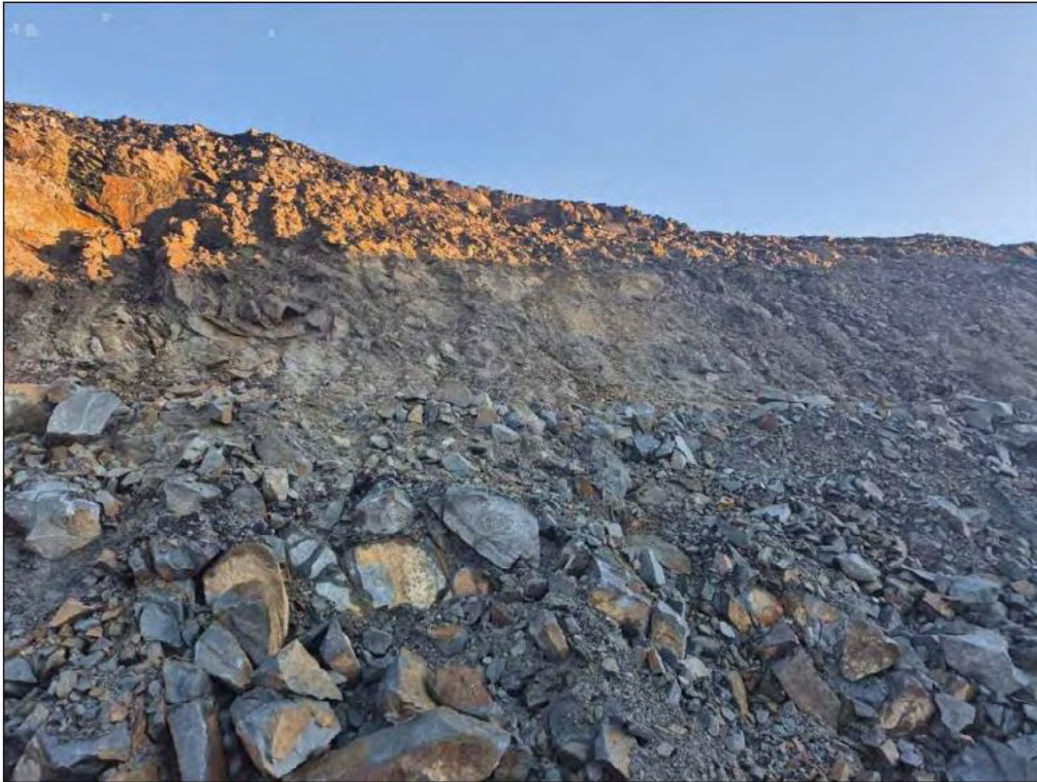
Figure B7: Example of previously blasted granite aggregate.
